NC DEPARTMENT OF TRANSPORTATION  
DIVISION OF HIGHWAYS  
STRUCTURE MANAGEMENT UNIT

## Structure Safety Report

### Routine Element Inspection - Contract

COUNTY: WAKE STRUCTURE NUMBER: 910252 FREQUENCY: 24 MONTHS

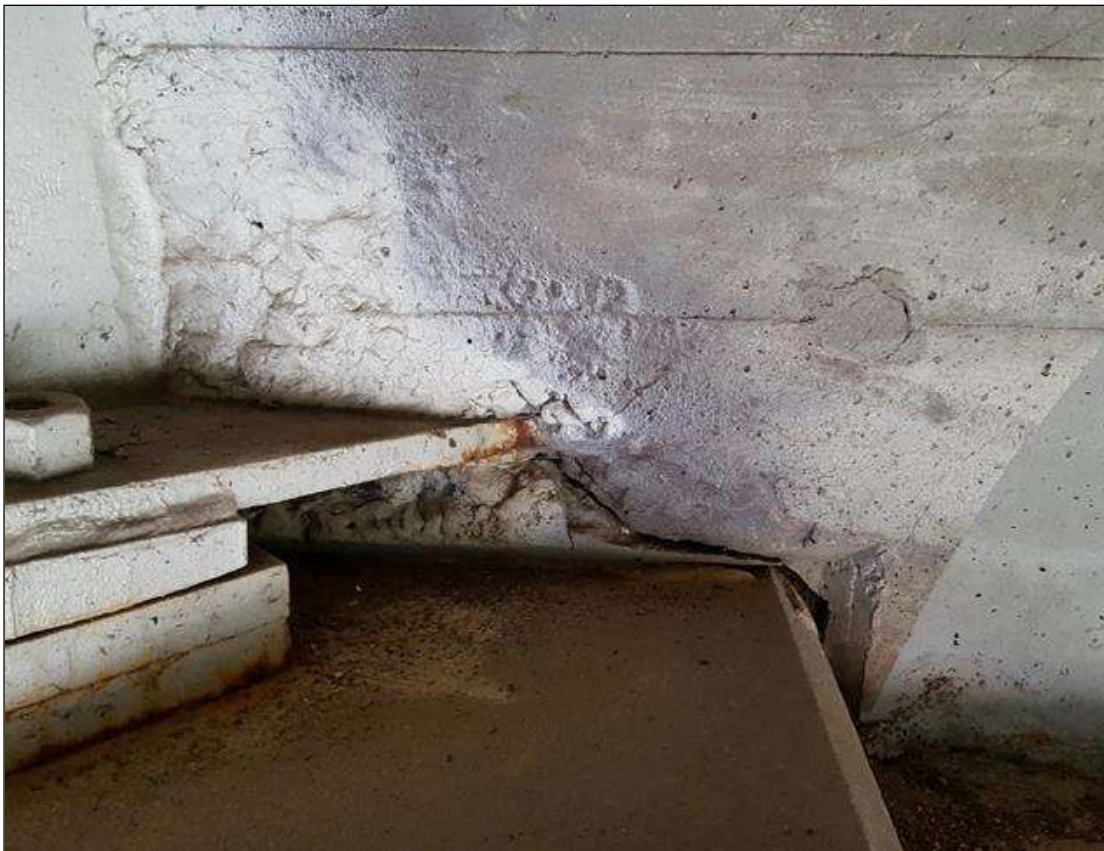
End Bent 1 Abutment/Backwall : 18" X 6" X 2" SPALL AT ENDS OF BEAMS 4, CURTAIN WALL, SIMILAR AT BEAMS 1, 2, AND 3

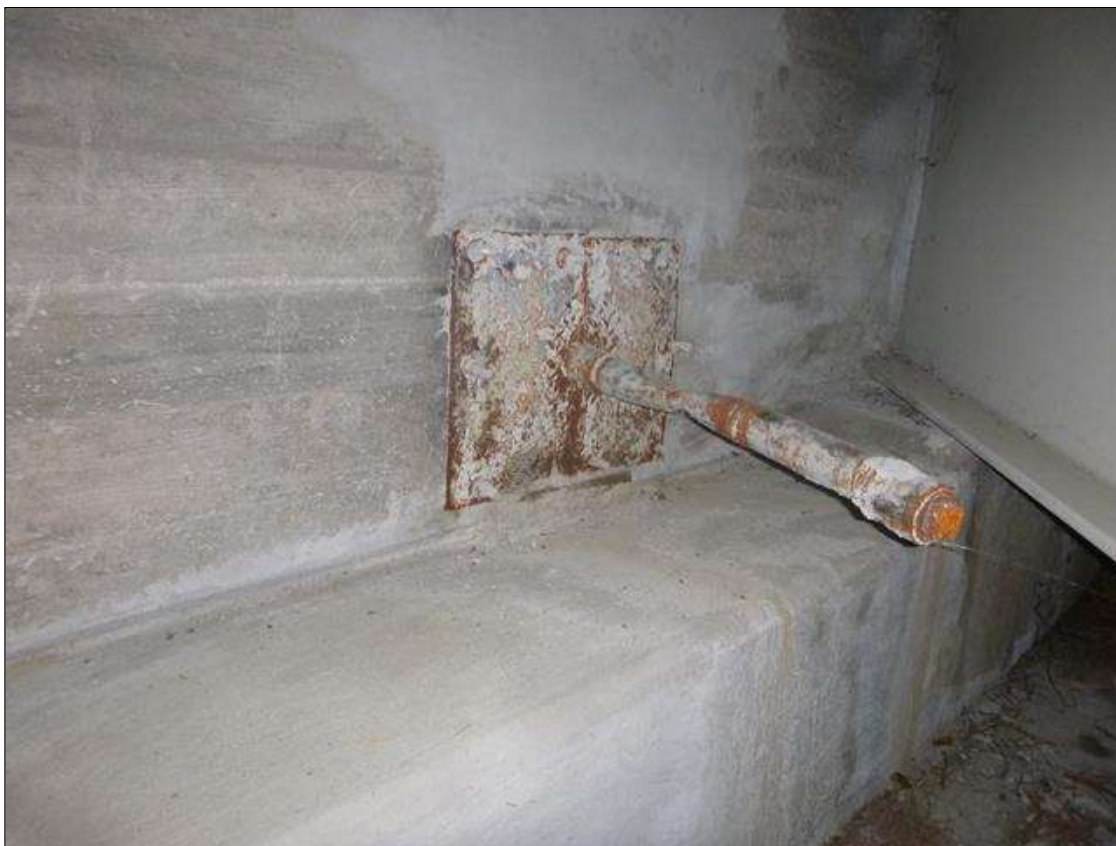
ABANDONED UTILITY AT END BENT 2, BAY 3

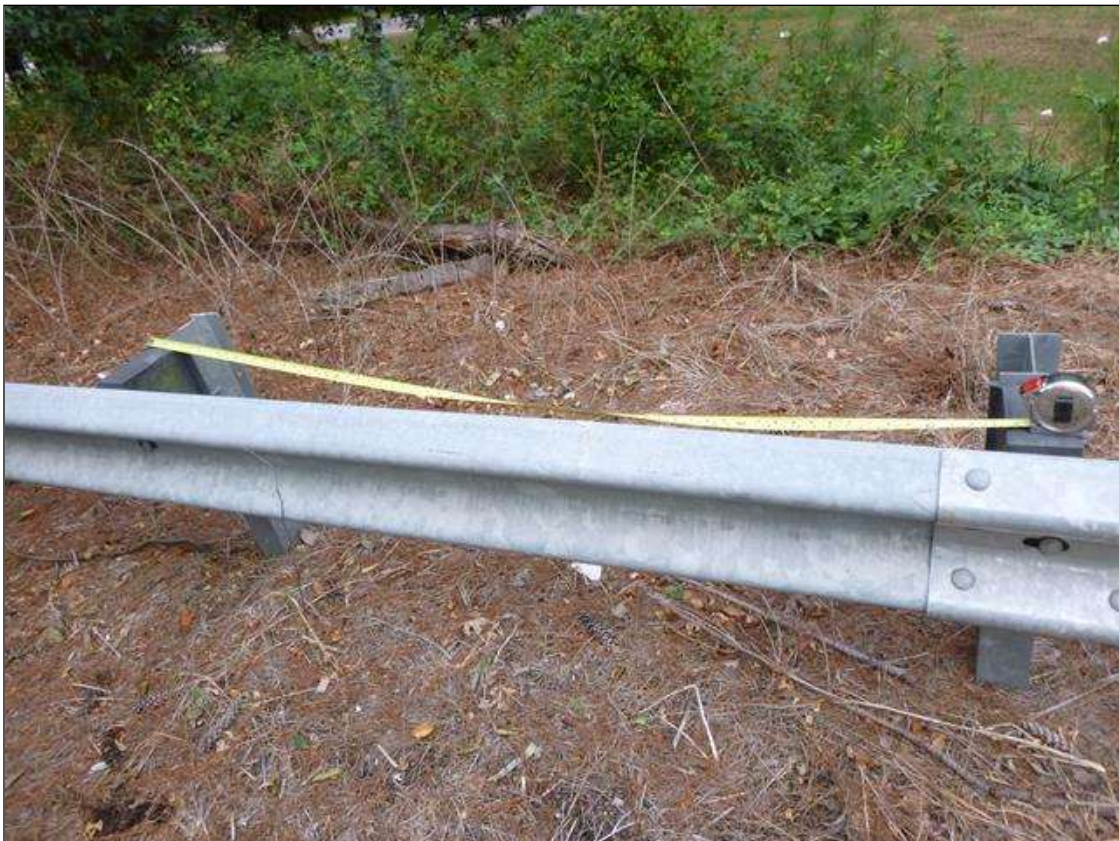
APPROACH GUARD RAIL POST SPACING, 75 IN. AT THE SOUTH WEST SIDE, SIMILAR AT THE NORTH WEST

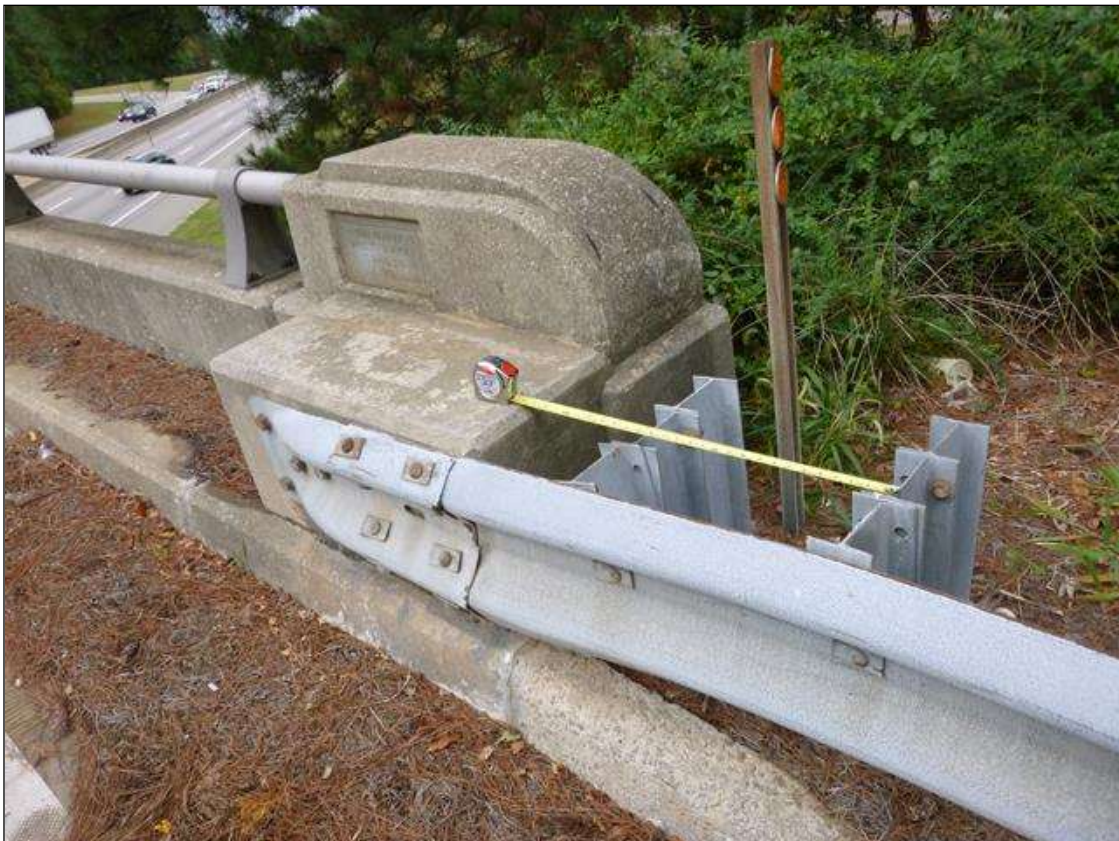
GUARD RAIL POST SPACING, 1.5 FT. AND ATTACHMENT AT THE SOUTH WEST CORNER OF THE BRIDGE,  
NORTH WEST SIMILAR

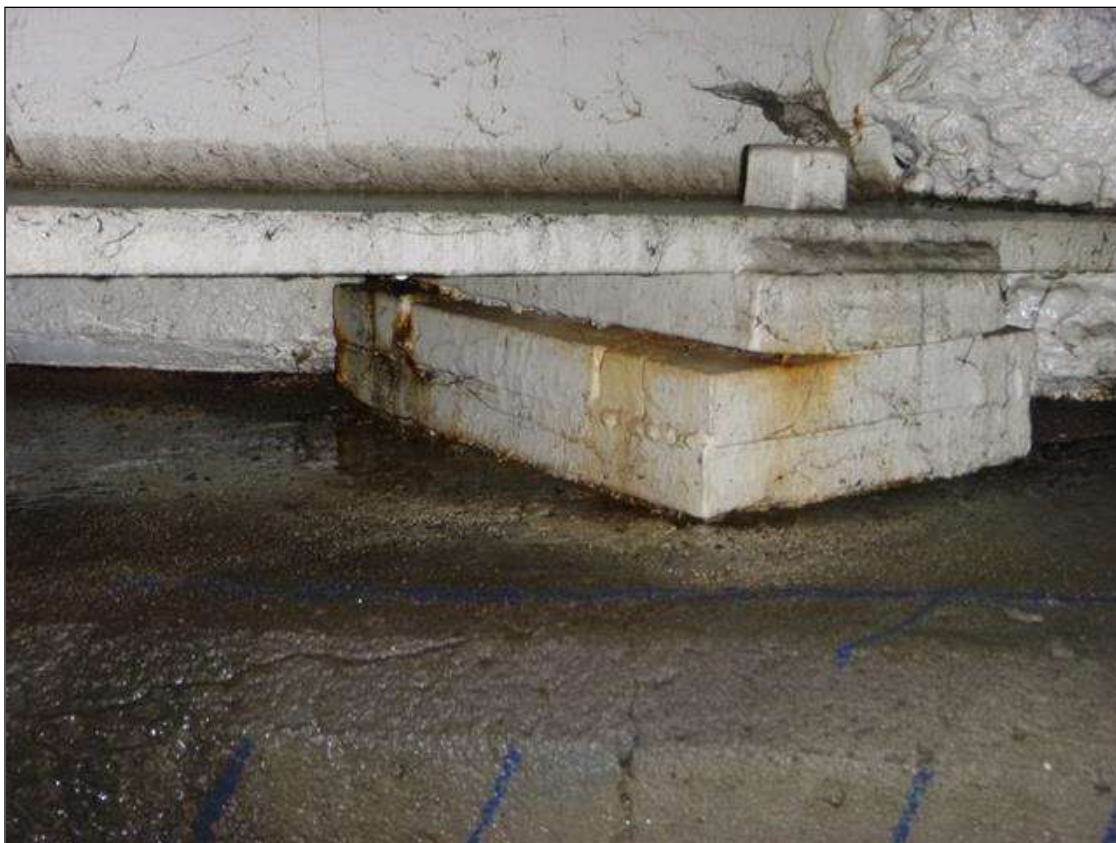
END BENT 1 BEAM 2 BEARING.

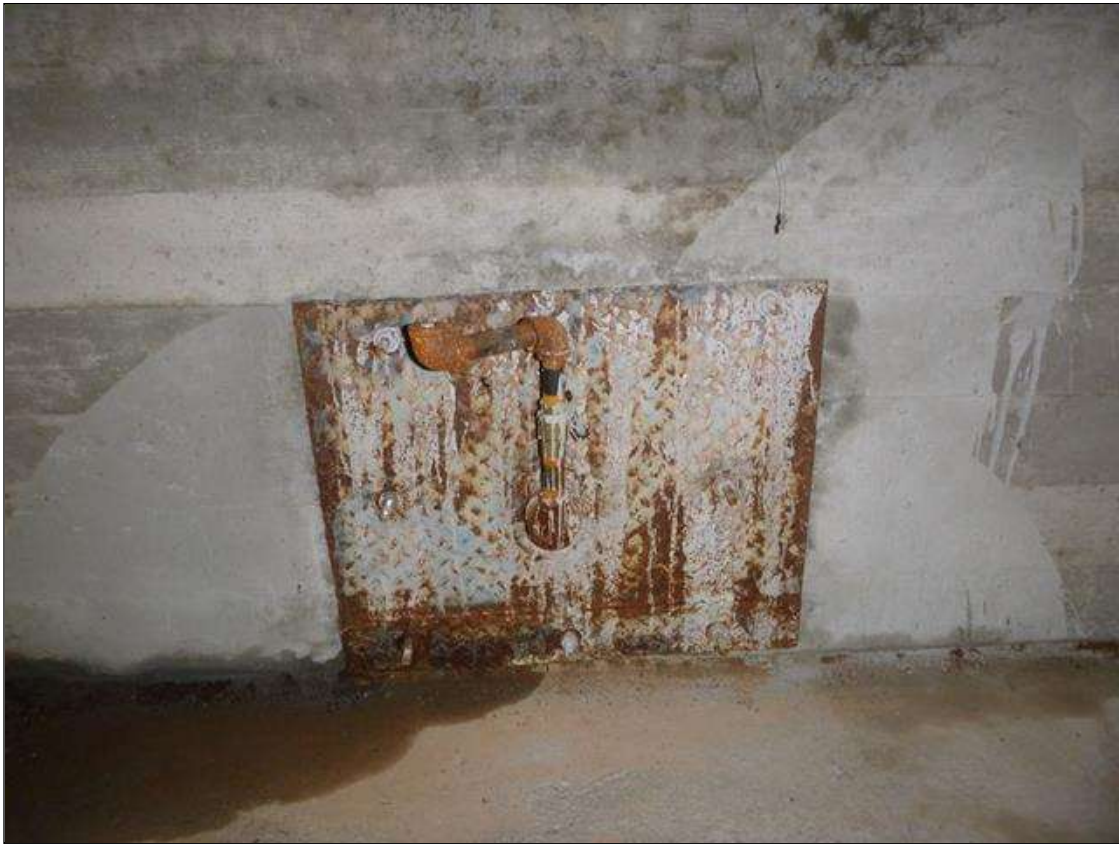
ABANDONED UTILITY ABUTMENT 1, BAY 3
