NC DEPARTMENT OF TRANSPORTATION DIVISION OF HIGHWAYS BRIDGE MAINTENANCE UNIT **ATTENTION**

BRIDGE INSPECTION REPORT

INSPECTION TYPE BRIDGE NO. 770169

STRUCTURE TYPE REINFORCED CONCRETE FLOOR ON PRESTRESSED CONCRETE GIRDERS ROUTE ORIENTATION W - E

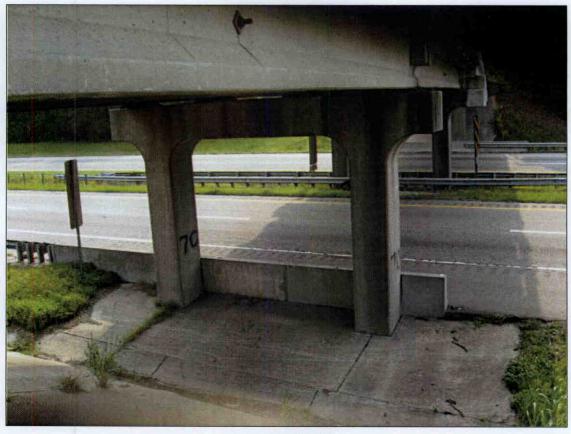
INTERIOR BENT 3

4	7	SOME MINOR SCRAPES AND MINOR VOIDS ARE PRESENT. THE CONCRETE IS SCALING, EXPOSING COARSE AGGREGATE.
6d	7	THERE IS A 6 INCH X 3 FOOT SECTION OF MISSING ASPHALT AND ROADWAY AT BENT 3.
7	7	THERE IS A MINOR BUILDUP OF STONE AND DEBRIS ALONG BOTH CURBS.
10	6	AT SPANS 1 AND 4 THE GIRDERS ARE GOOD. SPAN 2 CORED SLABS ARE GOOD. SPAN 3 GIRDERS APPEAR TO HAVE BEEN SCRAPED BY TRAFFIC. THESE SCRAPES APPEAR TO HAVE BEEN PATCHED. GIRDER 3, SPAN 3 HAS A SURFACE CHIP 6-8 INCHES LONG AND 1/2 INCH DEEP 15 FEET AWAY FROM BENT 3.
15	7	THE BEARING ASSEMBLIES IN PRECAST GIRDER SPANS WERE GALVANIZED BUT ARE NOW COVERED WITH RUST ON THE INTERIOR BENTS.
39	7	THERE IS MINOR SETTLEMENT AND UNEVENESS OF JOINTS AND SOME MISALIGNMENT. SEVERAL TRANSVERSE CRACKS ARE MISALIGNED.
50	6	BOTH APPROACHES ARE UNEVEN AND SETTLED SLIGHTLY.
54	8	SLOW TRAFFIC DUE TO SECONDARY ROAD AND SIGHT DISTANCES CAUSES LITTLE VIBRATION.
