January 6, 2012

Re: Site Inspection Report
Parcel 122A, 1211 Piney Green Road
Onslow County, North Carolina
TIP: U-3810, WBS No. 35801.1.1

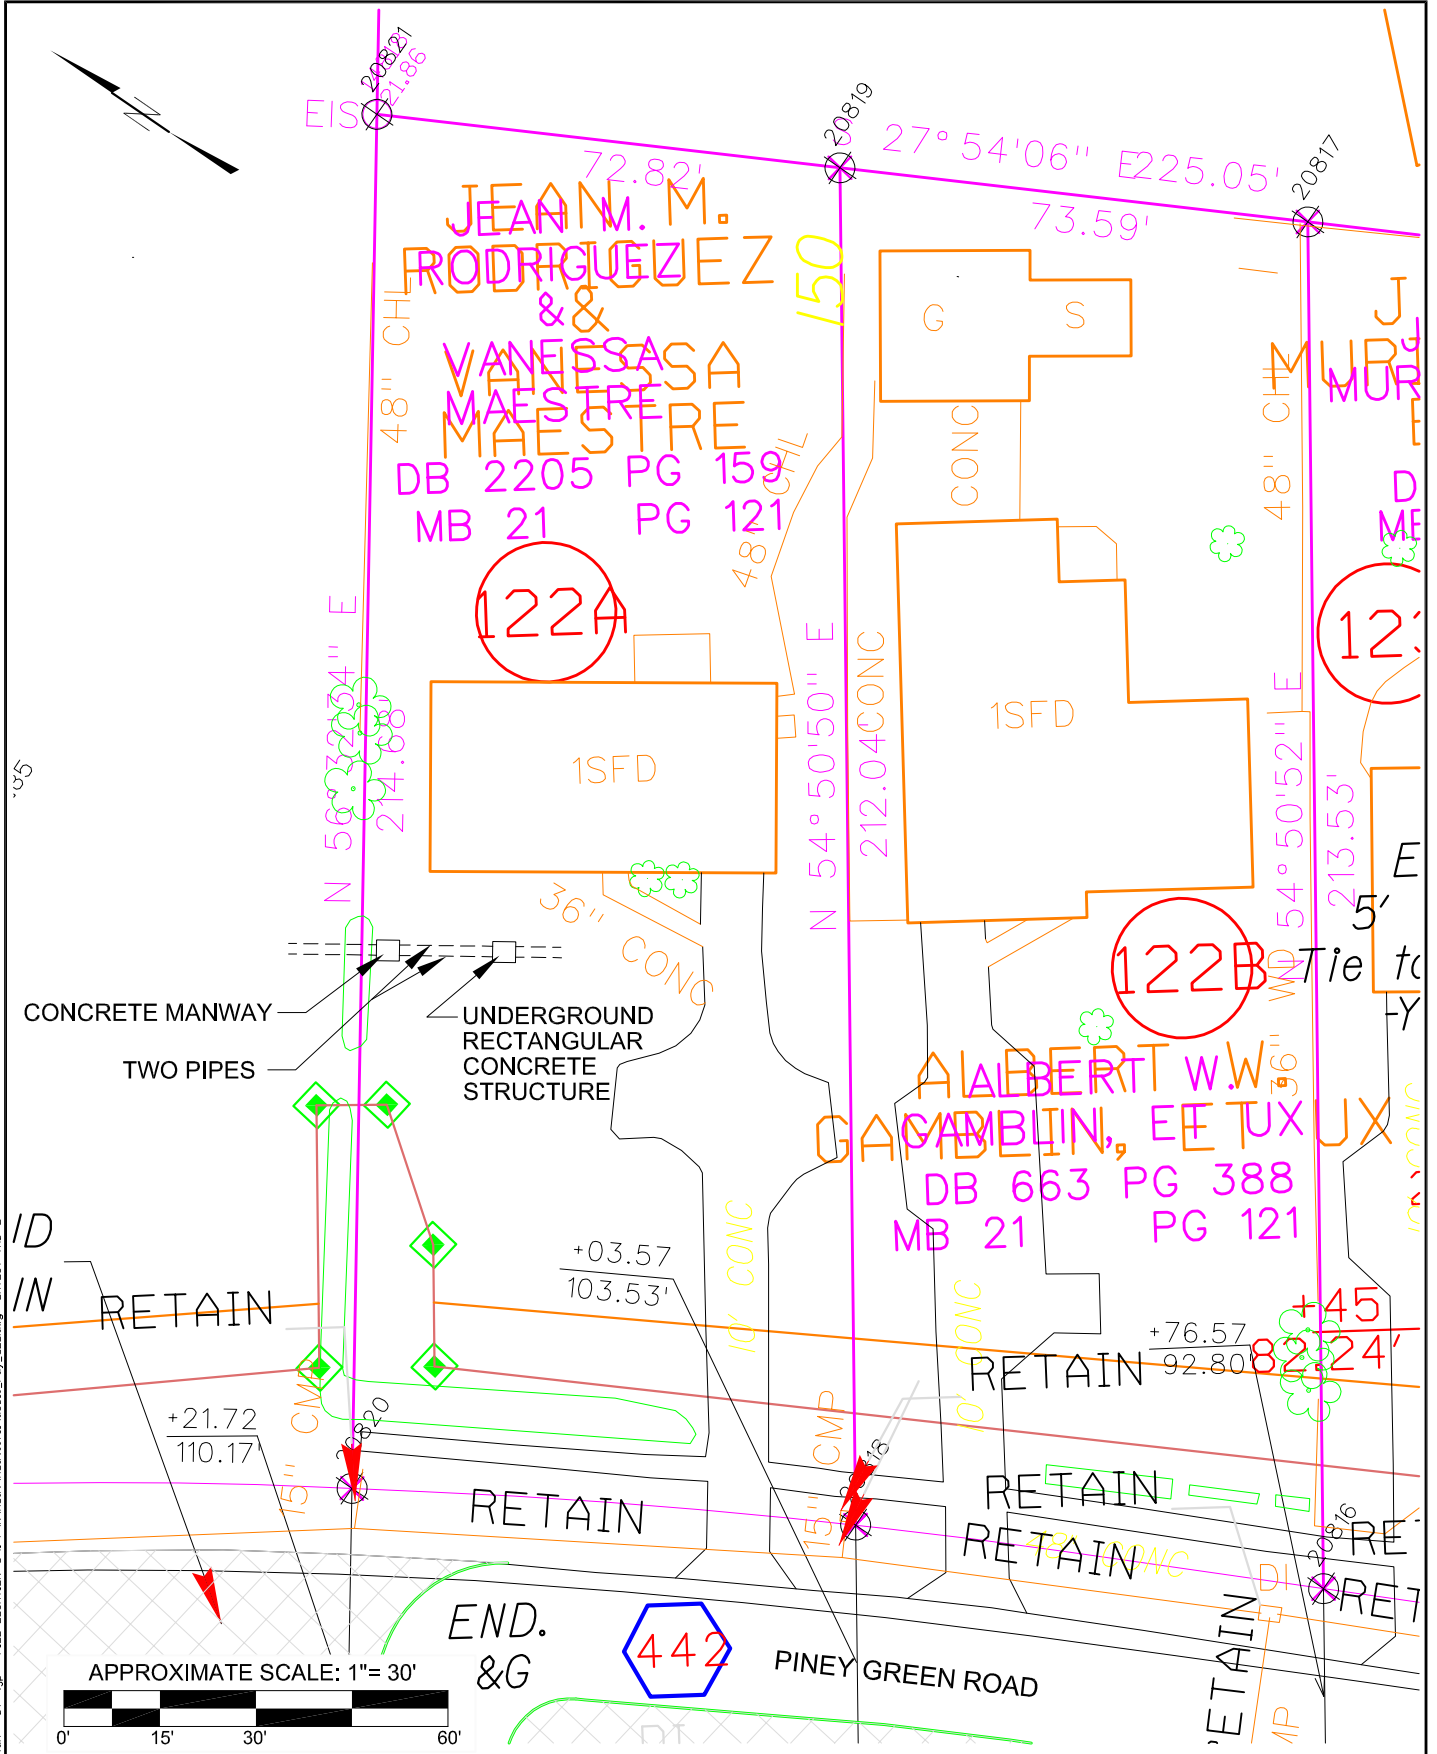
GEL Engineering of NC Inc. an Affiliate of THE GEL GROUP INC Post Office Box 14262 Research Triangle Park, NC 27709 P 919-544-1100 F 919-406-1807 www.gel.com	PROJECT: ncd100711	SITE LOCATION MAP	FIGURE 2
	DATE: January 3, 2012
