PROJECT NO. I-5756
HAYWOOD COUNTY
 BRIDGE NO. 230

SHEET 1 OF 4

BENT 1

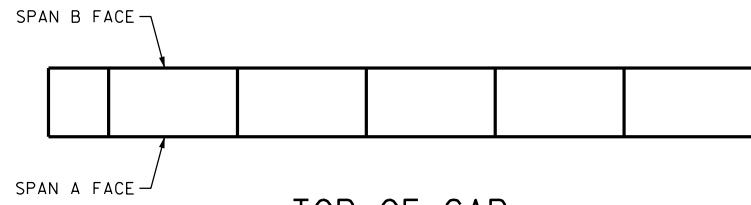
* QUANTITY HAS BEEN INCREASED DUE TO THE POTENTIAL FOR FURTHER DETERIORATION SINCE THE FIELD INSPECTION BY STRUCTURES MANAGEMENT UNIT.

EPOXY COATING SHALL BE APPLIED TO THE TOP FACE OF THE CAP. THE CONTRACTOR SHALL NOT COAT THE AREA OF THE CAP BENEATH THE MASONRY PLATES. FOR EPOXY COATING, SEE SPECIAL PROVISIONS.

FOR CAP REPAIRS, SEE "TYPICAL CAP AND COLUMN REPAIR DETAILS" SHEET.
