AS-BUILT REPAIR QUANTITY TABLE				
REPAIRS BENT 2	QUANTITIES			
	ESTIMATE		ACTUAL	
SHOTCRETE REPAIRS	AREA SF	VOLUME CF	AREA SF	VOLUME CF
CAP	102.5	64.1 *		
COLUMNS AND STRUTS	45.9	28.7 *		
CONCRETE REPAIRS	AREA SF	VOLUME CF	AREA SF	VOLUME CF
CAP	4.3	2.7 *		
COLUMNS AND STRUTS	0.0	0.0		
EPOXY RESIN INJECTION		LN. FT		LN. FT
CAP		4.0		
COLUMNS AND STRUTS		0.0		
EPOXY COATING		SO. FT		SO. FT
TOP OF BENT CAP		283

PROJECT NO. I-5892
BUNCOMBE COUNTY
 BRIDGE NO. 429

**BENT 2
 SPAN B FACE**

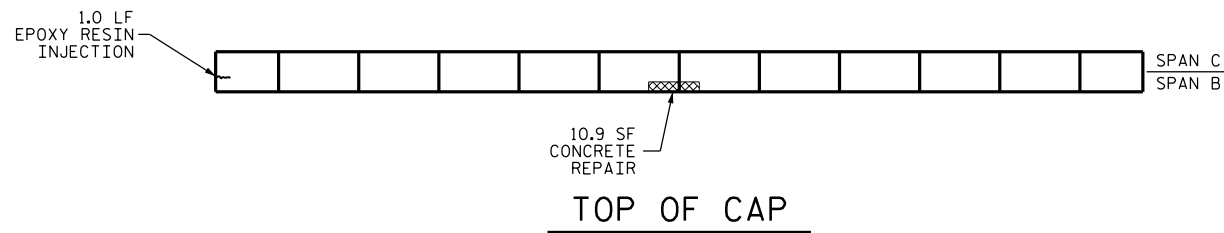
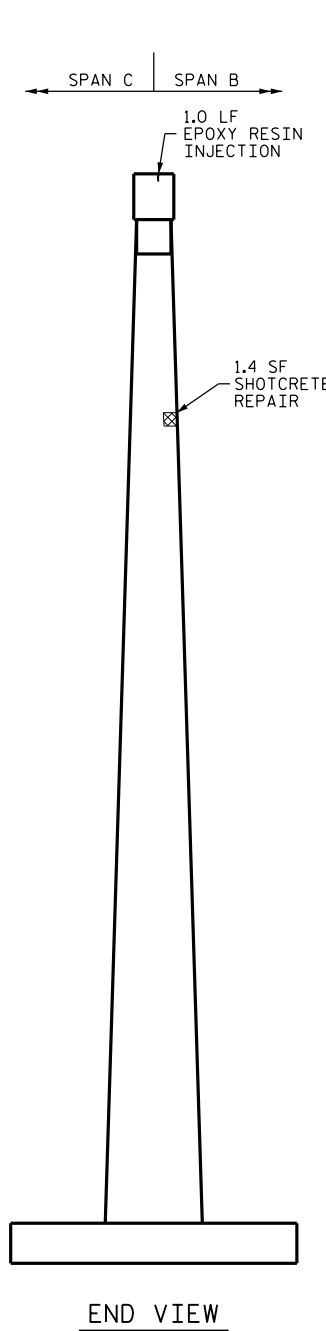
DAMAGED AREA

EPOXY RESIN INJECTION

VALUES IN CHART REPRESENT ESTIMATED REPAIR TOTALS AFTER REMOVAL OF UNSOUND CONCRETE, MINIMUM OF 1" BEHIND REBAR AND MINIMUM 2" CLEARANCE TO SAWCUT. SEE REPAIR DETAILS.
