PROJECT NO. I-5892  
BUNCOMBE COUNTY  
 BRIDGE NO. 429

SHEET 2 OF 3

STATE OF NORTH CAROLINA  
 DEPARTMENT OF TRANSPORTATION  
 RALEIGH

**BENT 4**  
**SPAN E FACE**

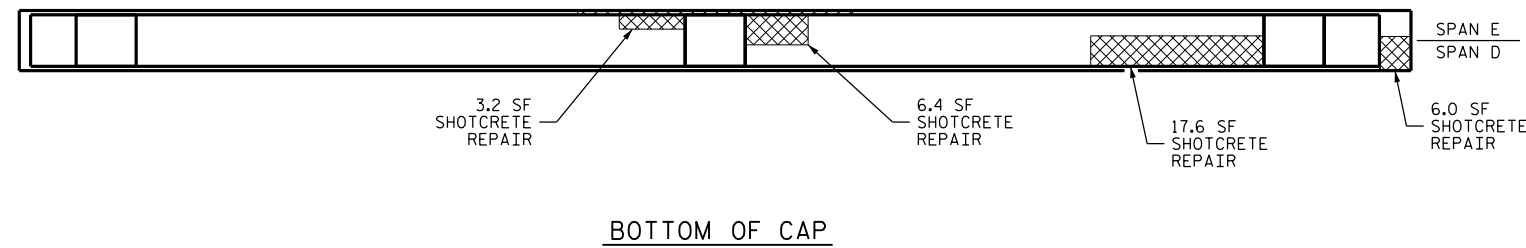
ELEVATION  
(SPAN E FACE)

DAMAGED AREA

CLEAN AND REMOVE DEBRIS FROM THE TOP OF THE CAP AND APPLY EPOXY PROTECTIVE COATING. EPOXY COATING SHALL BE APPLIED TO THE TOP FACE OF THE CAP. THE CONTRACTOR SHALL NOT COAT THE AREA OF THE CAP BENEATH THE MASONRY PLATES.

EPOXY RESIN INJECTION
