B-5939 PROJECT NO._ CARTERET COUNTY BRIDGE NO.

STATE OF NORTH CAROLINA DEPARTMENT OF TRANSPORTATION

SUBSTRUCTURE END BENT 1

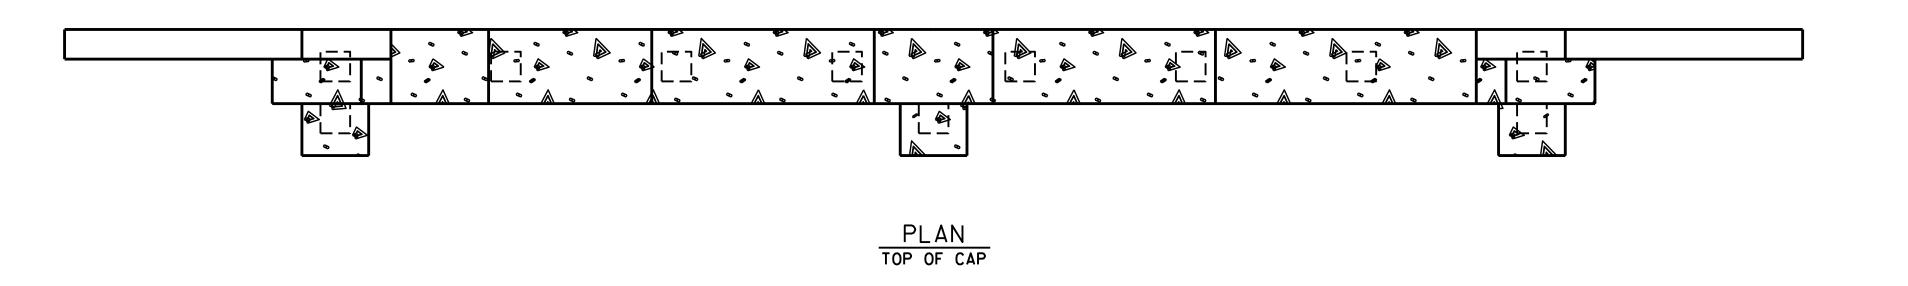
ELEVATION

SOUTH SIDE

NO REPAIRS NOTED DURING INSPECTION BY STRUCTURES MANAGEMENT UNIT. THE CONTRACTOR AND ENGINEER SHALL INSPECT THE BENT PRIOR TO BEGINNING WORK.
