ELEVATION SOUTH SIDE

PLAN BOTTOM OF CAP

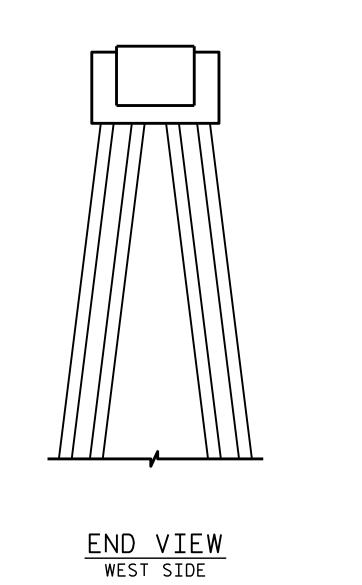
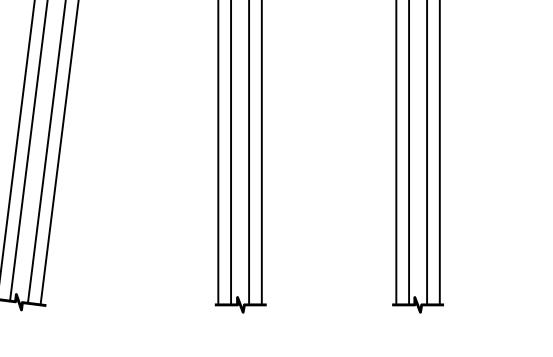
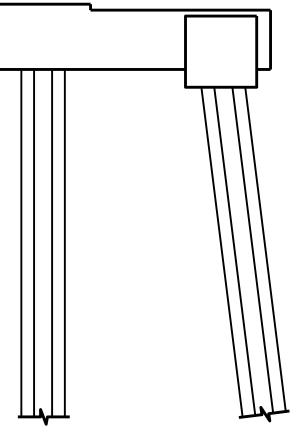
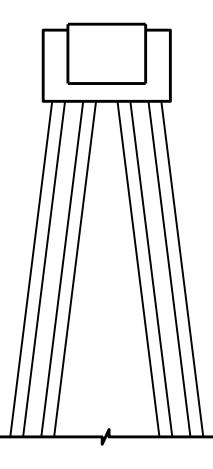
NO REPAIRS NOTED DURING INSPECTION BY STRUCTURES MANAGEMENT UNIT. THE CONTRACTOR AND ENGINEER SHALL INSPECT THE BENT PRIOR TO BEGINNING WORK.
