PROJECT NO. I-5781
JOHNSTON COUNTY
 BRIDGE NO. 497

SUBSTRUCTURE

REPAIR
 BENT 2

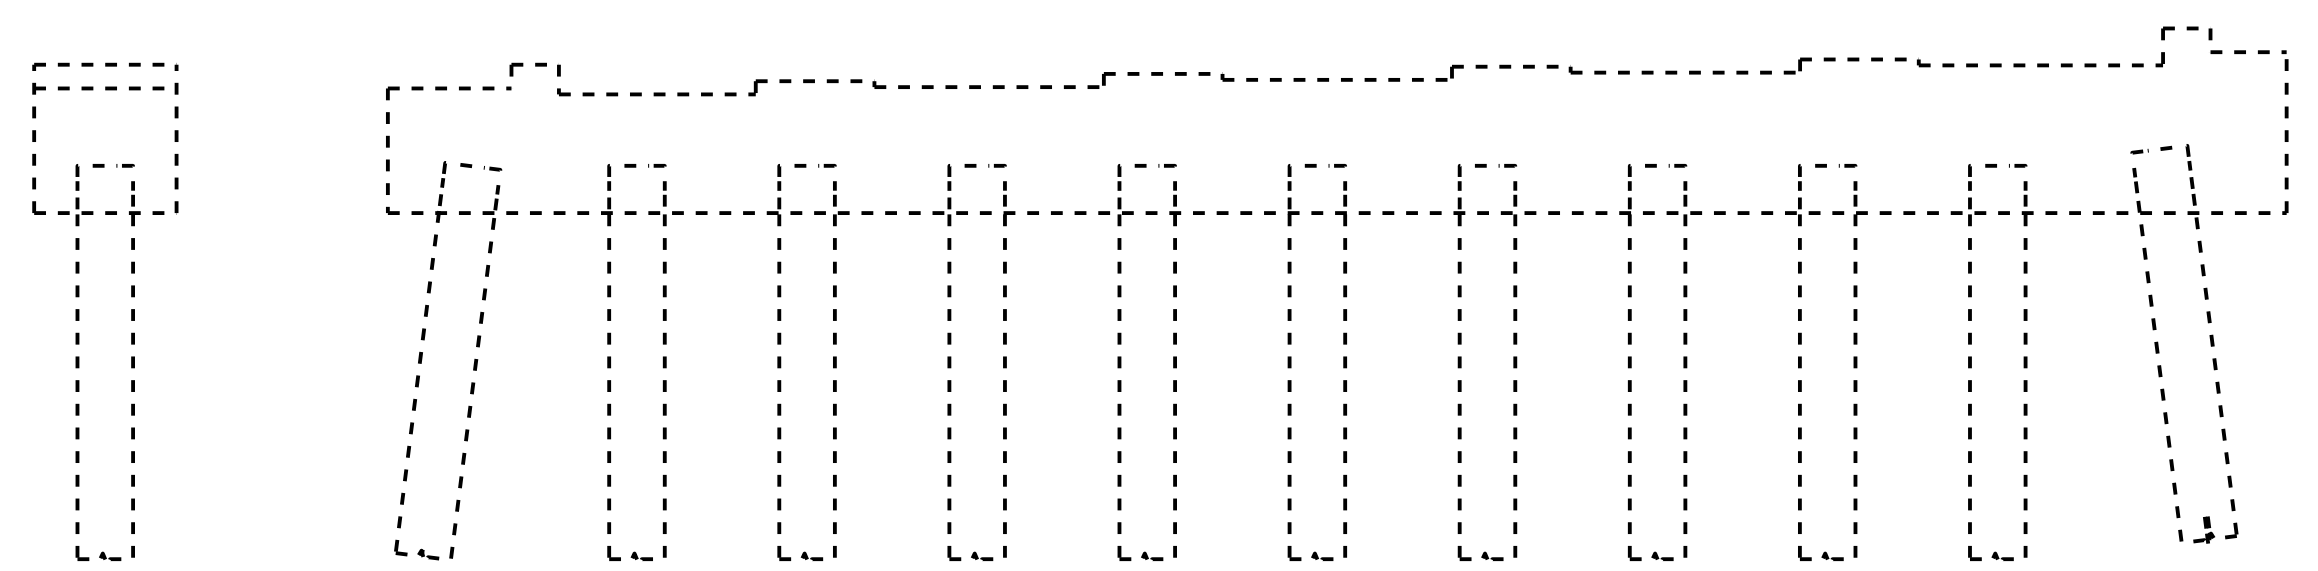
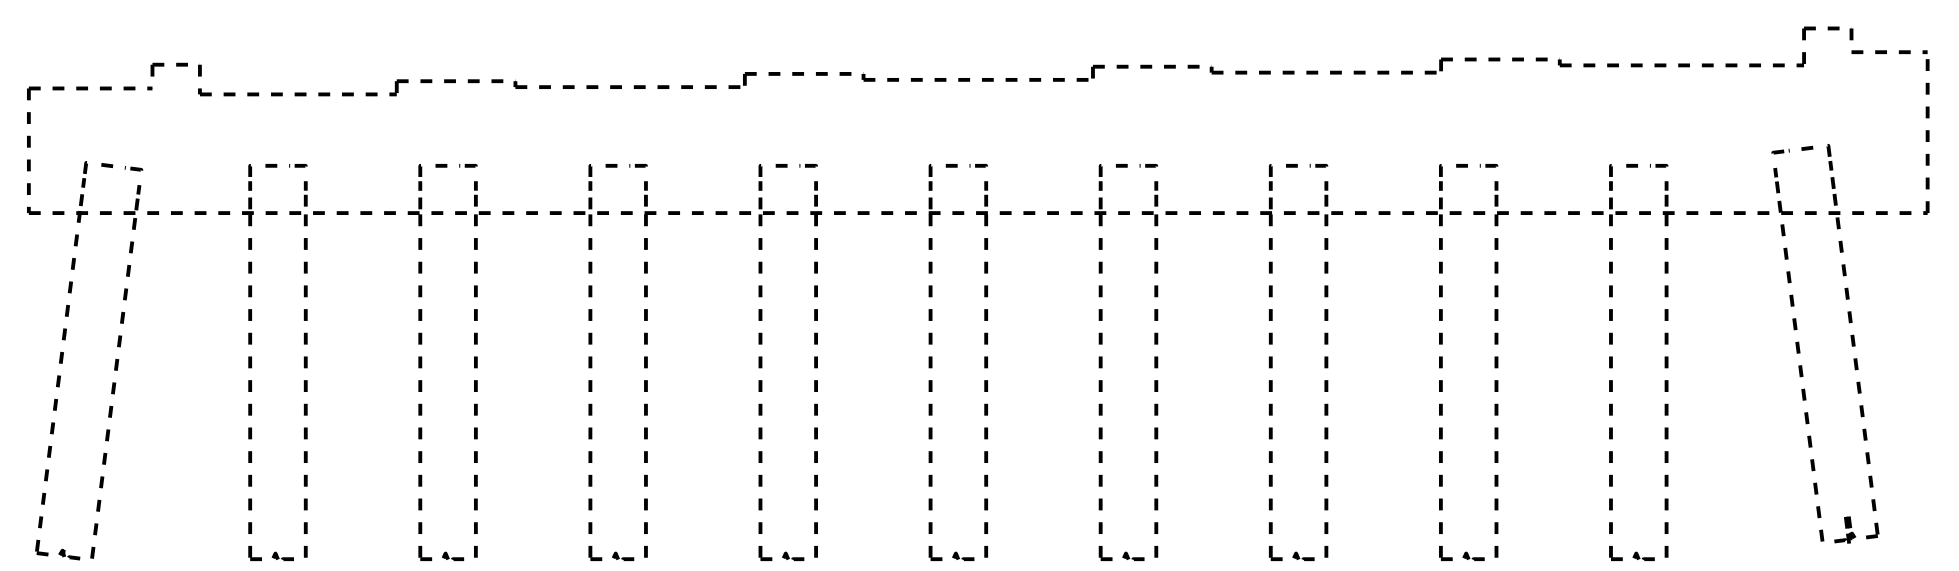
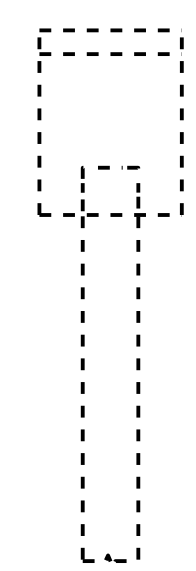
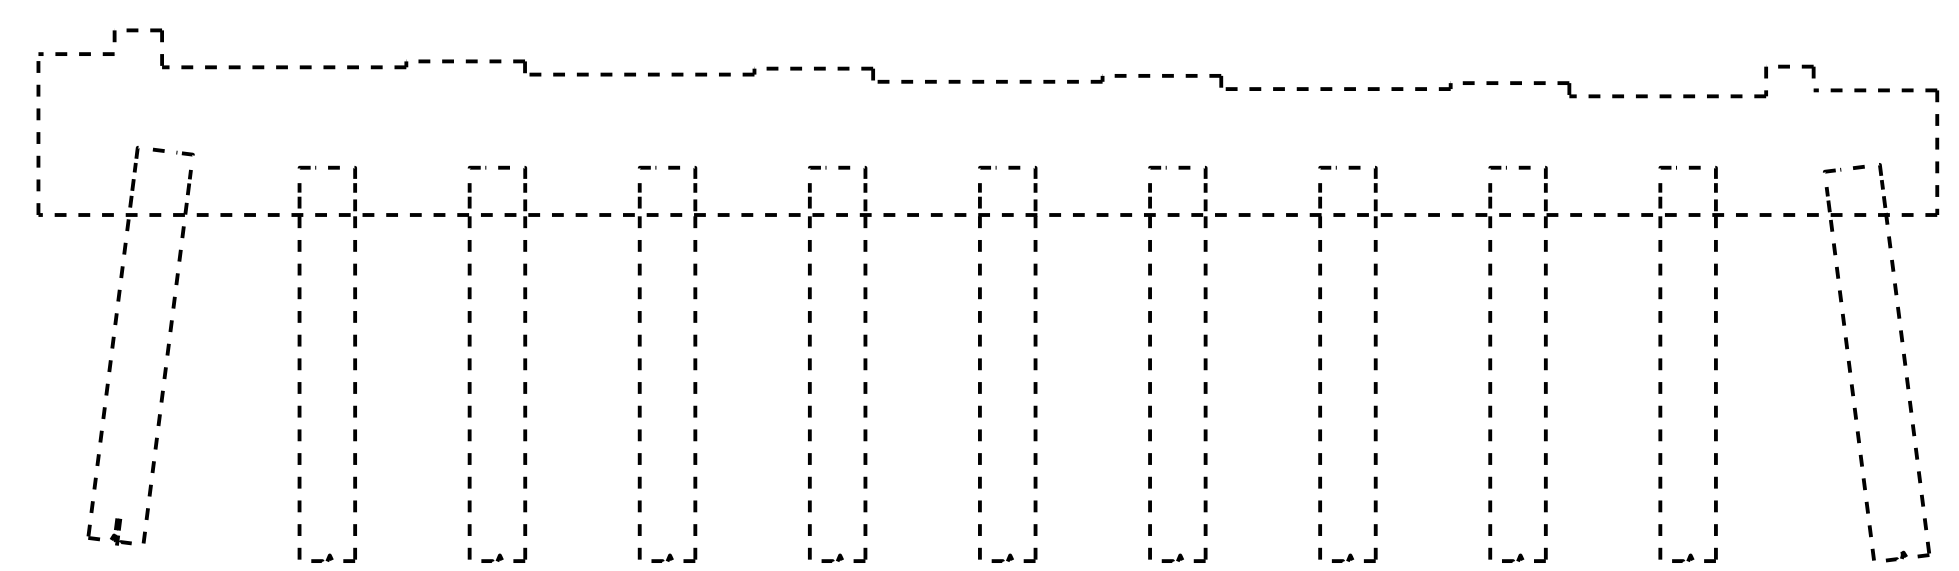
NO REPAIRS NOTED DURING INSPECTION BY STRUCTURES MANAGEMENT UNIT. THE CONTRACTOR AND ENGINEER SHALL REINSPECT THE SUBSTRUCTURE FOR POTENTIAL REPAIRS.
