PROJECT NO. I-5889A BUNCOMBE \_\_ COUNTY 356 BRIDGE NO.\_\_\_\_

BENT 1 SPAN A SIDE

REVISIONS SHEET NO. NO. BY: S-72 DATE: TOTAL SHEETS

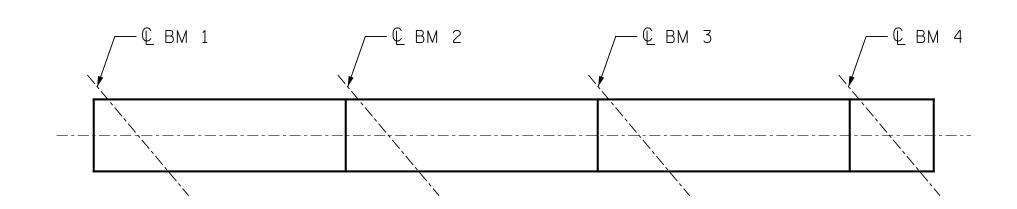
BENT 1 (SPAN A SIDE)

AS-BUILT REPAIR QUANTITY TABLE QUANTITIES BENT 1 REPAIRS ESTIMATE ACTUAL AREA DEPTH VOLUME
SF FT CF VOLUME AREA SHOTCRETE REPAIRS CAP (VERTICAL FACE) 26.9 13.5 CAP (HORIZONTAL, CORNER) 0 0 COLUMN

VALUES IN CHART REPRESENT ESTIMATED REPAIR TOTALS AFTER REMOVAL OF UNSOUND CONCRETE, MIN. OF 1"BEHIND REBAR AND MIN. 2"CL TO SAWCUT. SEE REPAIR DETAILS.
