PROJECT NO. 15BPR.20
HENDERSON COUNTY
 STATION: 35+30.22 -L-

REHABILITATION

STRUCTURAL STEEL
 REPAIRS

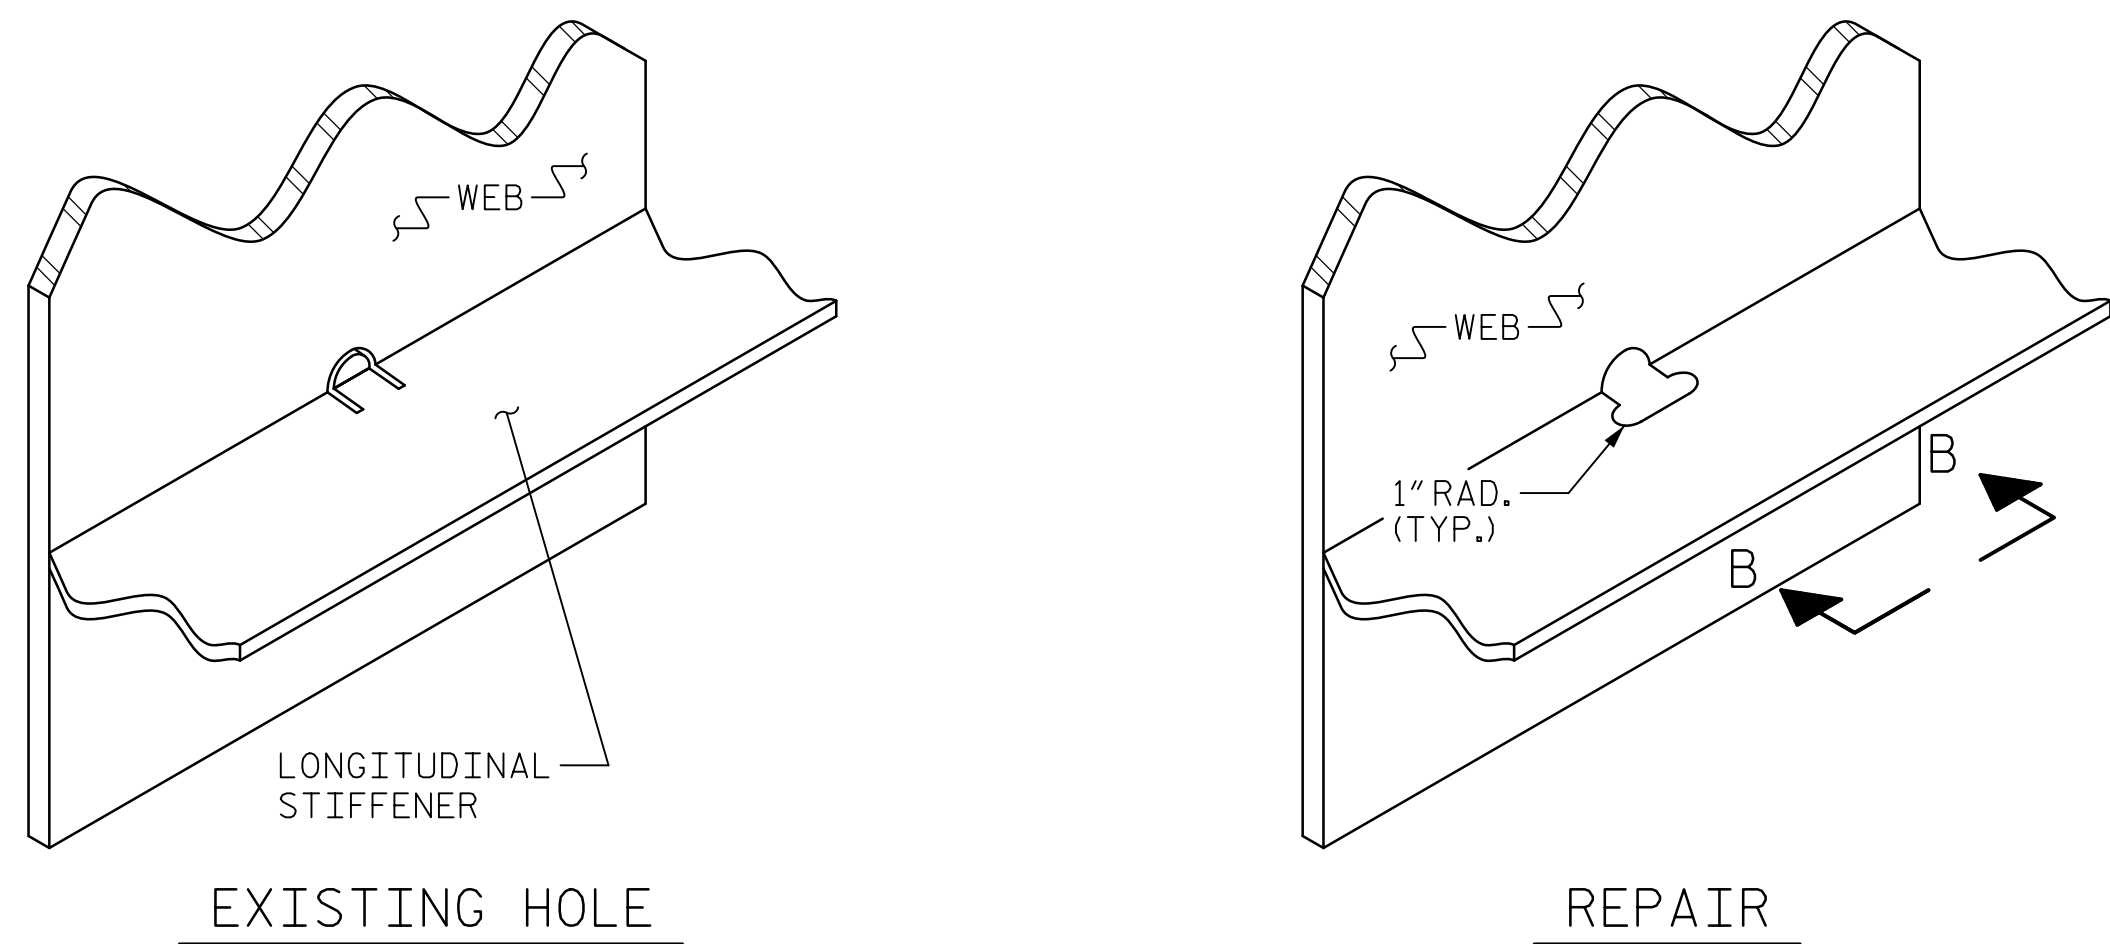
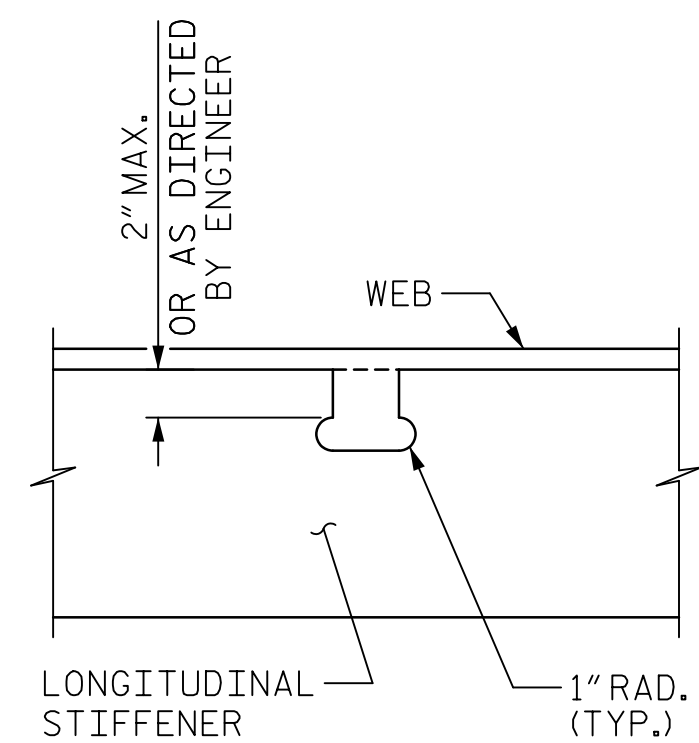
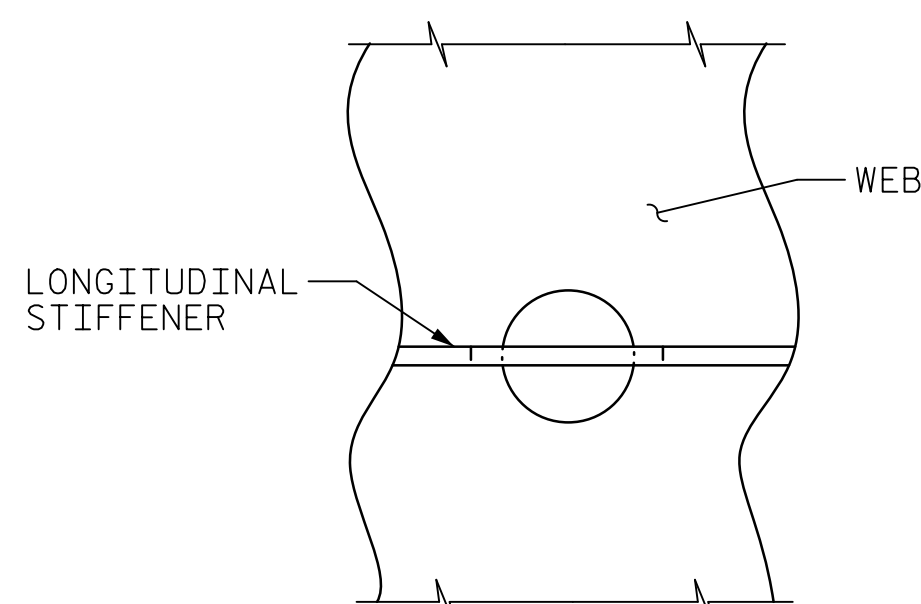
HOLE REPAIRS TYPE I

FOR REPRESENTATION ONLY, REPAIR SHALL BE PERFORMED AT EACH LOCATION NOTED, FOR REPAIR LOCATIONS, SEE PHOTO LEGEND ON SHEET 7.

1. DRILL 1" RADIUS HOLES AT THE TERMINATION OF THE EXISTING CUTS IN THE LONGITUDINAL STIFFENER.
2. SAW CUT BETWEEN HOLES TANGENTIAL TO THE RADIUS OF THE HOLE.
3. GRIND SMOOTH ADJACENT AREAS OF THE WEB, LONGITUDINAL STIFFENER, AND WELDS.

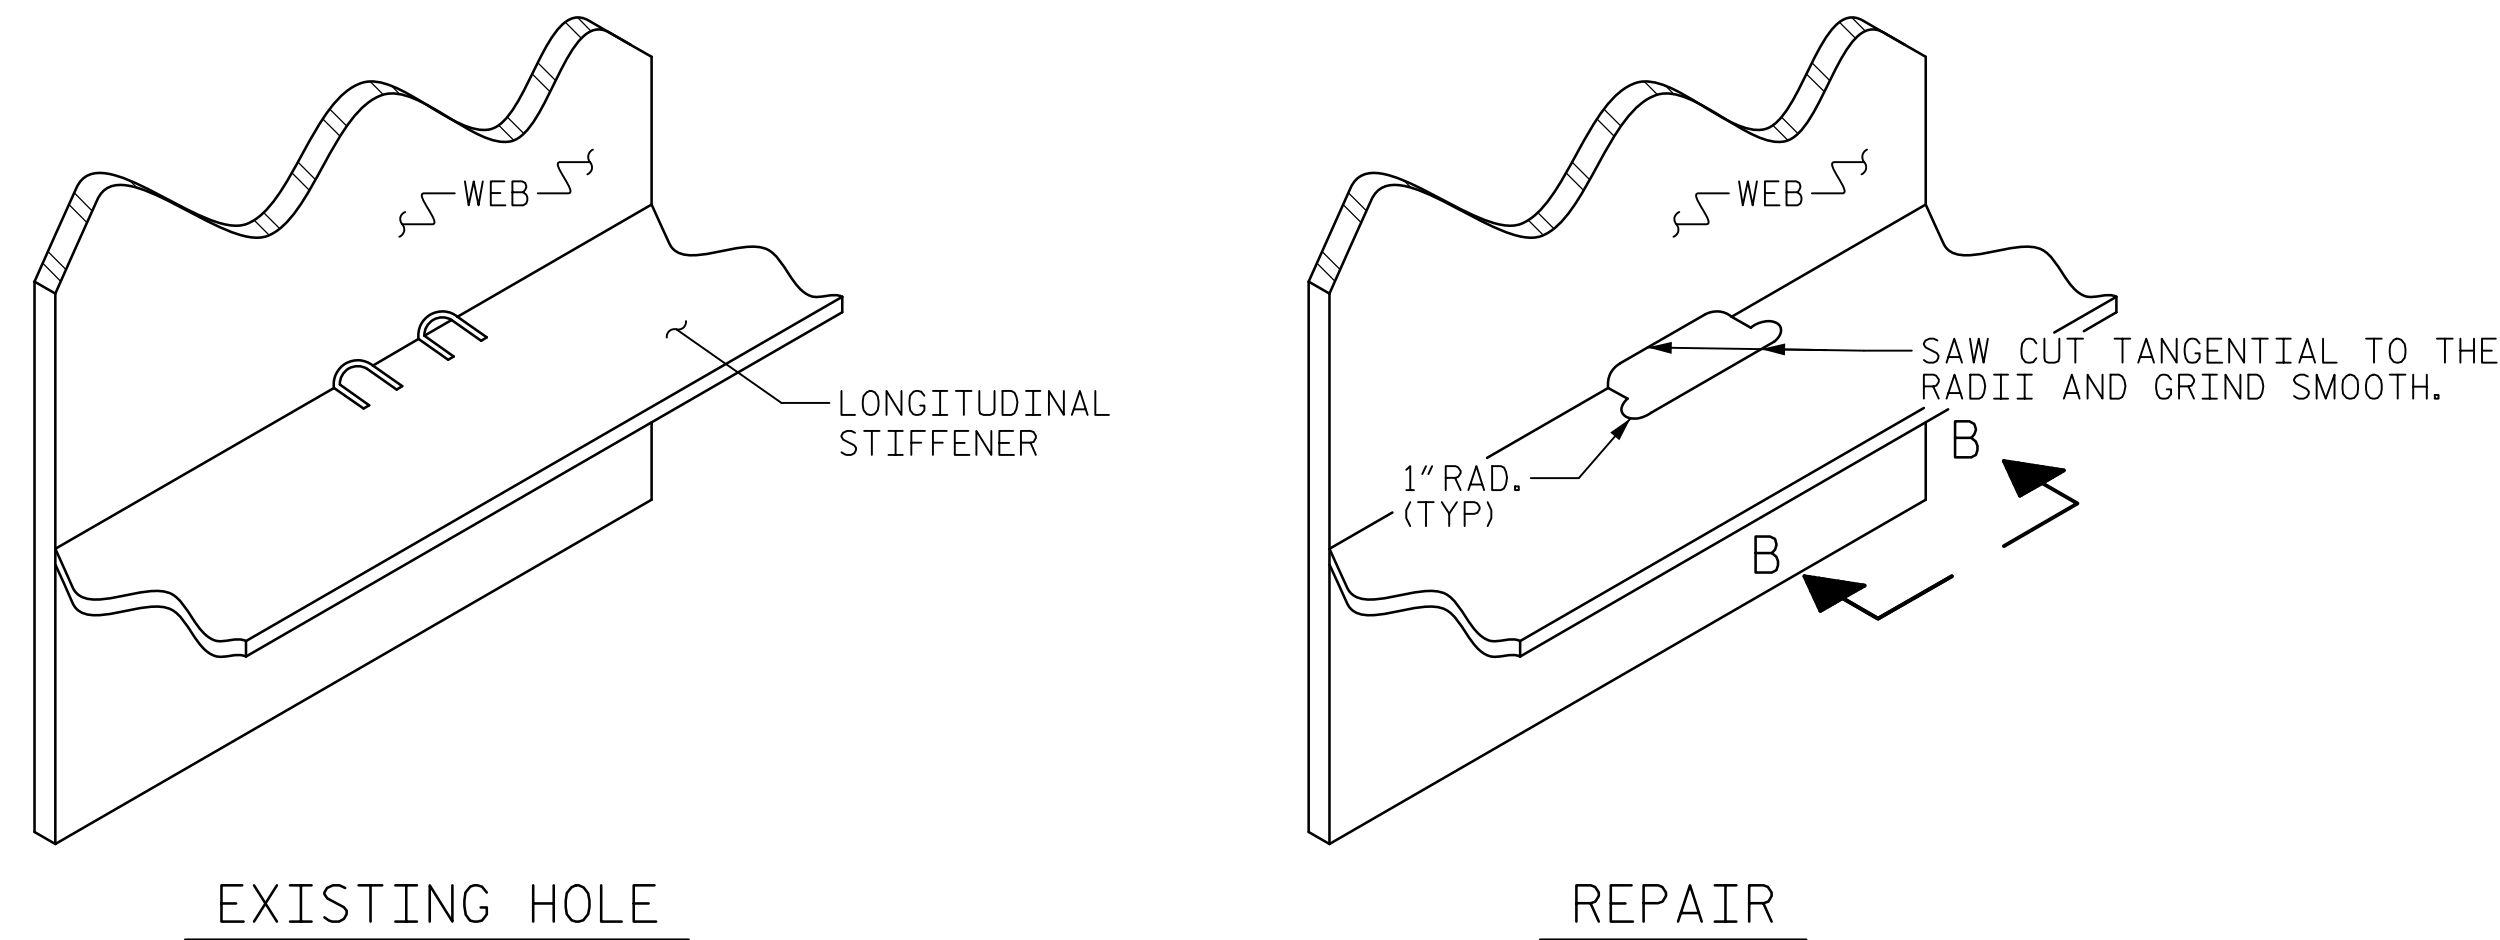
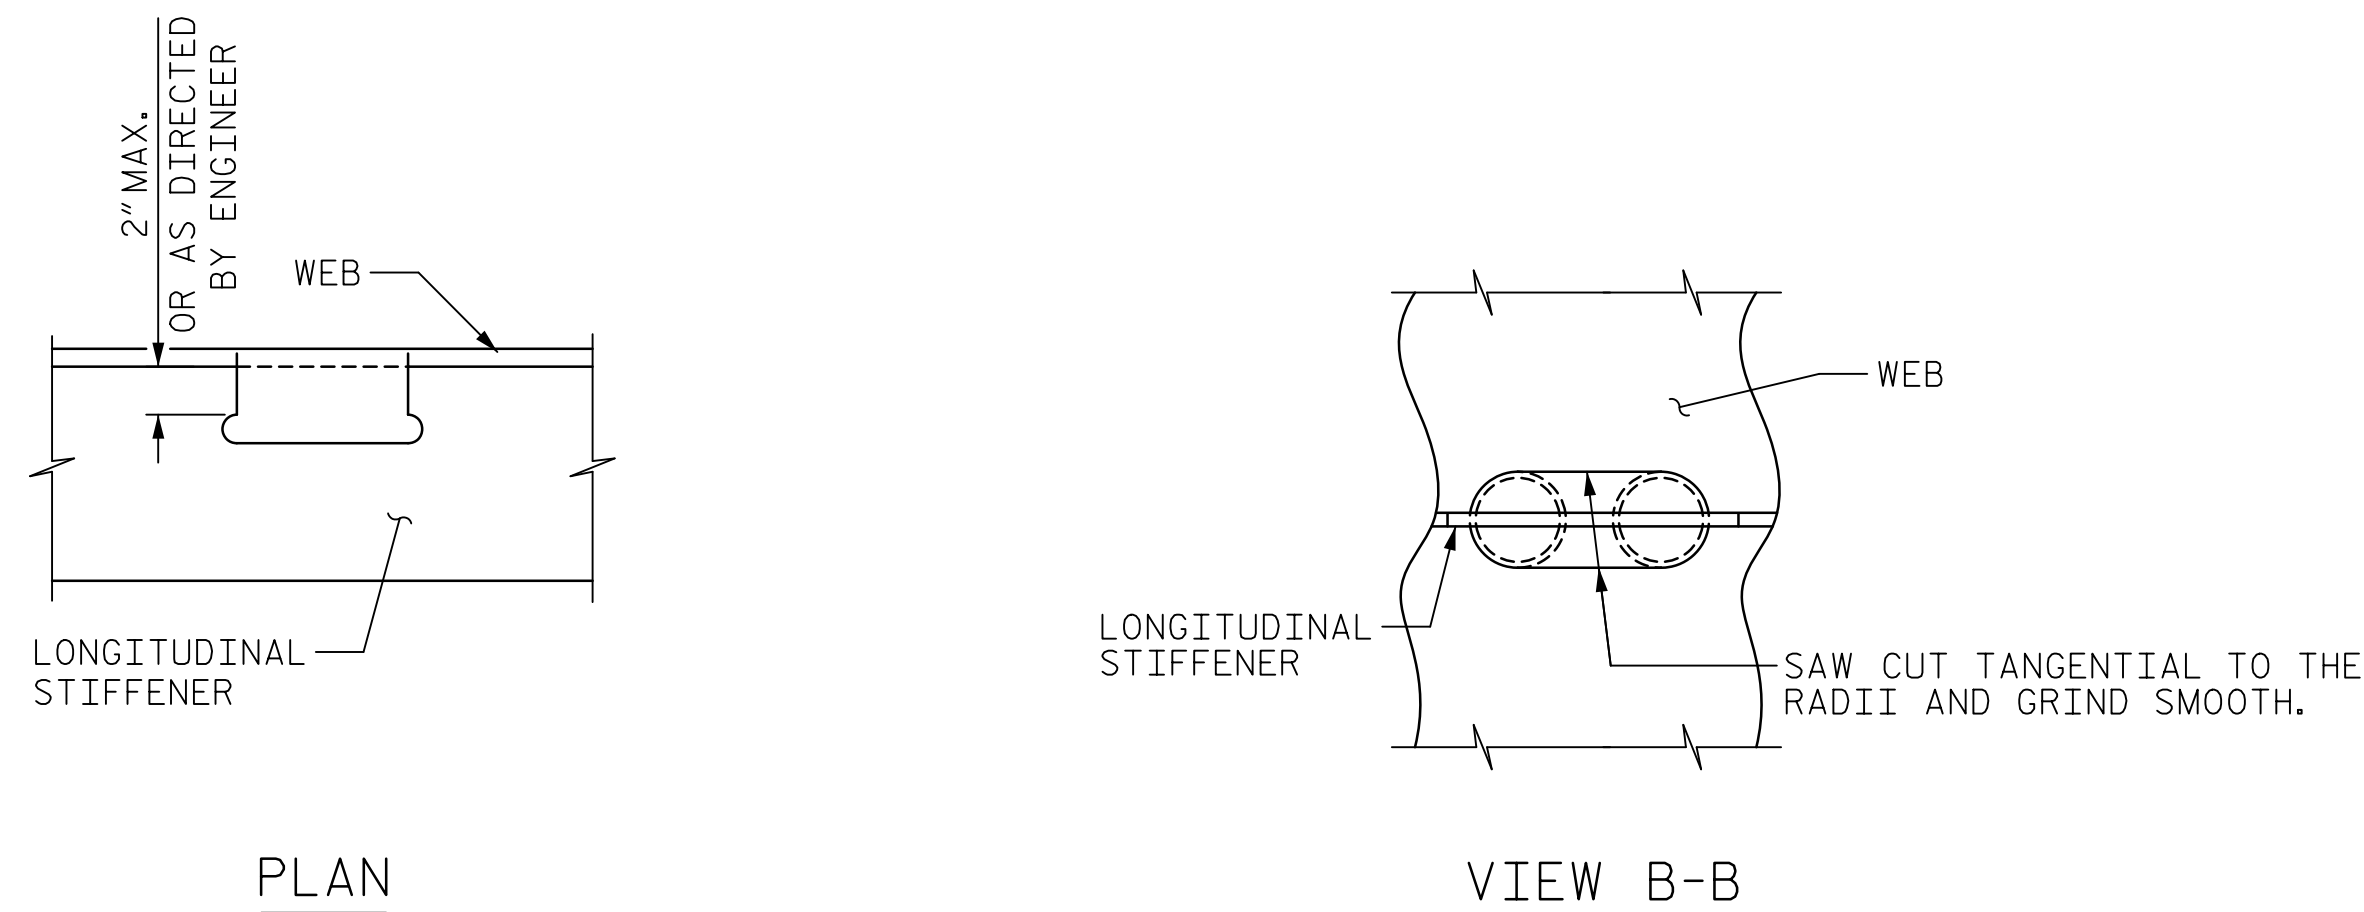
HOLE REPAIR TYPE II

FOR REPRESENTATION ONLY. REPAIR SHALL BE PERFORMED AT EACH LOCATION NOTED. FOR REPAIR LOCATIONS, SEE PHOTO LOCATION LEGEND.

1. DRILL 1" RADIUS AT THE TERMINATION OF THE EXISTING OUTSIDE CUTS IN THE LONGITUDINAL STIFFENER.
2. SAW CUT BETWEEN THE HOLES IN THE WEB AND THE STIFFENER TANGENTIAL TO THE RADII OF THE HOLES.
3. GRIND SMOOTH ADJACENT AREAS OF THE WEB, LONGITUDINAL STIFFENER, AND WELDS.

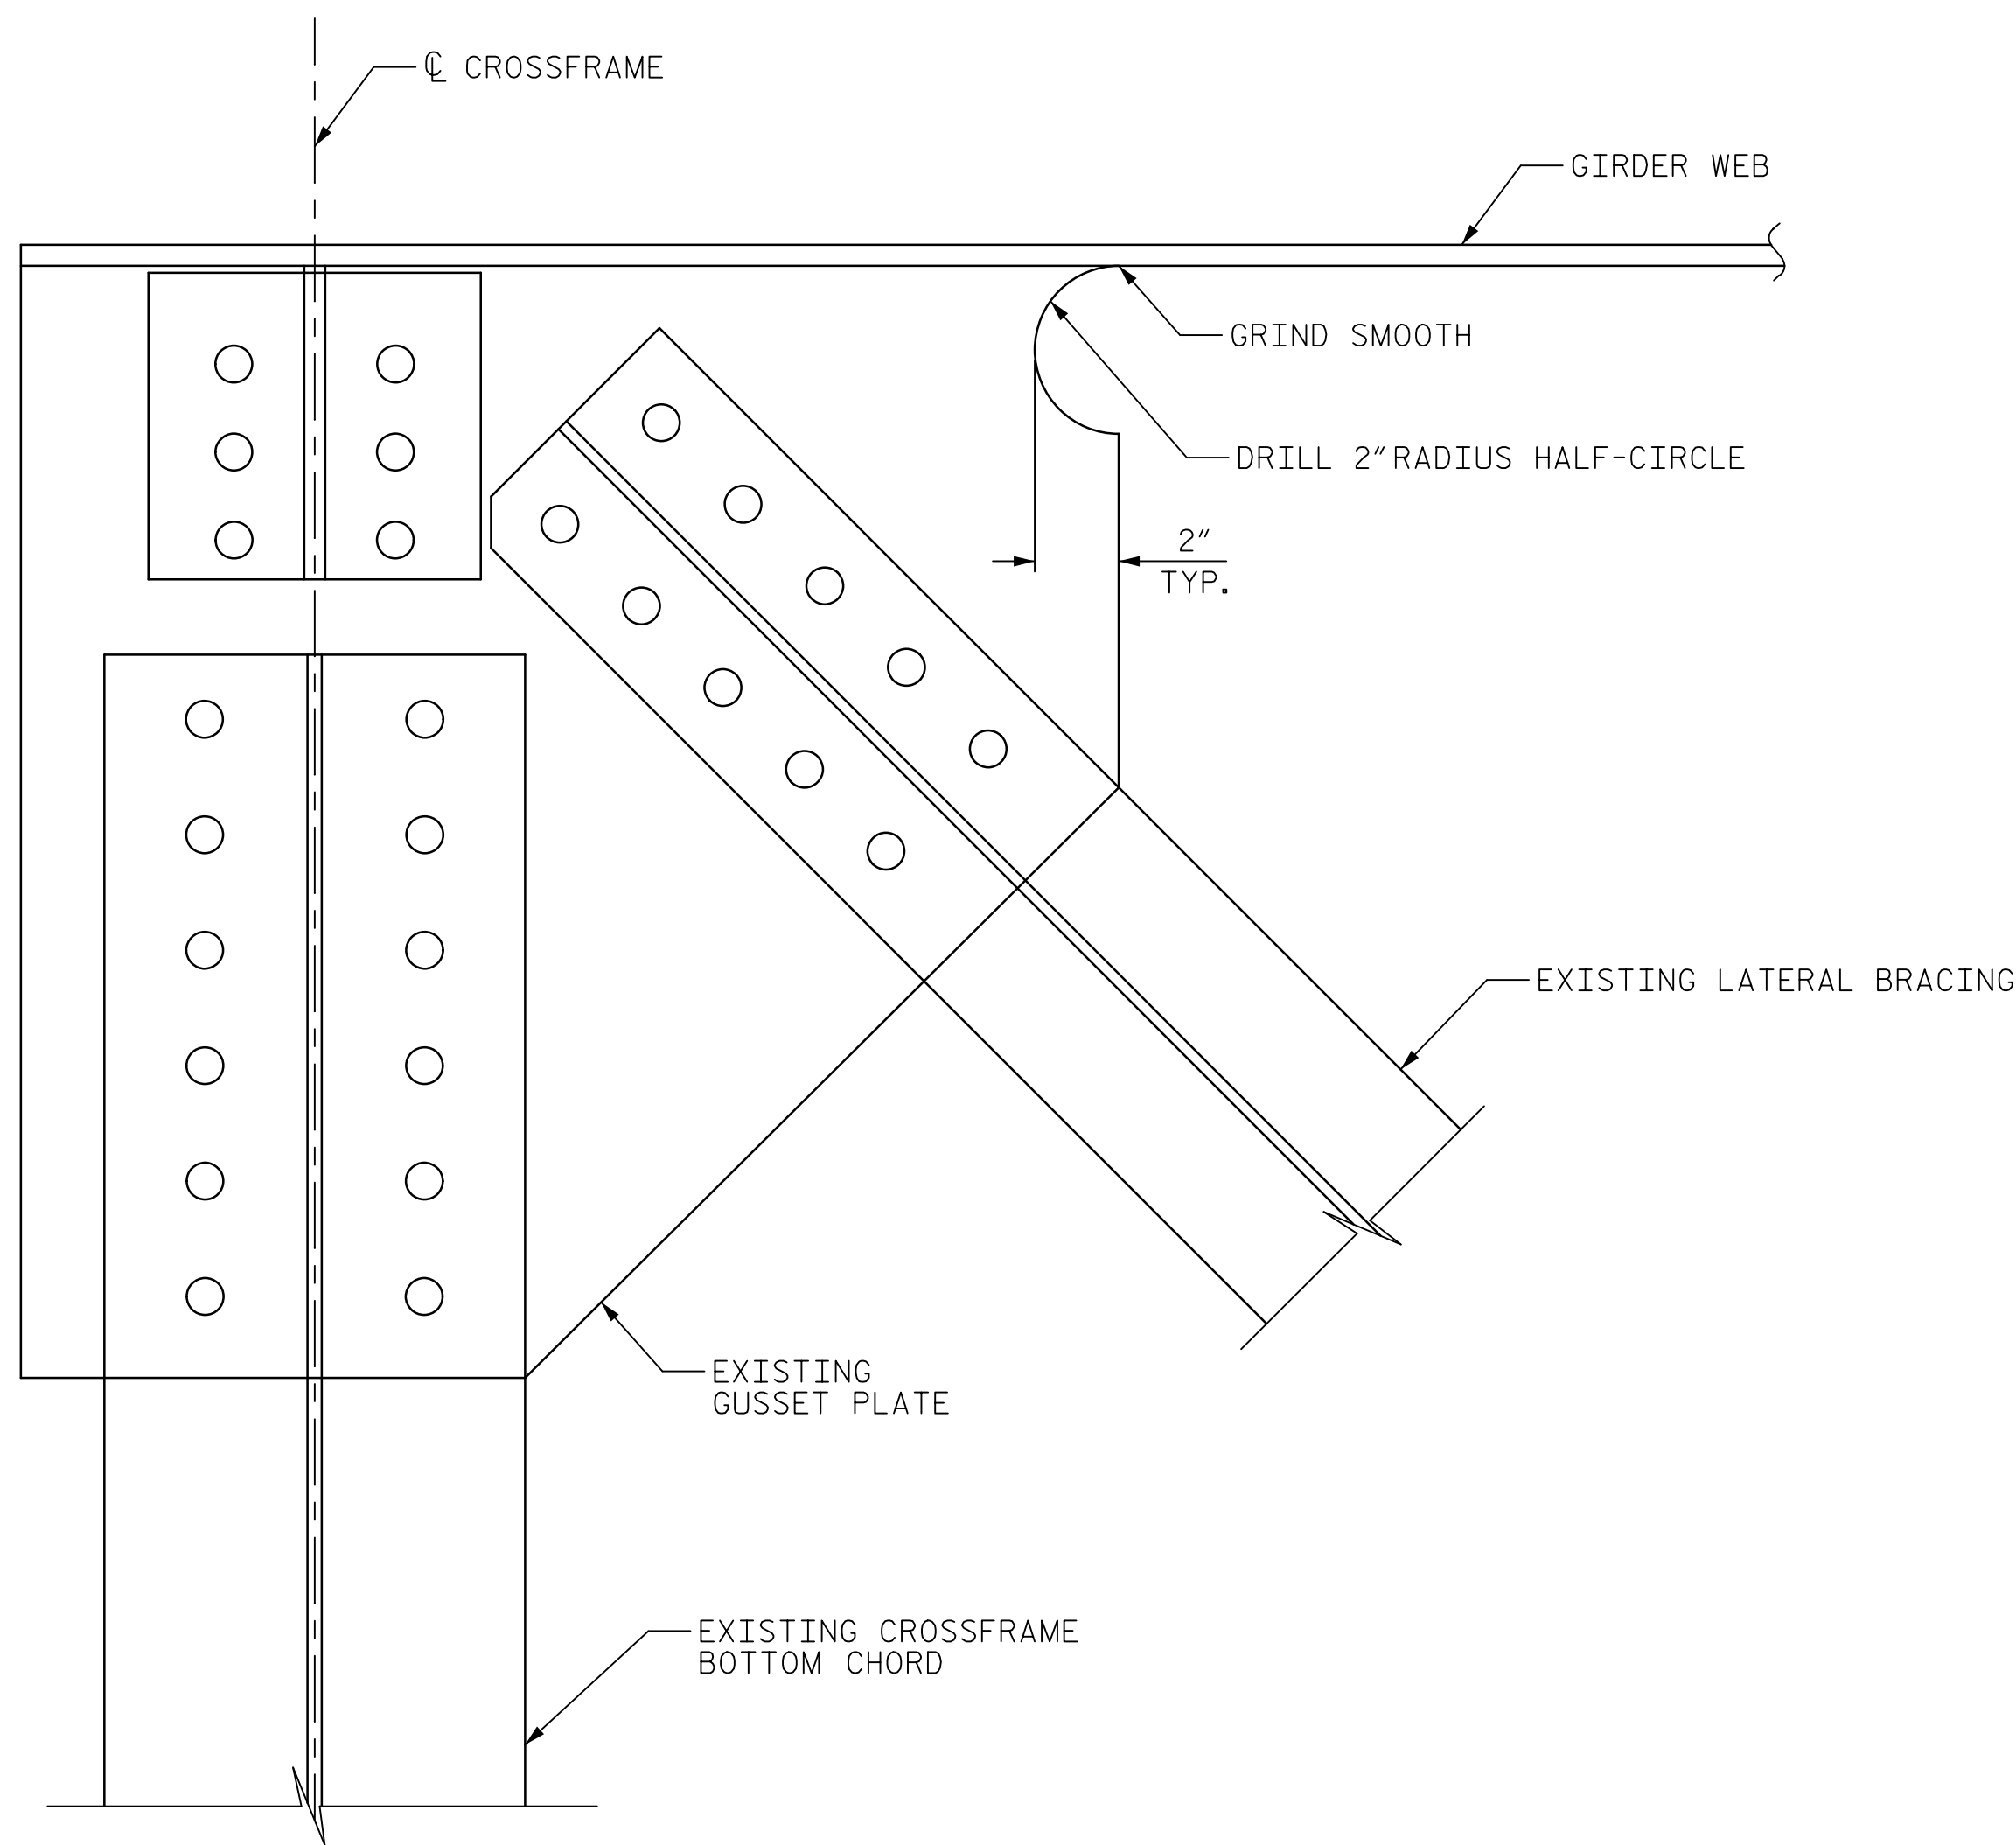
PLAN VIEW OF GUSSET PLATE RETROFIT

AT CROSSFRAMES A1, A5, 1, 37, E1 AND E5

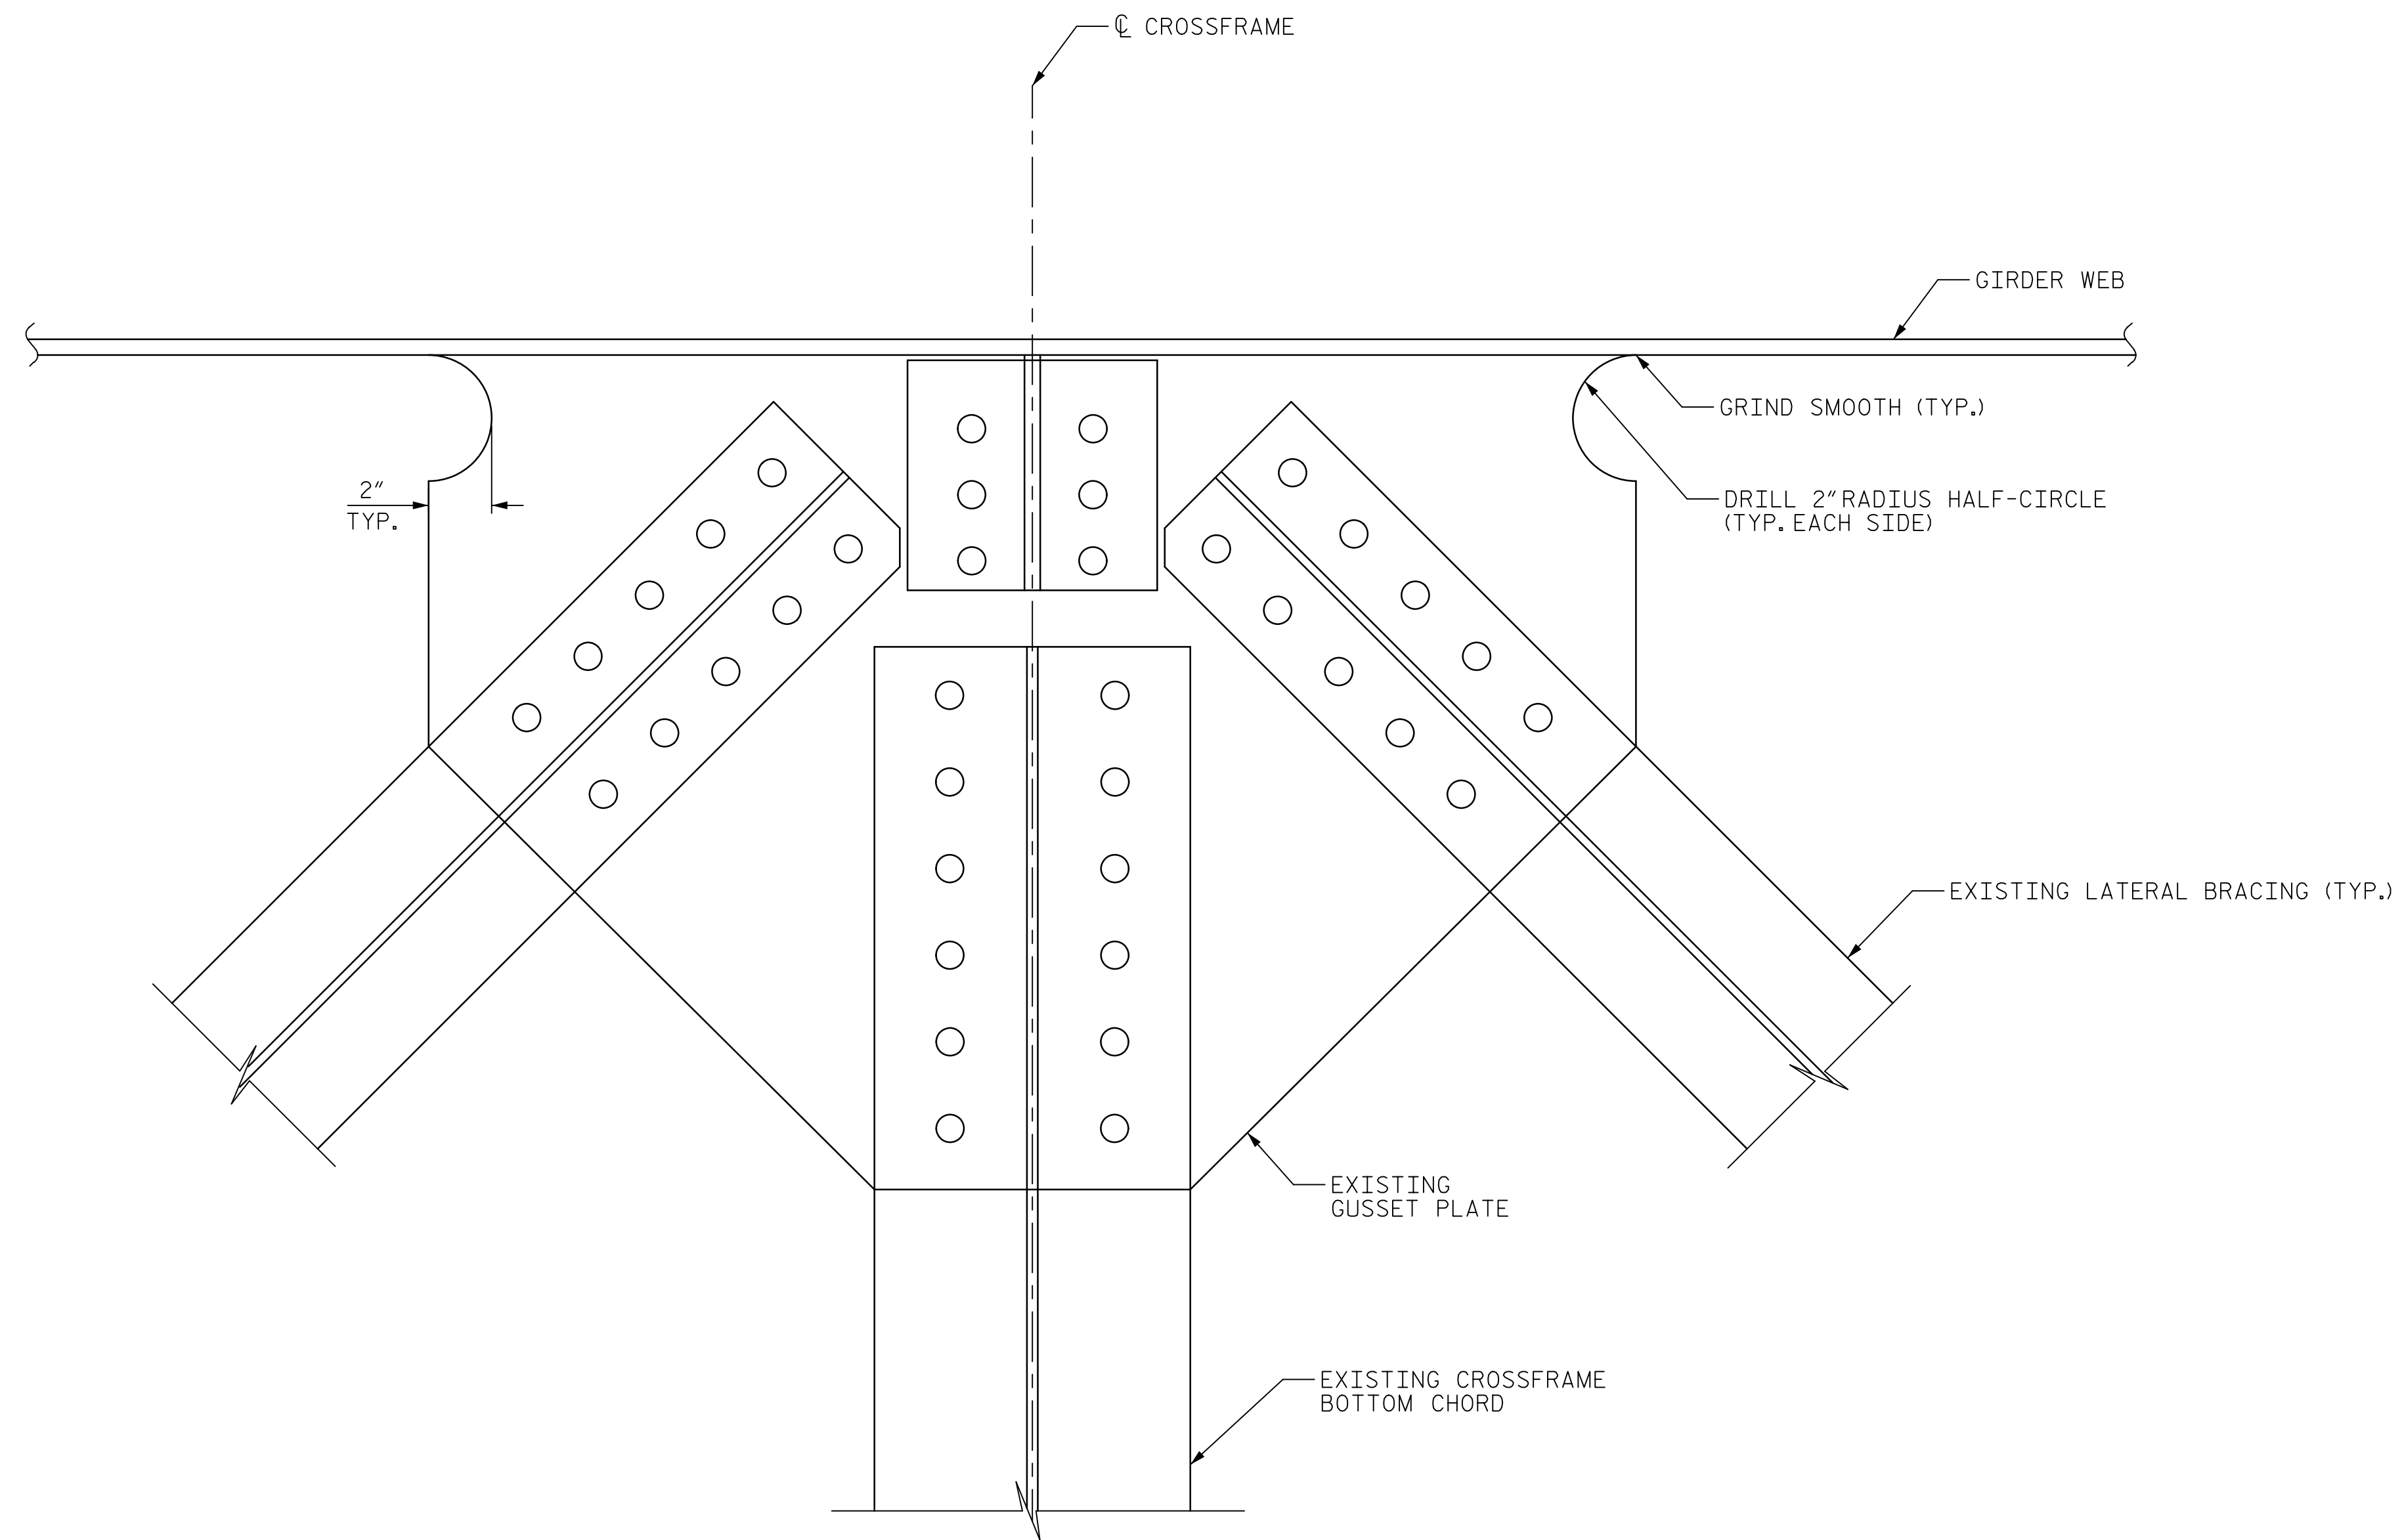
PLAN VIEW OF GUSSET PLATE RETROFIT

AT CROSSFRAMES A2-A4, 2-36 AND E2-E4

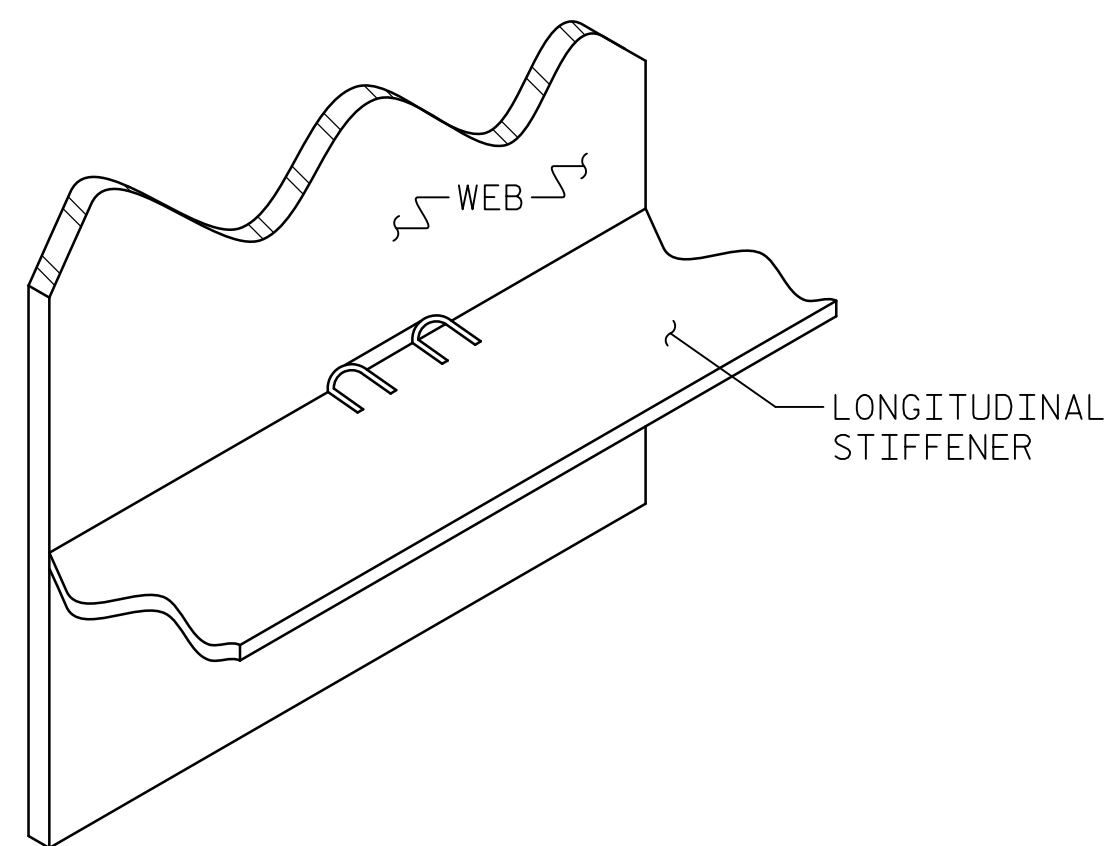
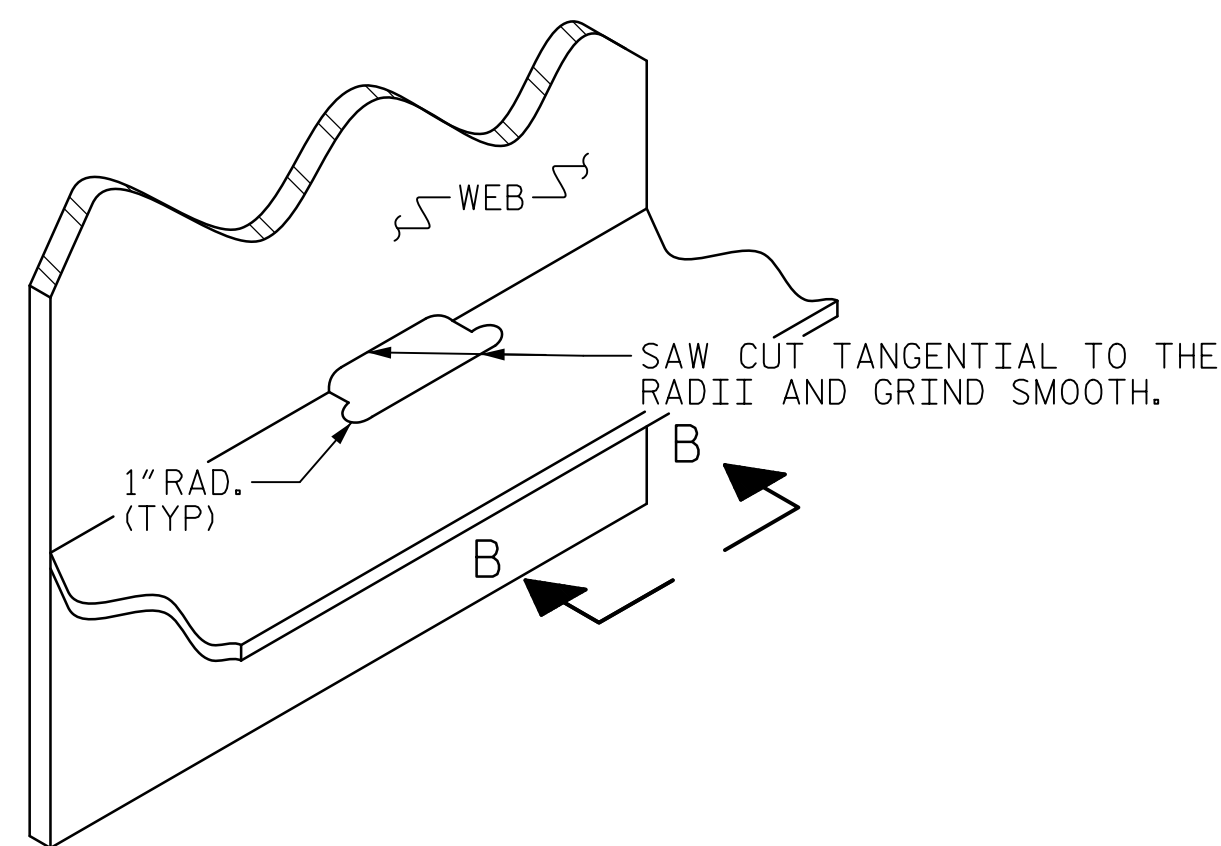
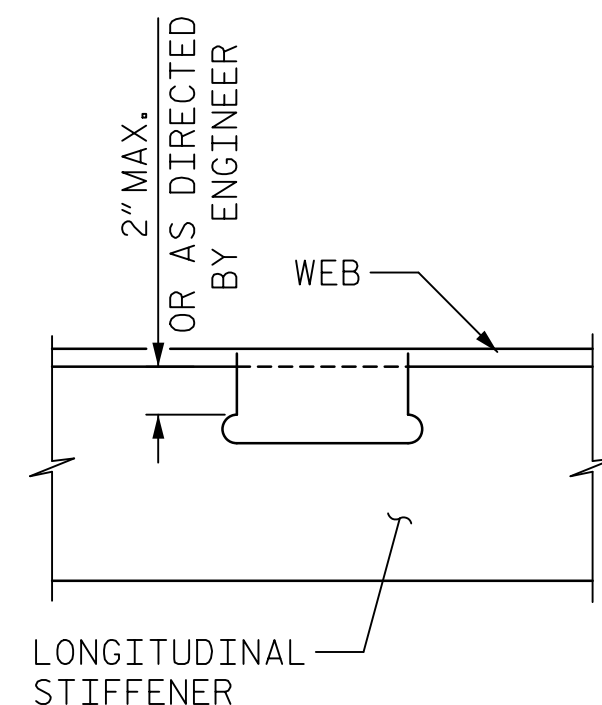
HOLE REPAIR TYPE III

EXISTING HOLE

FOR REPRESENTATION ONLY. REPAIR SHALL BE PERFORMED AT EACH LOCATION NOTED. FOR REPAIR LOCATIONS, SEE PHOTO LOCATION LEGEND.

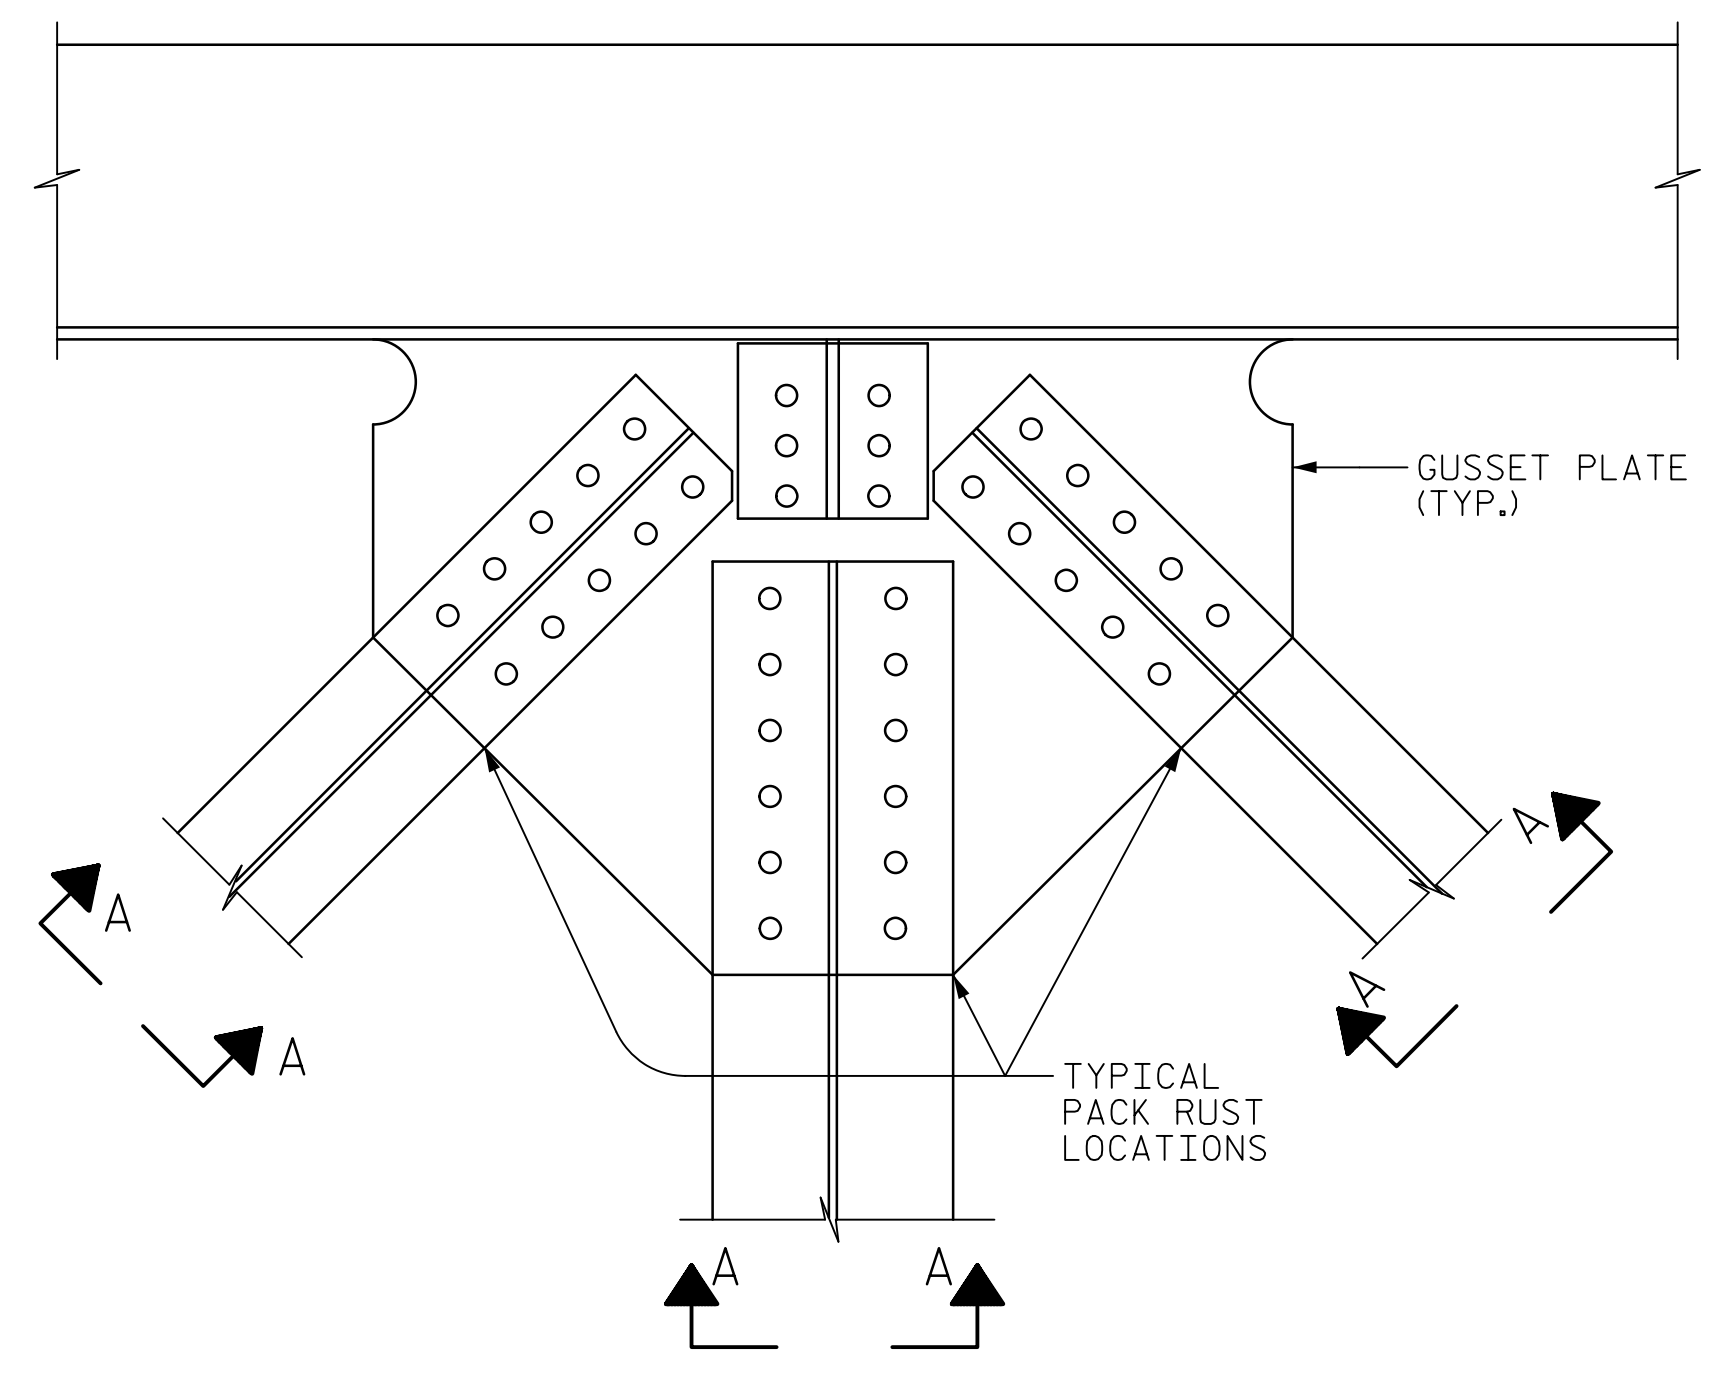
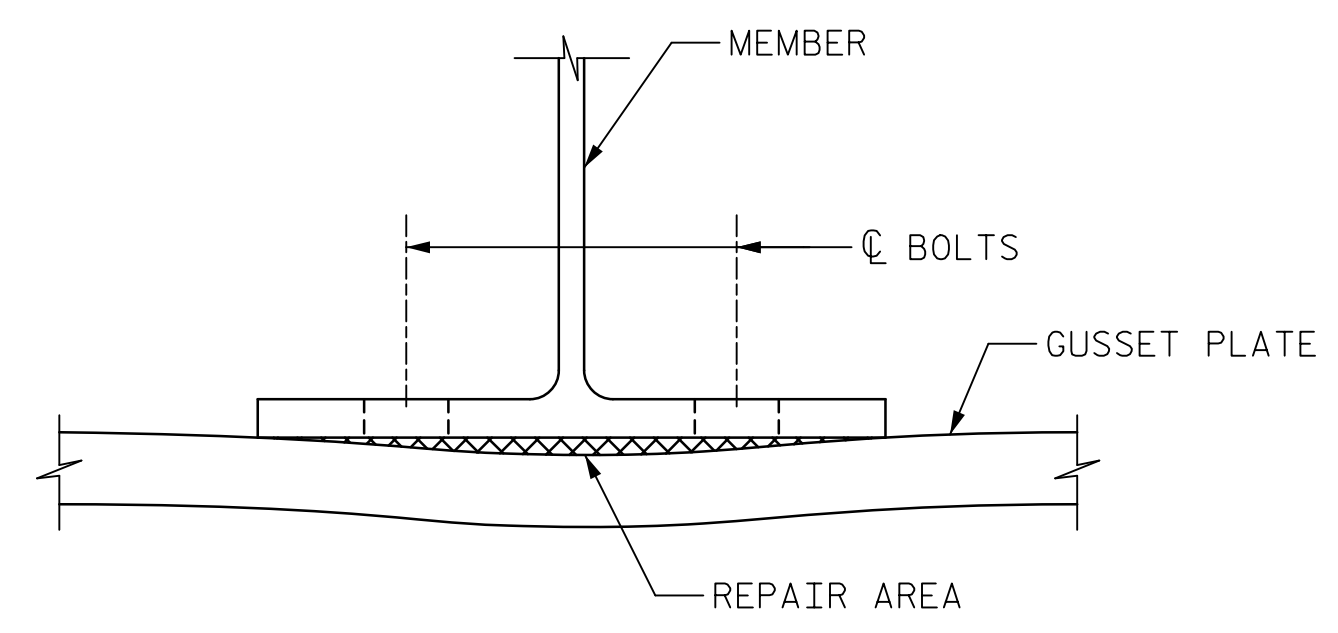
PLAN VIEW OF TYPICAL PACK RUST REPAIR LOCATION - TYPE I

PACK RUST REPAIRS
 FOR REPRESENTATION ONLY. REPAIR SHALL BE PERFORMED AT EACH LOCATION NOTED. FOR REPAIR LOCATIONS, SEE PHOTO LOCATION LEGEND ON SHEET 12

1. CLEAN AREA TO REMOVE PACK RUST. DO NOT DISCONNECT ANY MEMBERS OR LOOSEN ANY BOLTS.
2. APPLY AN HRCSA PENETRANT TO THE CLEANED AREA IN ACCORDANCE WITH MANUFACTURER'S RECOMENDATIONS.
3. APPLY COMPATIBLE ONE-STEP HRCSA PRIMER/TOP-COAT, APPLYING MULTIPLE COATS AS NECESSARY TO FILL GAP OR CREVICE. COAT THE ENTIRE GUSSET PLATE AND 3" BEYOND THE GUSSET PLATE ON EACH ADJOINING MEMBER.

THE ENGINEER SHALL INSPECT EACH REPAIR AREA BETWEEN EACH STEP OF THE REPAIR.
