Preliminary Site Assessment Report

November 20, 2018
WBS Element: 44625.1.1
State Project: U-5888
Haywood County

at
Clifford Gould LLC Property
Parcel #008
783 N Main Street, Waynesville, NC 28786
PIN #: 8615-59-6508
Facility ID No.: N/A
Groundwater Incident No.: 41466

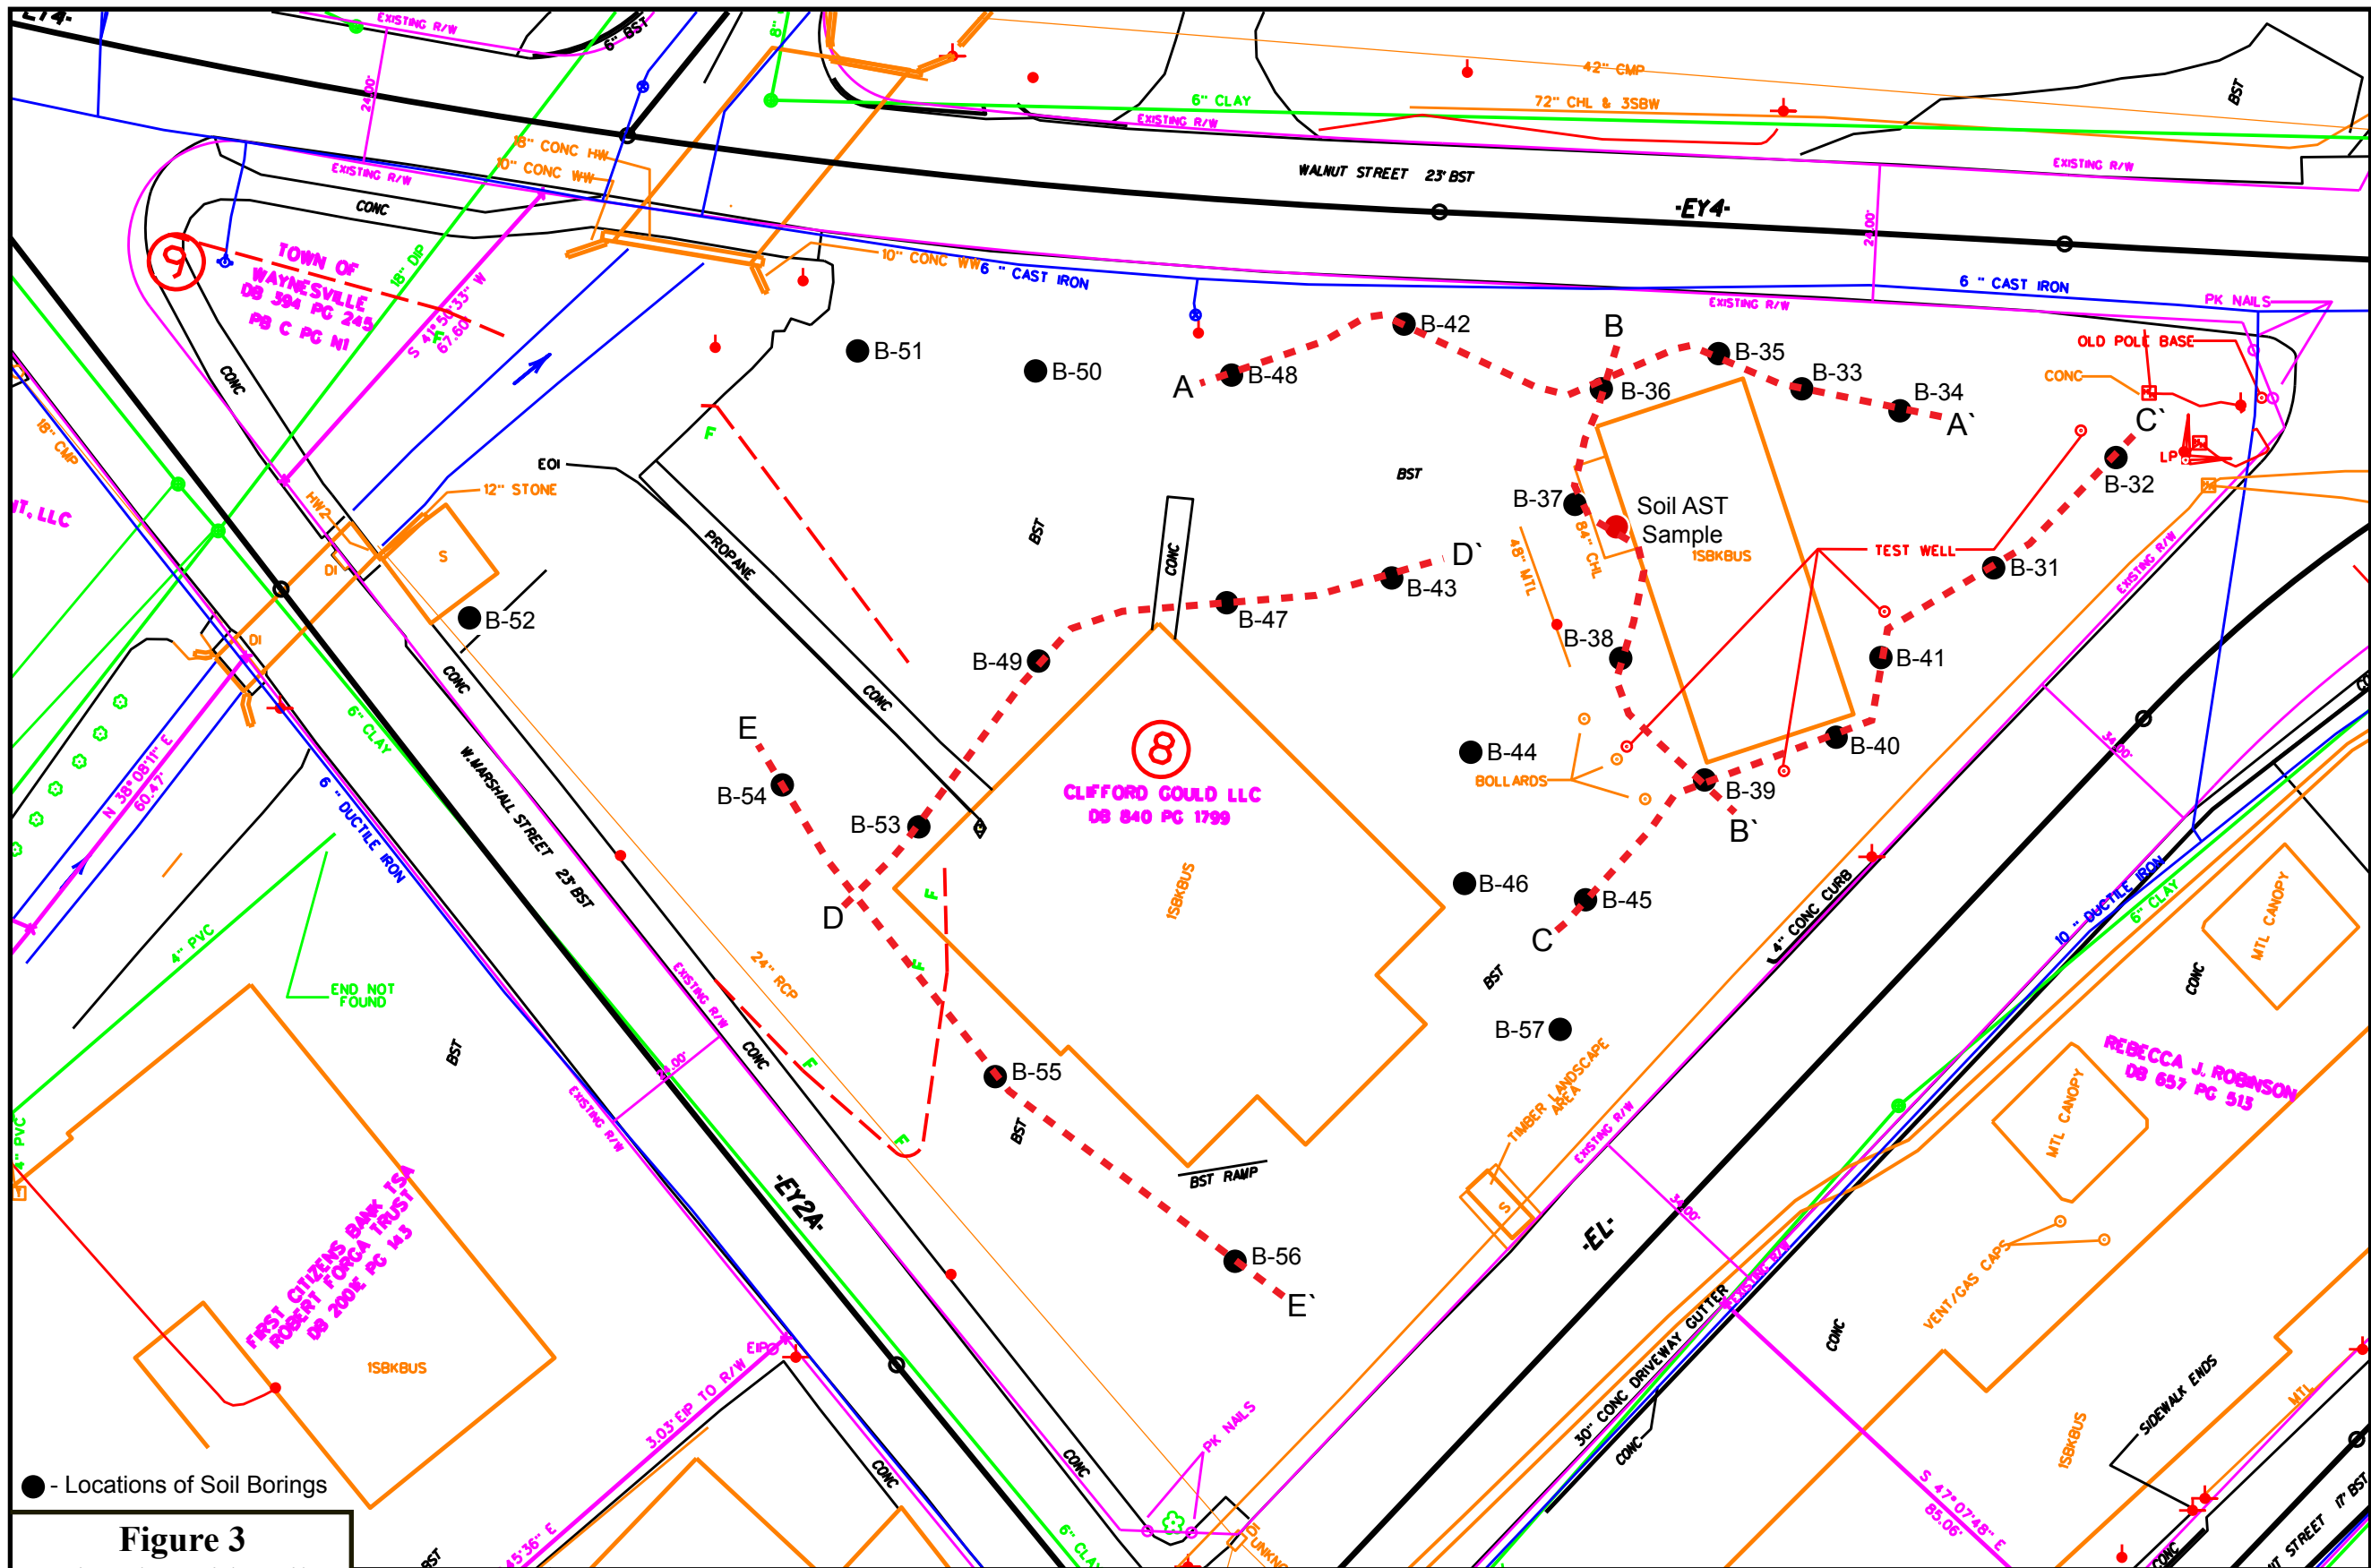
Figure 3

Carolina Soil Investigations, LLC mobilized to the site on October 24th, 2018 to drill Geoprobe borings and collect soil samples. Our project design called for collecting a shallow and deep soil sample from each boring (Figure 3). The purpose of collecting samples at a depth of ~3.0 feet is

to test for petroleum releases related to surface spills and releases from product lines. The purpose of collecting samples at a depth of ~9.0 feet is to test for petroleum releases related to underground storage tanks. Soil samples were collected at other depths within the Geoprobe cores if soil staining or petroleum vapors were observed or if limited core recovery occurred. Soil borings were drilled across the property with a particular focus on areas thought to be more likely to contain petroleum impacted soil (Figure 3).

● - Locations of Soil Borings

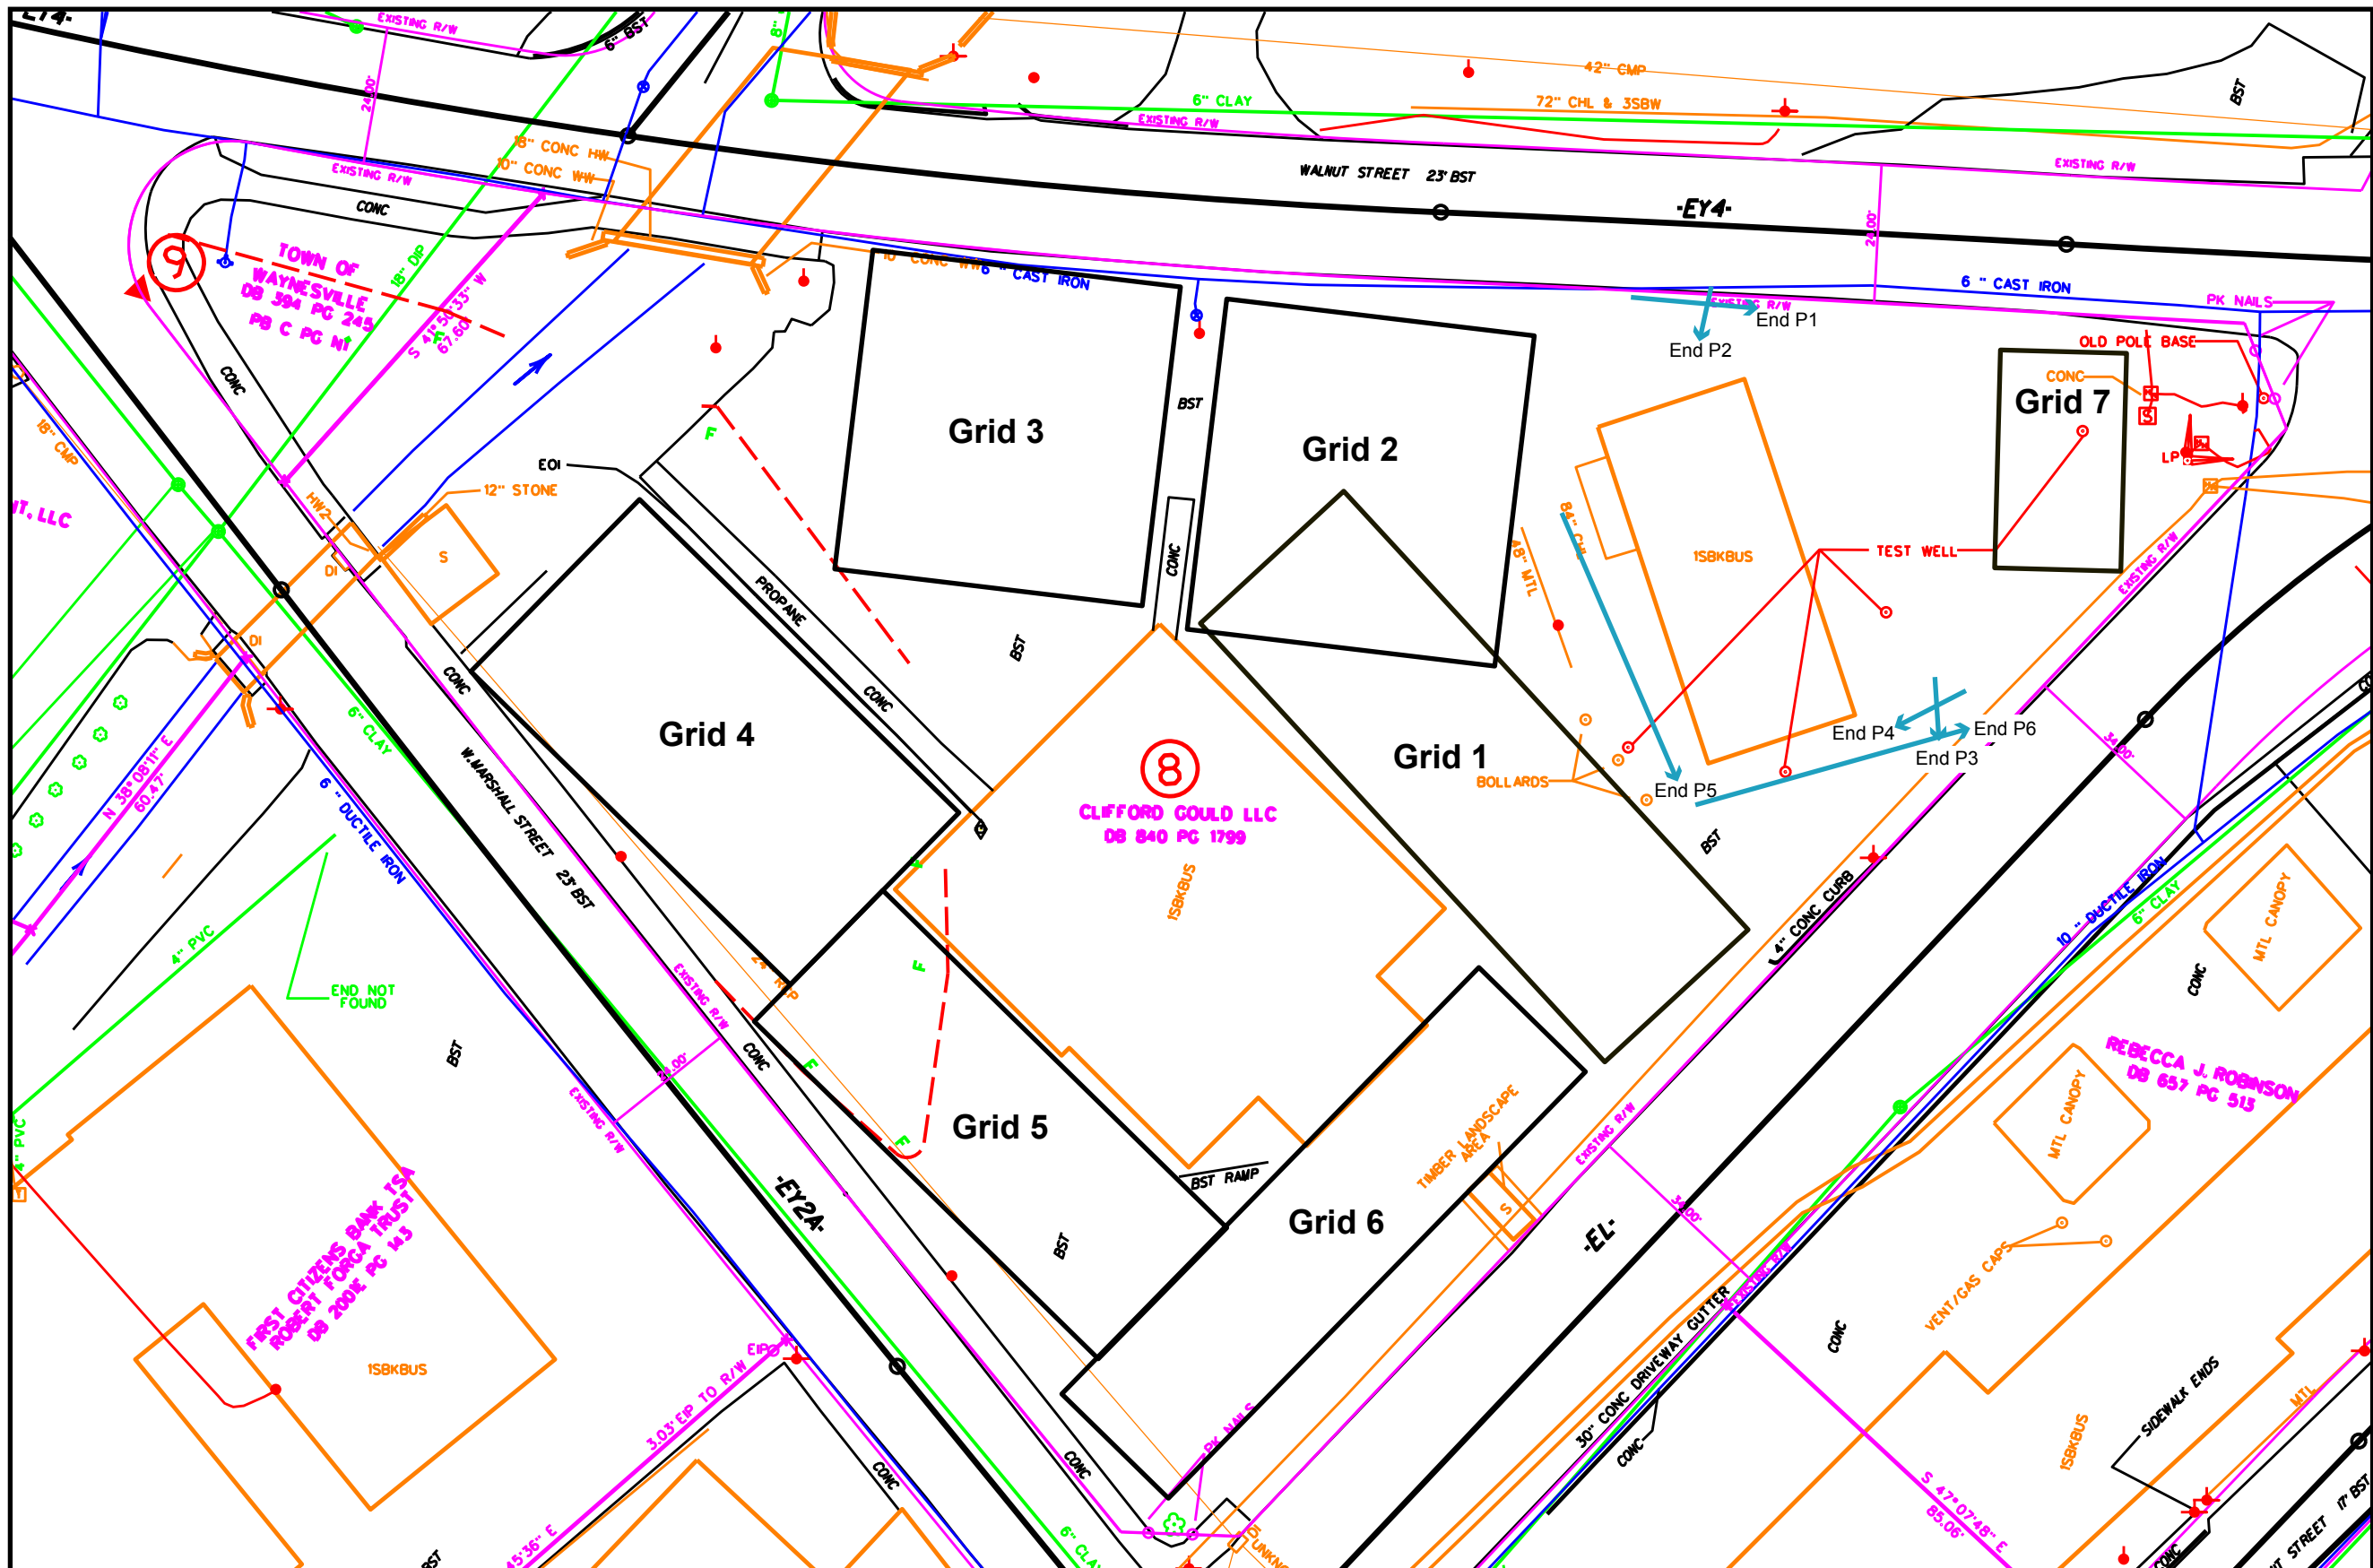
Figure 4
 Site Plan with
 Grid and GPR
 Profile Locations

Seramur & Associates set up seven grids for a geophysical survey at Parcel #008 (Figures 4 through 7). Grid 1 ran along the northeast side of the former restaurant building, perpendicular to North Main Street. Grid 2 extended from the northeast corner of Grid 1, west of the former auto-repair shop, perpendicular to Walnut Street. Grid 3 was located west of Grid 2 off of the northwest side of the former restaurant building. Grid 4 was located off the west corner of the former restaurant building, approximately parallel to Marshall Street. Grid 5 was located off of the southwest side of the former restaurant building continuing off of the south side of Grid 4. Grid 6 was located off of the southeast side of the building running parallel to North Main Street. Grid 7 was located in the northeast corner of the property near the light pole and utility boxes. The GPR and magnetometer were used to survey areas outside of the two grids that were areas of possible concern on the property. Geophysical data were collected along transects at a 2-foot spacing.

The Magnetometer survey was completed with a MF-1 Fluxgate magnetometer. The MF-1 Fluxgate magnetometer is designed to measure changes in the Earth's magnetic field associated with larger ferrous objects. It does not respond to smaller objects such as nails or wire, but responds well to variations in the Earth's magnetic field produced by manholes, steel pipe, buried drums and tanks. The sensitivity level is well suited for detecting buried USTs at commercial and industrial facilities. Magnetometer data was compiled in an Excel spreadsheet and a contour map with hill shade was drafted using Golden Software's Surfer® modeling program (Figure 4).

Two magnetic anomalies (C & D) were recorded outside of our grid locations (Figure 5). GPR Profiles 1 and 2 were collected across anomaly C (Figure 4). GPR Profile 1 shows a hyperbola that could be interpreted as a UST, but Profile 2 shows that this reflector is too small to be a UST (Figure 9). There is an irregular shaped asphalt patch at this location and the water line runs along this side of the road. This anomaly is interpreted to be related to a utility.

GPR Profiles 3 and 4 were collected across Anomaly D (Figure 4). These profiles show evidence of soil disturbance but no reflections characteristic of a UST (Figure 9).

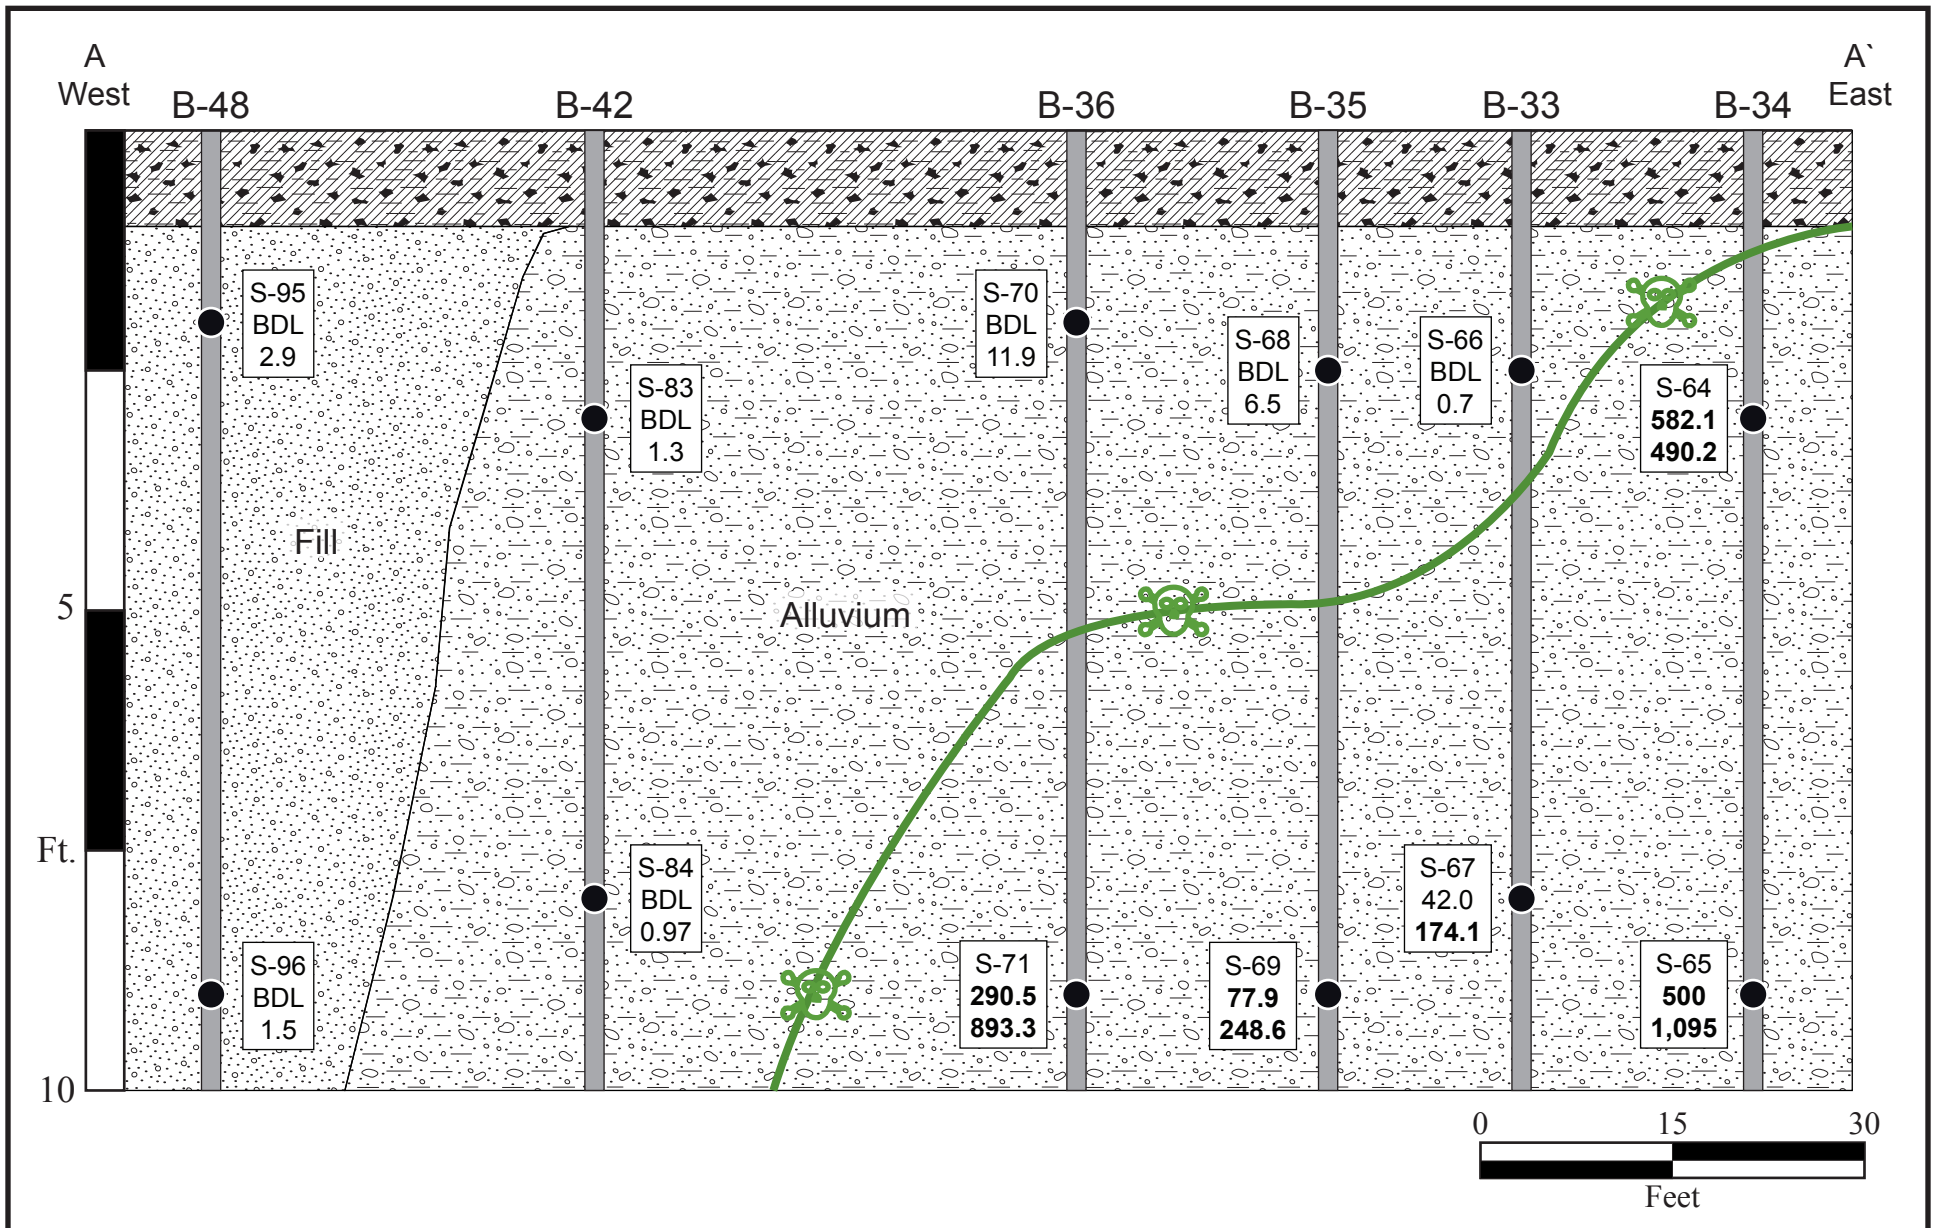
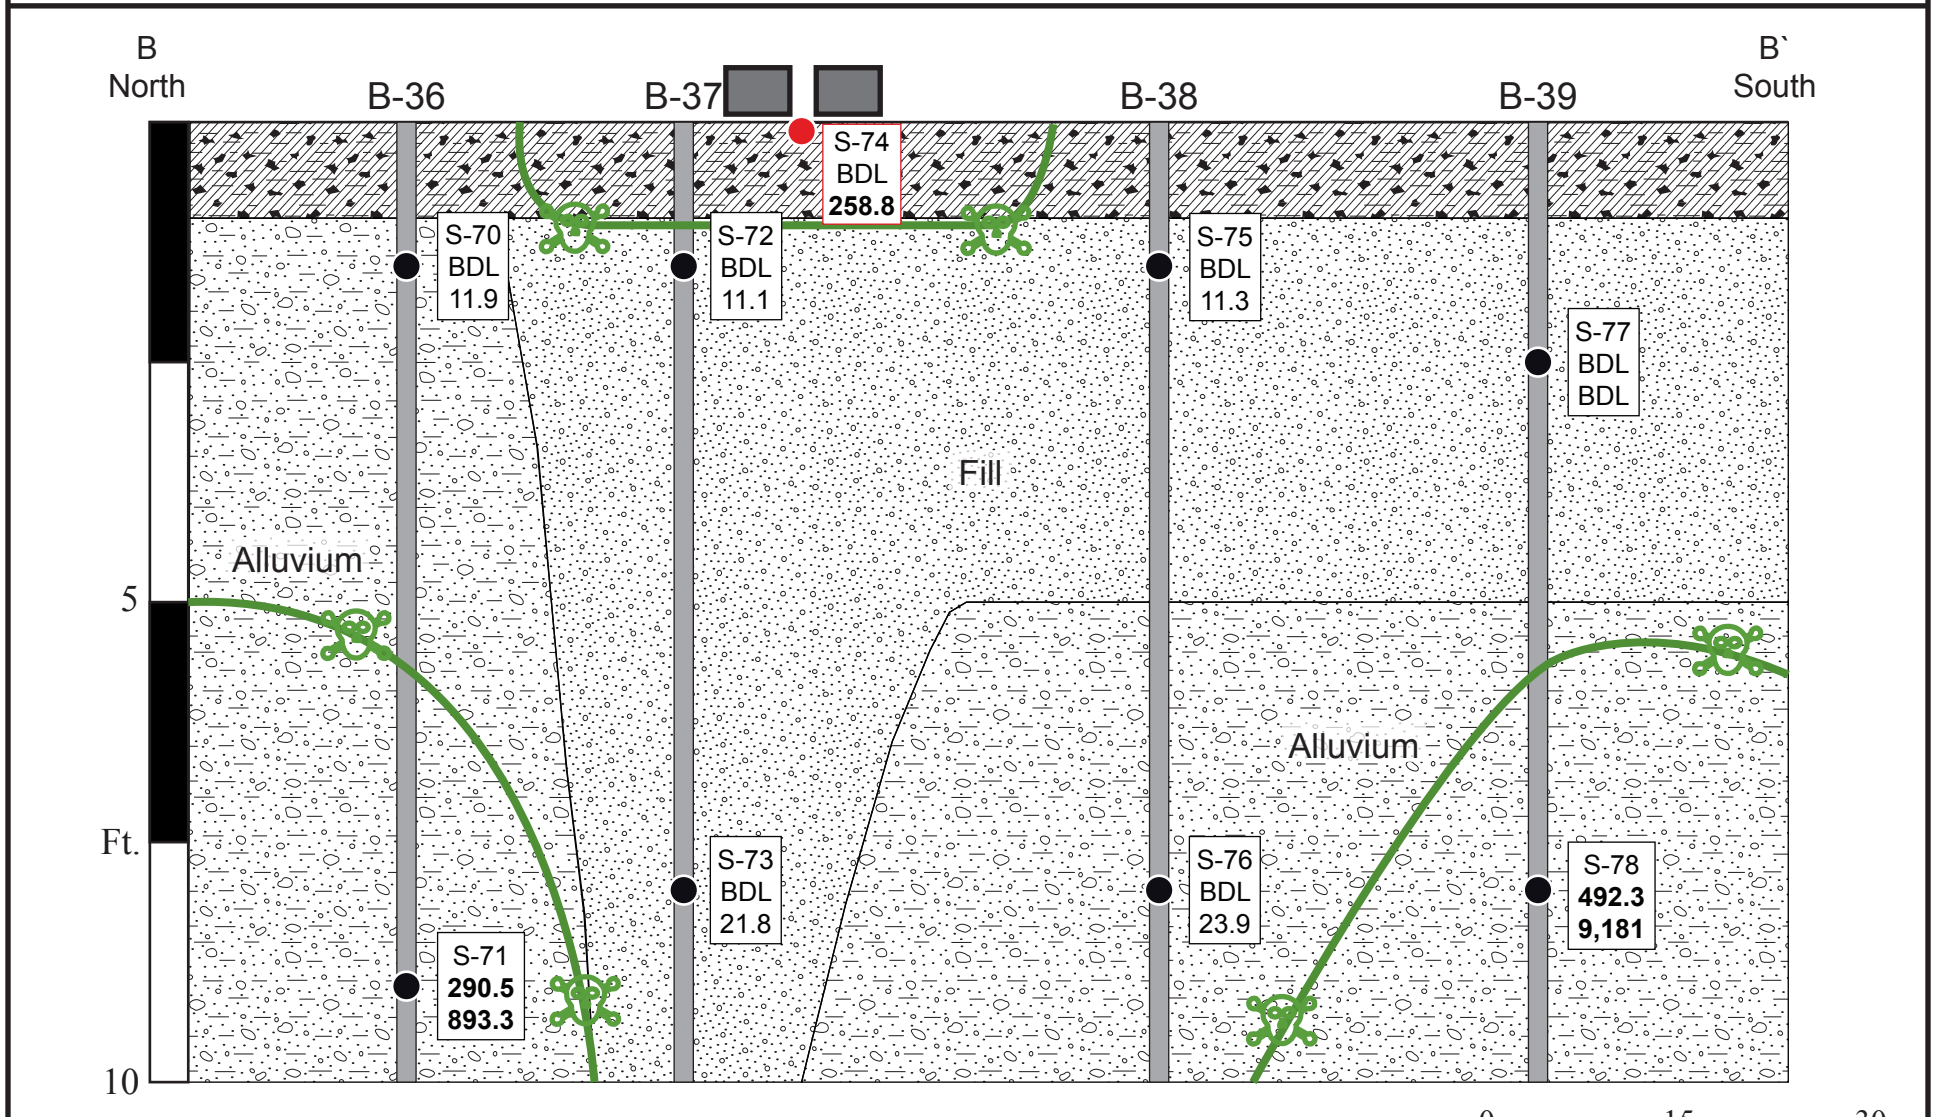
Figure 12 Cross-Sections A-A' and B-B'	State Project: U-5888 Haywood County, NC	Clifford Gould LLC Property 783 N Main Street Waynesville, NC	Parcel #008 Facility I.D.: N/A	Seramur & Associates, PC Boone, NC
---	---	---	-----------------------------------	---------------------------------------

● - Locations of Soil Samples BDL - Below Detectable Limit 42.0 - Petroleum Constituent Concentrations
 174.1 Detected as GRO (upper) and DRO (lower)

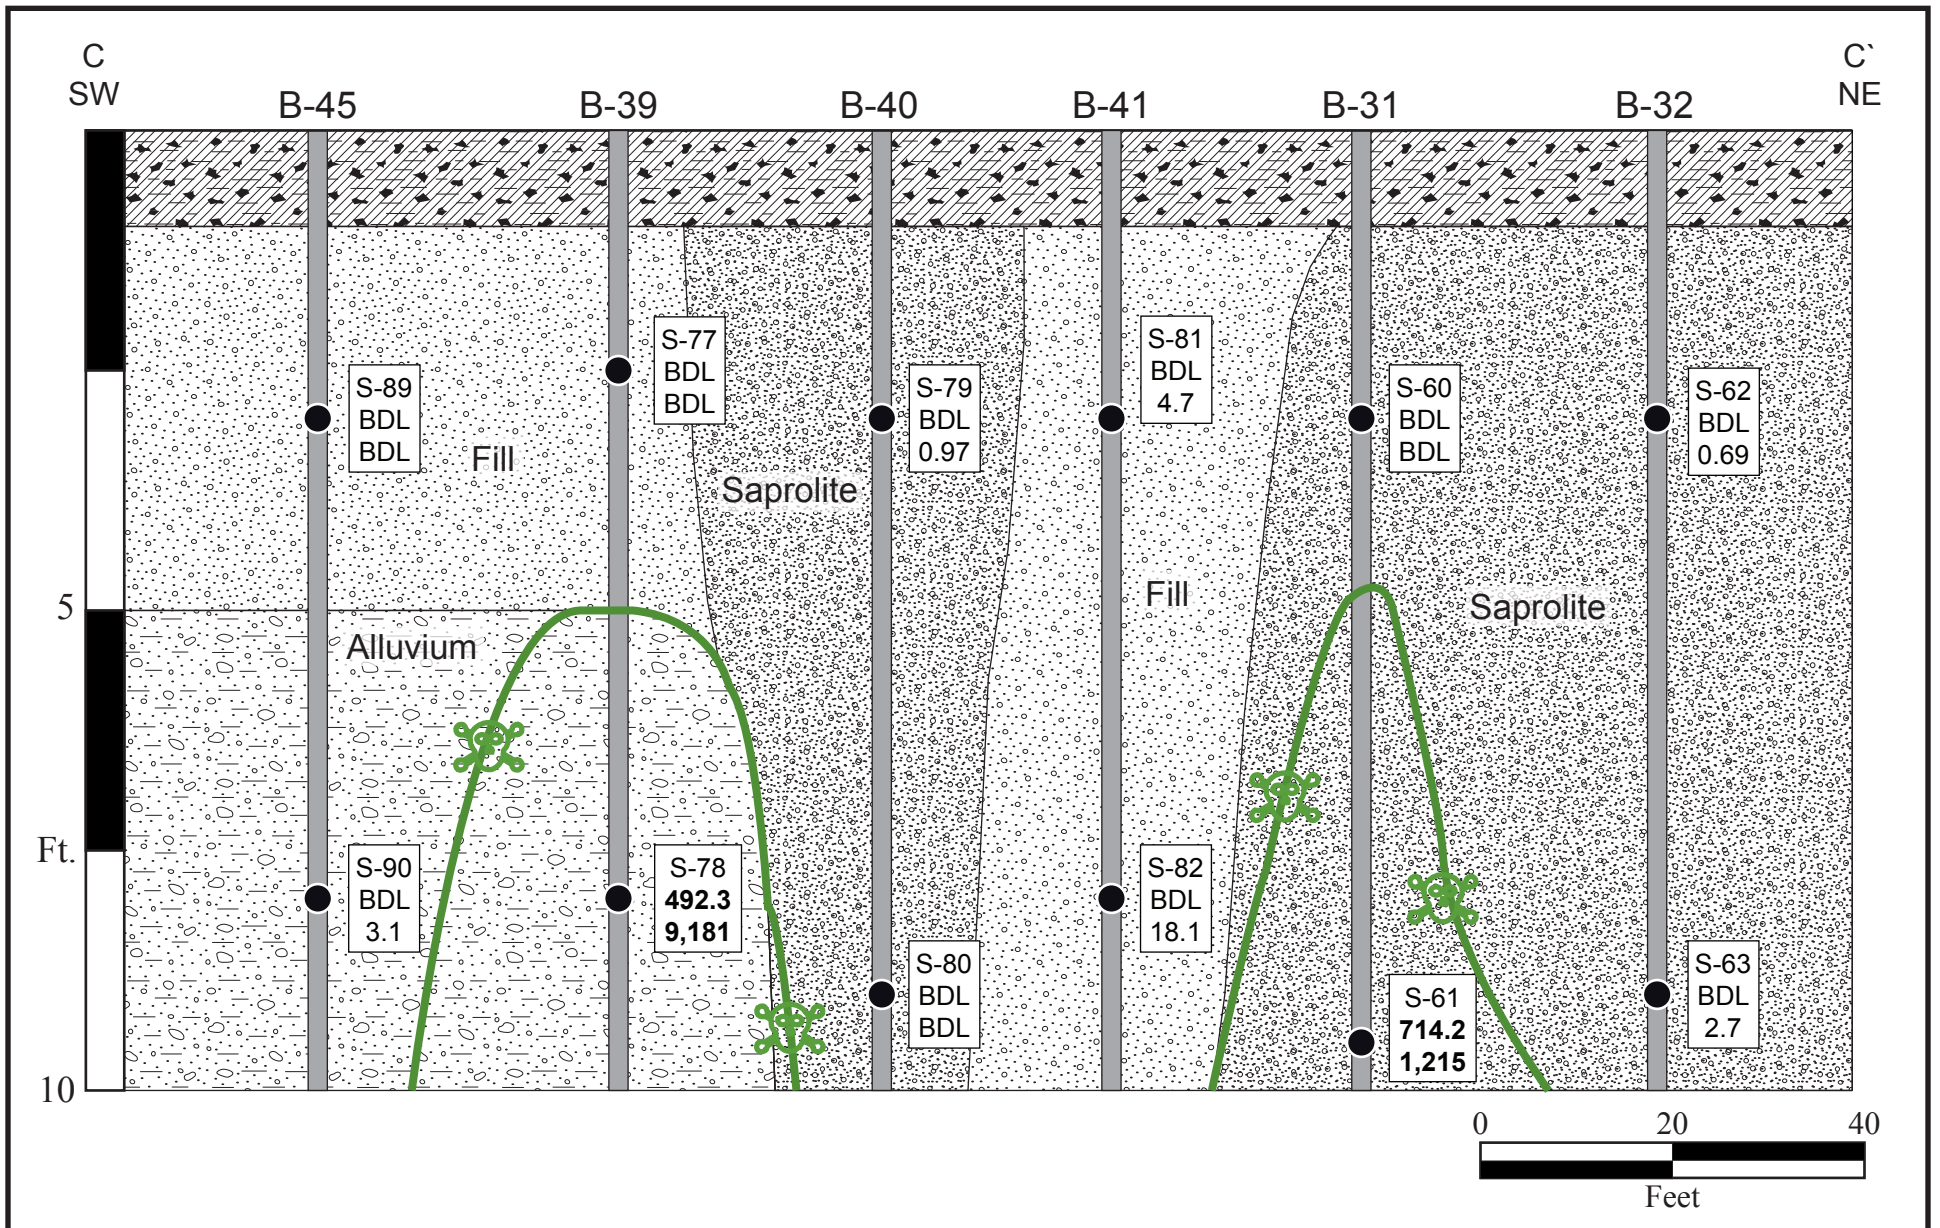
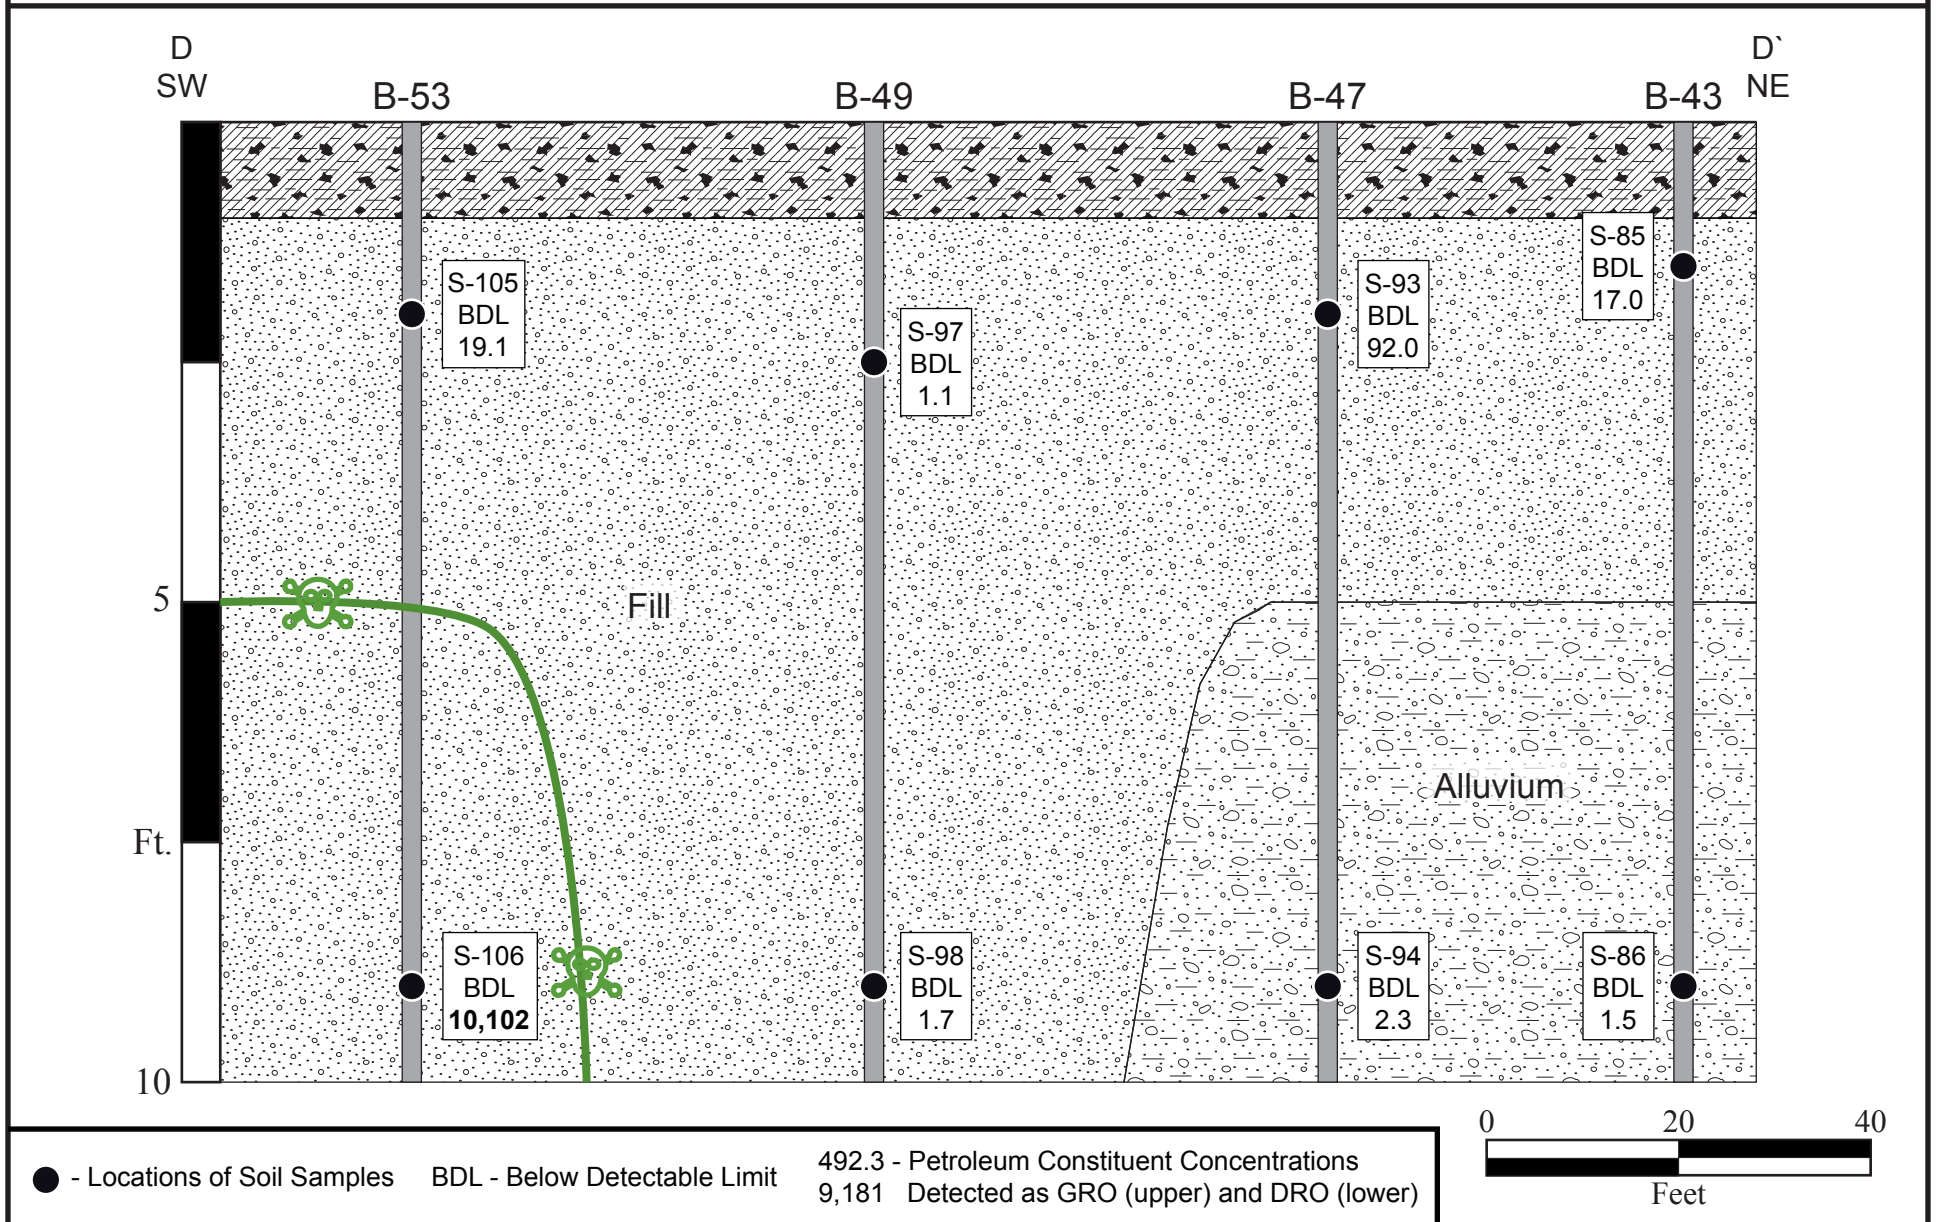
Figure 13 Cross-Sections C-C' and D-D'	State Project: U-5888 Haywood County, NC	Clifford Gould LLC Property 783 N Main Street Waynesville, NC	Parcel #008 Facility I.D.: N/A	Seramur & Associates, PC Boone, NC
---	---	---	-----------------------------------	---------------------------------------

● - Locations of Soil Samples BDL - Below Detectable Limit 492.3 - Petroleum Constituent Concentrations
9,181 Detected as GRO (upper) and DRO (lower)

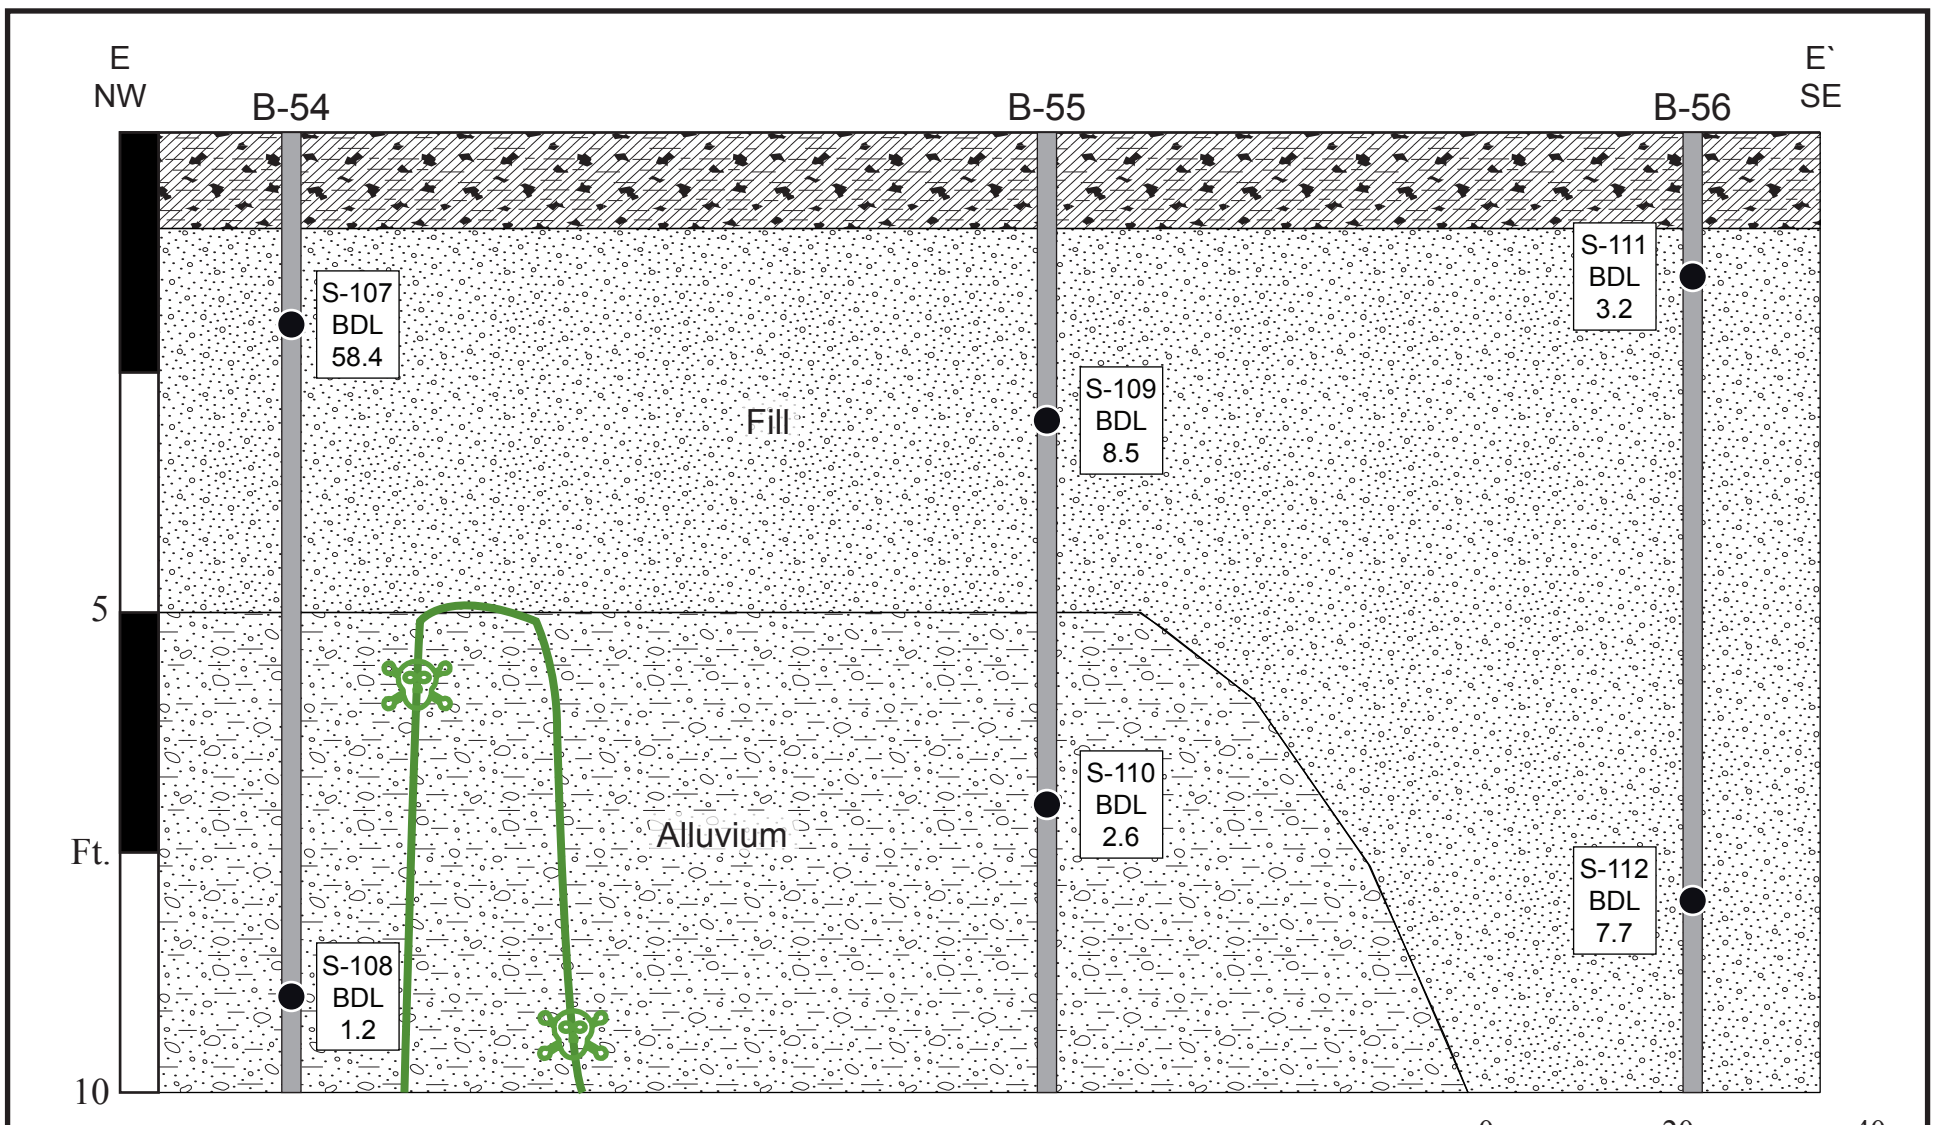
● - Locations of Soil Samples BDL - Below Detectable Limit BDL - Petroleum Constituent Concentrations
 8.5 Detected as GRO (upper) and DRO (lower)
