**AS-BUILT REPAIR QUANTITY TABLE**

PROJECT NO. I-5831A  
MADISON COUNTY  
 BRIDGE NO. 560547

**BENT 4  
 SPAN E FACE**

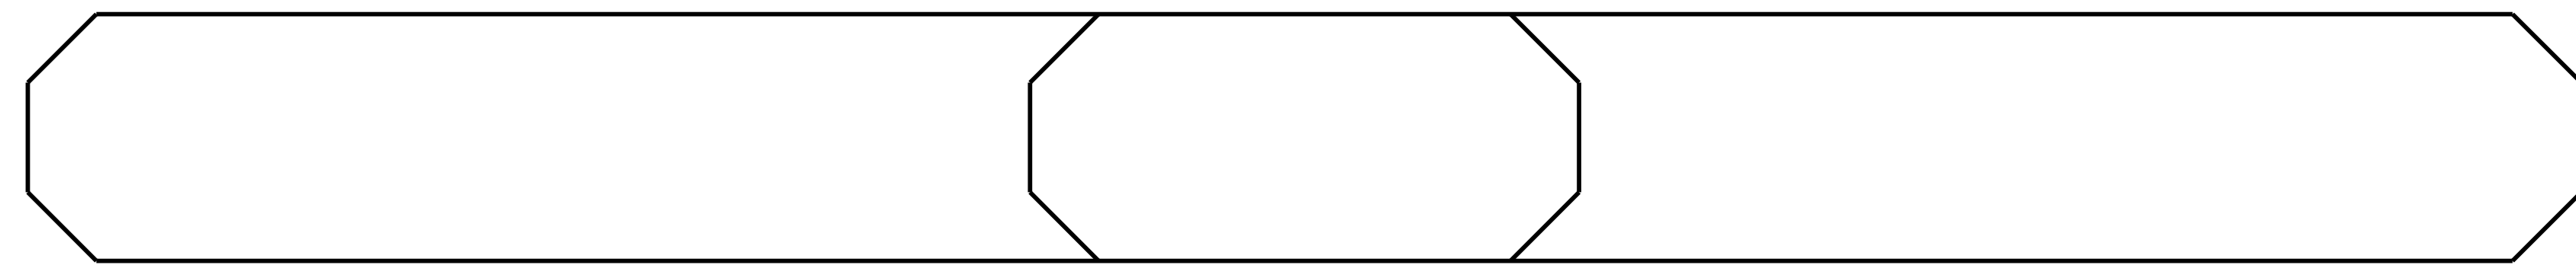
BENT 4 SPAN E FACE	QUANTITIES			
	ESTIMATE		ACTUAL	
SHOTCRETE REPAIRS	AREA SQ. FT.	VOLUME CU. FT.	AREA SQ. FT.	VOLUME CU. FT.
CAP	0.0	0.0		
COLUMN	0.0	0.0		
CONCRETE REPAIRS	AREA SQ. FT.	VOLUME CU. FT.	AREA SQ. FT.	VOLUME CU. FT.
CAP	0.0	0.0		
COLUMN	0.0	0.0		
EPOXY RESIN INJECTION		LIN. FT.	LIN. FT.	
CAP		3.5		
COLUMN		0.0

VALUES IN CHART REPRESENT ESTIMATED REPAIR TOTALS AFTER REMOVAL OF UNSOUND CONCRETE, MINIMUM OF 1" BEHIND REBAR AND MINIMUM 2" CLEARANCE TO SAWCUT. SEE "TYPICAL CAP AND COLUMN REPAIR DETAILS" SHEET SD-01.
