PROJECT NO. 15BPR.56
BEAUFORT COUNTY
 BRIDGE NO. 060028

SHEET 21 OF 48

STATE OF NORTH CAROLINA
 DEPARTMENT OF TRANSPORTATION
 RALEIGH

**SUBSTRUCTURE
 BENT 21 REPAIR**

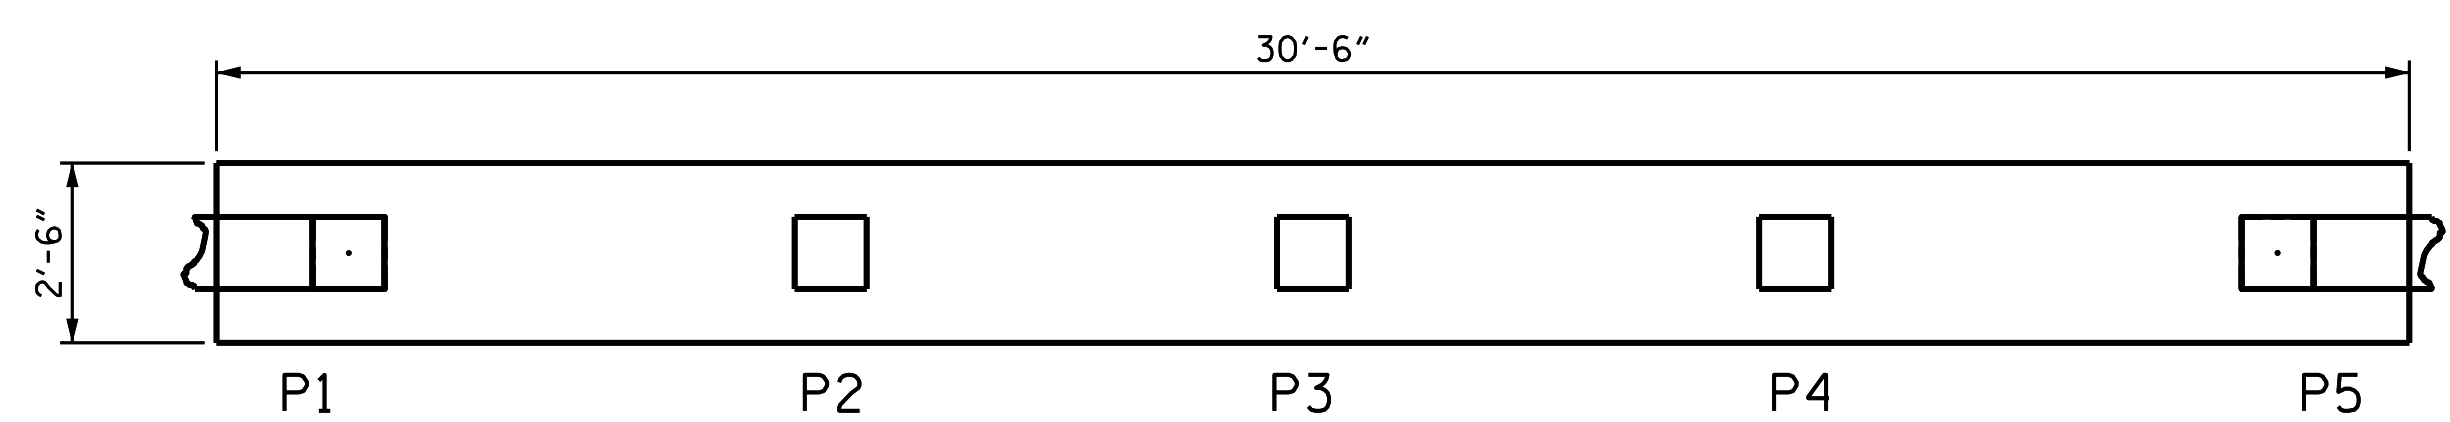
BOTTOM OF CAP

BENT 21	QUANTITIES			
	ESTIMATE		ACTUAL	
SHOTCRETE REPAIR	AREA SF	VOLUME CF	AREA SF	VOLUME CF
CAP (VERTICAL FACE)	0.3	0.2		
CAP (HORIZONTAL FACE)	0.0	0.0		
COLUMN	0.0	0.0		
CONCRETE REPAIR				
CAP (VERTICAL FACE)	0.0	0.0		
CAP (HORIZONTAL FACE)	0.0	0.0		
COLUMN	0.0	0.0		
EPOXY RESIN INJECTION		LF		LF
CAP		0.0		
COLUMN		0.0
