PROJECT NO. I-5915B  
IREDELL COUNTY  
 BRIDGE NO. 480006

STATE OF NORTH CAROLINA  
 DEPARTMENT OF TRANSPORTATION  
 RALEIGH

## BEARING REPAIRS

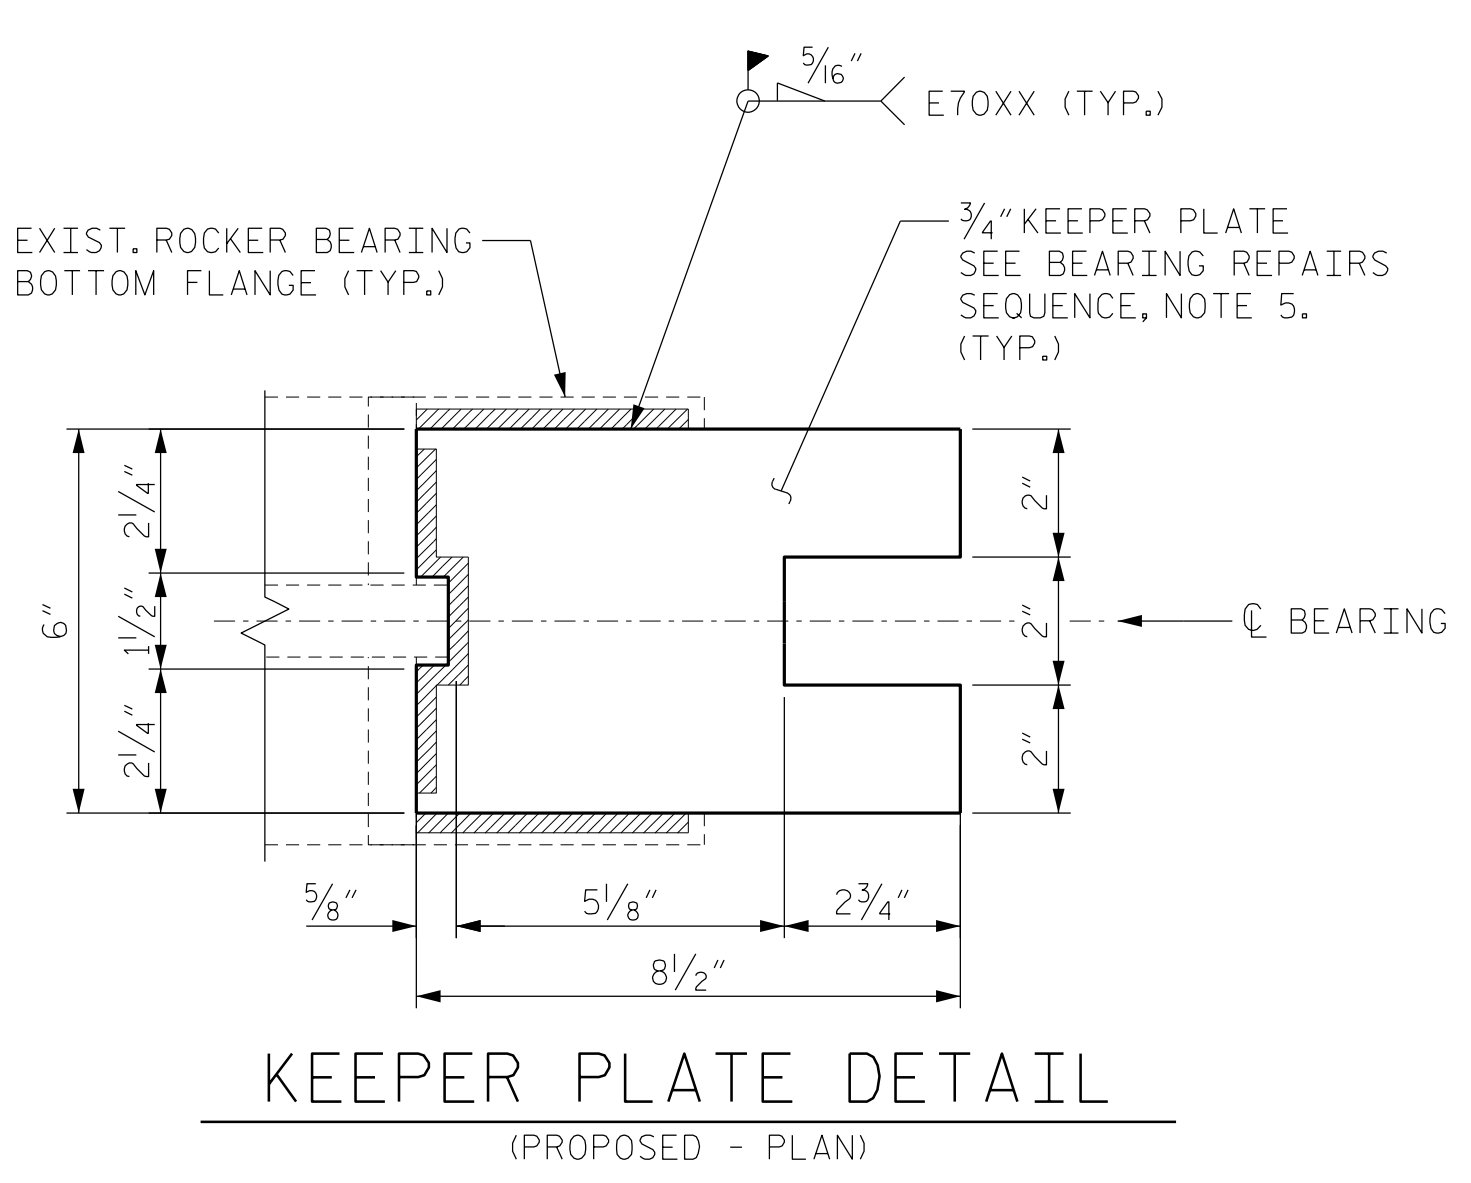
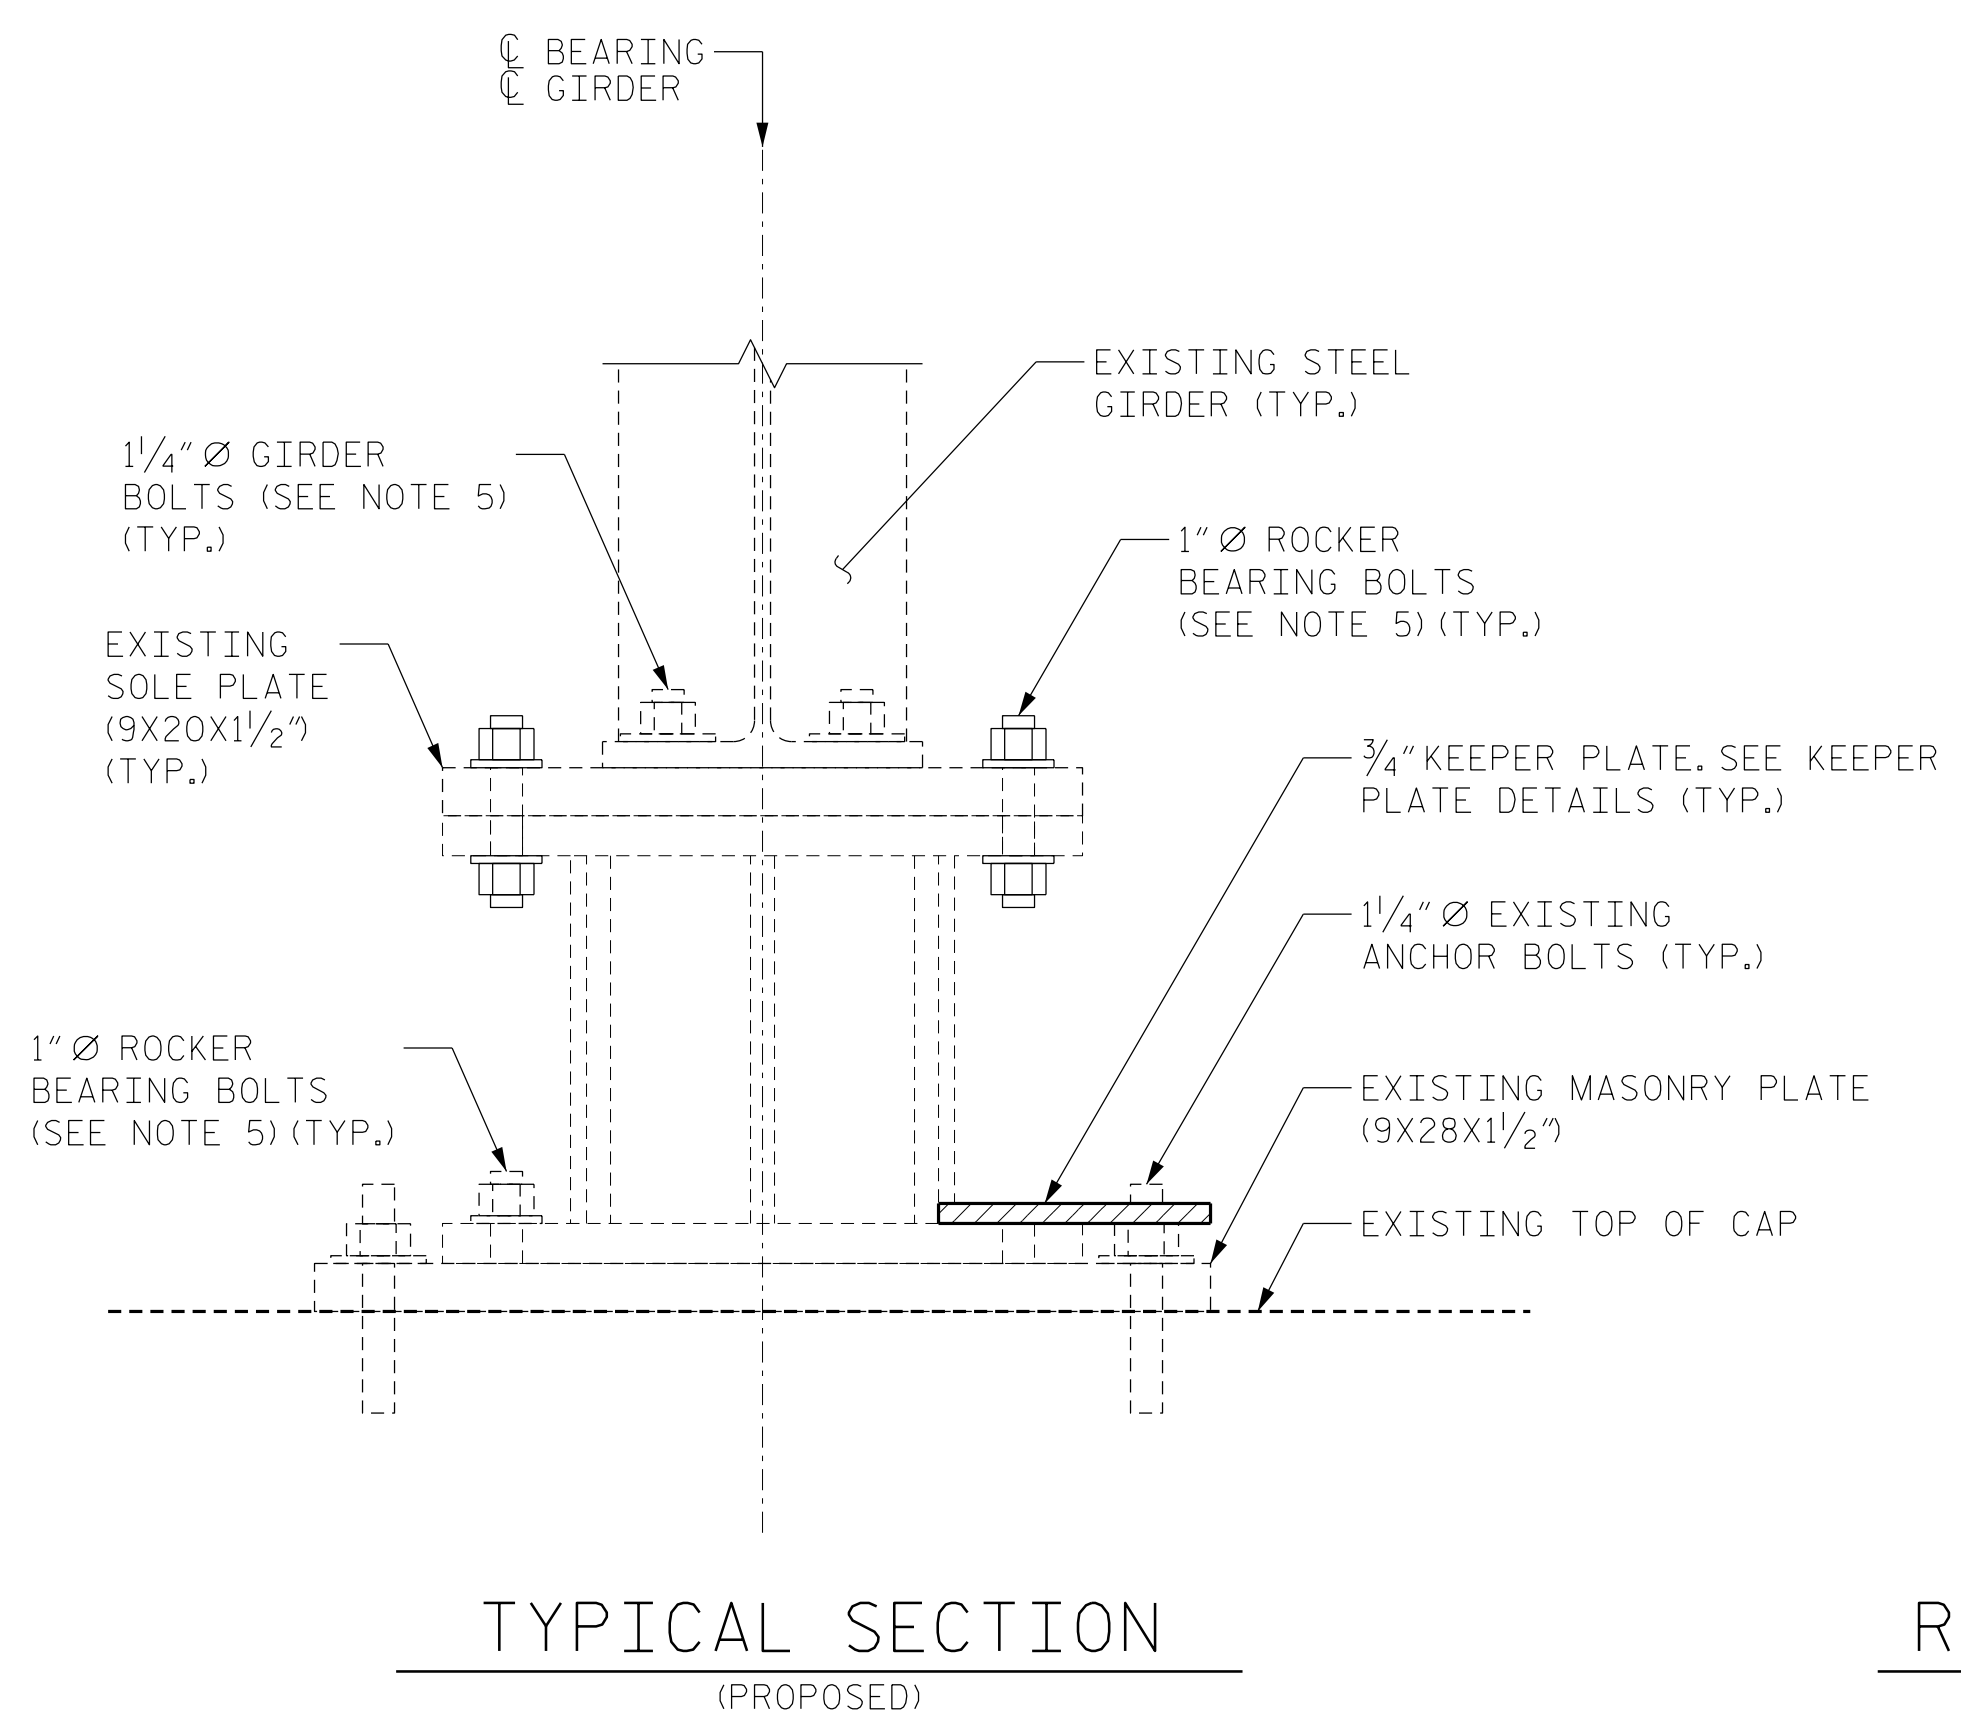
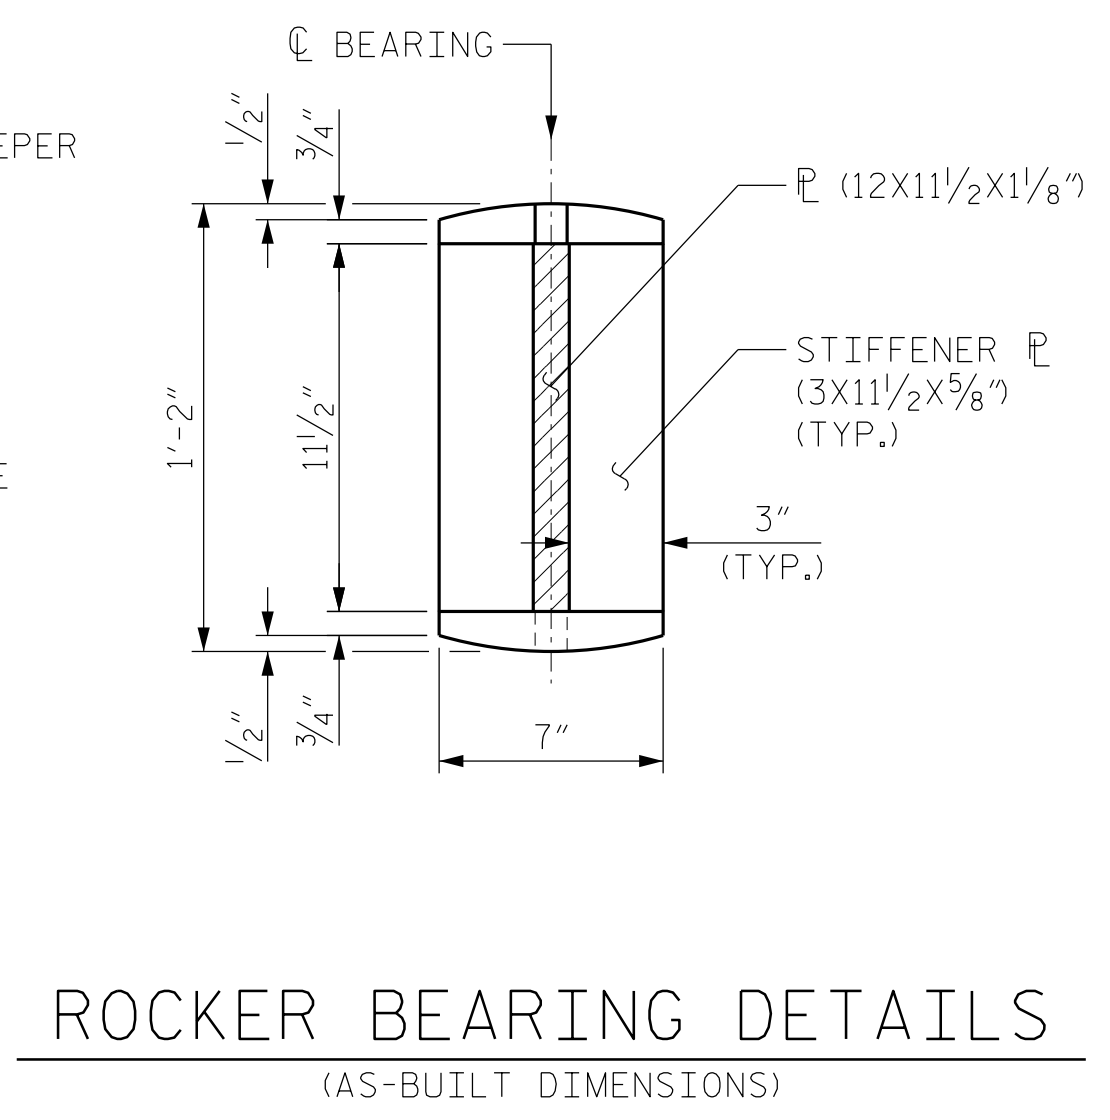
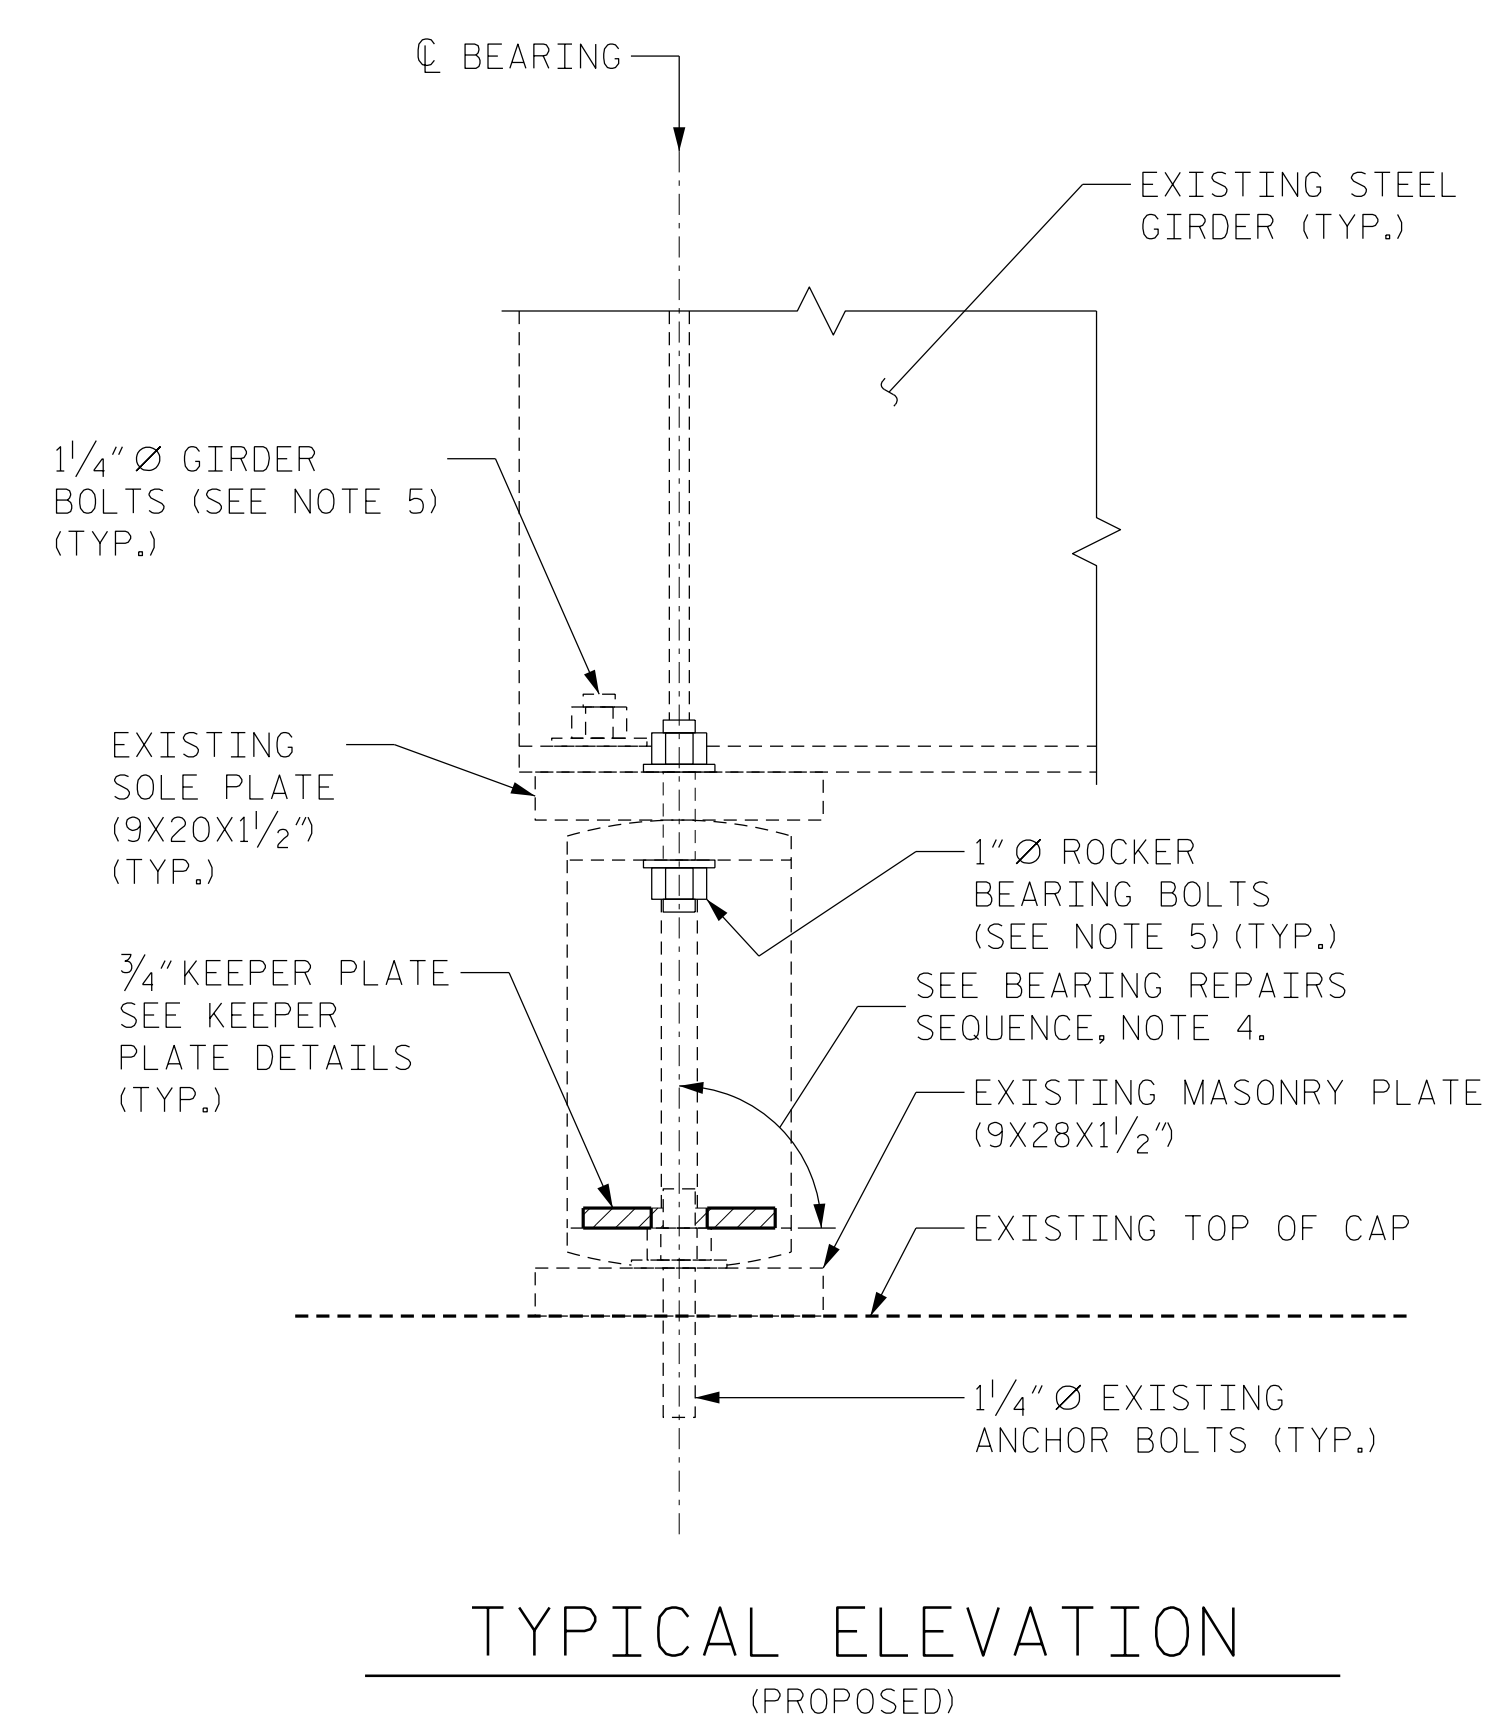
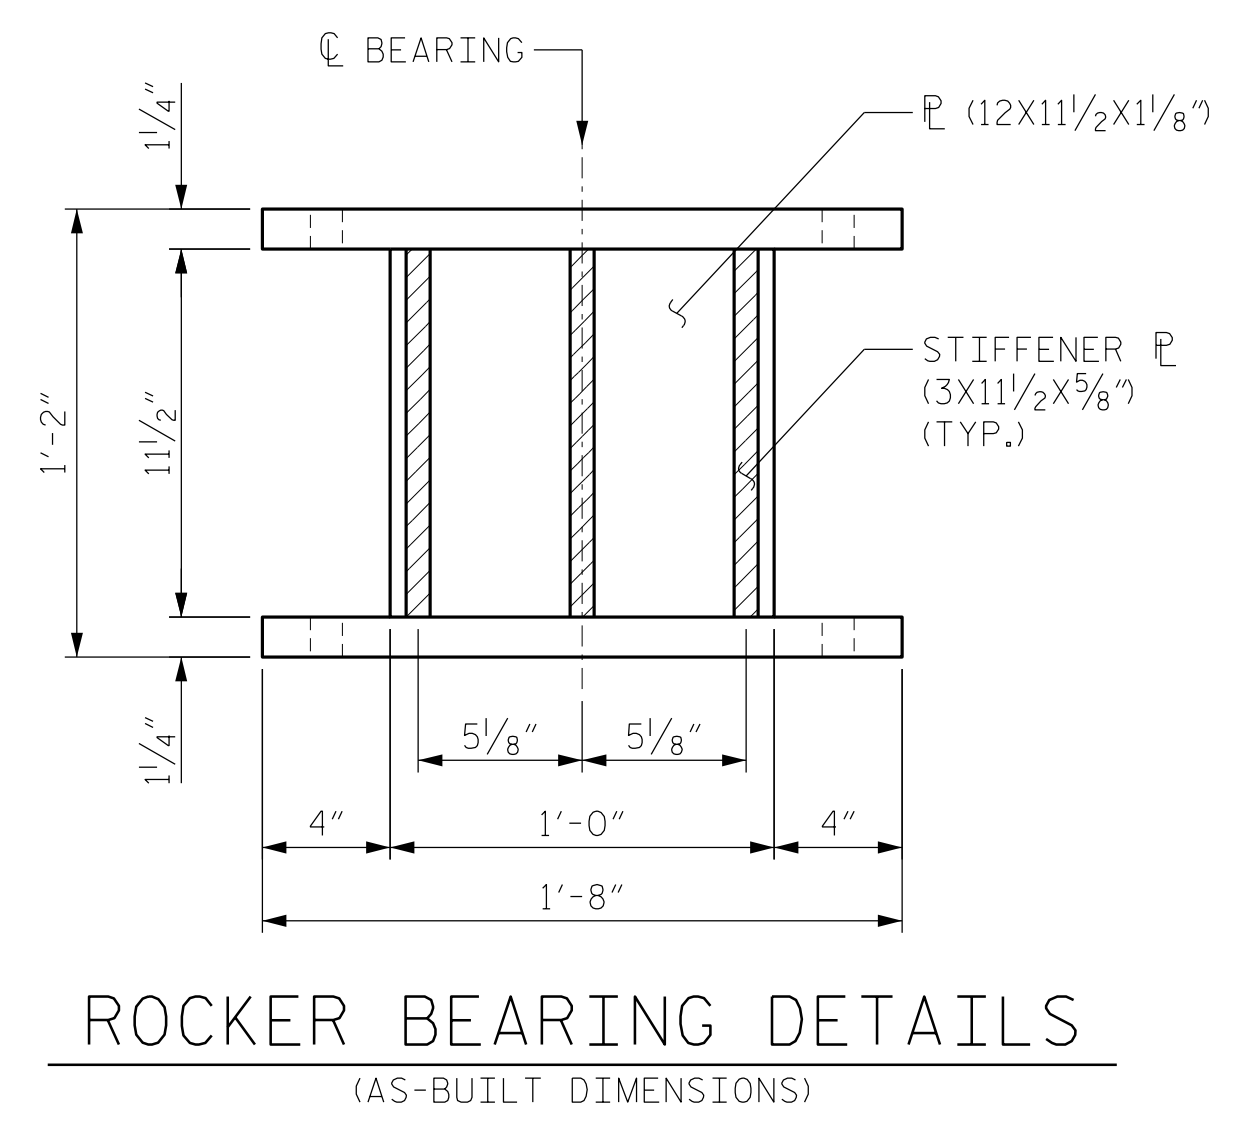
### EXISTING ROCKER BEARINGS

- TYPICAL DAMAGE INCLUDES:
- CORROSION AND SECTION LOSS THROUGHOUT
  - MISSING/BROKEN ROCKER BEARING BOLTS
  - MISALIGNED/ROTATED AND/OR SHIFTED ROCKER BEARINGS

- CLEAN AND REMOVE PACK RUST FROM ROCKER BEARING AND CONNECTING PLATES. IF, AFTER THE BEARING CLEANING PROCESS, VISIBLE STEEL CRACKS OR MORE THAN 30% SECTION LOSS ARE OBSERVED, OR IF PERMANENT DEFORMATIONS DUE TO SECTION LOSS AND PACK RUST DO NOT ALLOW ROCKER BEARINGS TO FUNCTION APPROPRIATELY, ALL WORK SHALL STOP AND THE ENGINEER SHALL BE NOTIFIED IMMEDIATELY.

- PERFORM JACKING OPERATIONS AS INDICATED IN THE "JACKING DETAILS" SHEET.
- DISCONNECT BOTH TOP AND BOTTOM ROCKER BEARING BOLTS.
- ALIGN AND/OR ROTATE ROCKER BEARINGS SUCH THAT THE VERTICAL AXIS SHALL BE AT 90° WITH RESPECT TO THE TOP FACE OF THE CAP, WITH A TOLERANCE OF +/- 2°. IN PLAN VIEW, THE CL OF THE BEARING ASSEMBLY SHALL BE ALIGNED WITH THE C GIRDER AND C BEARING LINES ON THE CAP. CONDUCT THE WORK WHEN TEMPERATURES ARE BETWEEN 45° F AND 75° F. WORK WITH THE ENGINEER TO ADJUST AS REQUIRED WHEN WORKING UNDER EXTREME TEMPERATURES.

- REPLACE MISSING/BROKEN BOLTS IN KIND AT THE GIRDER-SOLE PLATE CONNECTION, AND AT TOP ROCKER BEARING CONNECTIONS; BOLTS SHALL BE FINGER TIGHT AND THEN BACKED OFF 1/2 TURN. FOR BOTTOM ROCKER BEARING CONNECTIONS, WELD A KEEPER PLATE TO BOTH SIDES OF THE ROCKER BEARING BOTTOM FLANGE.

- CONCLUDE JACKING OPERATIONS AS INDICATED IN THE "JACKING DETAILS" SHEET.
- ENSURE THAT THE BEARINGS ARE NOT LEFT UNRESTRAINED DURING TEMPERATURE MOVEMENTS. IF THE CONTRACTOR MUST DE-MOBILIZE, WORK WITH THE ENGINEER TO PROVIDE TEMPORARY REPLACEMENT OF THE BOLTS TO PROHIBIT UNWANTED ROTATION OF THE ROCKER BEARINGS.
