PROJECT NO. I-5915B
IREDELL COUNTY
 BRIDGE NO. 480007

STATE OF NORTH CAROLINA
 DEPARTMENT OF TRANSPORTATION
 RALEIGH

BEARING REPAIRS

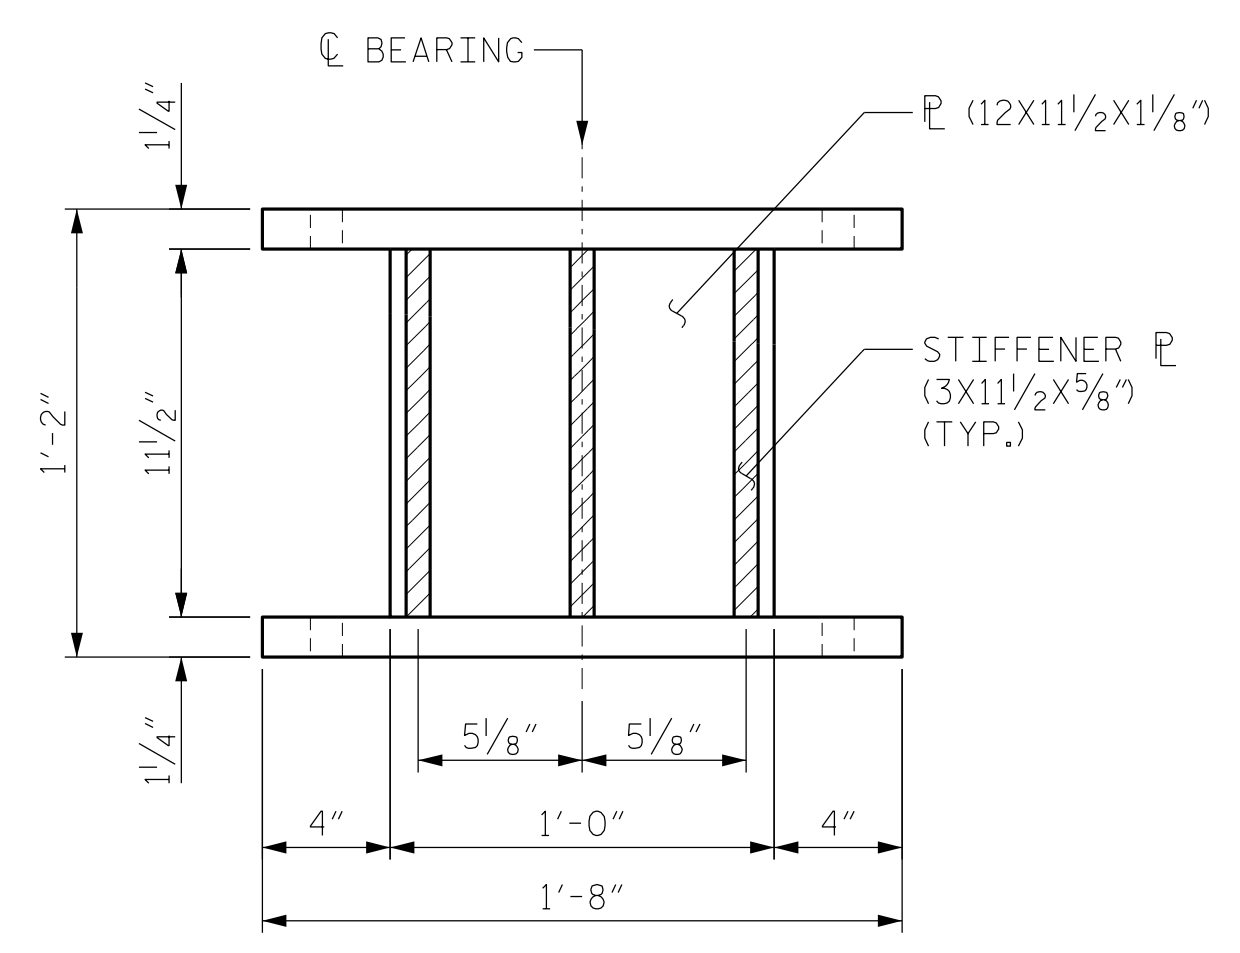
ROCKER BEARING DETAILS
(AS-BUILT DIMENSIONS)

EXISTING ROCKER BEARINGS

- TYPICAL DAMAGE INCLUDES:
- CORROSION AND SECTION LOSS THROUGHOUT
 - MISSING/BROKEN ROCKER BEARING BOLTS
 - MISALIGNED/ROTATED AND/OR SHIFTED ROCKER BEARINGS

- CLEAN AND REMOVE PACK RUST FROM ROCKER BEARING AND CONNECTING PLATES. IF, AFTER THE BEARING CLEANING PROCESS, VISIBLE STEEL CRACKS OR MORE THAN 30% SECTION LOSS ARE OBSERVED, OR IF PERMANENT DEFORMATIONS DUE TO SECTION LOSS AND PACK RUST DO NOT ALLOW ROCKER BEARINGS TO FUNCTION APPROPRIATELY, ALL WORK SHALL STOP AND THE ENGINEER SHALL BE NOTIFIED IMMEDIATELY.

- PERFORM JACKING OPERATIONS AS INDICATED IN THE "JACKING DETAILS" SHEET.
- DISCONNECT BOTH TOP AND BOTTOM ROCKER BEARING BOLTS.
- ALIGN AND/OR ROTATE ROCKER BEARINGS SUCH THAT THE VERTICAL AXIS SHALL BE AT 90° WITH RESPECT TO THE TOP FACE OF THE CAP, WITH A TOLERANCE OF +/- 2°. IN PLAN VIEW, THE CL OF THE BEARING ASSEMBLY SHALL BE ALIGNED WITH THE C GIRDER AND C BEARING LINES ON THE CAP. CONDUCT THE WORK WHEN TEMPERATURES ARE BETWEEN 45° F AND 75° F. WORK WITH THE ENGINEER TO ADJUST AS REQUIRED WHEN WORKING UNDER EXTREME TEMPERATURES.

- REPLACE MISSING/BROKEN BOLTS IN KIND AT THE GIRDER-SOLE PLATE CONNECTION, AND AT TOP ROCKER BEARING CONNECTIONS; BOLTS SHALL BE FINGER TIGHT AND THEN BACKED OFF 1/2 TURN. FOR BOTTOM ROCKER BEARING CONNECTIONS, WELD A KEEPER PLATE TO BOTH SIDES OF THE ROCKER BEARING BOTTOM FLANGE.
