I-5997 PROJECT NO.____ WAKE COUNTY 910242

BRIDGE NO. _

ACB8082119D74CD... DEPARTMENT OF TRANSPORTATION
RALEIGH

RESET BEARING DETAILS

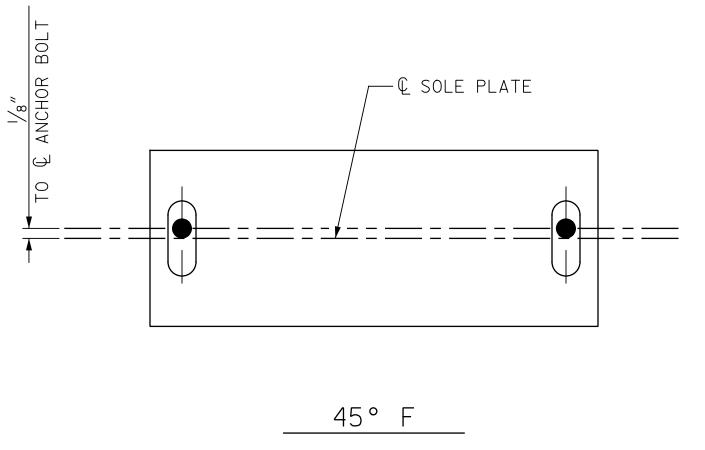
BEAM END VIEW

EXISTING CONDITIONS PHOTOS SHOW POSITION OF ANCHOR BOLTS AT EXPANSION END OF SPAN B (BENT 1). AIR TEMPERATURE IS 91° F.

WITH GIRDERS IN A JACKED AND SUPPORTED CONDITION, DETACH EXISTING SOLE PLATES. FOR JACKING DETAILS, SEE "JACKING DETAILS" SHEET. RESET SOLE PLATE AS SHOWN AND LOWER GIRDER ONTO THE EXISTING SOLE PLATE AND ELASTOMERIC BEARING.

WELD THE SOLE PLATE TO THE PLATE EMBEDDED INTO THE CONCRETE GIRDER.

PRIOR TO WELDING, GRIND THE GALVANIZED SURFACE OF THE PORTION OF THE EMBEDDED PLATE AND SOLE PLATE THAT ARE TO BE WELDED. AFTER WELDING, DAMAGED GALVANIZED SURFACES SHALL BE REPAIRED IN ACCORDANCE WITH THE STANDARD SPECIFICATIONS.

WHEN WELDING THE SOLE PLATE TO THE EMBEDDED PLATE IN THE GIRDER, USE TEMPERATURE INDICATING WAX PENS, OR OTHER SUITABLE MEANS, TO ENSURE THAT THE TEMPERATURE OF THE SOLE PLATE DOES NOT EXCEED 300°F. TEMPERATURES ABOVE THIS MAY DAMAGE THE ELASTOMER.

TIGHTEN ANCHOR BOLT NUTS TO FINGER TIGHT AND THEN BACK THEM OFF $\frac{1}{2}$ TURN.
