AS-BUILT REPAIR QUANTITY TABLE

PROJECT NO. HB-0017  
DARE COUNTY  
BRIDGE NO. 270009

BENT 7 & BENT 8

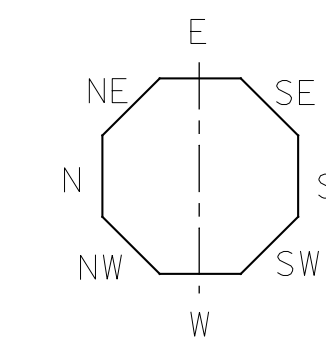
BENT 8

CAP REPAIRS		ESTIMATE			
SHOTCRETE REPAIRS	5.4 SF	2.7 CF	SF	CF	
EPOXY RESIN INJECTION	- LF				LF
PILE REPAIRS		ESTIMATE			
PILE CONCRETE RESTORATION	11.9 SF	5.1 CF	SF	CF	
FRP PROTECTIVE SYSTEM AWL	121.9 SF				
FRP PROTECTIVE SYSTEM BWL	49.5 SF

BENT	PILE	NW	W	SW	S	SE	E	NE	N
		7	5	-	-	-	-	-	-
8	PILE 1	-	5	-	-	-	-	-	-
	PILE 2	-	-	-	-	-	-	-	5
	PILE 3	-	-	-	-	-	-	-	6
	PILE 4	-	-	-	-	-	-	-	-
