AS-BUILT REPAIR QUANTITY TABLE

PROJECT NO. HB-0017  
DARE COUNTY  
 BRIDGE NO. 270009

BENT 43 & BENT 44

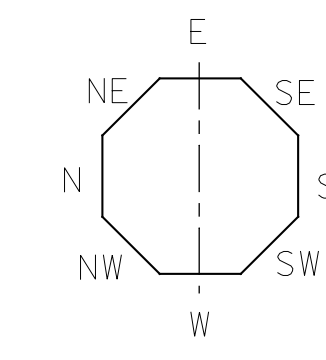
NW	W	SW	S	SE	E	NE	N
BENT 43	PILE 1	-	-	-	-	-	-	-	-
	PILE 2	-	-	-	-	-	-	-	-
	PILE 3	-	4	-	-	-	3	-	-
	PILE 4	8	-	-	2	-	-	6	8
BENT 44	PILE 1	-	5	-	-	-	-	-	-
	PILE 2	-	-	-	3	-	-	8	-
	PILE 3	-	-	-	5	3	-	-	-
	PILE 4	-	-	-	4	-	-	4	-

NOTE: FOR INFORMATION ON PILE CONDITION ONLY.
