AS-BUILT REPAIR QUANTITY TABLE

PROJECT NO. HB-0017  
DARE COUNTY  
BRIDGE NO. 270009

STATE OF NORTH CAROLINA  
DEPARTMENT OF TRANSPORTATION  
RALEIGH

BENT 245 & BENT 246

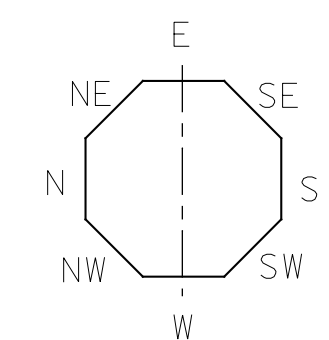
BENT 245

CAP REPAIRS			
SHOTCRETE REPAIRS	2.2 SF	1.1 CF	SF CF
EPOXY RESIN INJECTION	- LF		LF
PILE REPAIRS			
PILE CONCRETE RESTORATION	23.7 SF	10.1 SF	SF CF
FRP PROTECTIVE SYSTEM AWL	181.5 SF		
FRP PROTECTIVE SYSTEM BWL	66.0 SF
