AS-BUILT REPAIR QUANTITY TABLE

PROJECT NO. HB-0017
DARE COUNTY
 BRIDGE NO. 270009

BENT 267 & BENT 268

REVISIONS						SHEET NO.
NO.	BY:	DATE:	NO.	BY:	DATE:	S-303
1			3			TOTAL SHEETS
2			4			355

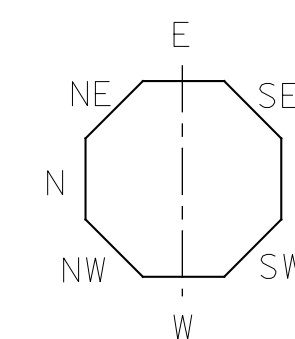
BENT 267

CAP REPAIRS		ESTIMATE			
SHOTCRETE REPAIRS	- SF	- CF	SF	CF	
EPOXY RESIN INJECTION		- LF			LF
PILE REPAIRS		ESTIMATE			
PILE CONCRETE RESTORATION	7.3 SF	3.2 CF	SF	CF	
FRP PROTECTIVE SYSTEM AWL	224.6 SF				
FRP PROTECTIVE SYSTEM BWL	66.0 SF
