AS-BUILT REPAIR QUANTITY TABLE

PROJECT NO. HB-0017
DARE COUNTY
BRIDGE NO. 270009

BENT 293 & BENT 294

REVISIONS						SHEET NO.
NO.	BY:	DATE:	NO.	BY:	DATE:	S-316
1			3			TOTAL SHEETS
2			4			355

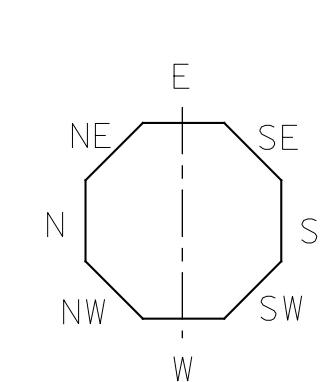
BENT 293

CAP REPAIRS		ESTIMATE			
SHOTCRETE REPAIRS	- SF	- CF	SF	CF	
EPOXY RESIN INJECTION	- LF				LF
PILE REPAIRS		ESTIMATE			
PILE CONCRETE RESTORATION	16.3 SF	6.8 CF	SF	CF	
FRP PROTECTIVE SYSTEM AWL	170.5 SF				
FRP PROTECTIVE SYSTEM BWL	66.0 SF

(AWL = ABOVE WATERLINE)
(BWL = BELOW WATERLINE)
(*QUANTITY INCLUDES ADJACENT REPAIRS)
