AS-BUILT REPAIR QUANTITY TABLE

PROJECT NO. HB-0017
DARE COUNTY
BRIDGE NO. 270009

BENT 73 & BENT 74

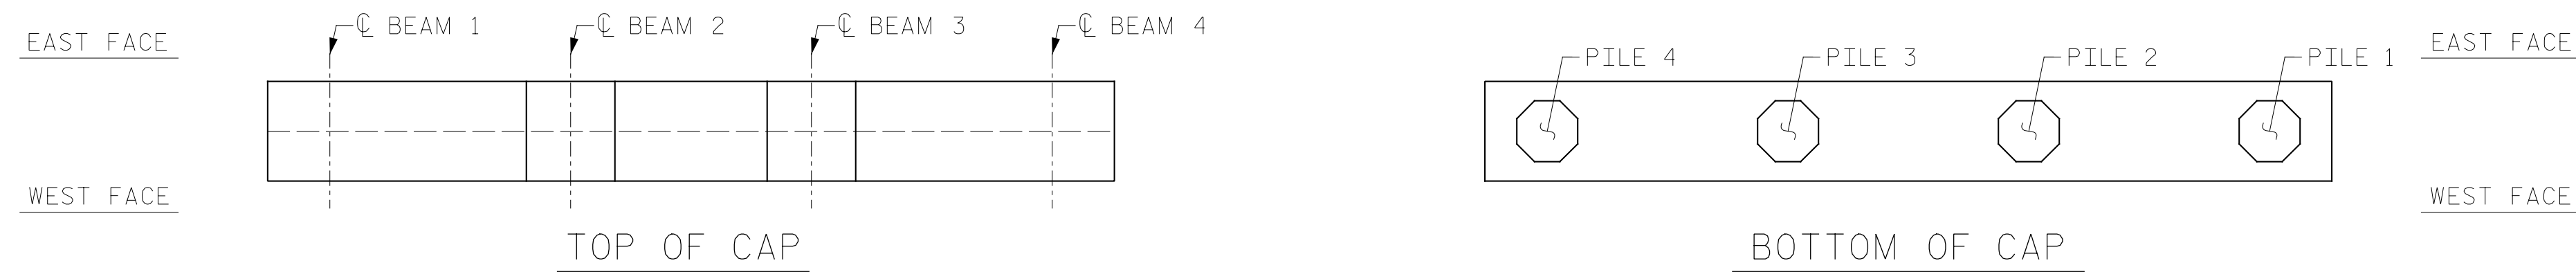
BENT 75

CAP REPAIRS			
SHOTCRETE REPAIRS	- SF	- CF	SF CF
EPOXY RESIN INJECTION	- LF		LF
PILE REPAIRS			
PILE CONCRETE RESTORATION	34.0 SF	13.4 CF	SF CF
FRP PROTECTIVE SYSTEM AWL	148.5 SF		
FRP PROTECTIVE SYSTEM BWL	66.0 SF

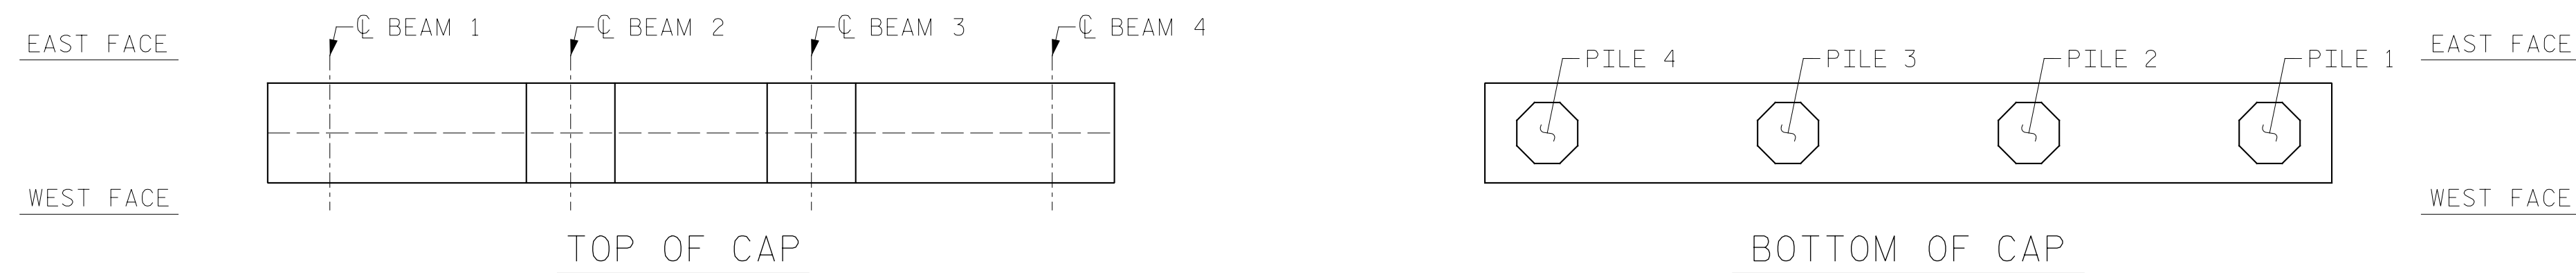
BENT 76

CAP REPAIRS			
SHOTCRETE REPAIRS	- SF	- CF	SF CF
EPOXY RESIN INJECTION	- LF		LF
PILE REPAIRS			
PILE CONCRETE RESTORATION	26.3 SF	11.5 CF	SF CF
FRP PROTECTIVE SYSTEM AWL	159.5 SF		
FRP PROTECTIVE SYSTEM BWL	66.0 SF

BENT	PILE	DIRECTION							
		NW	W	SW	S	SE	E	NE	N
75	PILE 1	3	-	-	7	-	-	-	-
	PILE 2	-	7	7	-	-	-	-	5
	PILE 3	4	-	4	-	-	-	-	-
	PILE 4	-	5	-	2	-	-	-	-
76	PILE 1	6	7	-	8	-	-	4	-
	PILE 2	-	-	-	8	6	-	7	-
	PILE 3	-	-	-	-	-	-	2	3
	PILE 4	-	-	4	2	5	-	-	6

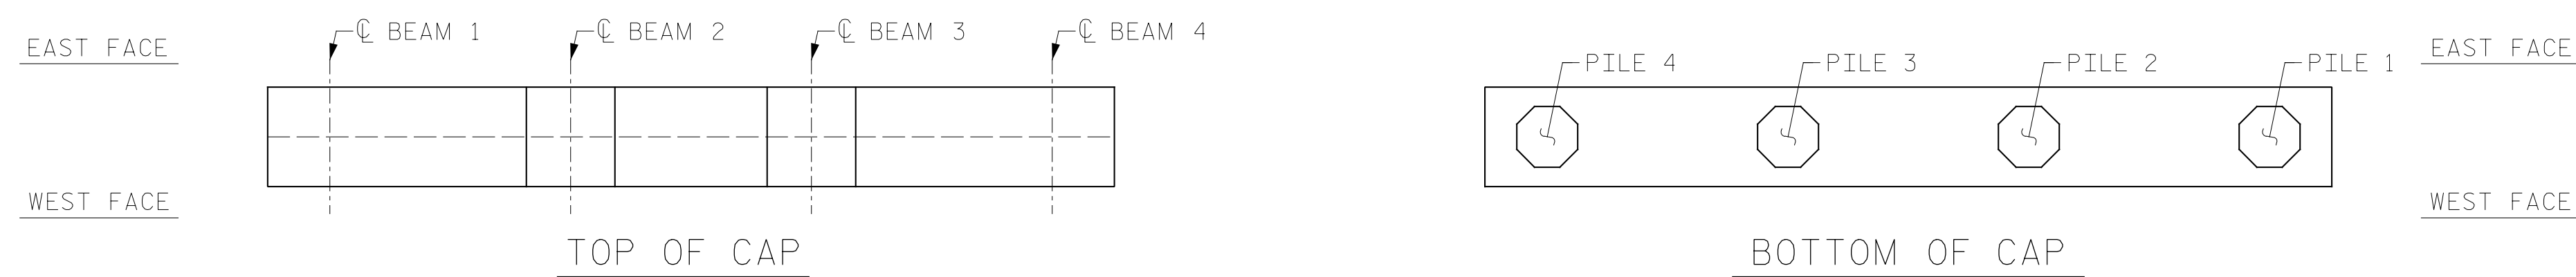
BENT 79

CAP REPAIRS			
SHOTCRETE REPAIRS	- SF	- CF	SF CF
EPOXY RESIN INJECTION	- LF		LF
PILE REPAIRS			
PILE CONCRETE RESTORATION	18.5 SF	7.0 CF	SF CF
FRP PROTECTIVE SYSTEM AWL	165.0 SF		
FRP PROTECTIVE SYSTEM BWL	66.0 SF

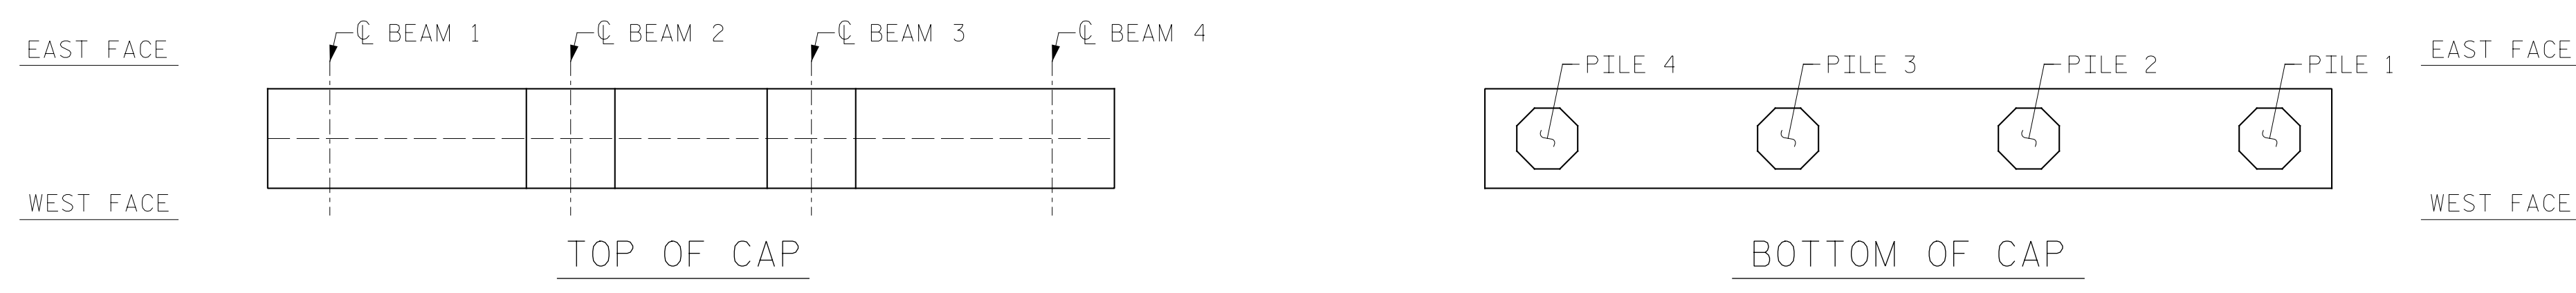
CAP REPAIRS			
SHOTCRETE REPAIRS	1.5 SF	0.8 CF	SF CF
EPOXY RESIN INJECTION	- LF		LF
PILE REPAIRS			
PILE CONCRETE RESTORATION	25.0 SF	10.0 CF	SF CF
FRP PROTECTIVE SYSTEM AWL	115.5 SF		
FRP PROTECTIVE SYSTEM BWL	49.5 SF

NW	W	SW	S	SE	E	NE	N
BENT 79	PILE 1	1	4	-	6	8	-	-	1
	PILE 2	-	-	-	6.5	6	-	2	4
	PILE 3	-	-	6	3	6	-	6	4
	PILE 4	5	4	2	-	4	-	5	4
BENT 80	PILE 1	-	-	-	2	2	-	4	-
	PILE 2	-	-	-	-	-	-	-	-
	PILE 3	5	-	-	-	5	2	3	7
	PILE 4	2	-	-	3	3	2	2	5

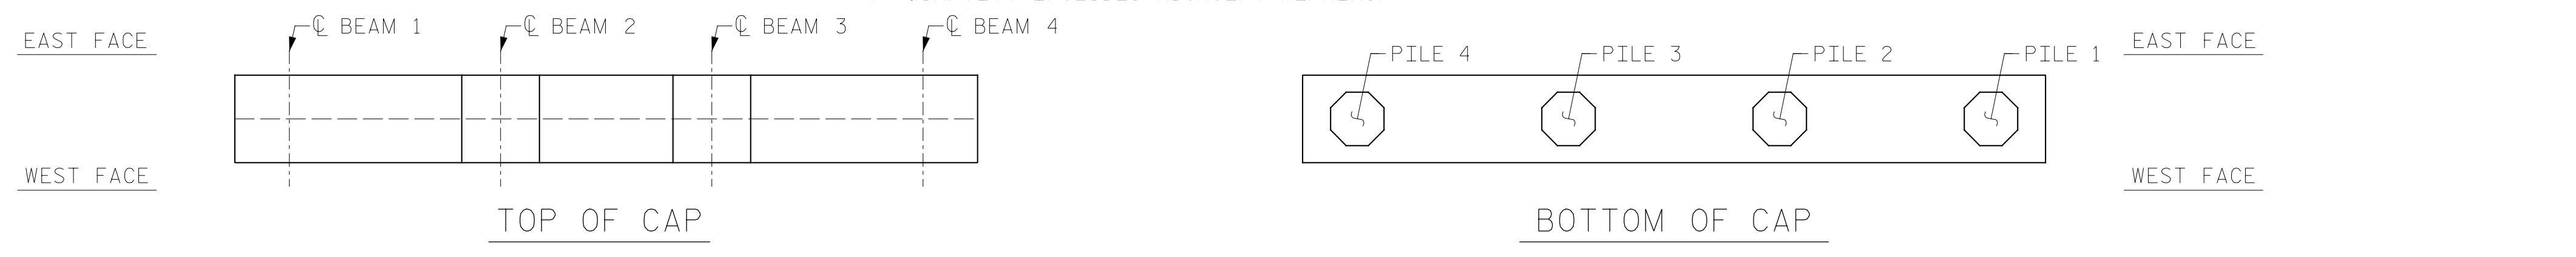
BENT 86

CAP REPAIRS			
SHOTCRETE REPAIRS	- SF	- CF	SF CF
EPOXY RESIN INJECTION	- LF		LF
PILE REPAIRS			
PILE CONCRETE RESTORATION	44.5 SF	17.0 CF	SF CF
FRP PROTECTIVE SYSTEM AWL	188.0 SF		
FRP PROTECTIVE SYSTEM BWL	66.0 SF

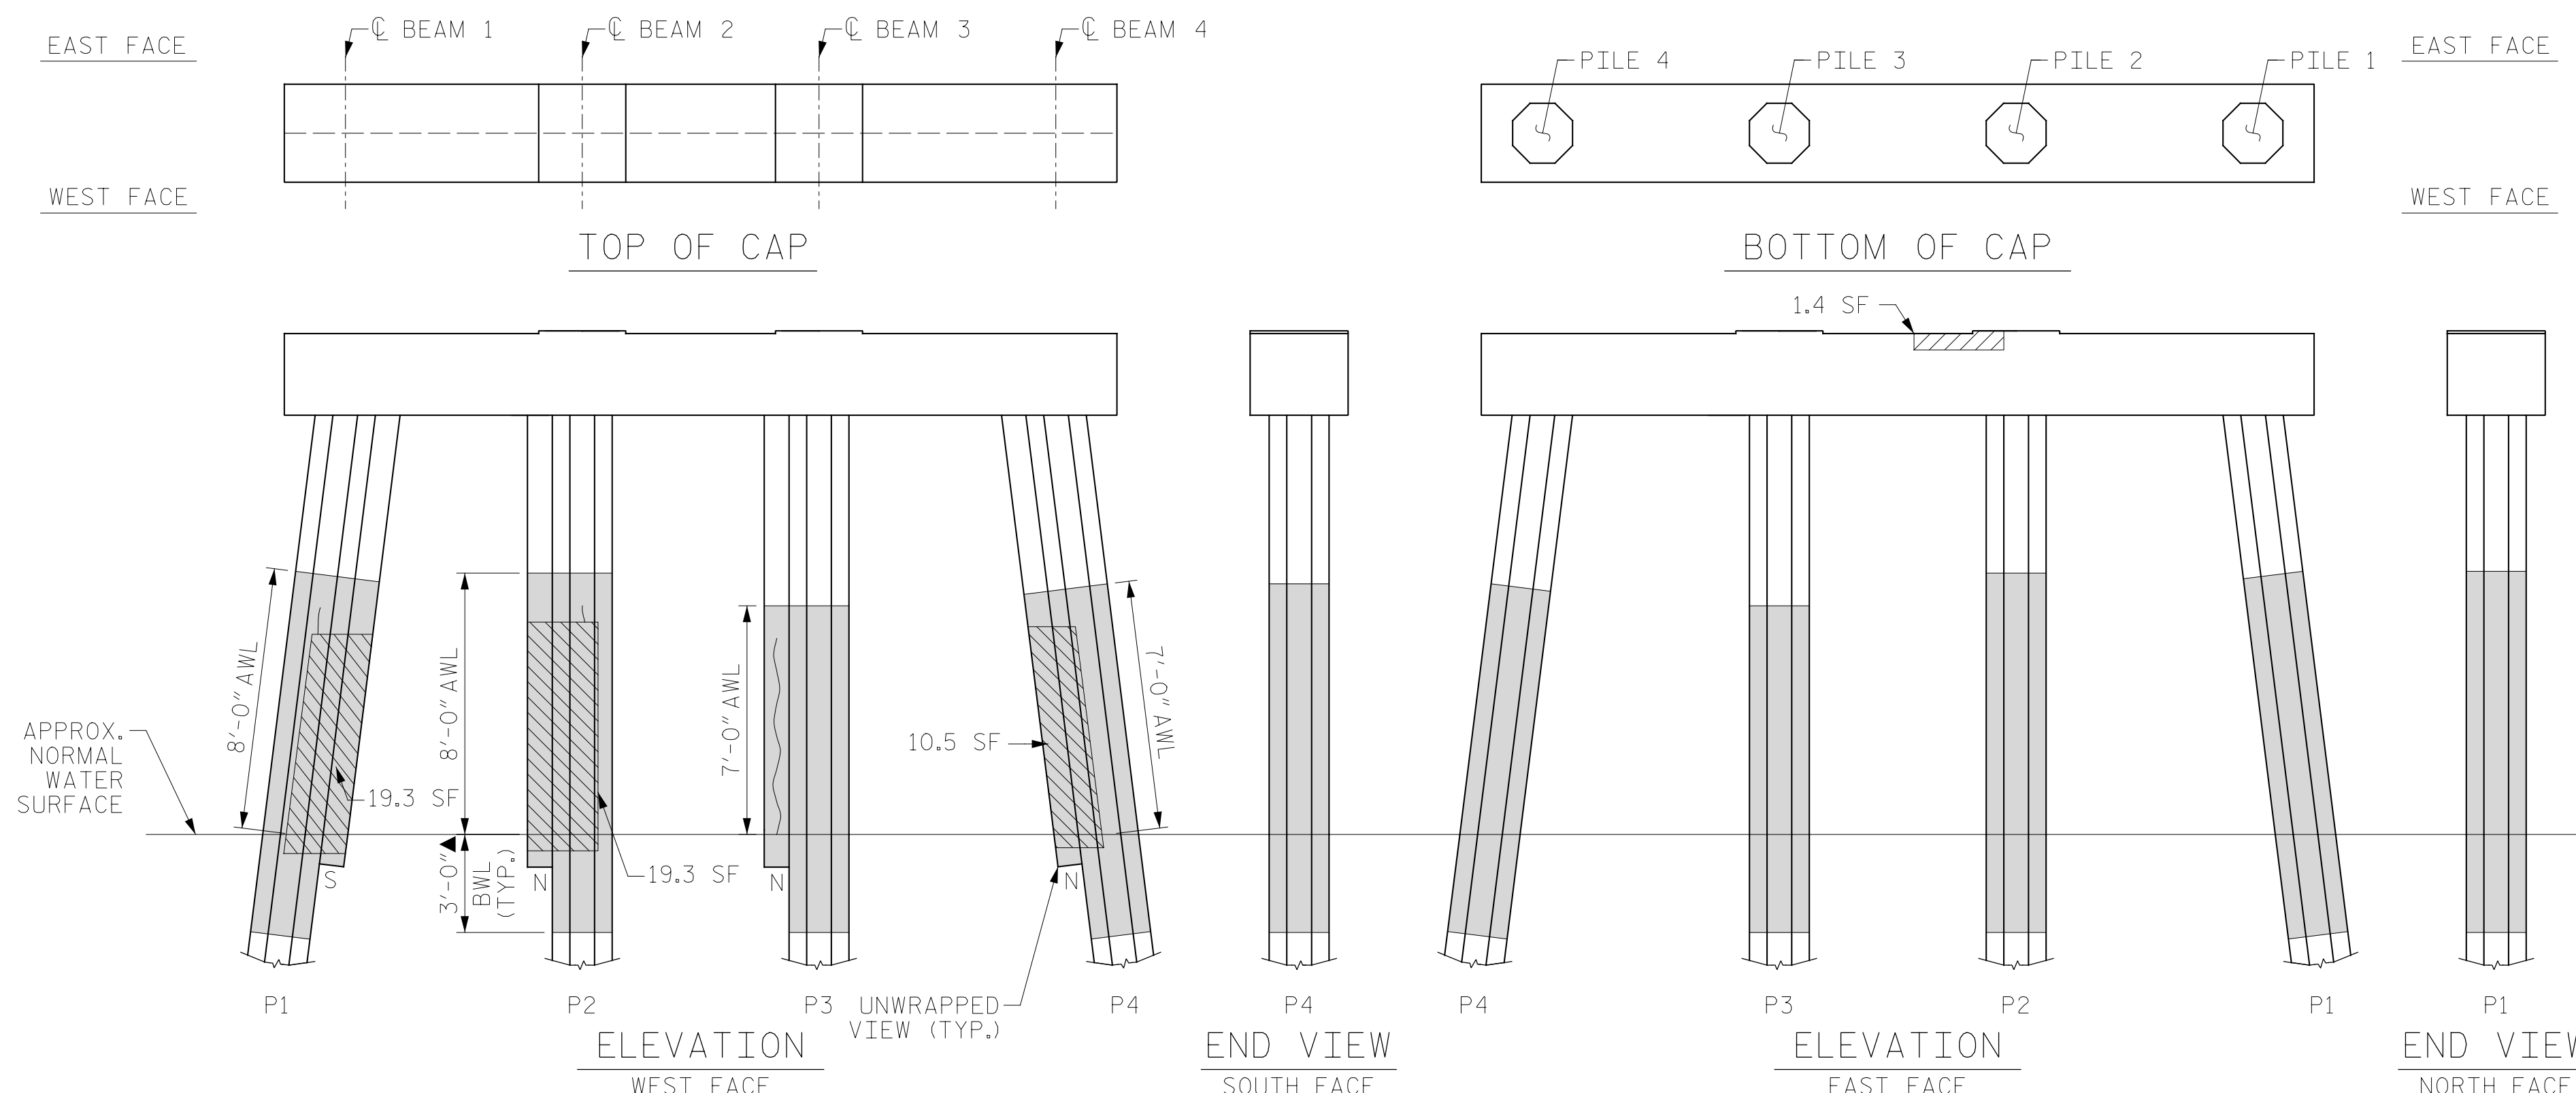
BENT 106

CAP REPAIRS				
SHOTCRETE REPAIRS	- SF	- CF	SF	CF
EPOXY RESIN INJECTION	- LF			LF
PILE REPAIRS				
PILE CONCRETE RESTORATION	39.0 SF	15.7 CF	SF	CF
FRP PROTECTIVE SYSTEM AWL	170.5 SF			
FRP PROTECTIVE SYSTEM BWL	66.0 SF

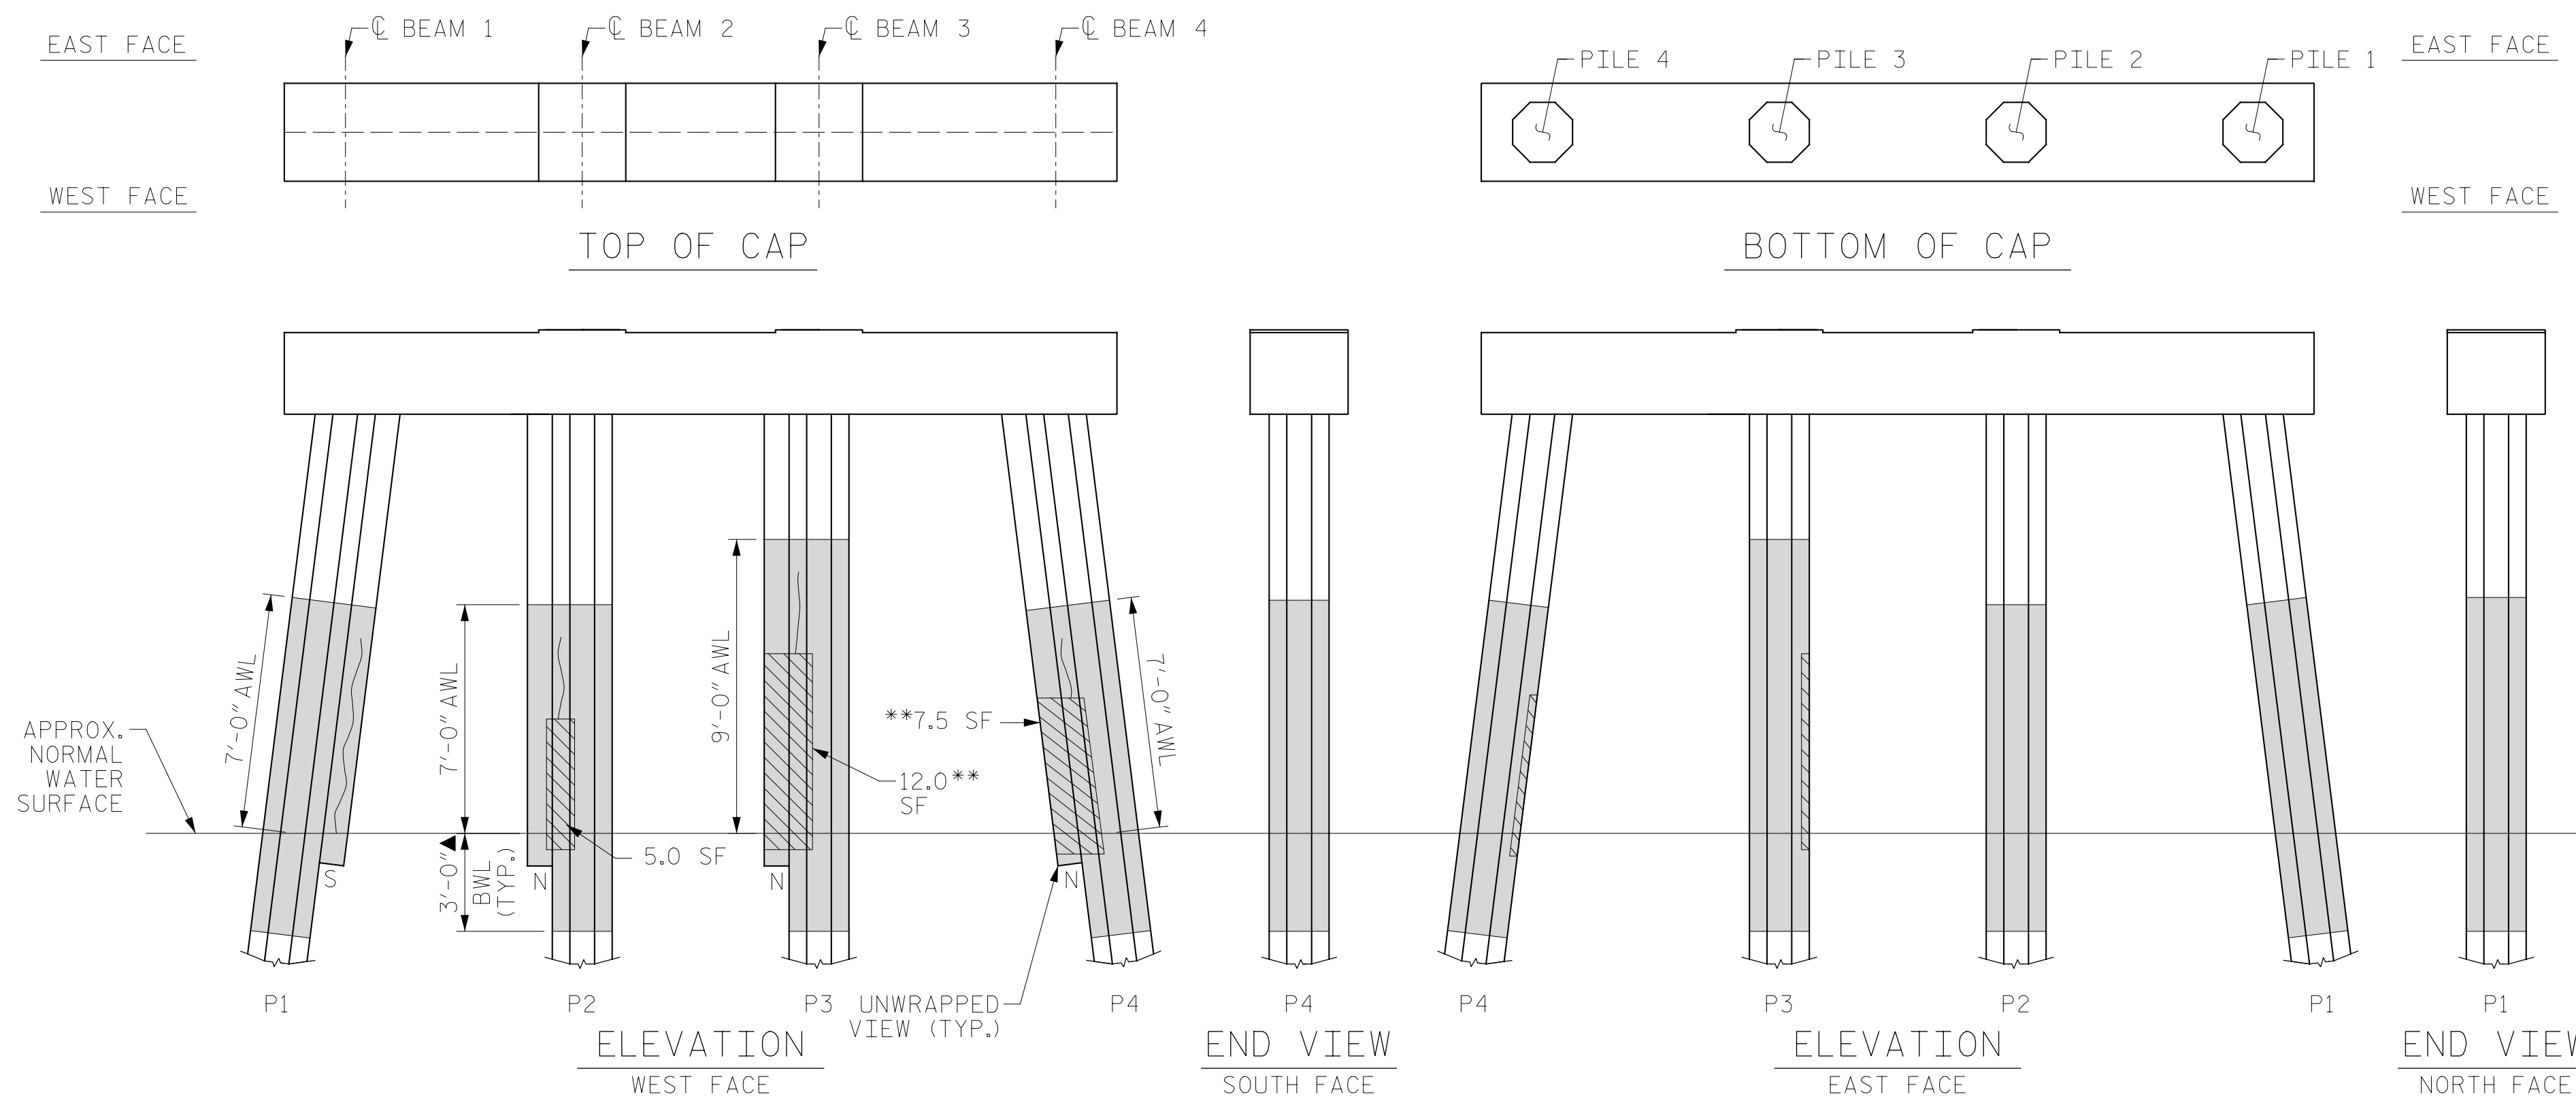
BENT 107

CAP REPAIRS			
SHOTCRETE REPAIRS	2.1 SF	1.1 CF	SF CF
EPOXY RESIN INJECTION	- LF		LF
PILE REPAIRS			
PILE CONCRETE RESTORATION	55.3 SF	22.2 CF	SF CF
FRP PROTECTIVE SYSTEM AWL	269.5 SF		
FRP PROTECTIVE SYSTEM BWL	99.0 SF

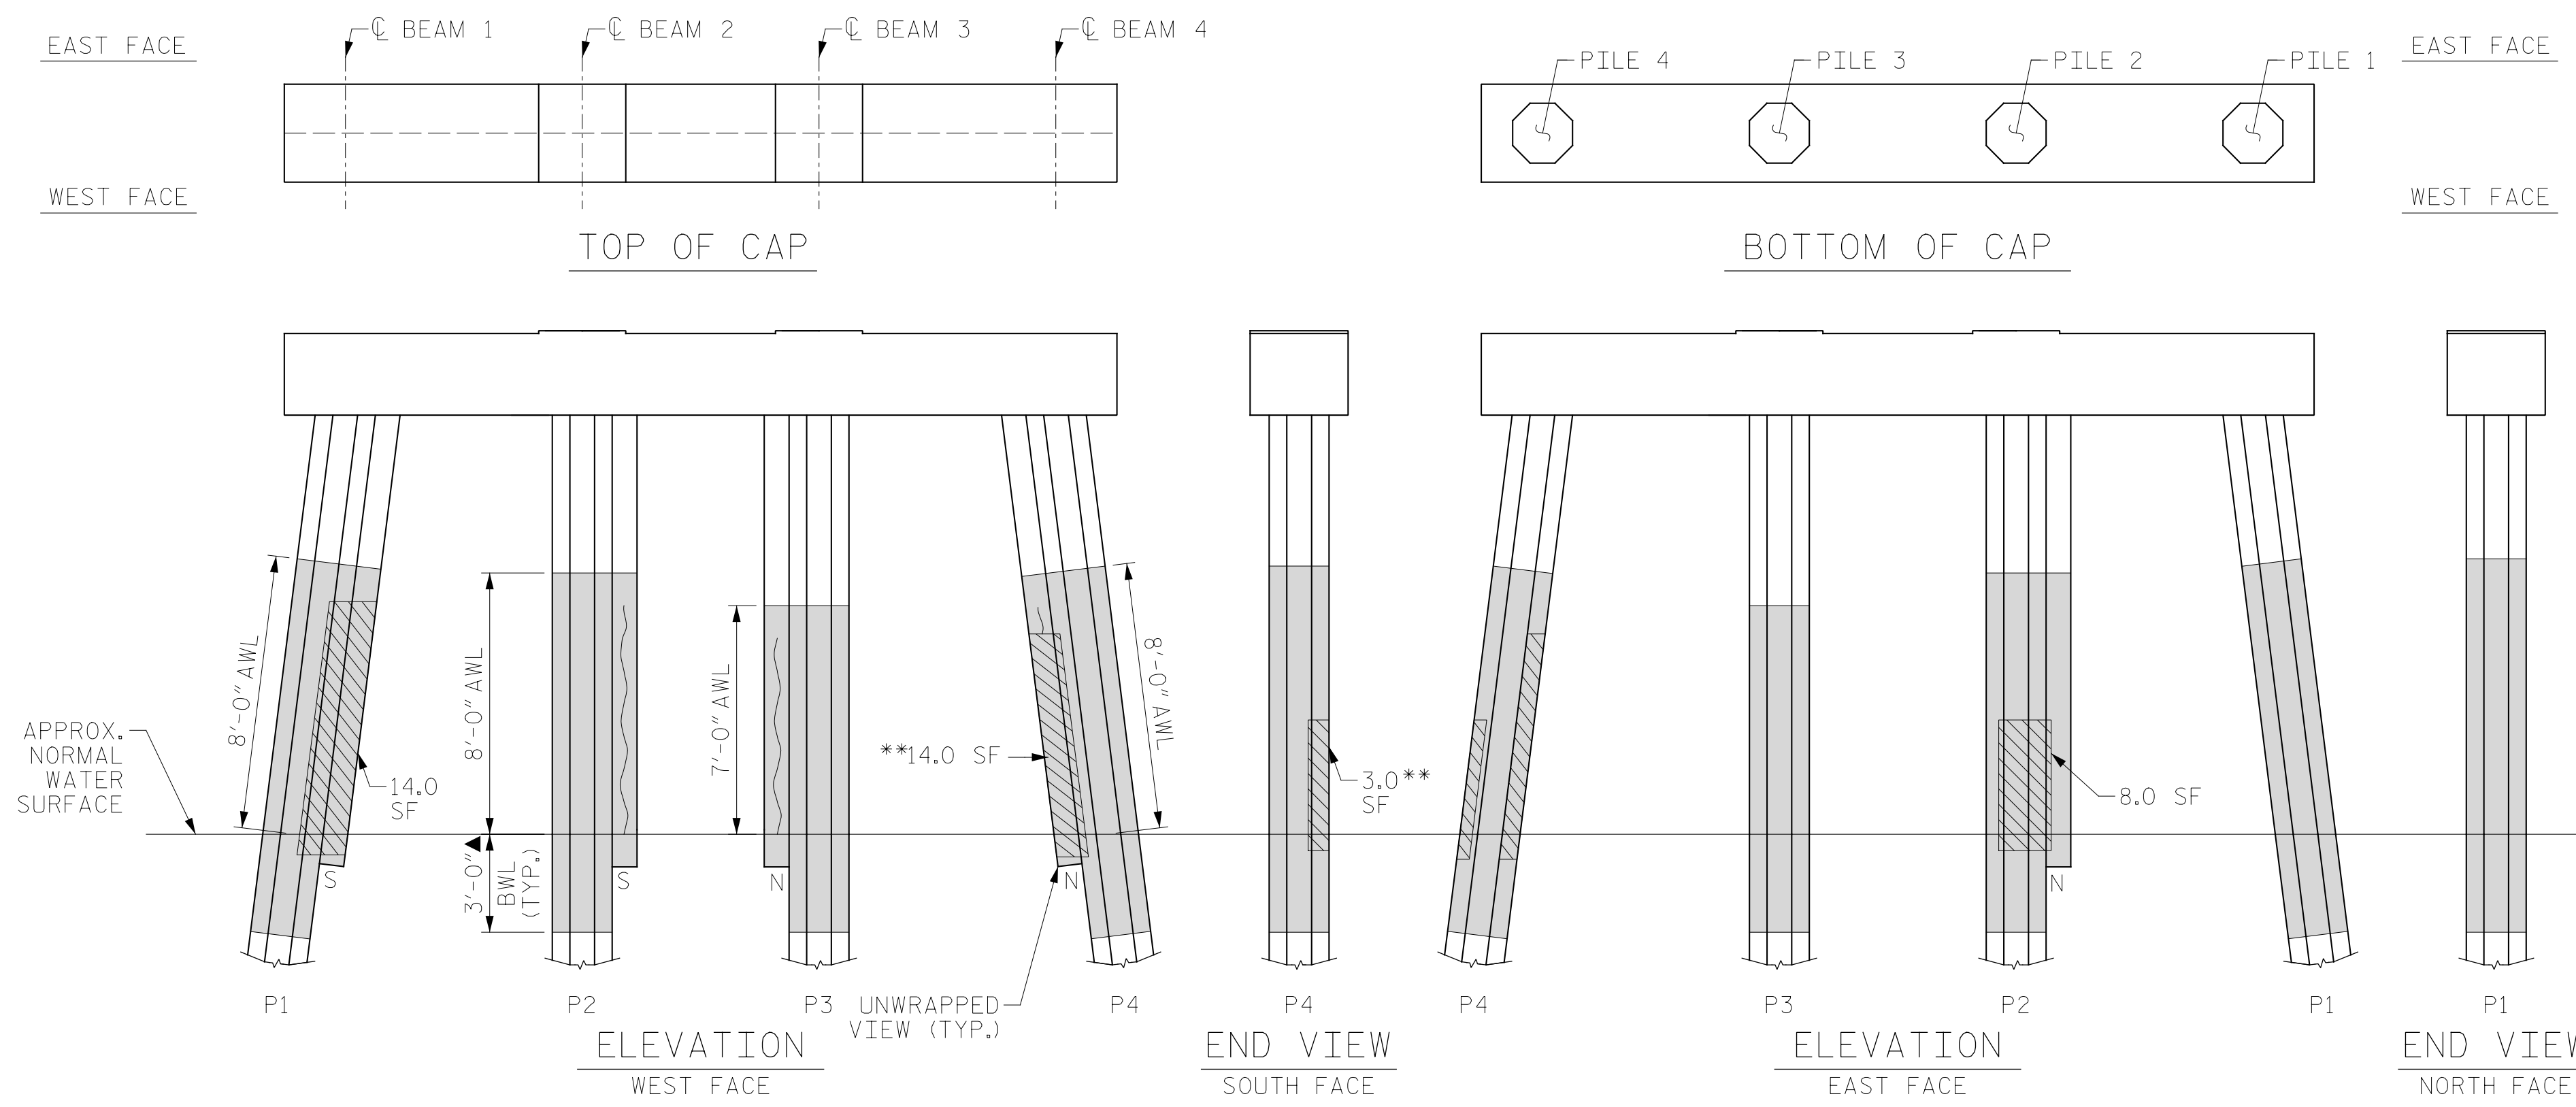
BENT 108

CAP REPAIRS			
SHOTCRETE REPAIRS	11.5 SF	5.8 CF	SF CF
EPOXY RESIN INJECTION	- LF		LF
PILE REPAIRS			
PILE CONCRETE RESTORATION	55.8 SF	22.2 CF	SF CF
FRP PROTECTIVE SYSTEM AWL	176.0 SF		
FRP PROTECTIVE SYSTEM BWL	66.0 SF

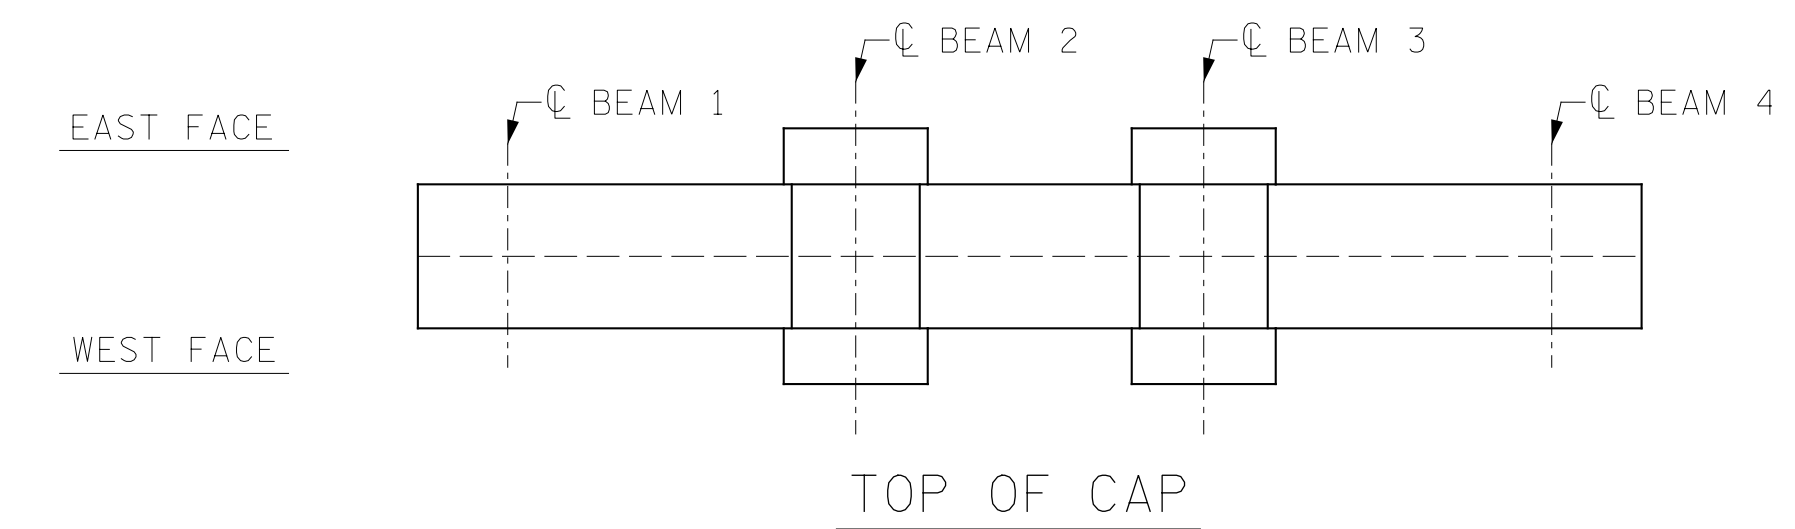
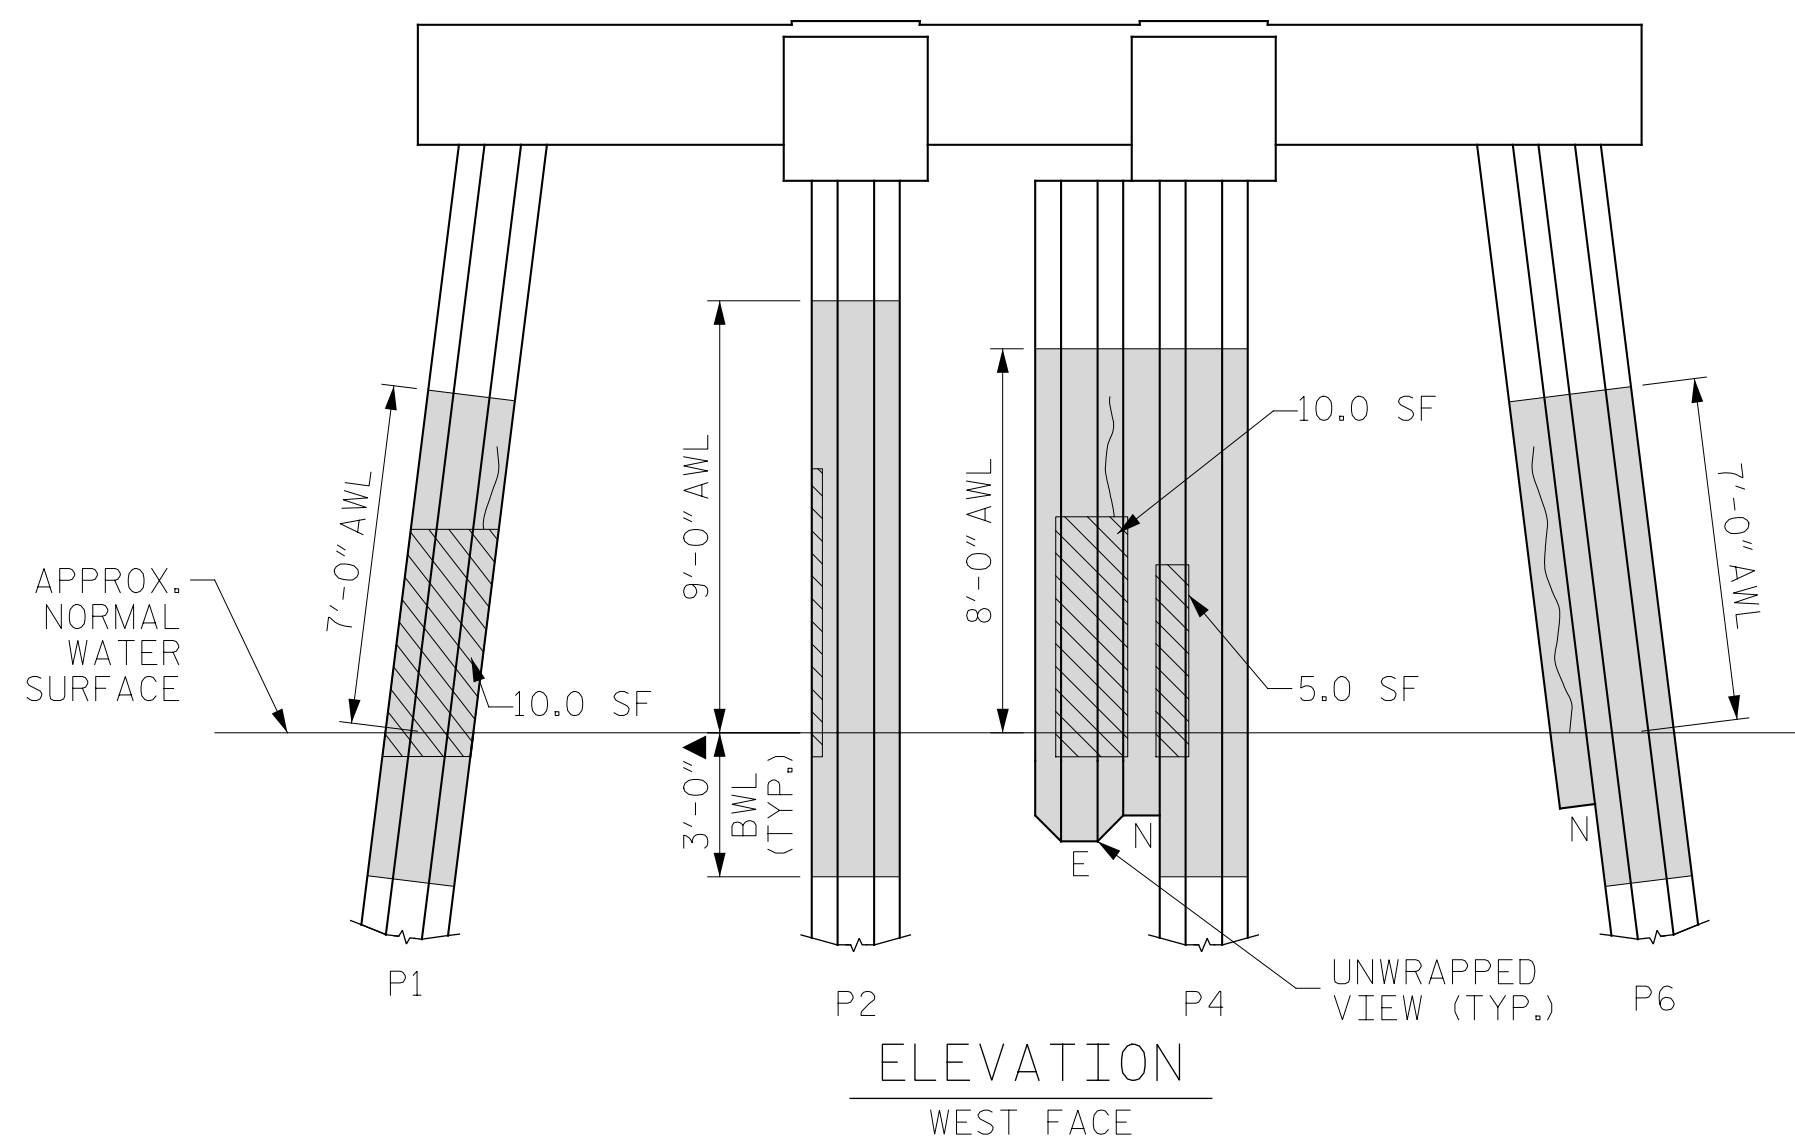
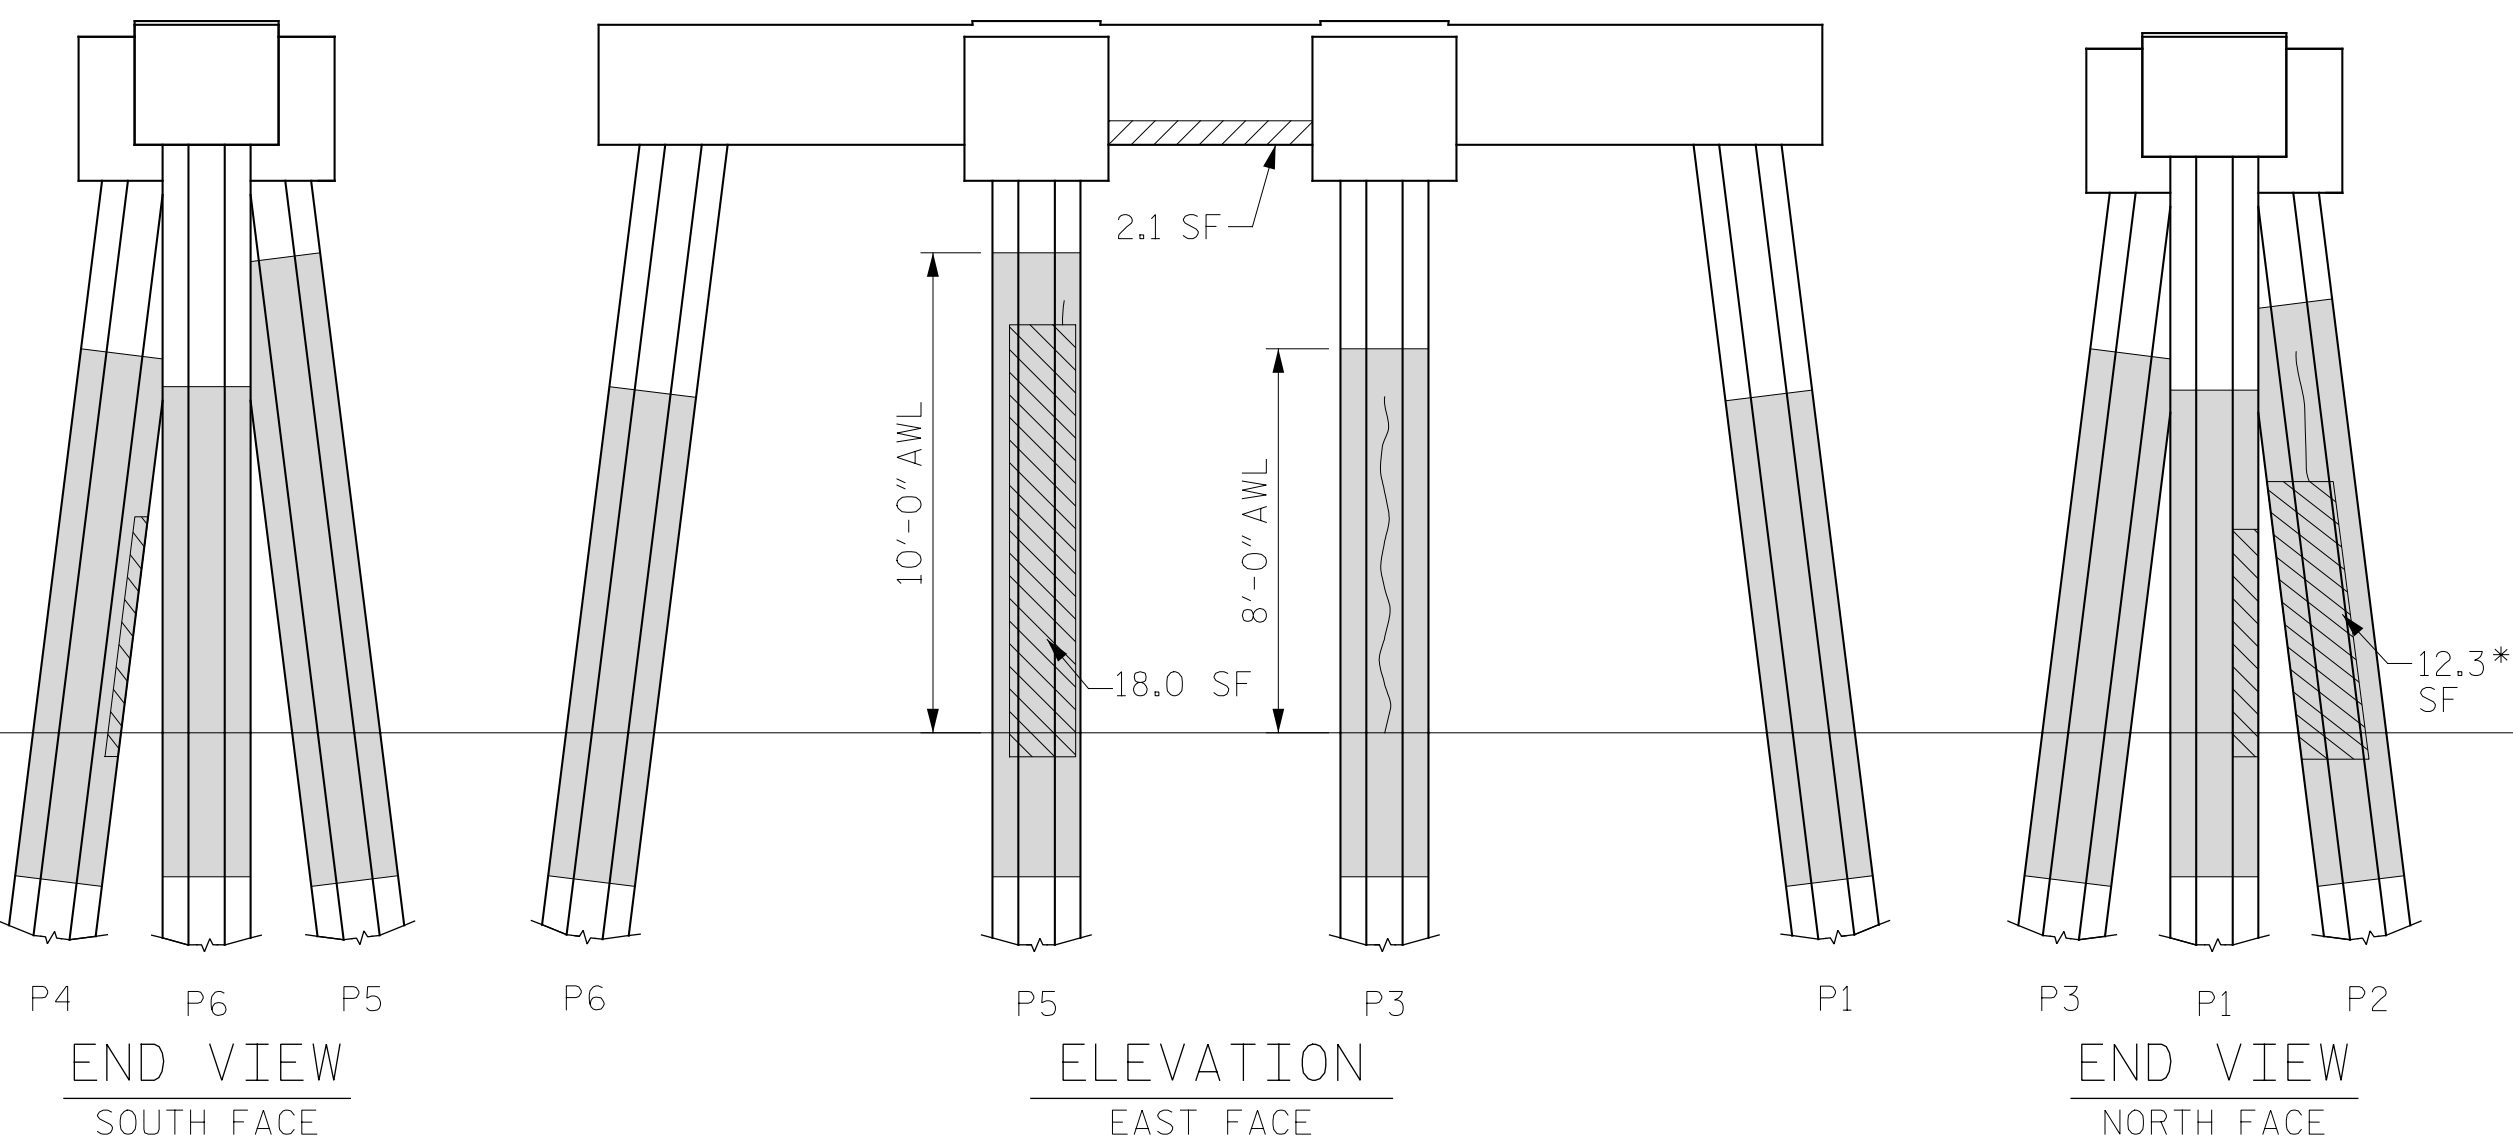
BENT 109

CAP REPAIRS			
SHOTCRETE REPAIRS	0.5 SF	0.3 CF	SF CF
EPOXY RESIN INJECTION	- LF		LF
PILE REPAIRS			
PILE CONCRETE RESTORATION	142.0 SF	54.6 CF	SF CF
FRP PROTECTIVE SYSTEM AWL	229.2 SF		
FRP PROTECTIVE SYSTEM BWL	66.0 SF
