AS-BUILT REPAIR QUANTITY TABLE

PROJECT NO. HB-0017
DARE COUNTY
BRIDGE NO. 270009

BENT 73 & BENT 74

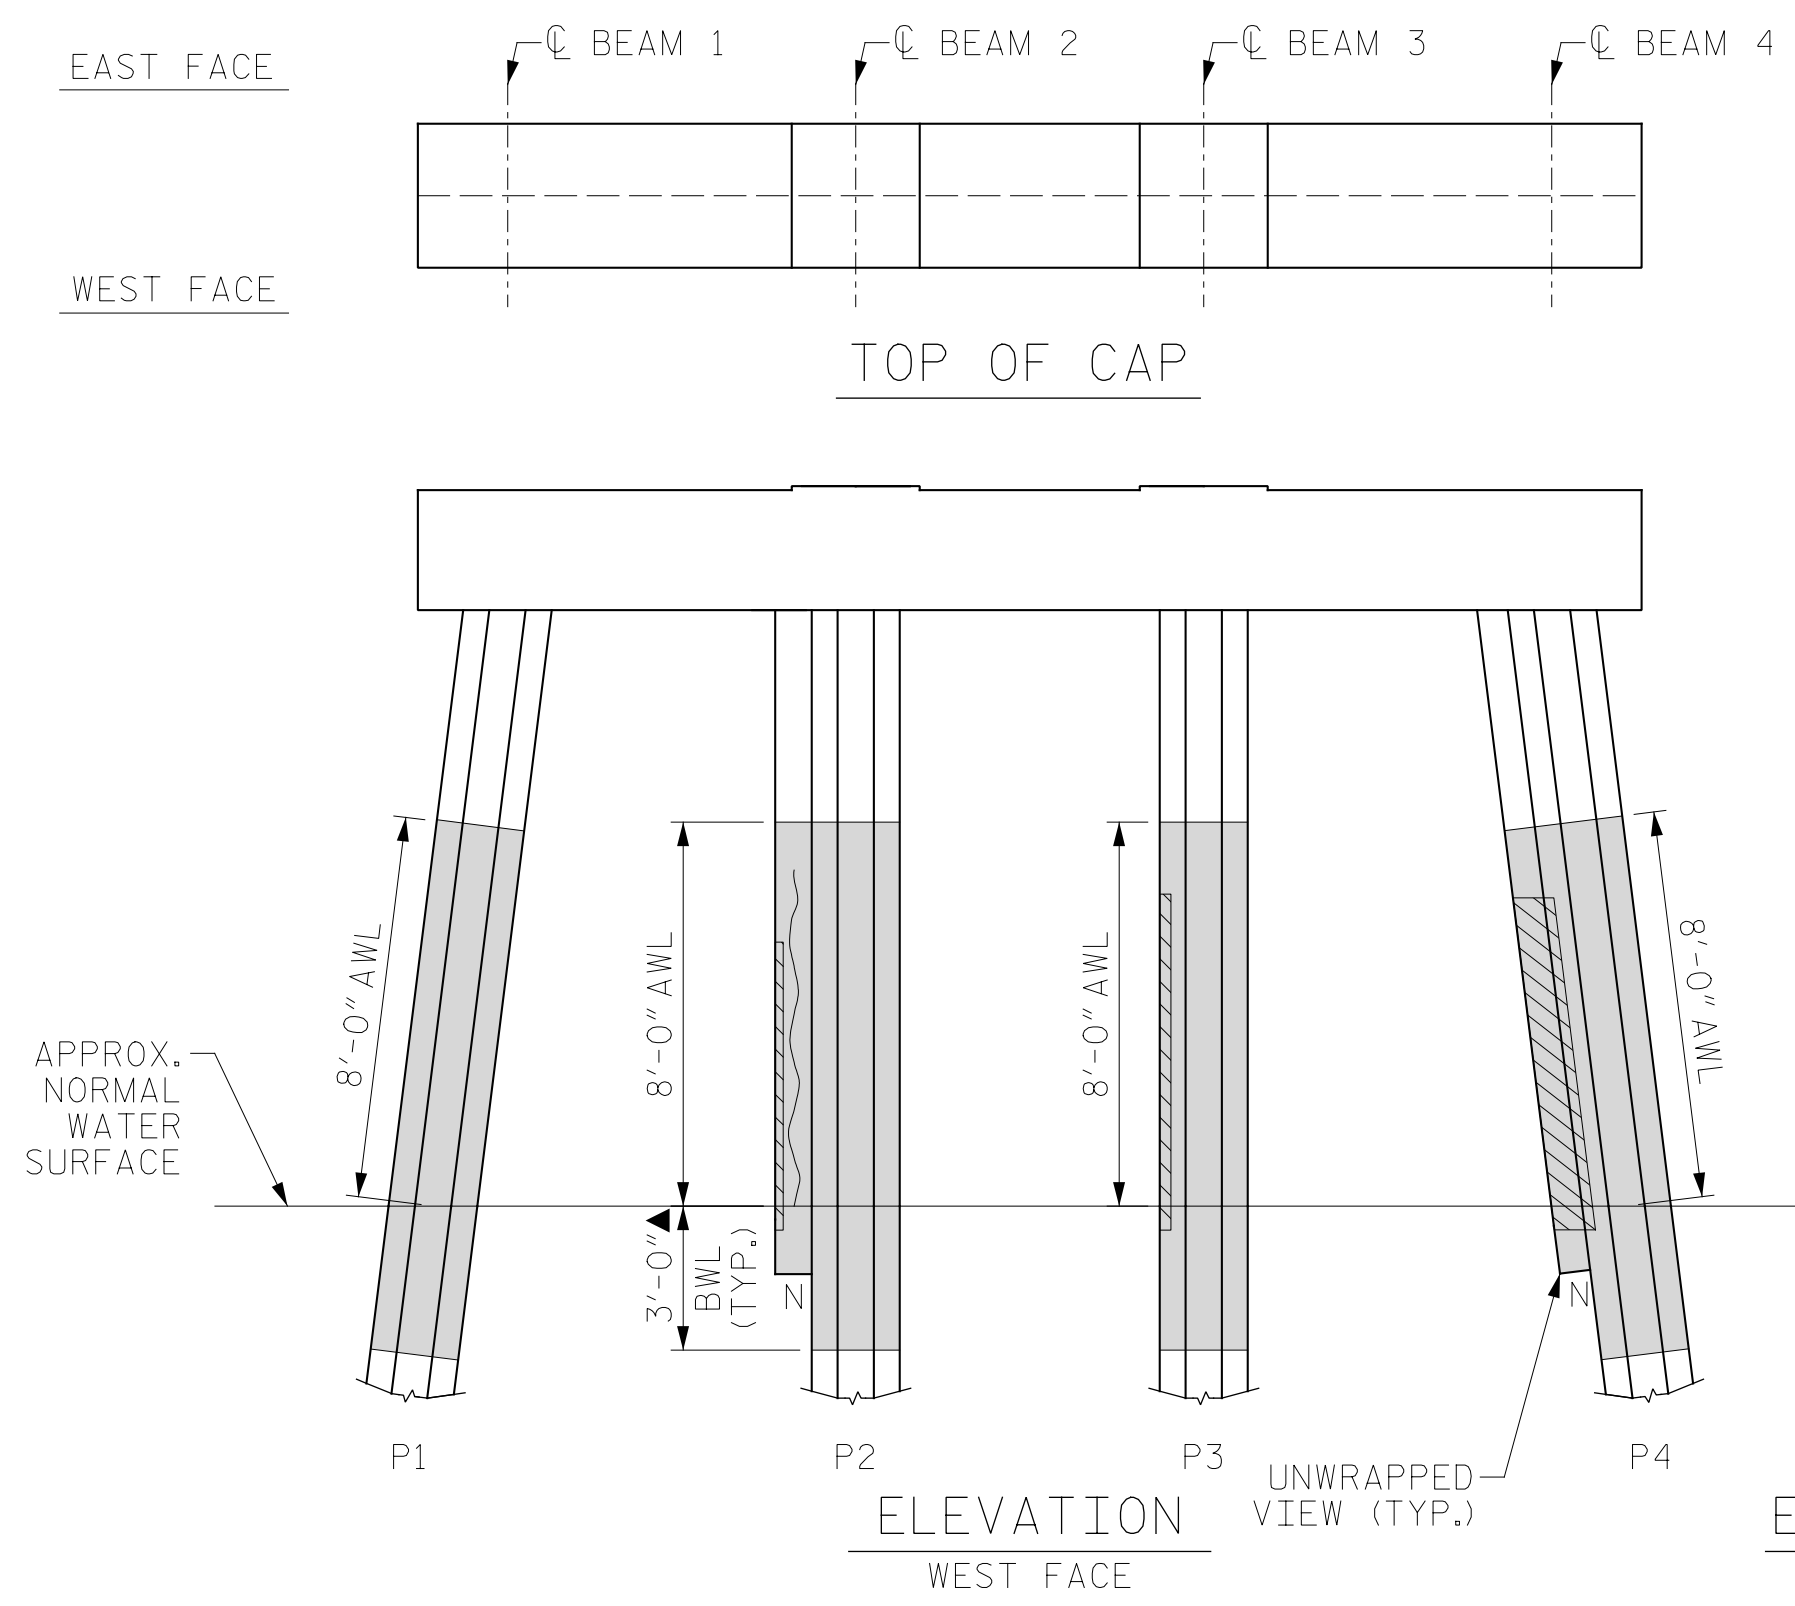
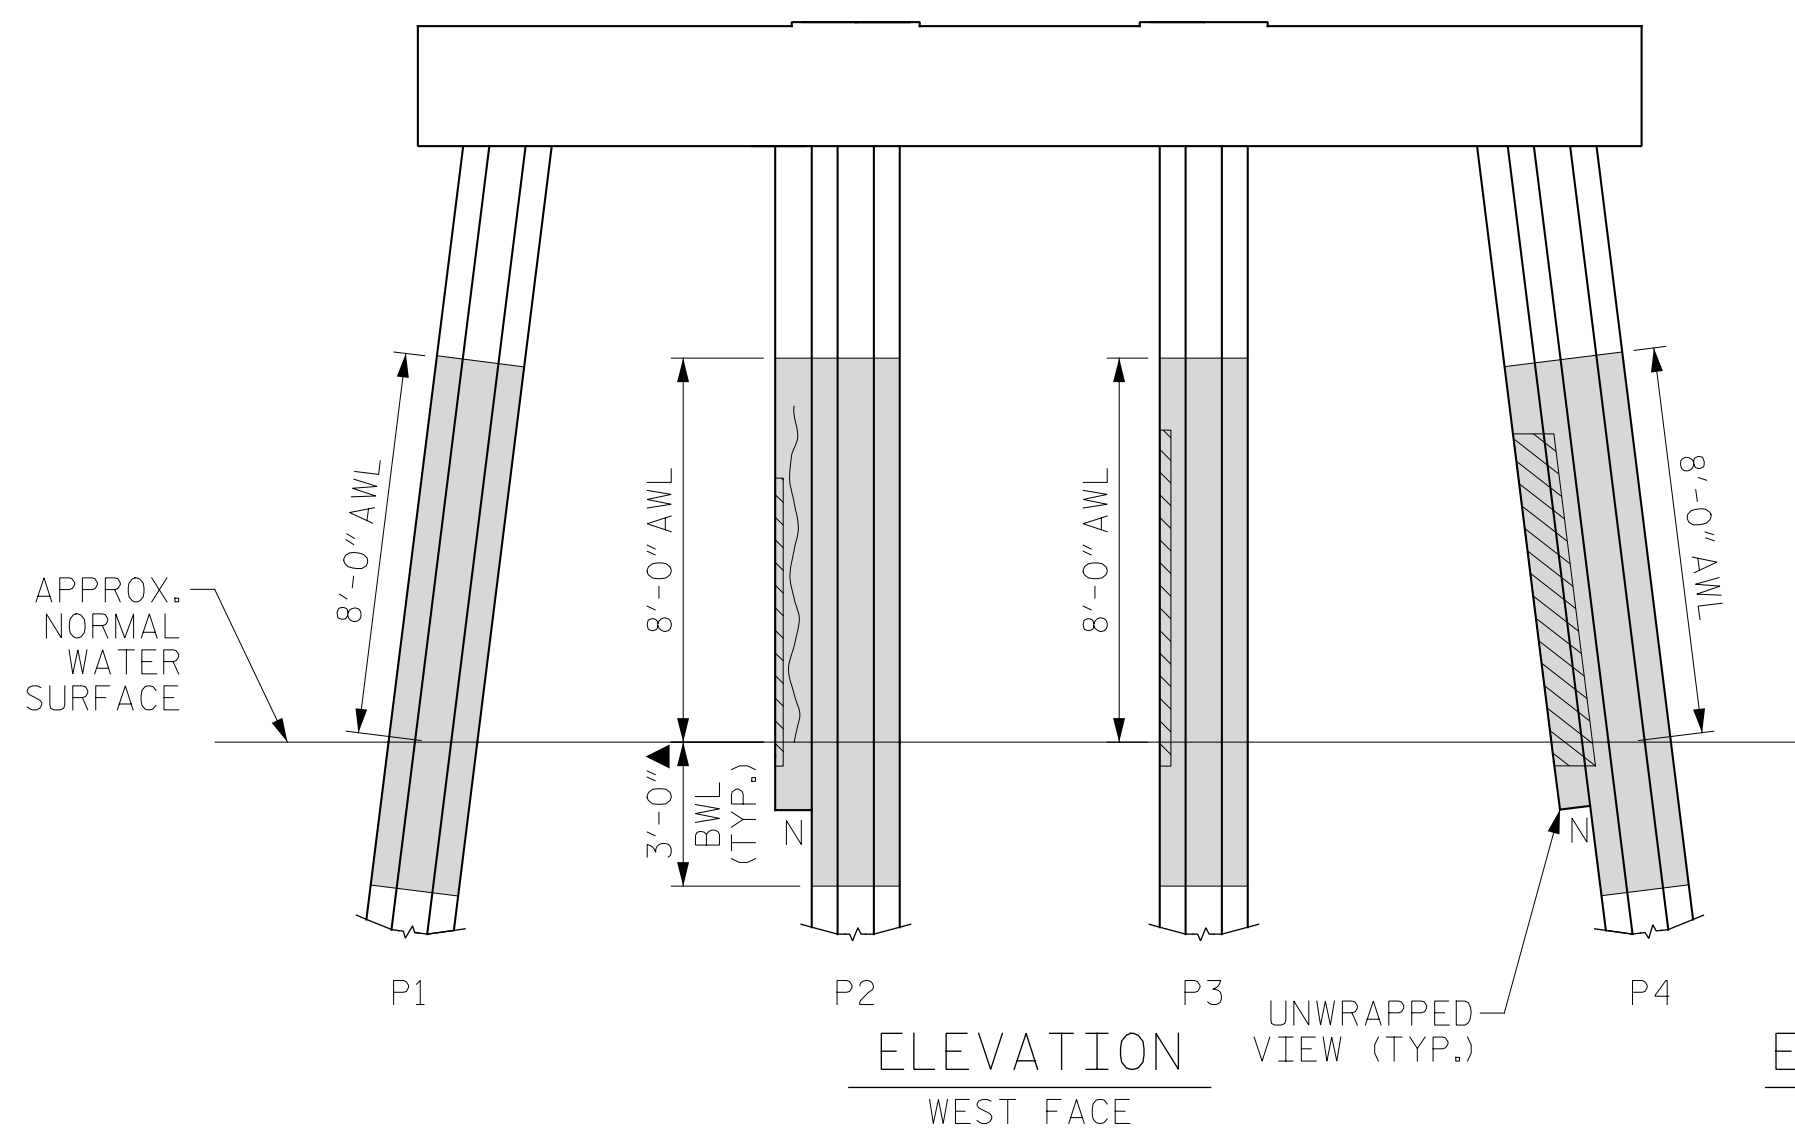
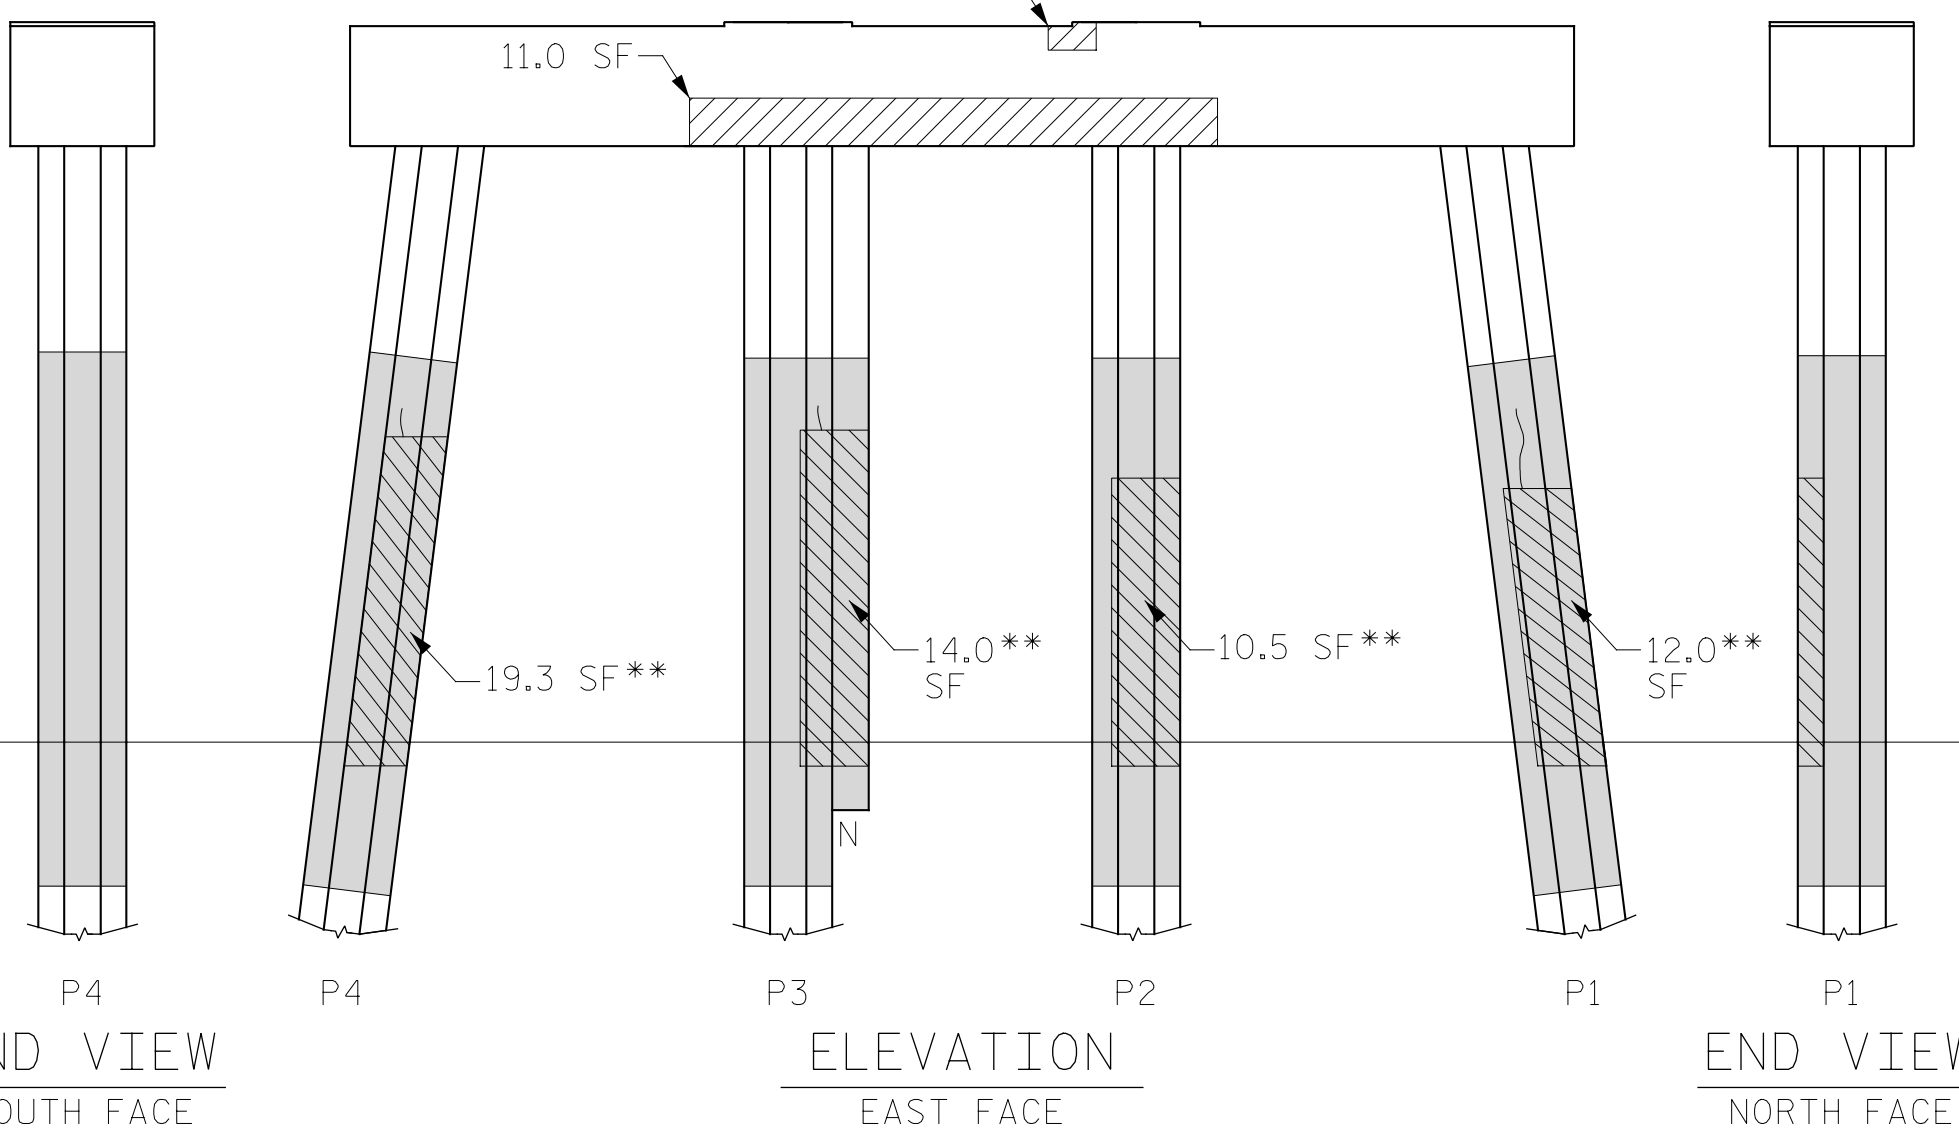
BENT 110

CAP REPAIRS			
SHOTCRETE REPAIRS	1.0 SF	0.5 CF	SF CF
EPOXY RESIN INJECTION	- LF		LF
PILE REPAIRS			
PILE CONCRETE RESTORATION	81.3 SF	31.8 CF	SF CF
FRP PROTECTIVE SYSTEM AWL	176.0 SF		
FRP PROTECTIVE SYSTEM BWL	66.0 SF

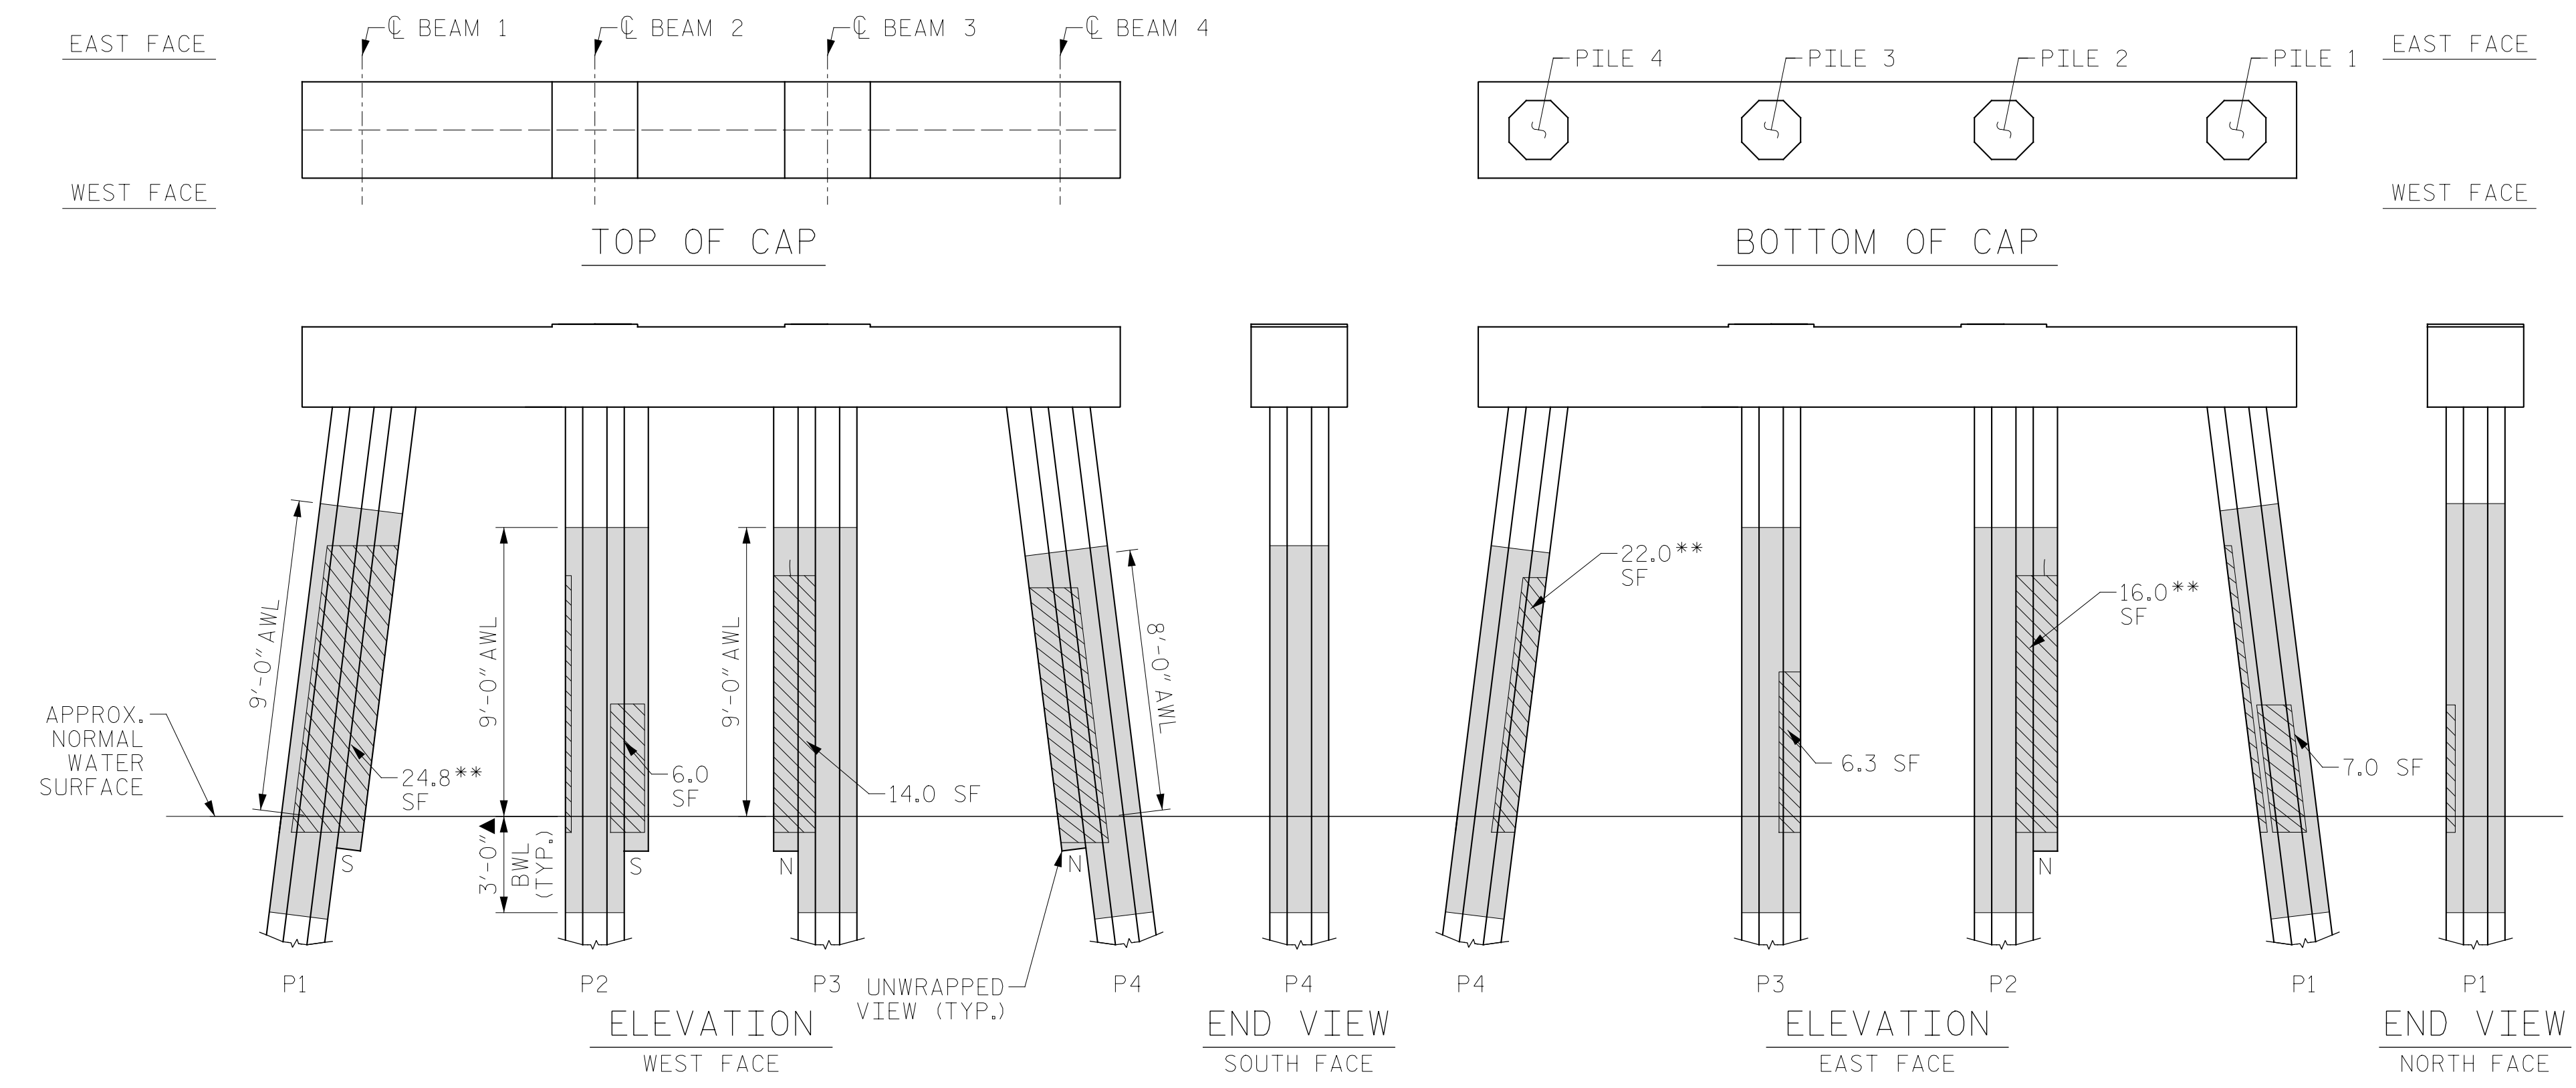
BENT 115

CAP REPAIRS			
SHOTCRETE REPAIRS	- SF	- CF	SF CF
EPOXY RESIN INJECTION	- LF		LF
PILE REPAIRS			
PILE CONCRETE RESTORATION	98.1 SF	39.3 CF	SF CF
FRP PROTECTIVE SYSTEM AWL	192.5 SF		
FRP PROTECTIVE SYSTEM BWL	66.0 SF

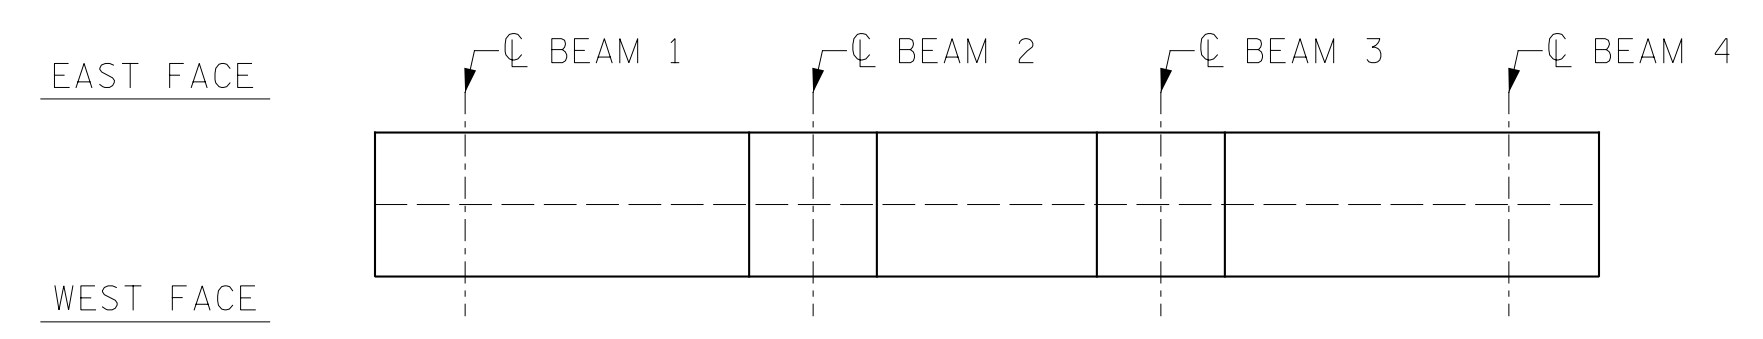
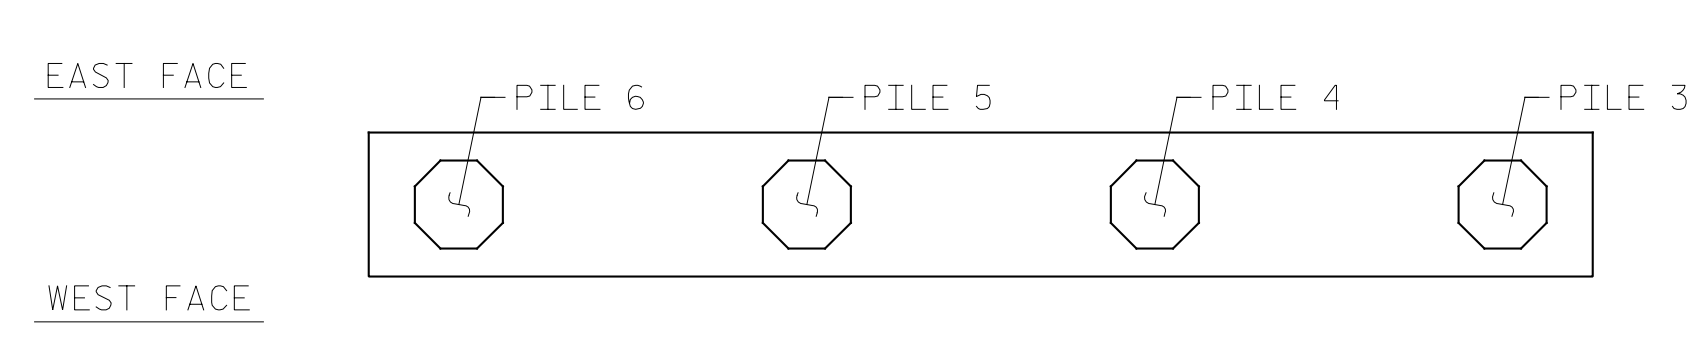
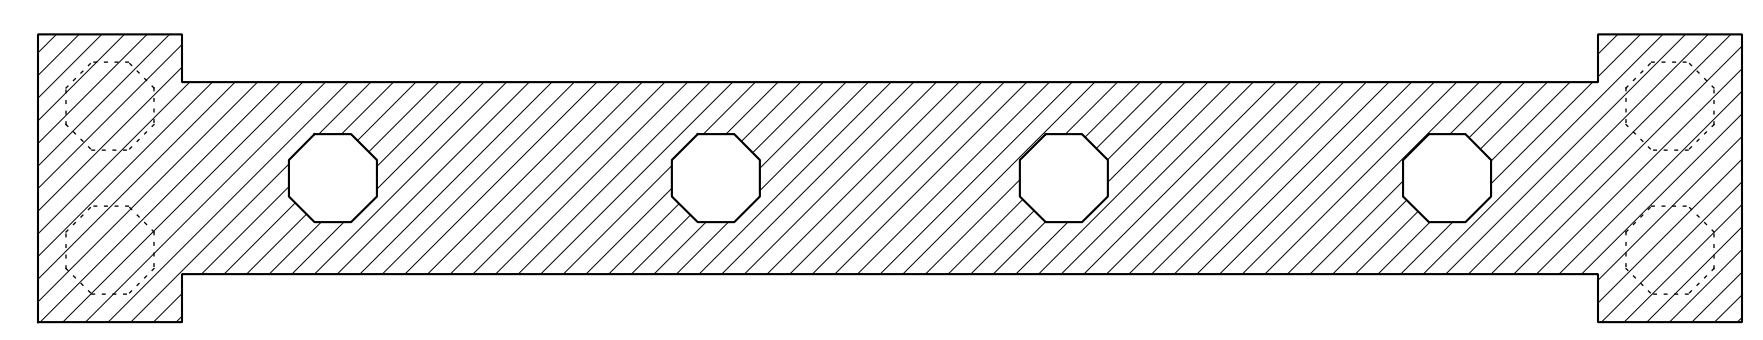
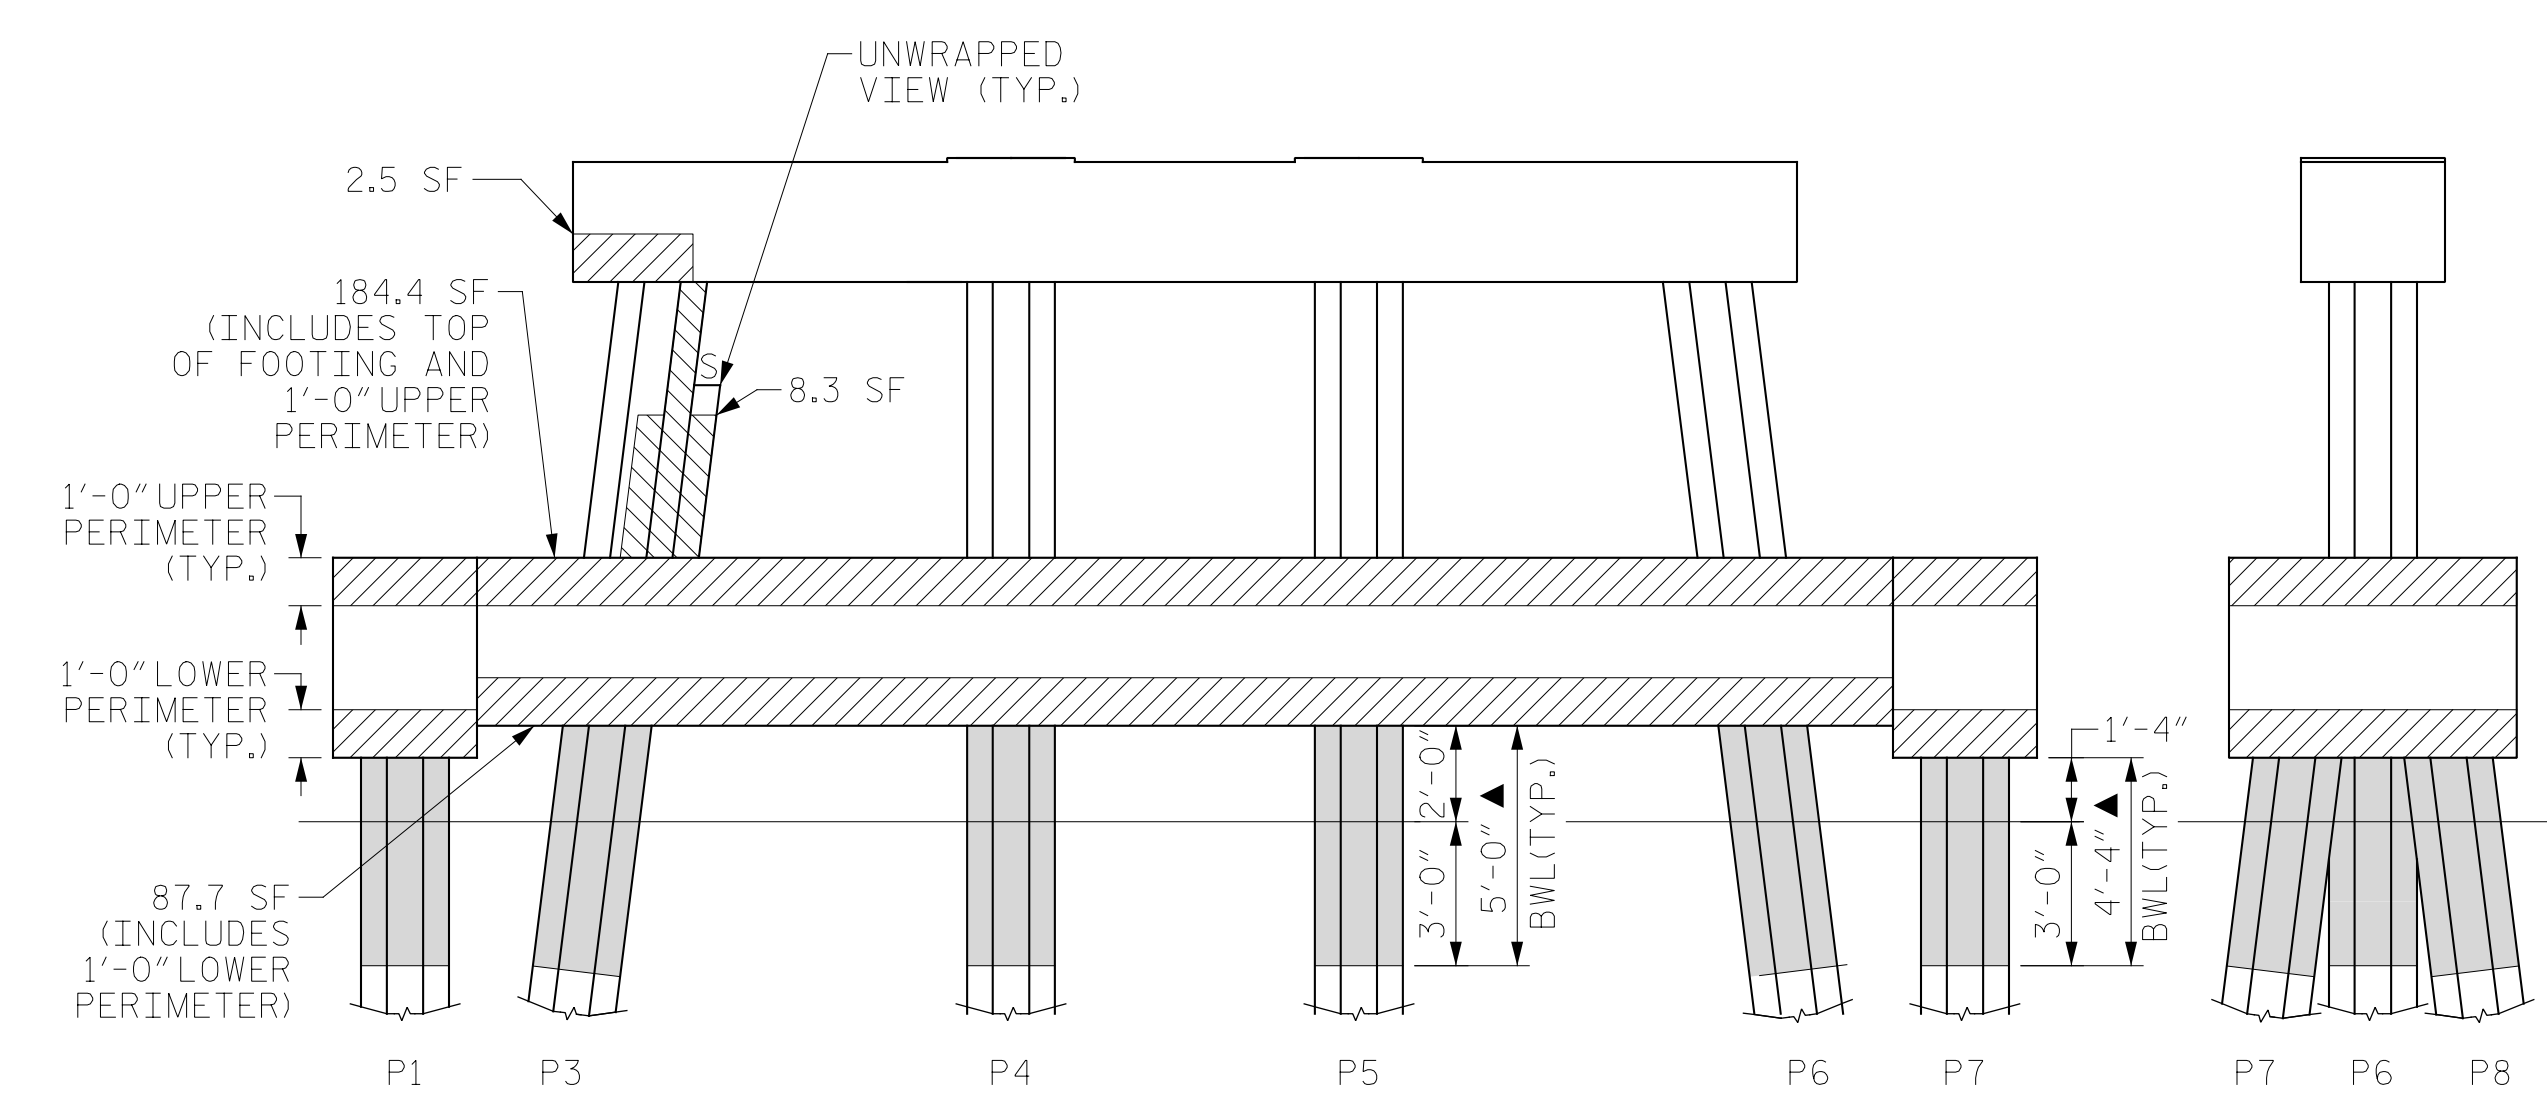
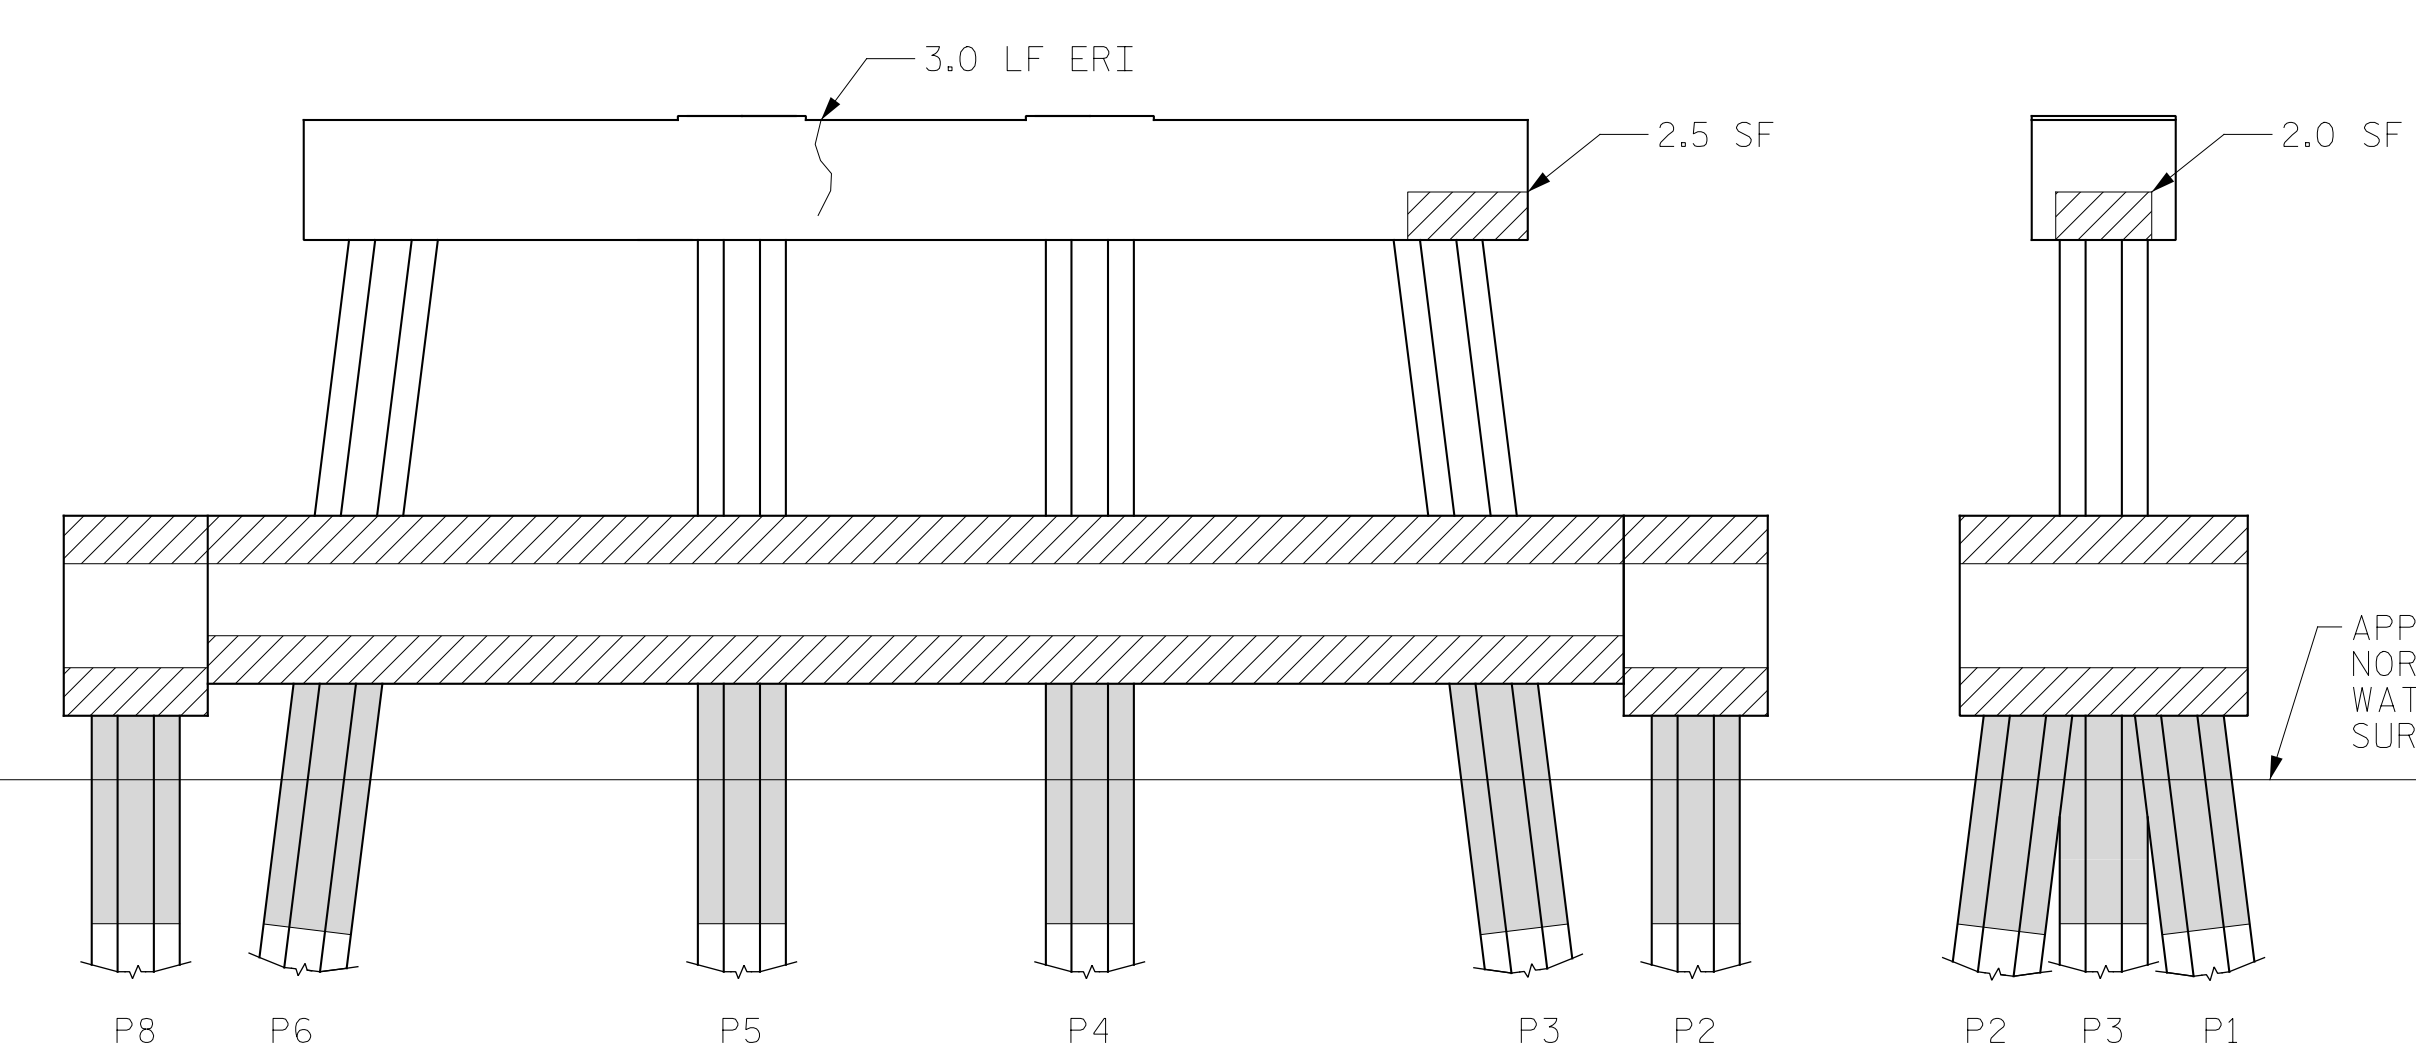
BENT 116

CAP/FOOTING REPAIRS			
SHOTCRETE REPAIRS	279.1 SF	139.6 CF	SF CF
EPOXY RESIN INJECTION	3.0 LF		LF
PILE REPAIRS			
PILE CONCRETE RESTORATION	8.3 SF	3.9 CF	SF CF
FRP PROTECTIVE SYSTEM AWL	- SF		
FRP PROTECTIVE SYSTEM BWL	205.2 SF

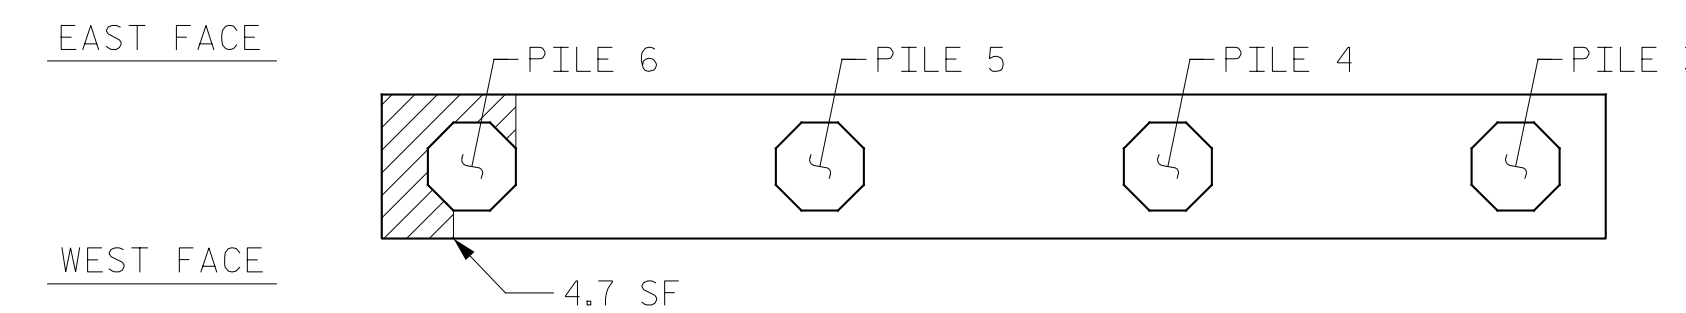
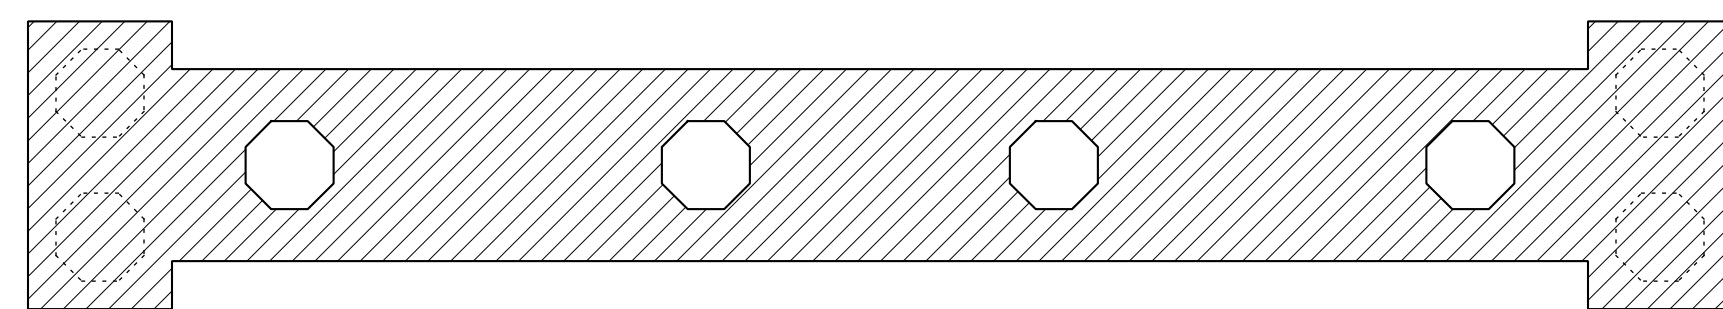
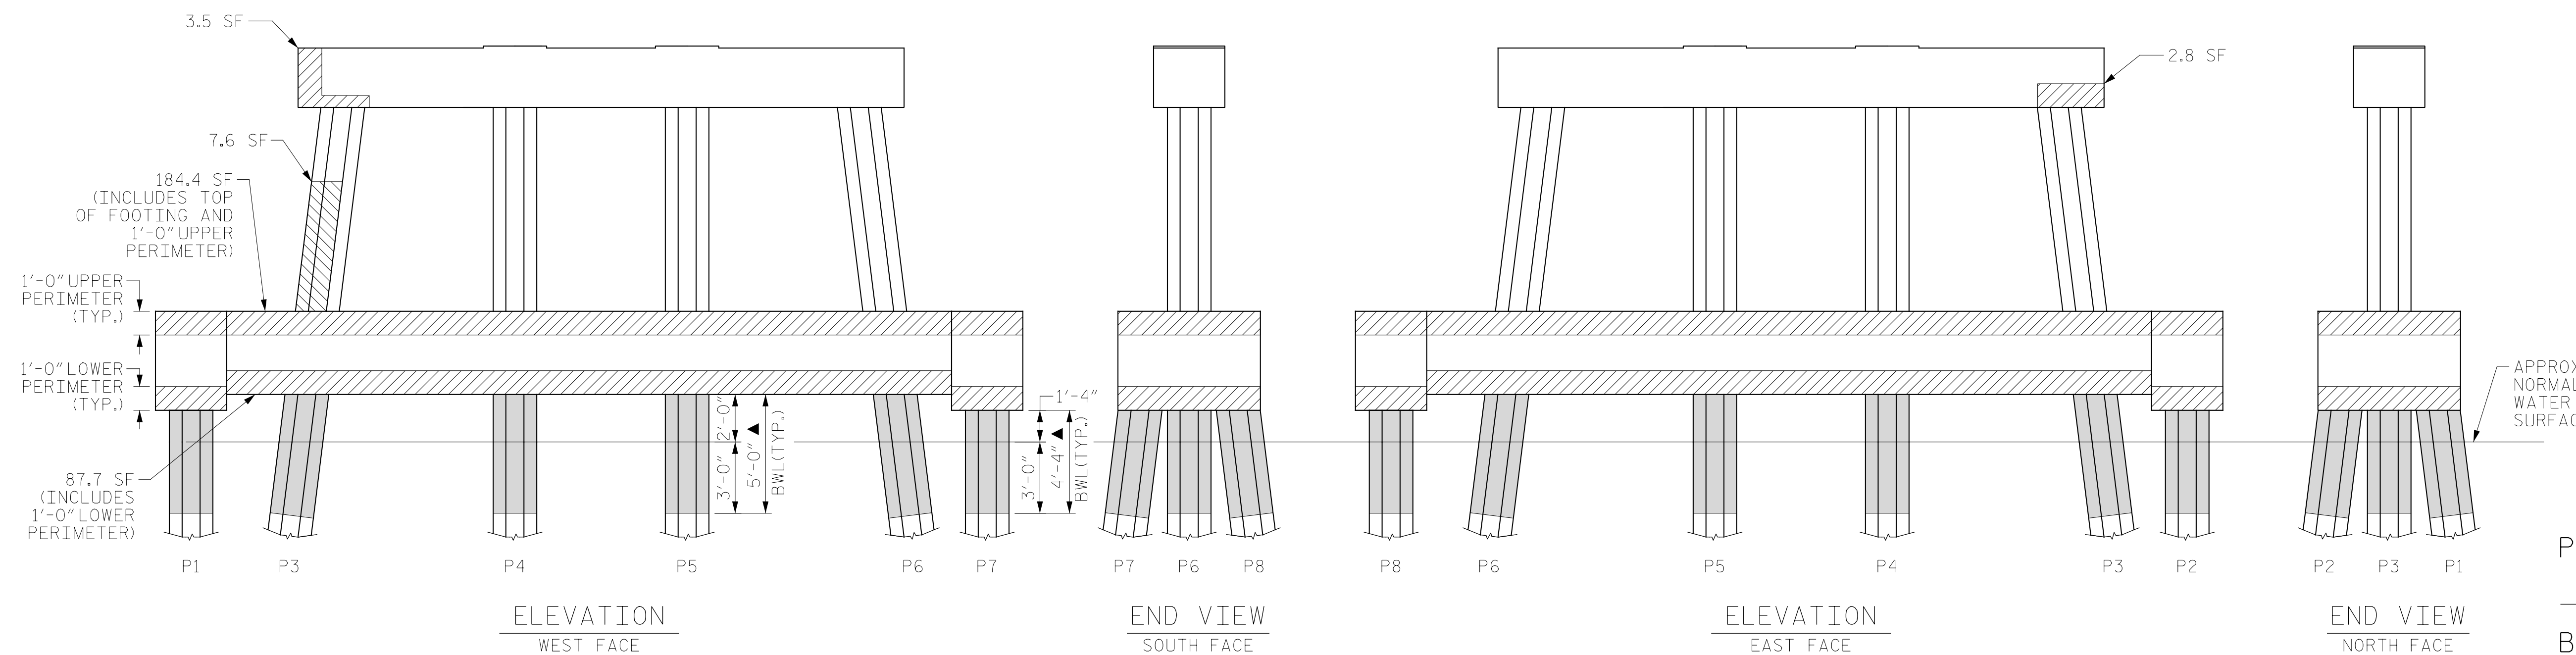
BENT 120

CAP/FOOTING REPAIRS					
SHOTCRETE REPAIRS	283.1 SF	141.6 CF	SF	CF	
EPOXY RESIN INJECTION	- LF				LF
PILE REPAIRS					
PILE CONCRETE RESTORATION	7.6 SF	3.7 CF	SF	CF	
FRP PROTECTIVE SYSTEM AWL	- SF				
FRP PROTECTIVE SYSTEM BWL	205.2 SF
