AS-BUILT REPAIR QUANTITY TABLE

PROJECT NO. HB-0017
DARE COUNTY
BRIDGE NO. 270009

BENT 73 & BENT 74

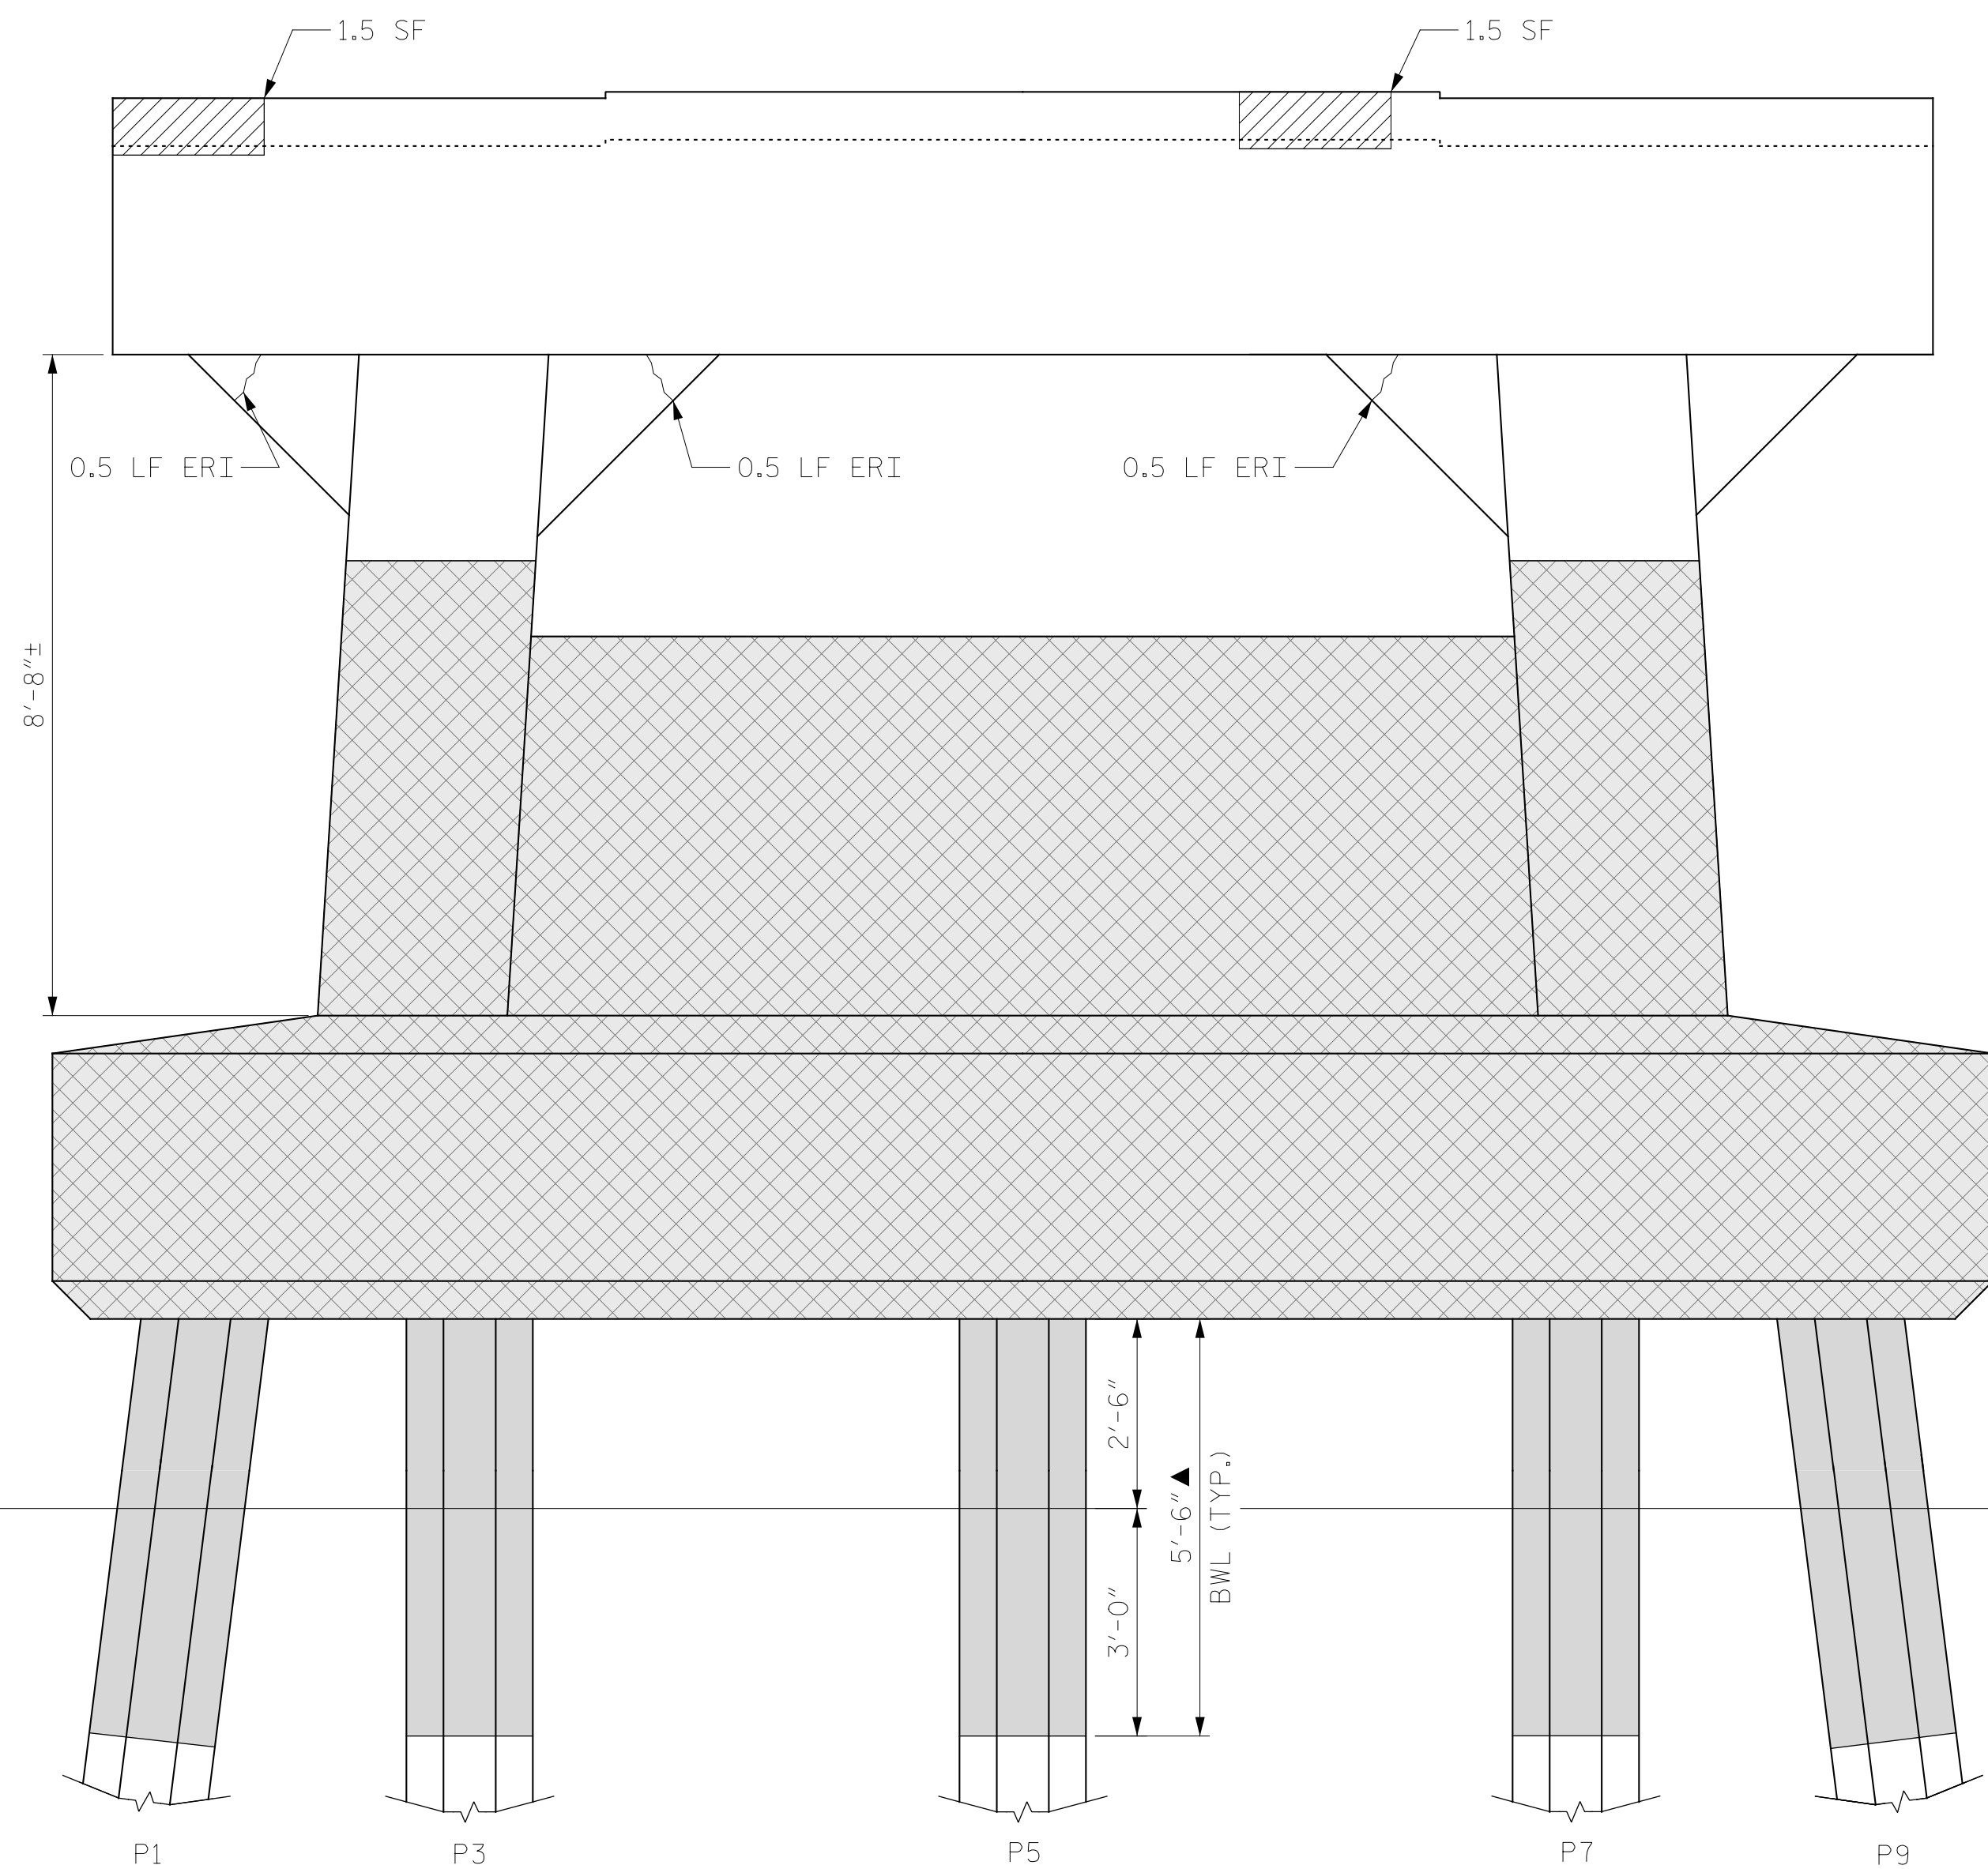
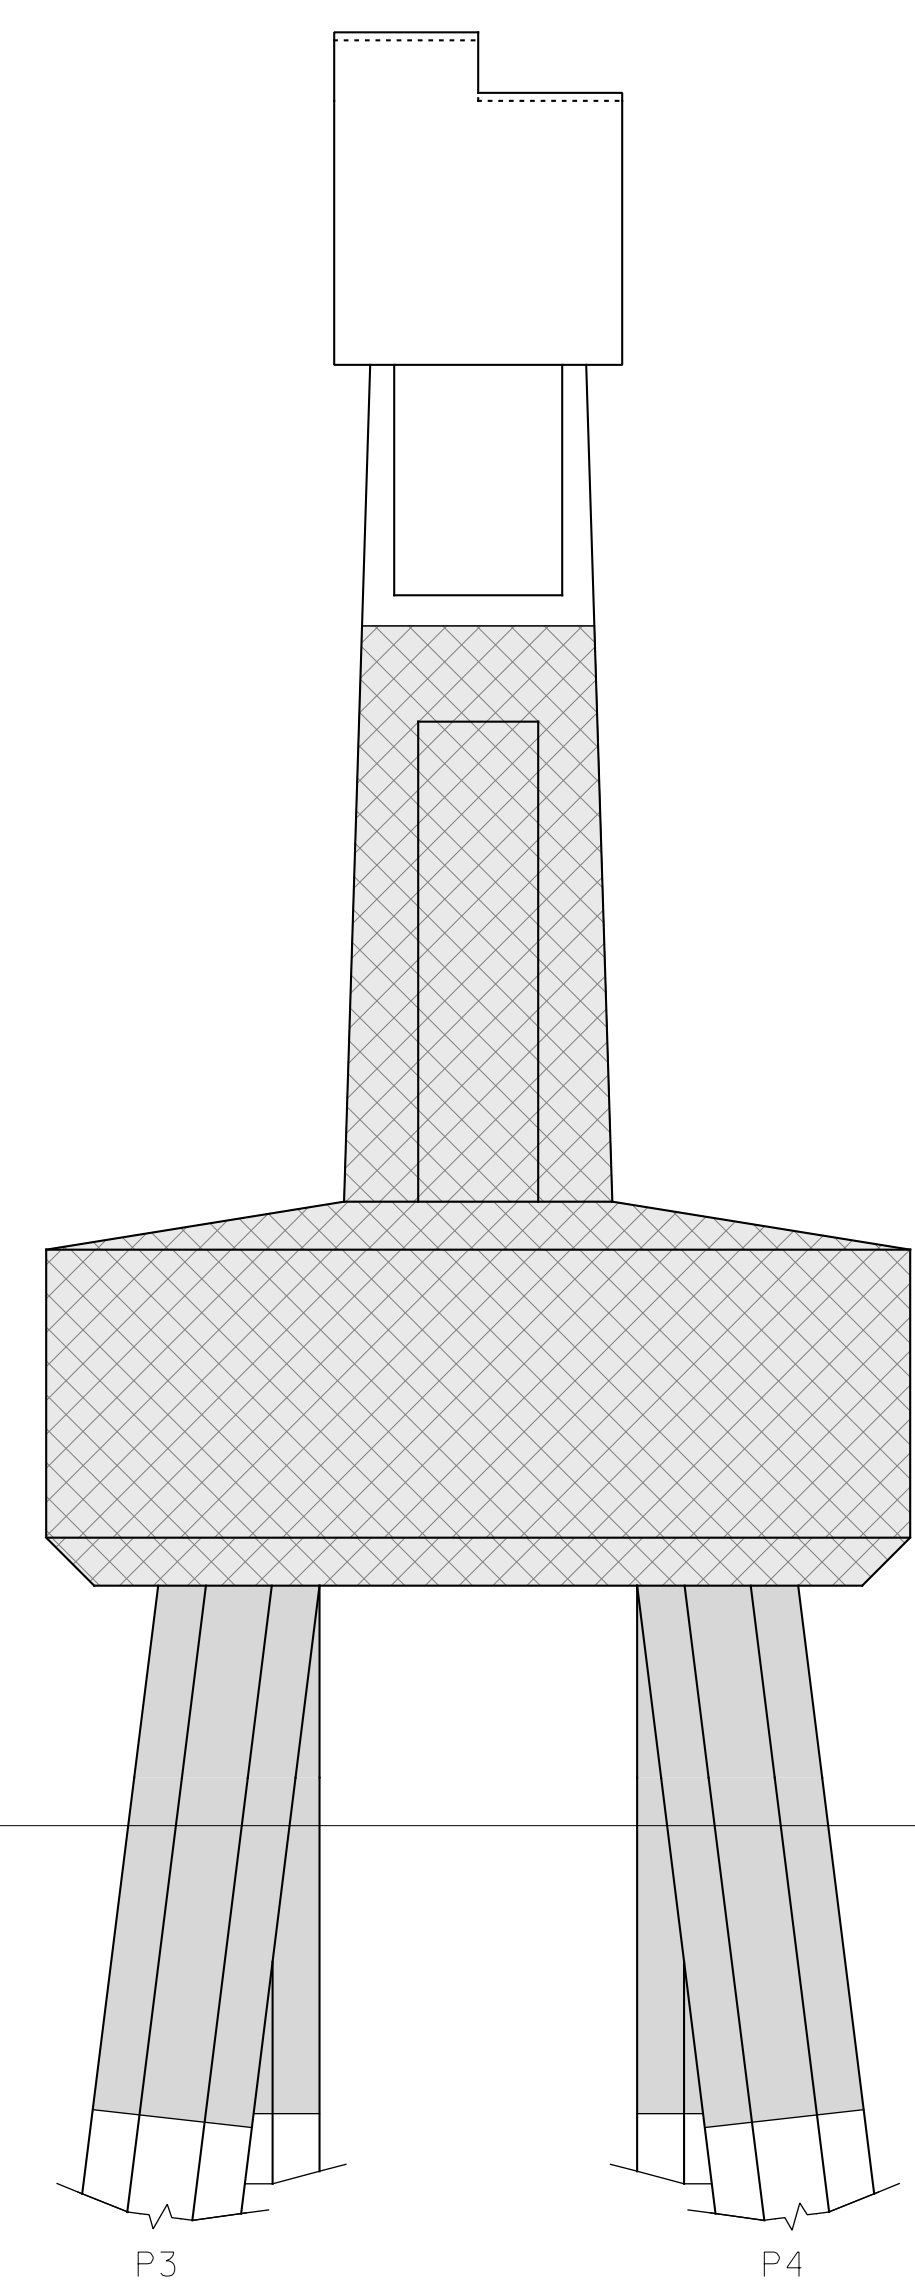
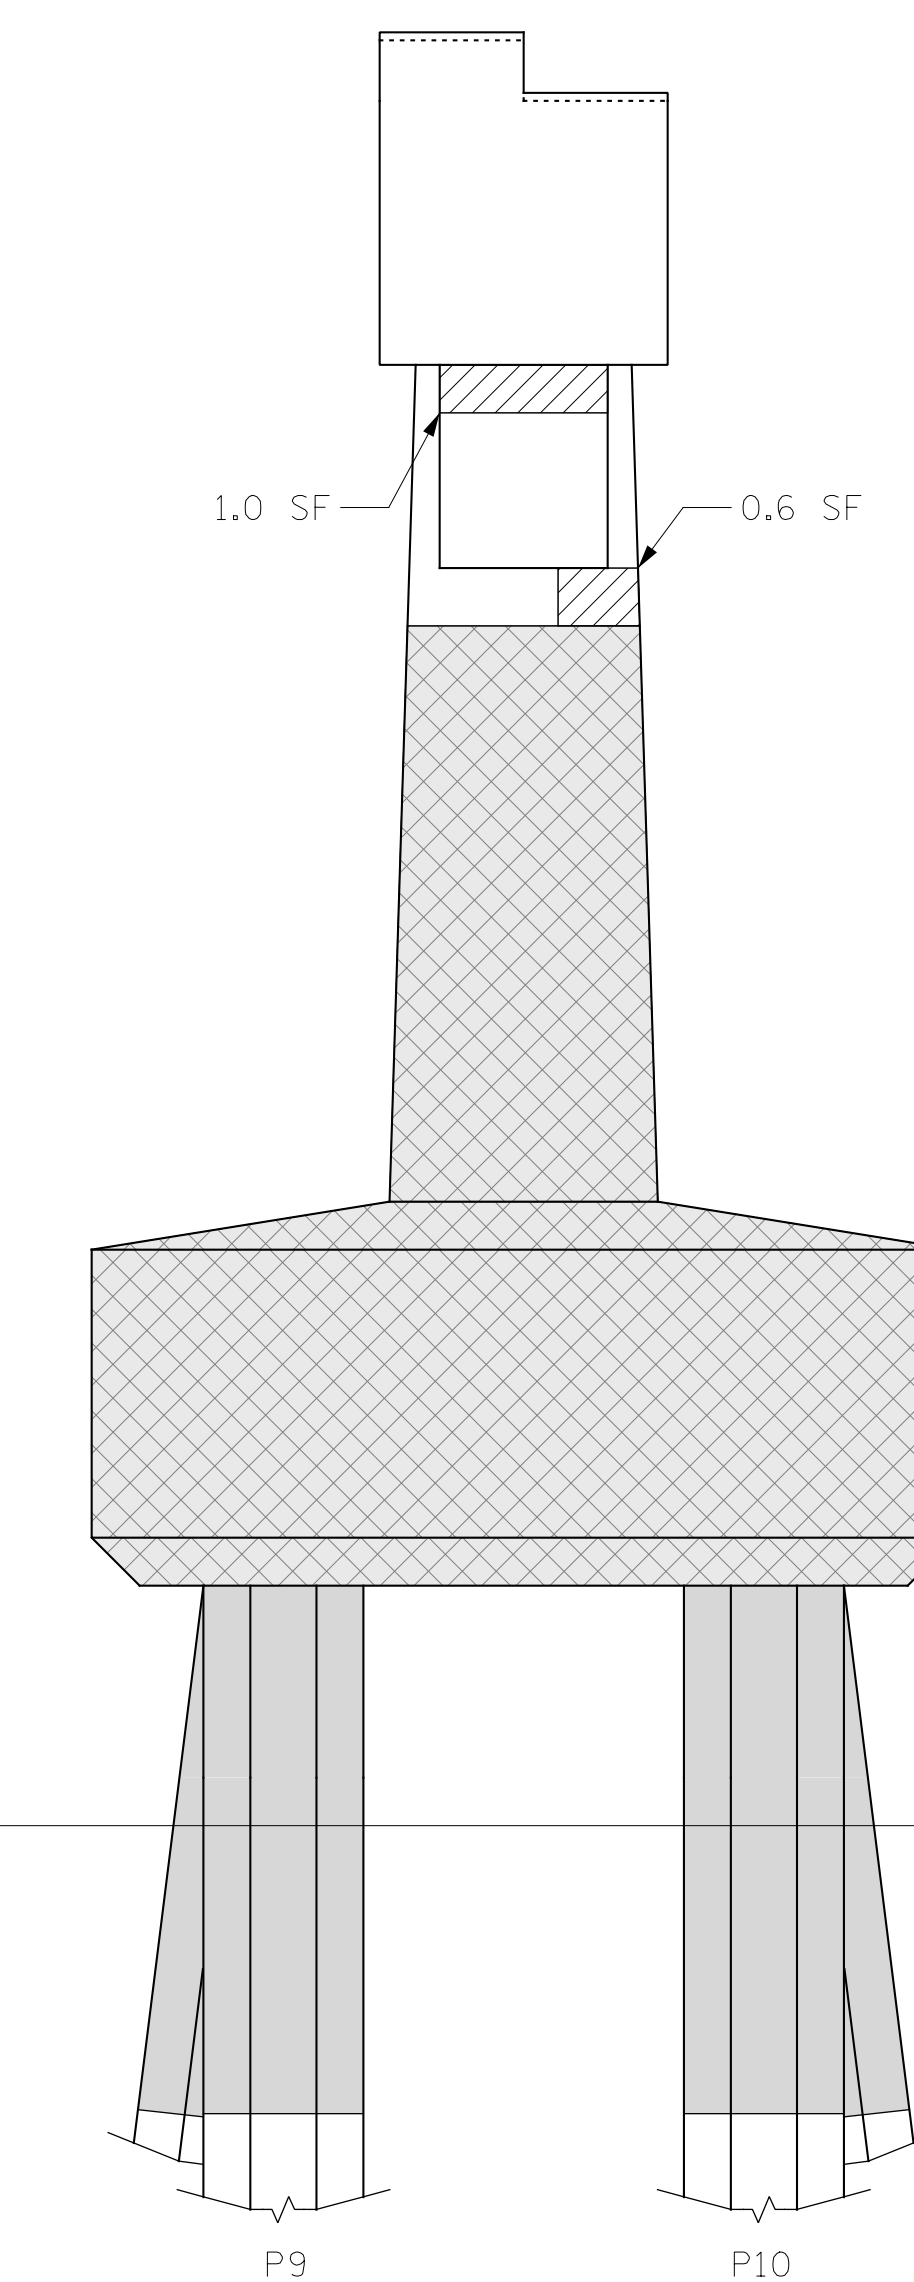
STATE OF NORTH CAROLINA
 DEPARTMENT OF TRANSPORTATION
 RALEIGH
**BENT 121
 WEST FACE**

AS-BUILT REPAIR QUANTITY TABLE				
BENT 121				
CAP REPAIRS		ESTIMATE		ACTUAL
SHOTCRETE REPAIRS	7.6 SF	3.8 CF	SF	CF
EPOXY RESIN INJECTION	- LF			LF
COLUMN REPAIRS		ESTIMATE		ACTUAL
SHOTCRETE REPAIRS	1.6 SF	0.8 CF	SF	CF
EPOXY RESIN INJECTION	1.5 LF			LF
PILE REPAIRS		ESTIMATE		ACTUAL
FRP PROTECTIVE SYSTEM AWL	- SF			SF
FRP PROTECTIVE SYSTEM BWL	302.5 SF			SF

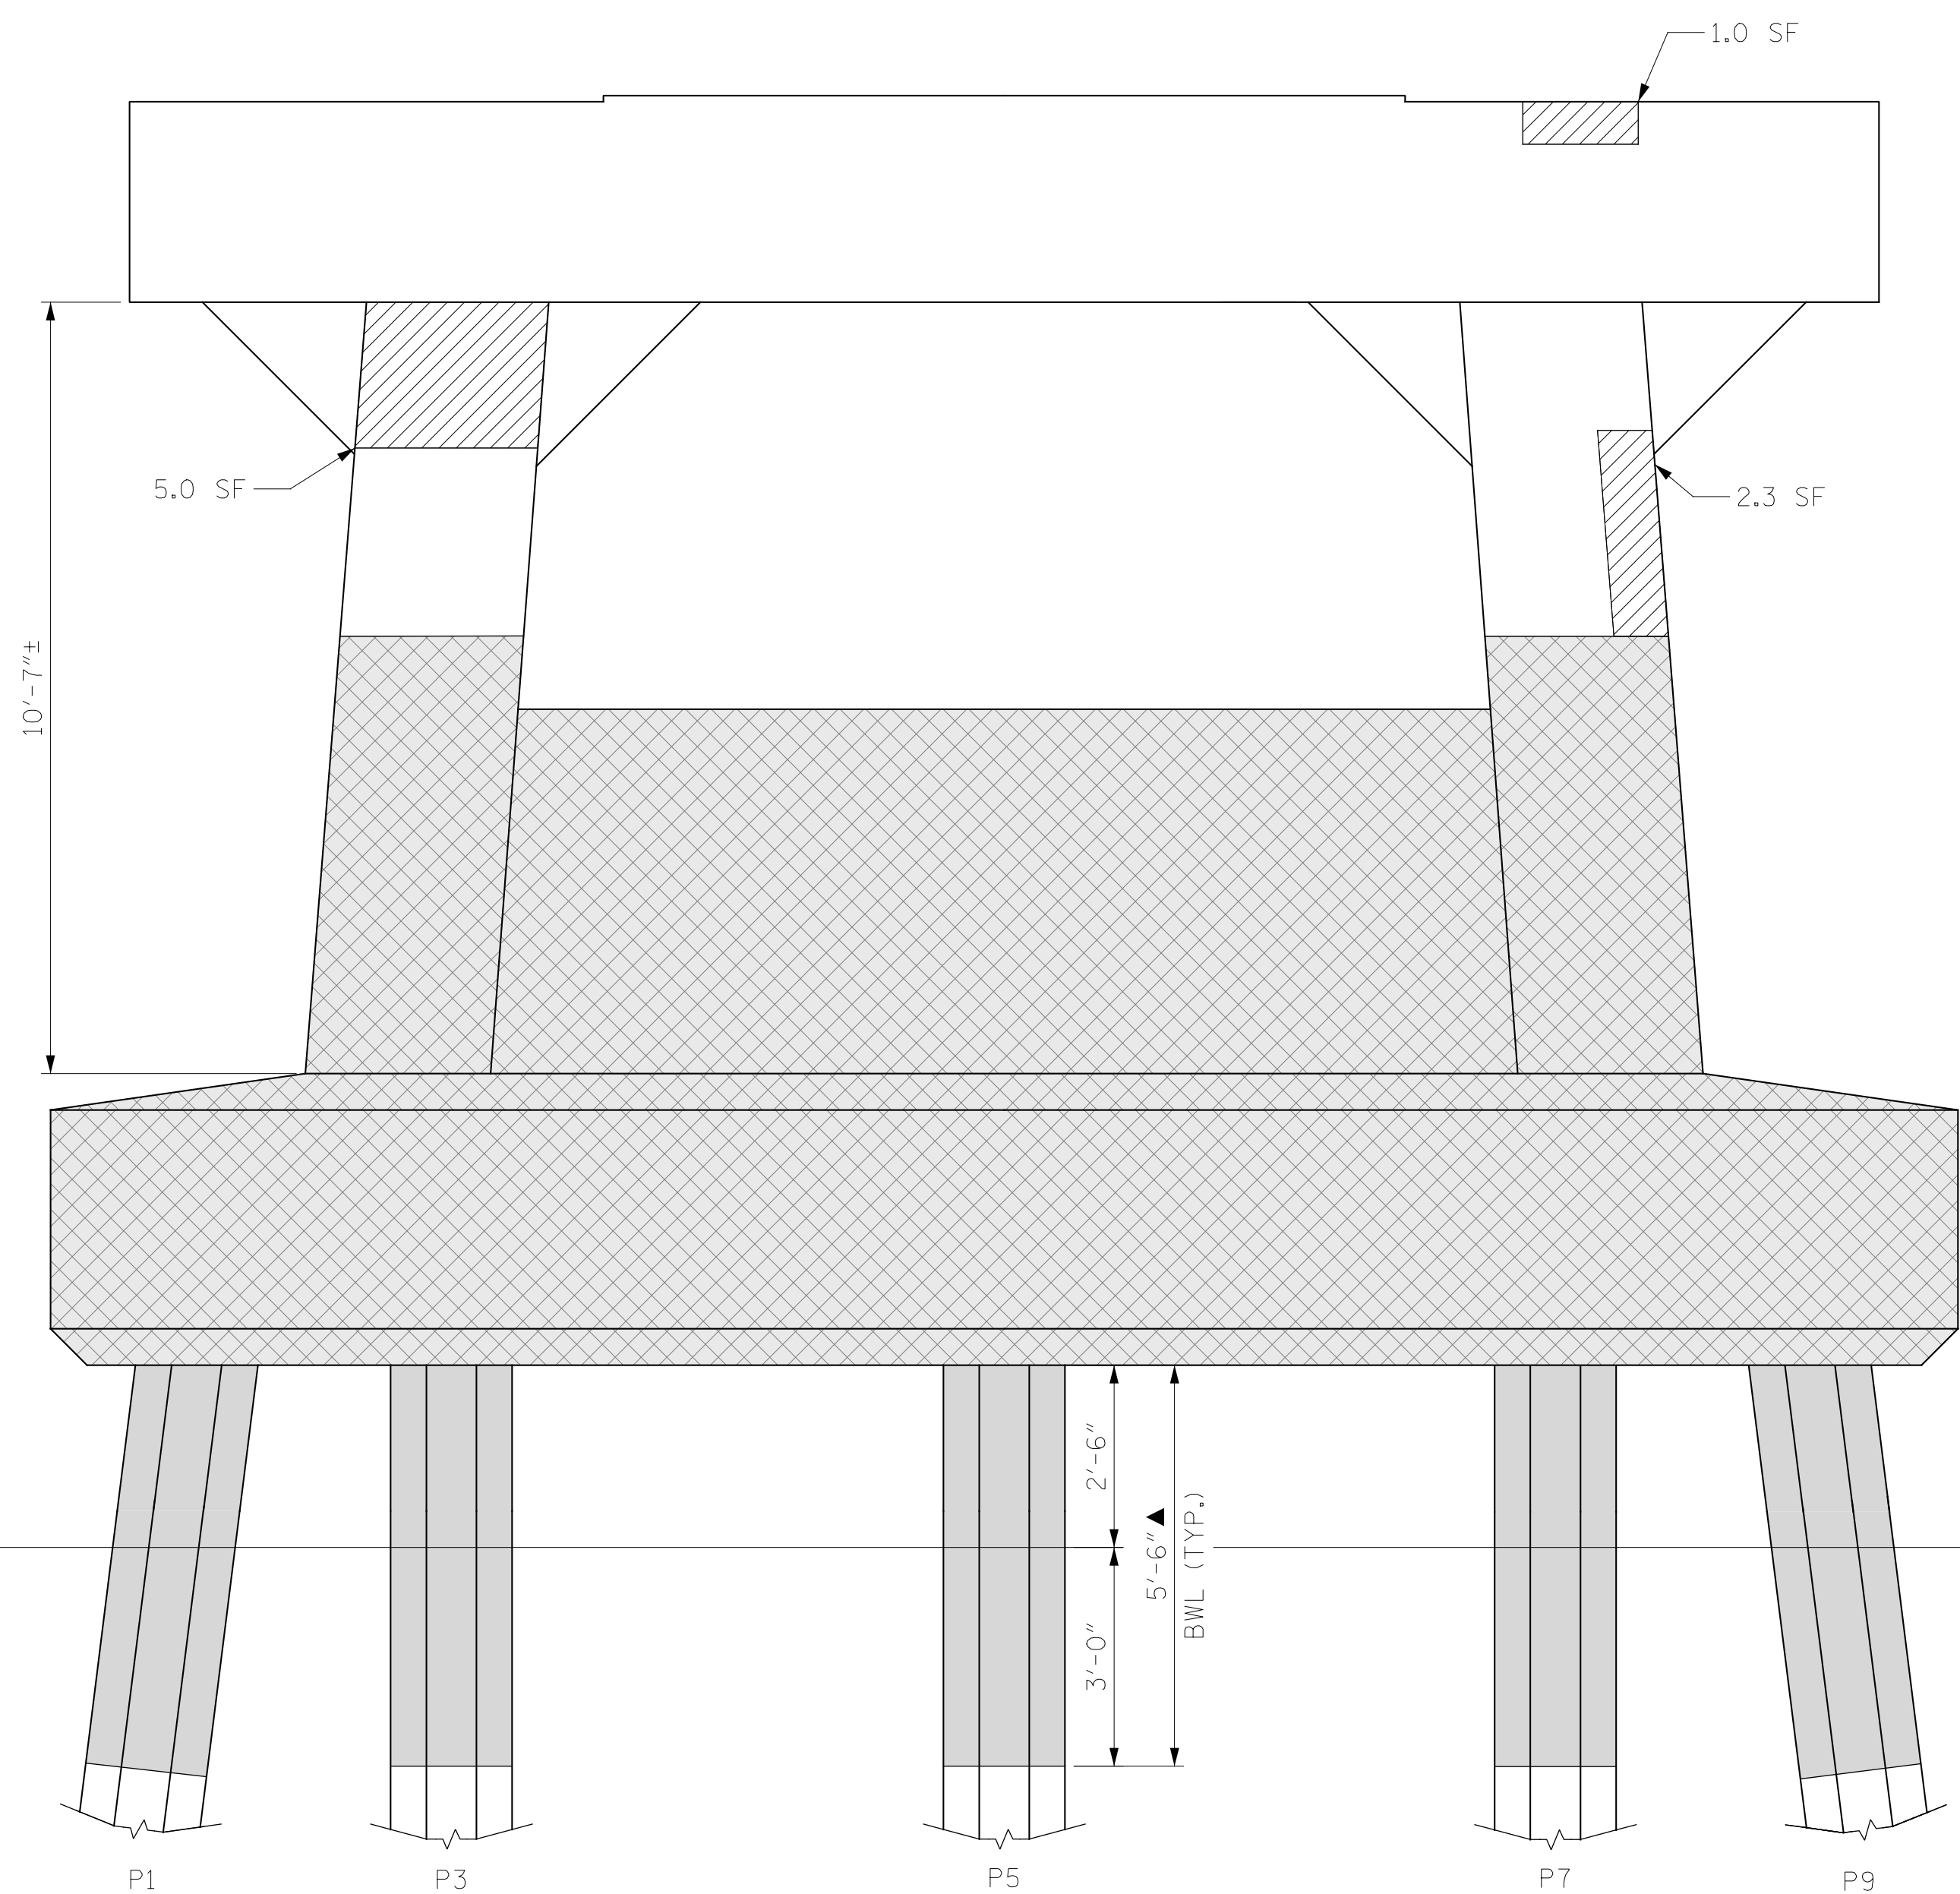
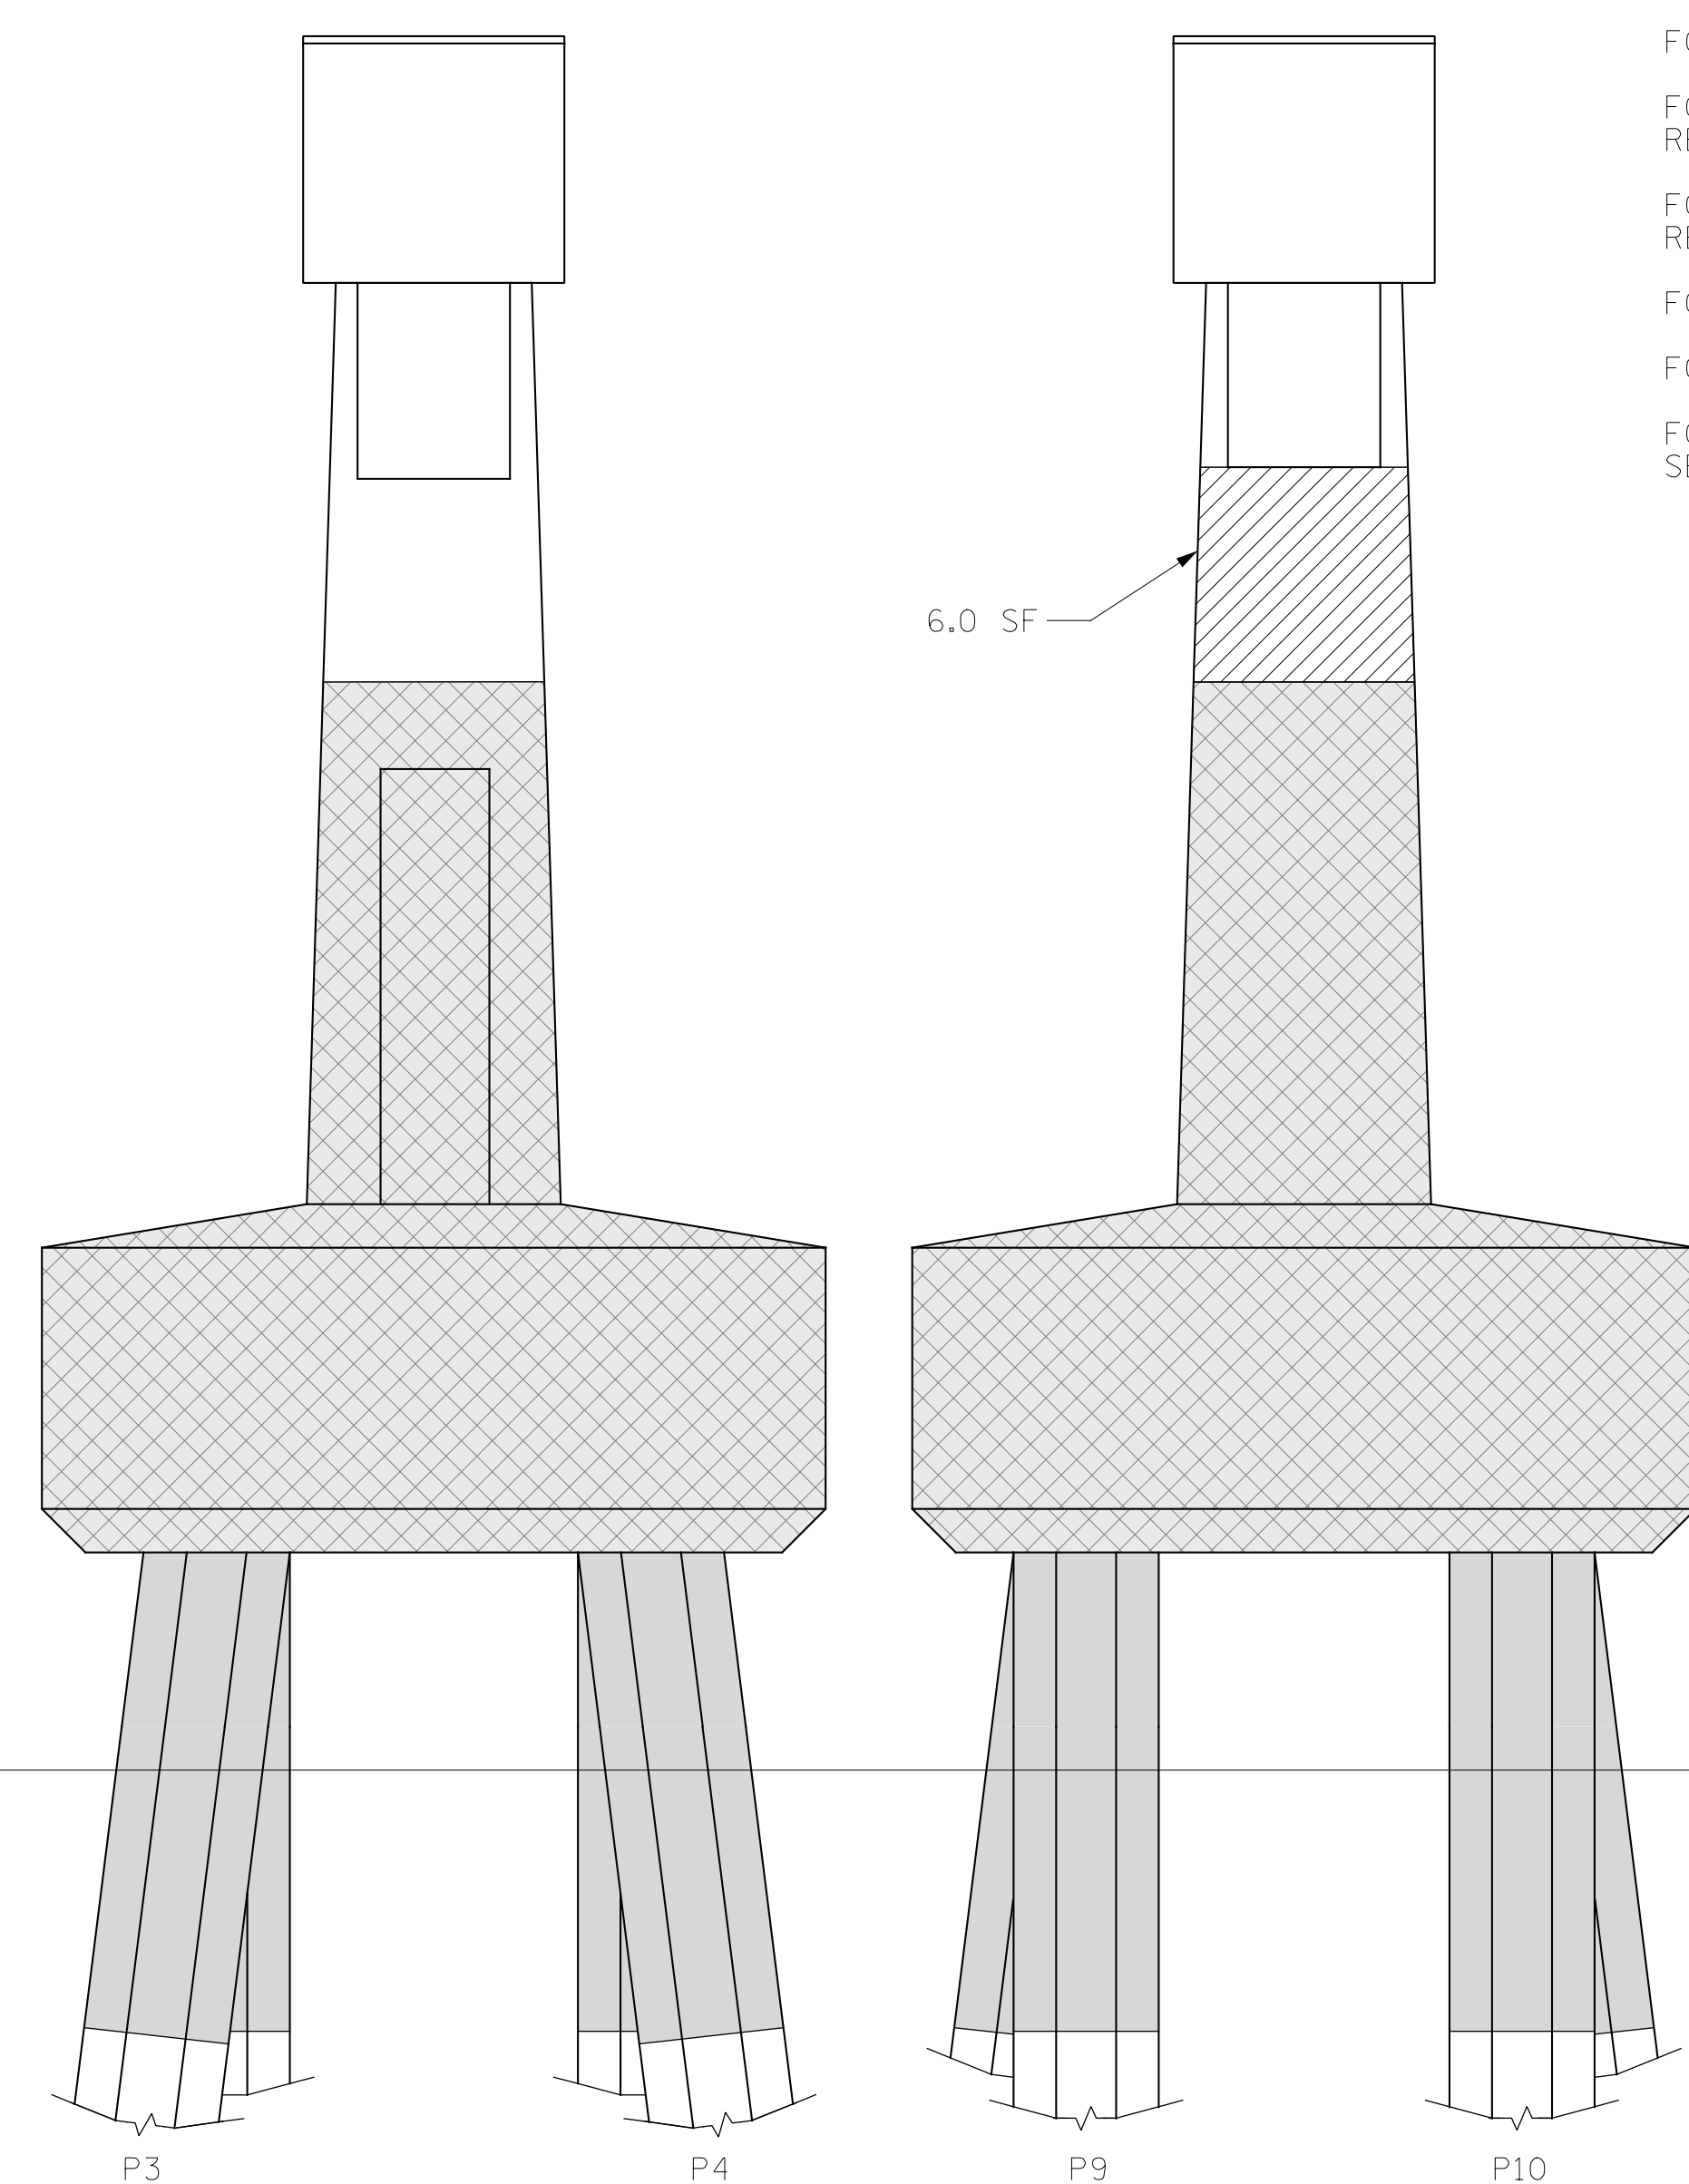
BENT 122 WEST FACE

CAP REPAIRS		ESTIMATE		ACTUAL	
SHOTCRETE REPAIRS	5.7 SF	2.9 CF	SF	CF	
EPOXY RESIN INJECTION	- LF				LF
COLUMN REPAIRS		ESTIMATE		ACTUAL	
SHOTCRETE REPAIRS	32.4 SF	16.2 SF	SF	CF	
EPOXY RESIN INJECTION	- LF				LF
PILE REPAIRS		ESTIMATE		ACTUAL	
FRP PROTECTIVE SYSTEM AWL	- SF				SF
FRP PROTECTIVE SYSTEM BWL	302.5 SF				SF

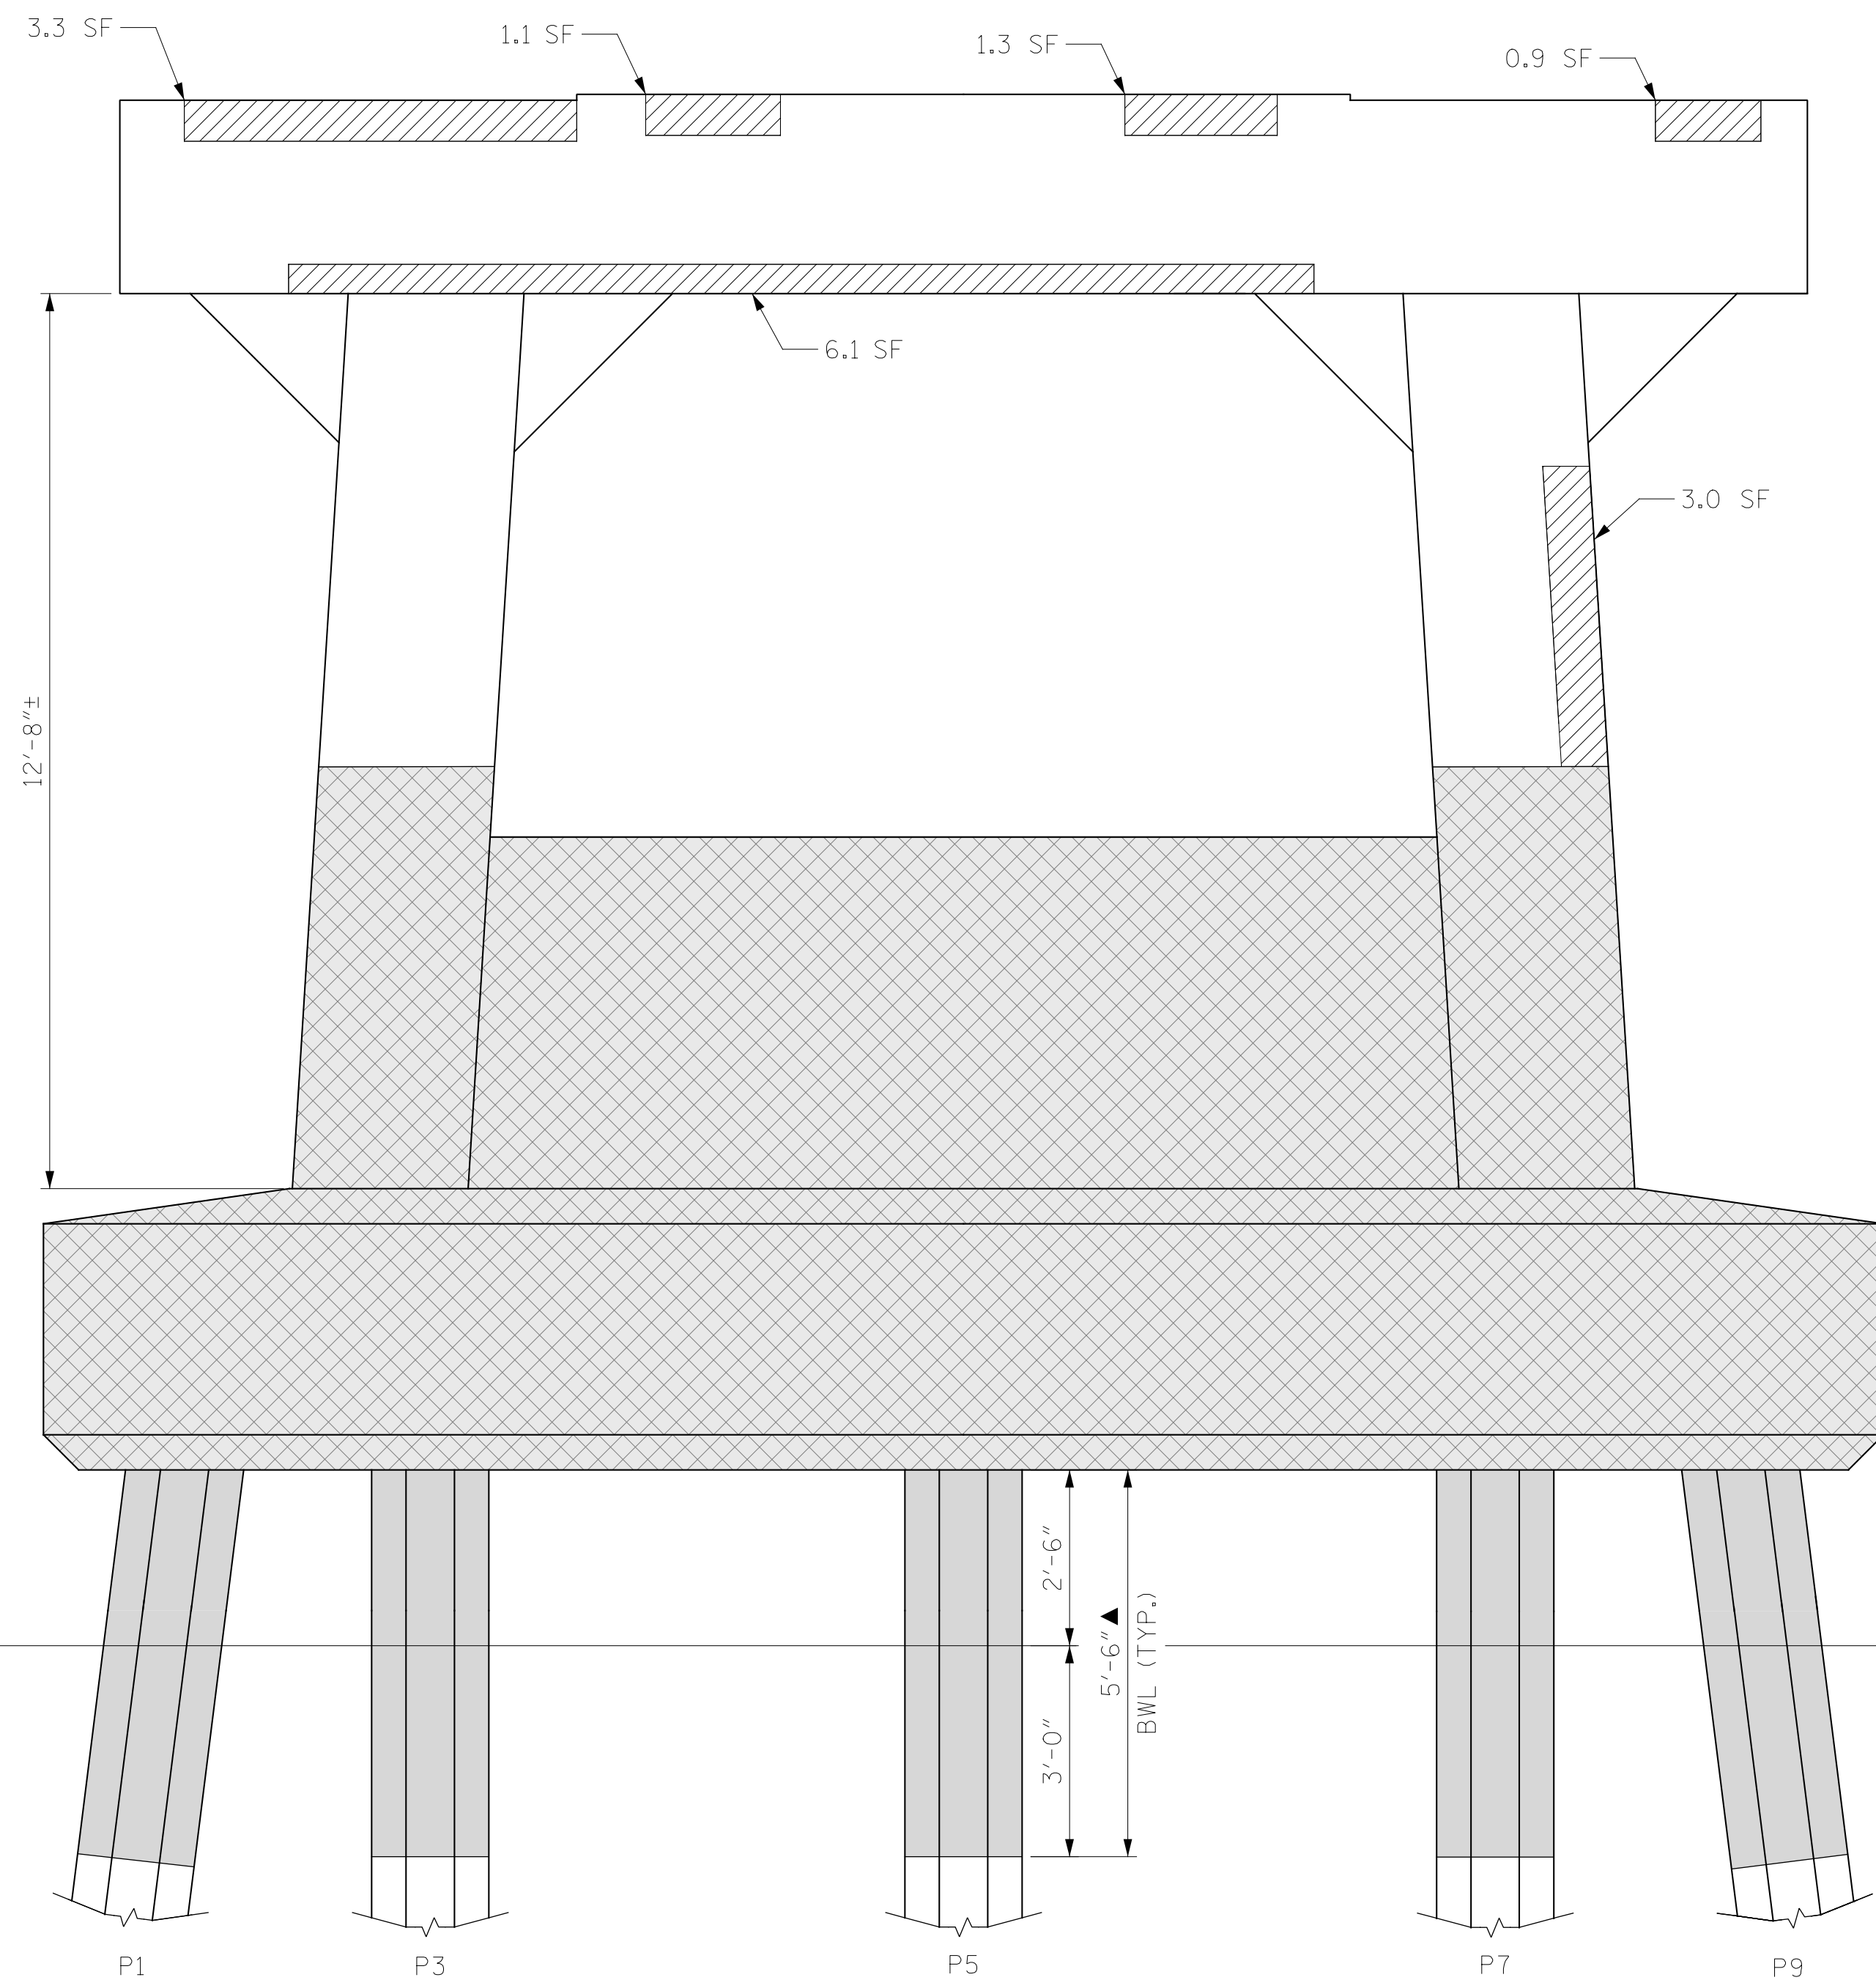
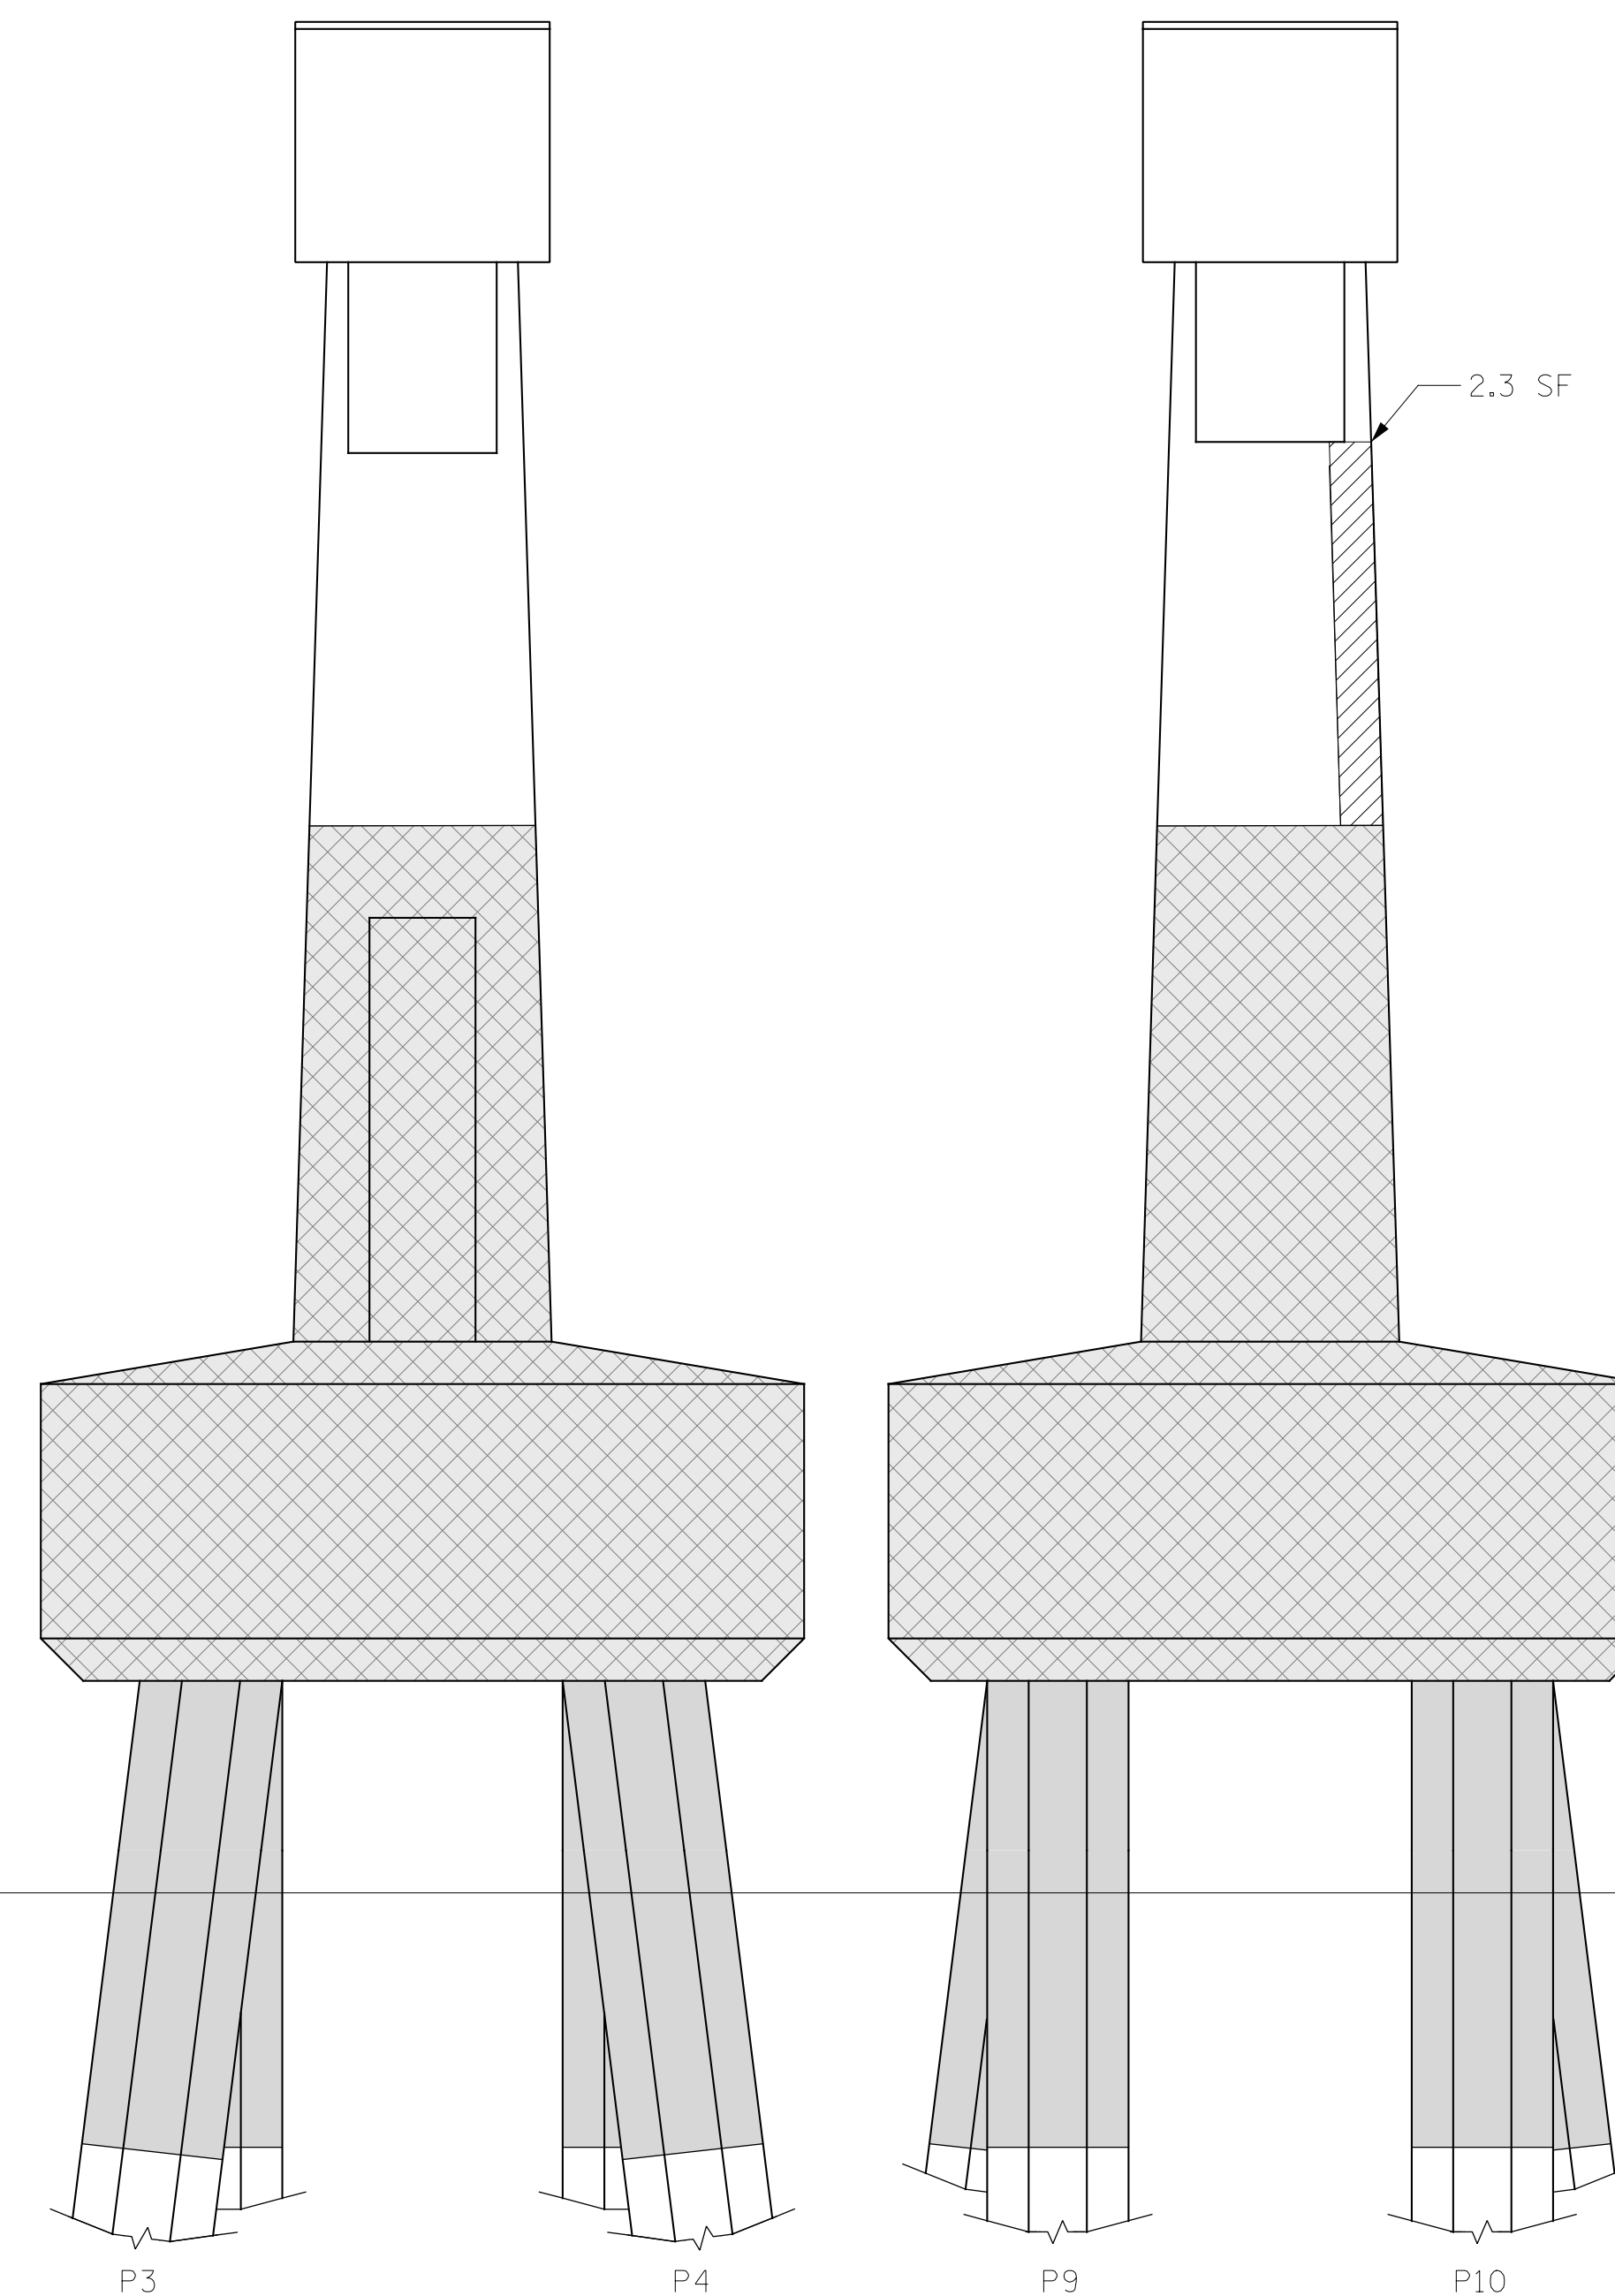
BENT 123 WEST FACE

CAP REPAIRS		ESTIMATE		ACTUAL	
SHOTCRETE REPAIRS	16.4 SF	8.2 CF	SF	CF	
EPOXY RESIN INJECTION	- LF				LF
COLUMN REPAIRS		ESTIMATE		ACTUAL	
SHOTCRETE REPAIRS	5.9 SF	3.0 CF	SF	CF	
EPOXY RESIN INJECTION	- LF				LF
PILE REPAIRS		ESTIMATE		ACTUAL	
FRP PROTECTIVE SYSTEM AWL	- SF				SF
FRP PROTECTIVE SYSTEM BWL	302.5 SF				SF
