AS-BUILT REPAIR QUANTITY TABLE

PROJECT NO. HB-0017
DARE COUNTY
BRIDGE NO. 270009

BENT 73 & BENT 74

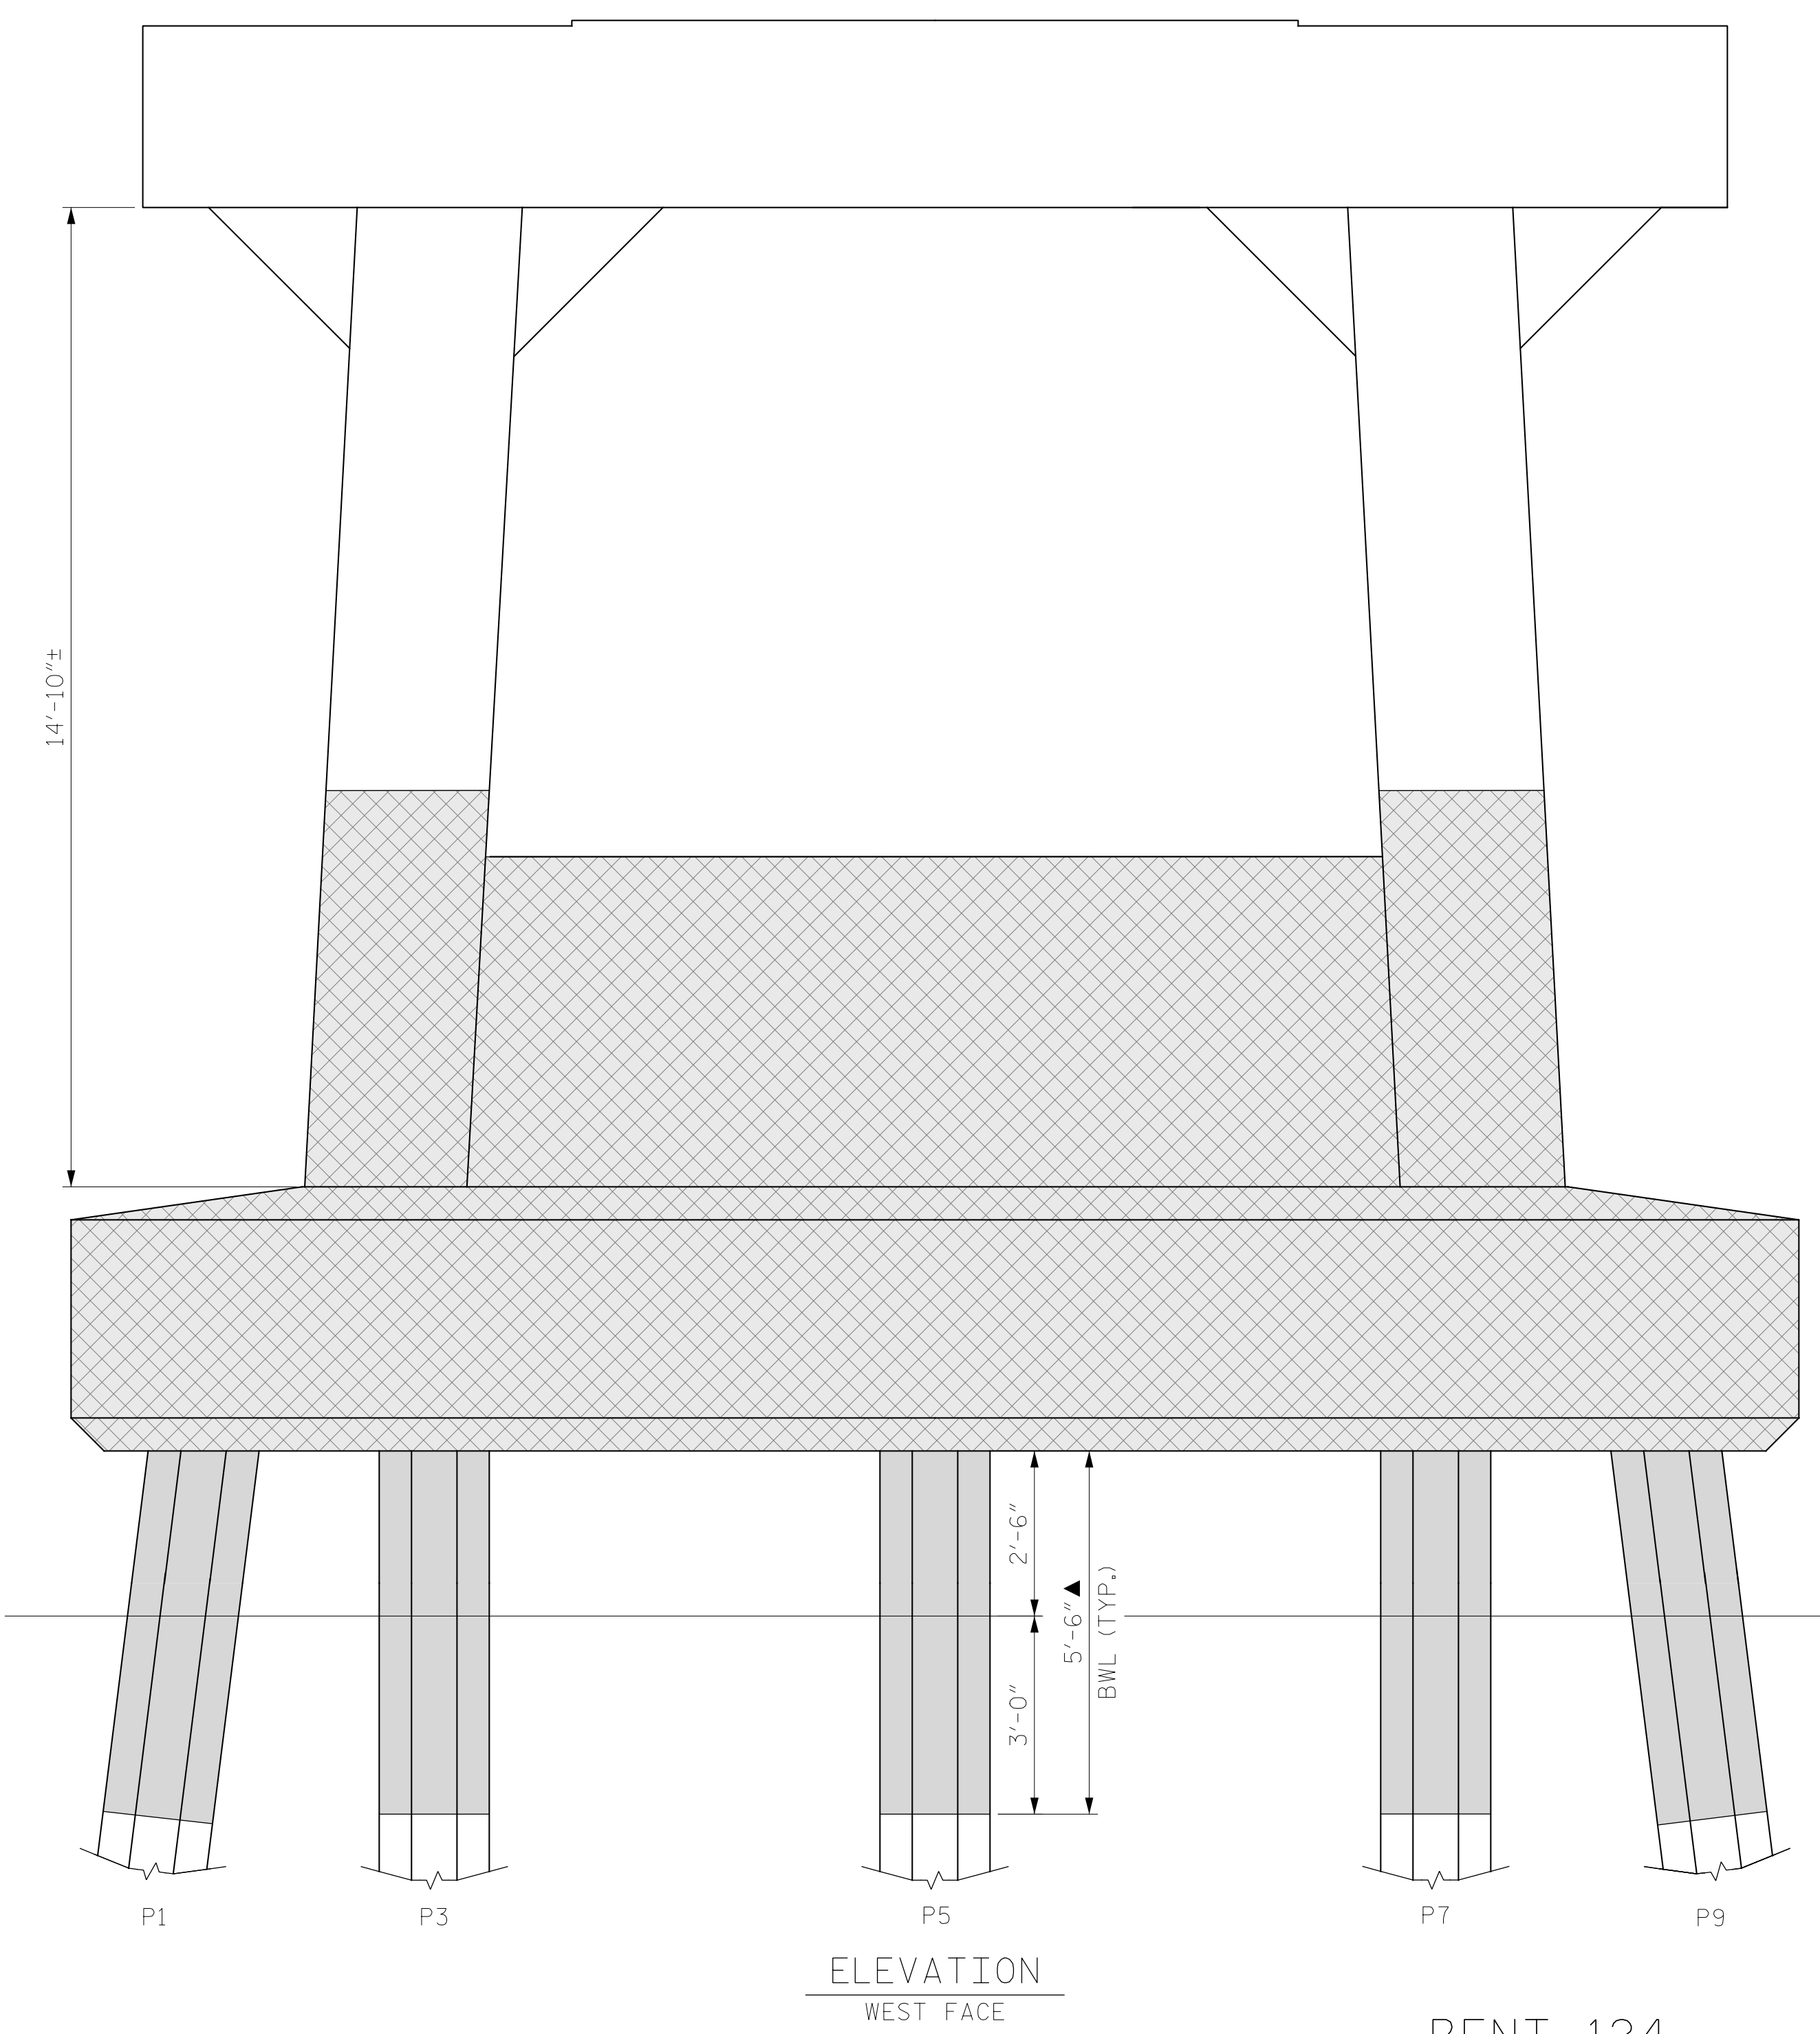
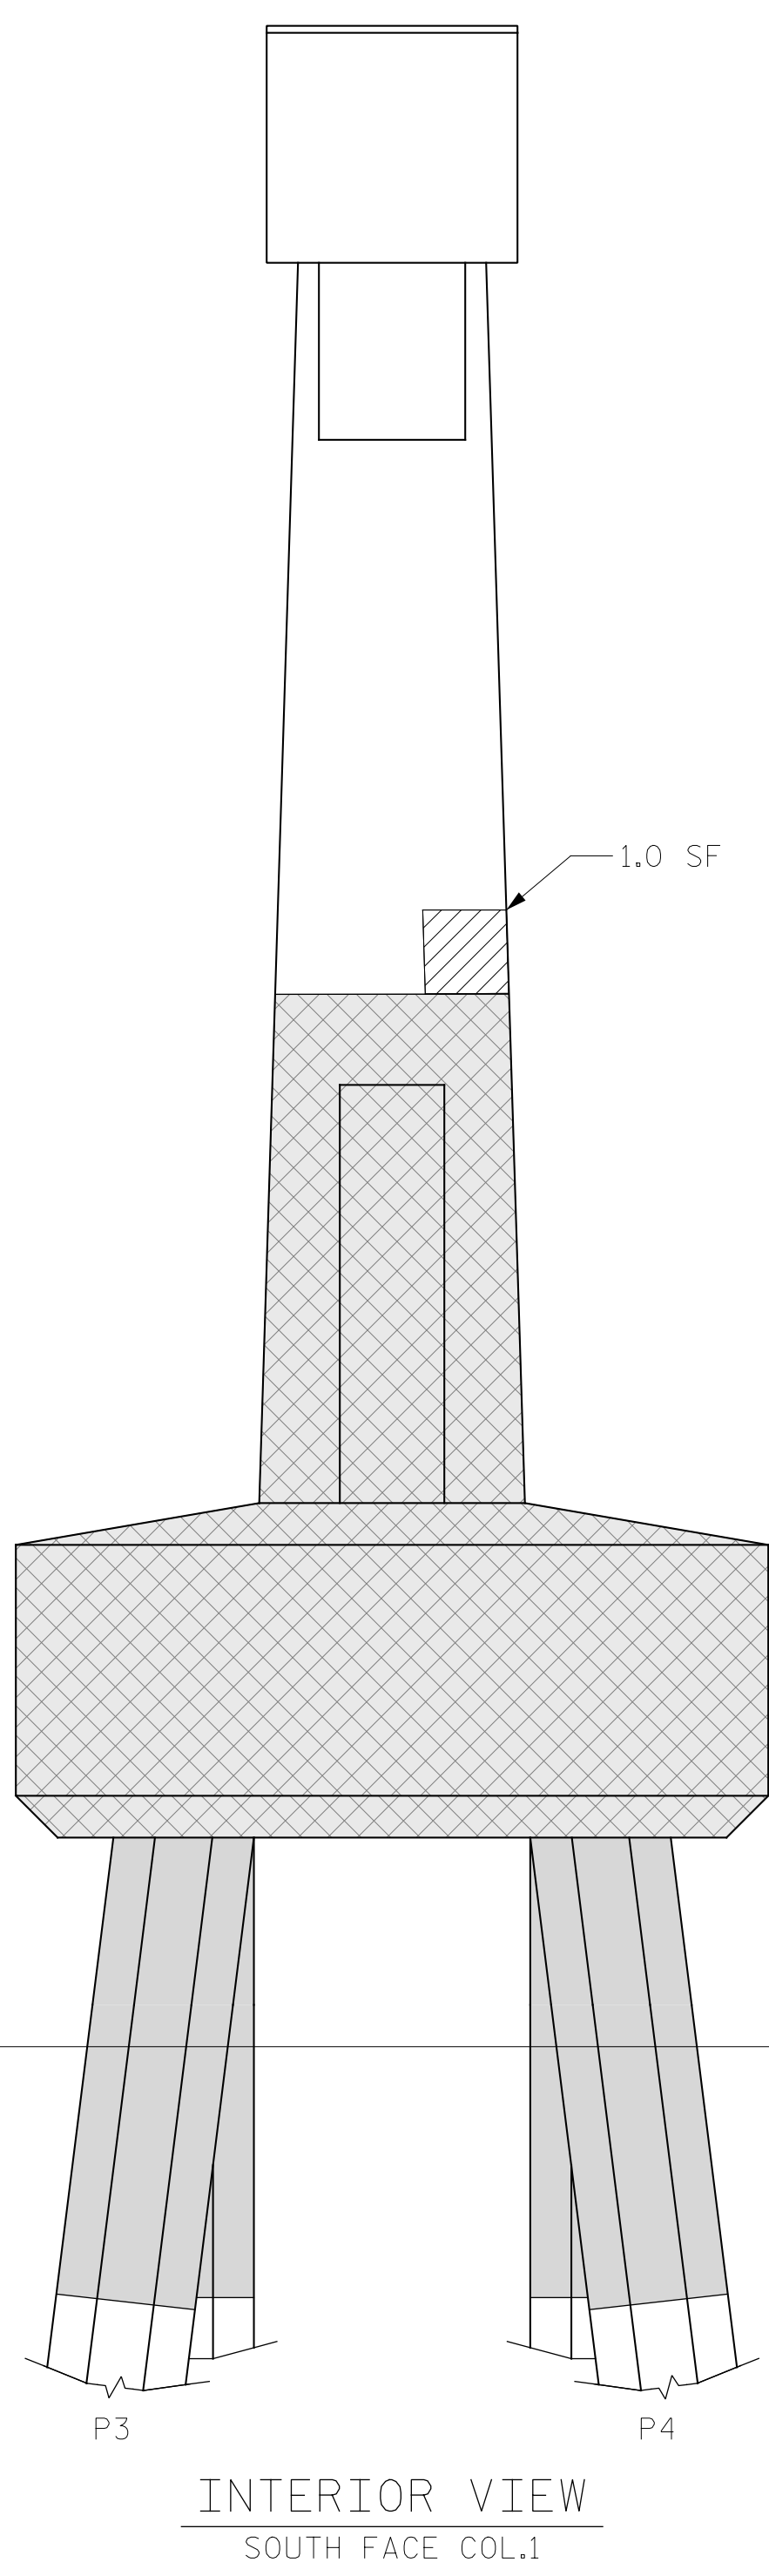
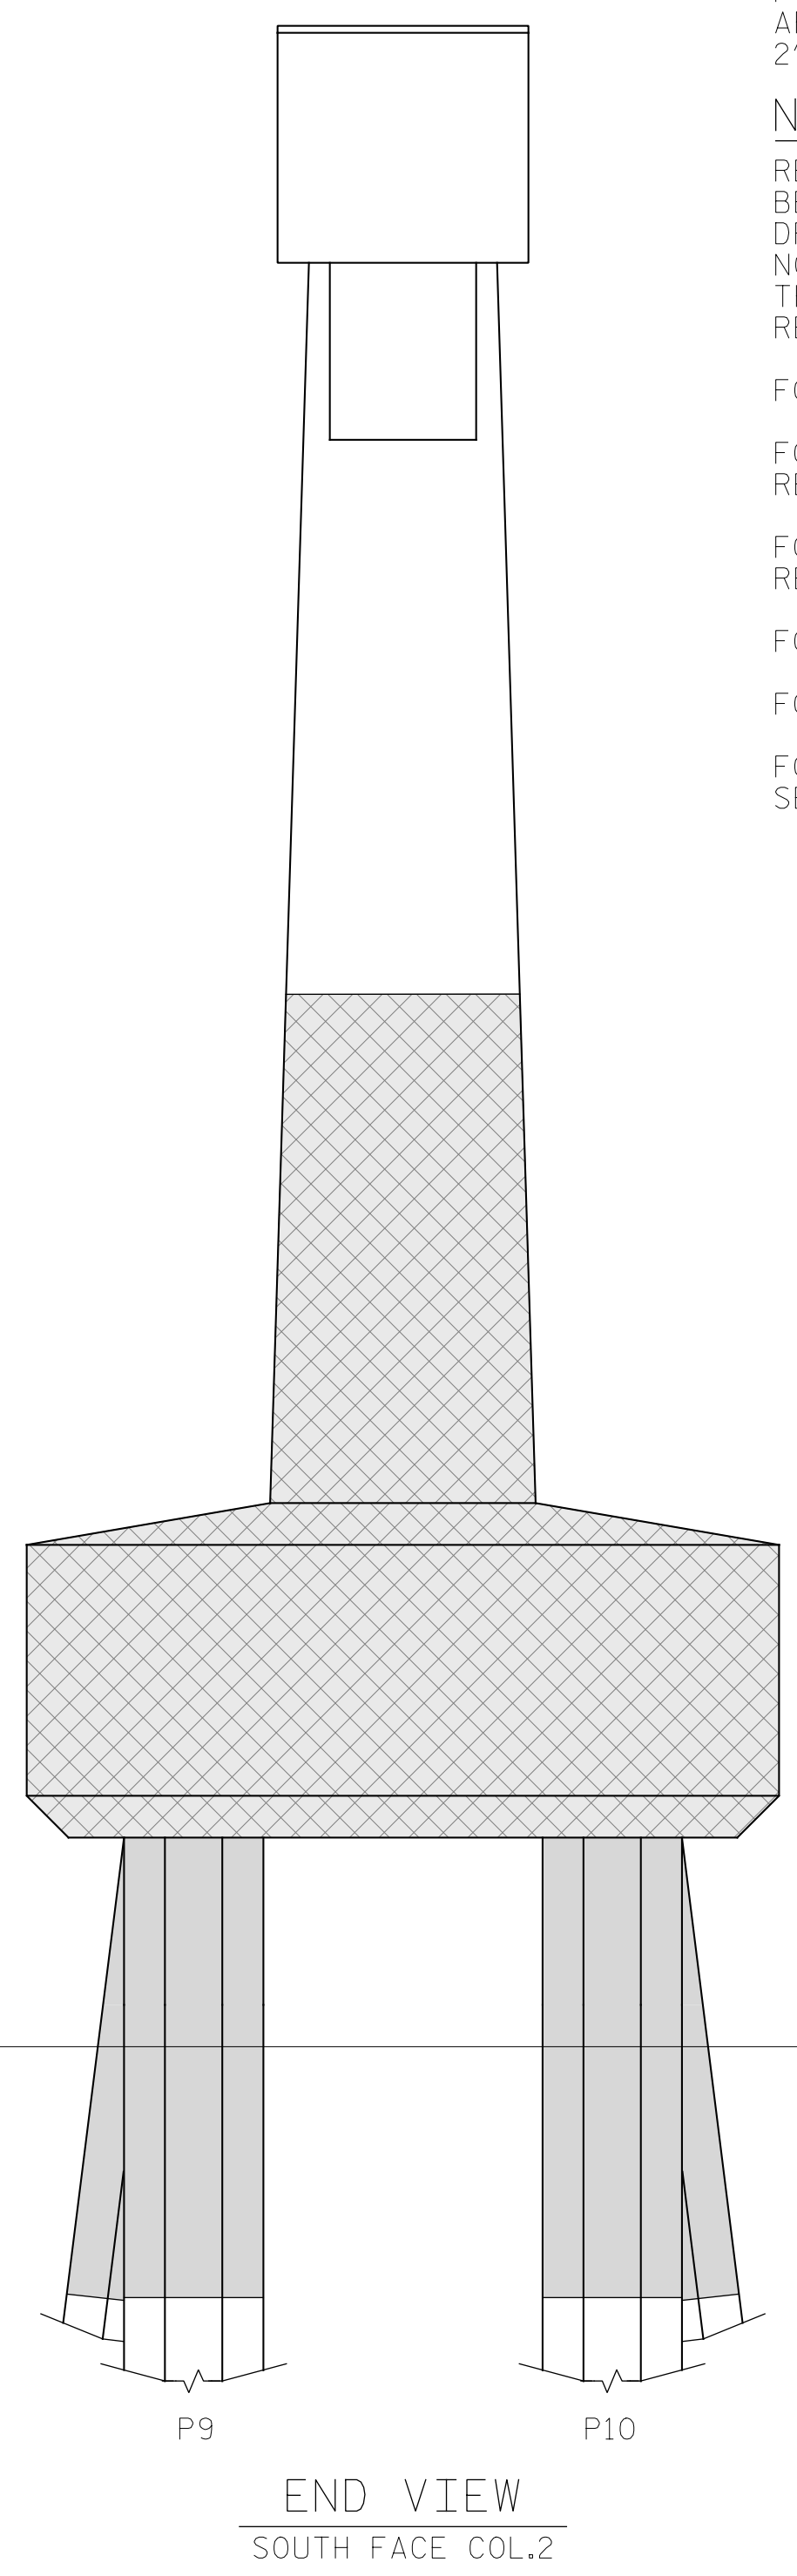
AS-BUILT REPAIR QUANTITY TABLE BENT 124

CAP REPAIRS		ESTIMATE		ACTUAL	
SHOTCRETE REPAIRS	2.8 SF	1.4 CF	SF	CF	
EPOXY RESIN INJECTION	- LF				LF
COLUMN REPAIRS		ESTIMATE		ACTUAL	
SHOTCRETE REPAIRS	7.6 SF	3.8 CF	SF	CF	
EPOXY RESIN INJECTION	- LF				LF
PILE REPAIRS		ESTIMATE		ACTUAL	
FRP PROTECTIVE SYSTEM AWL	- SF				SF
FRP PROTECTIVE SYSTEM BWL	302.5 SF				SF

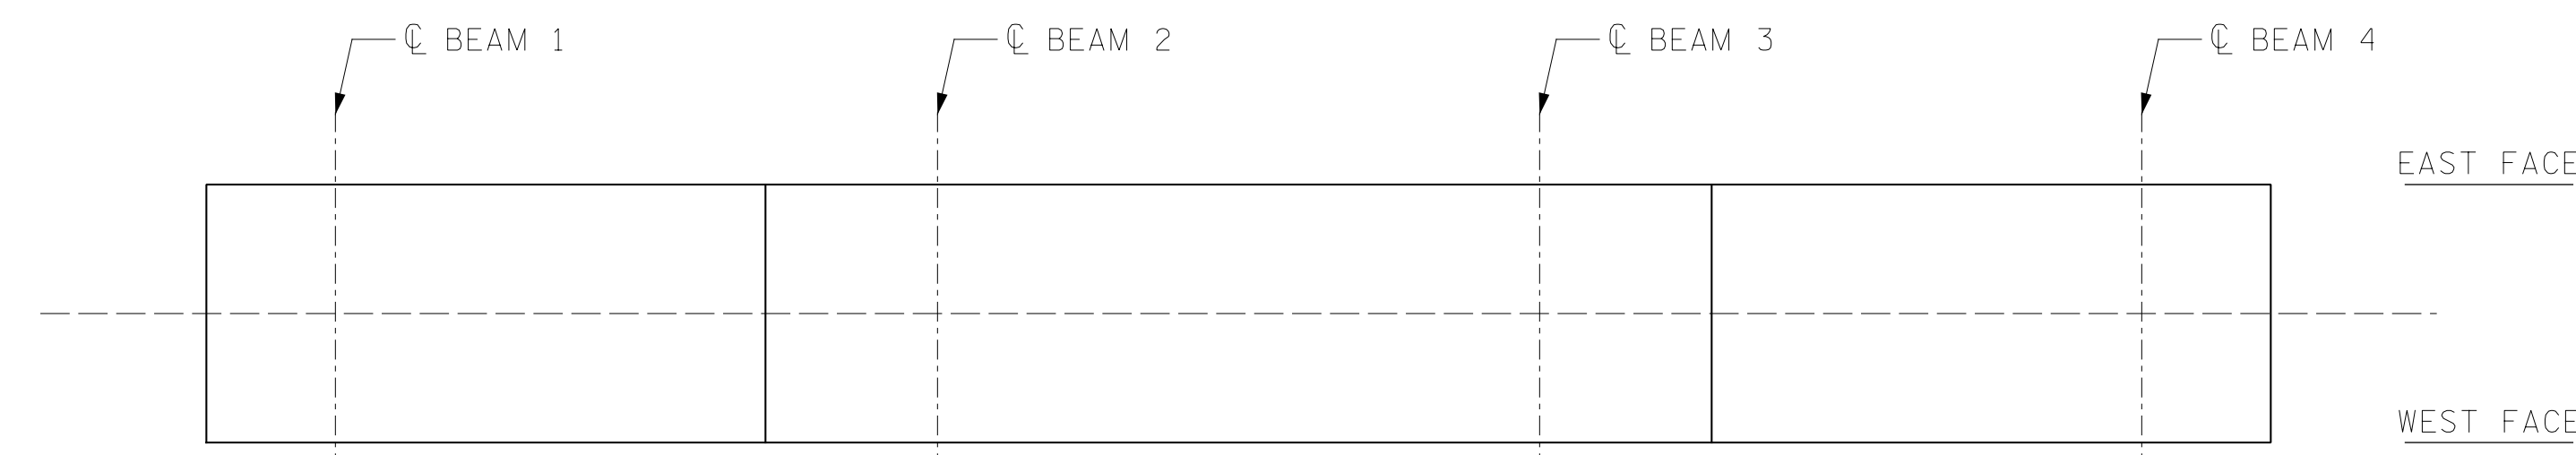
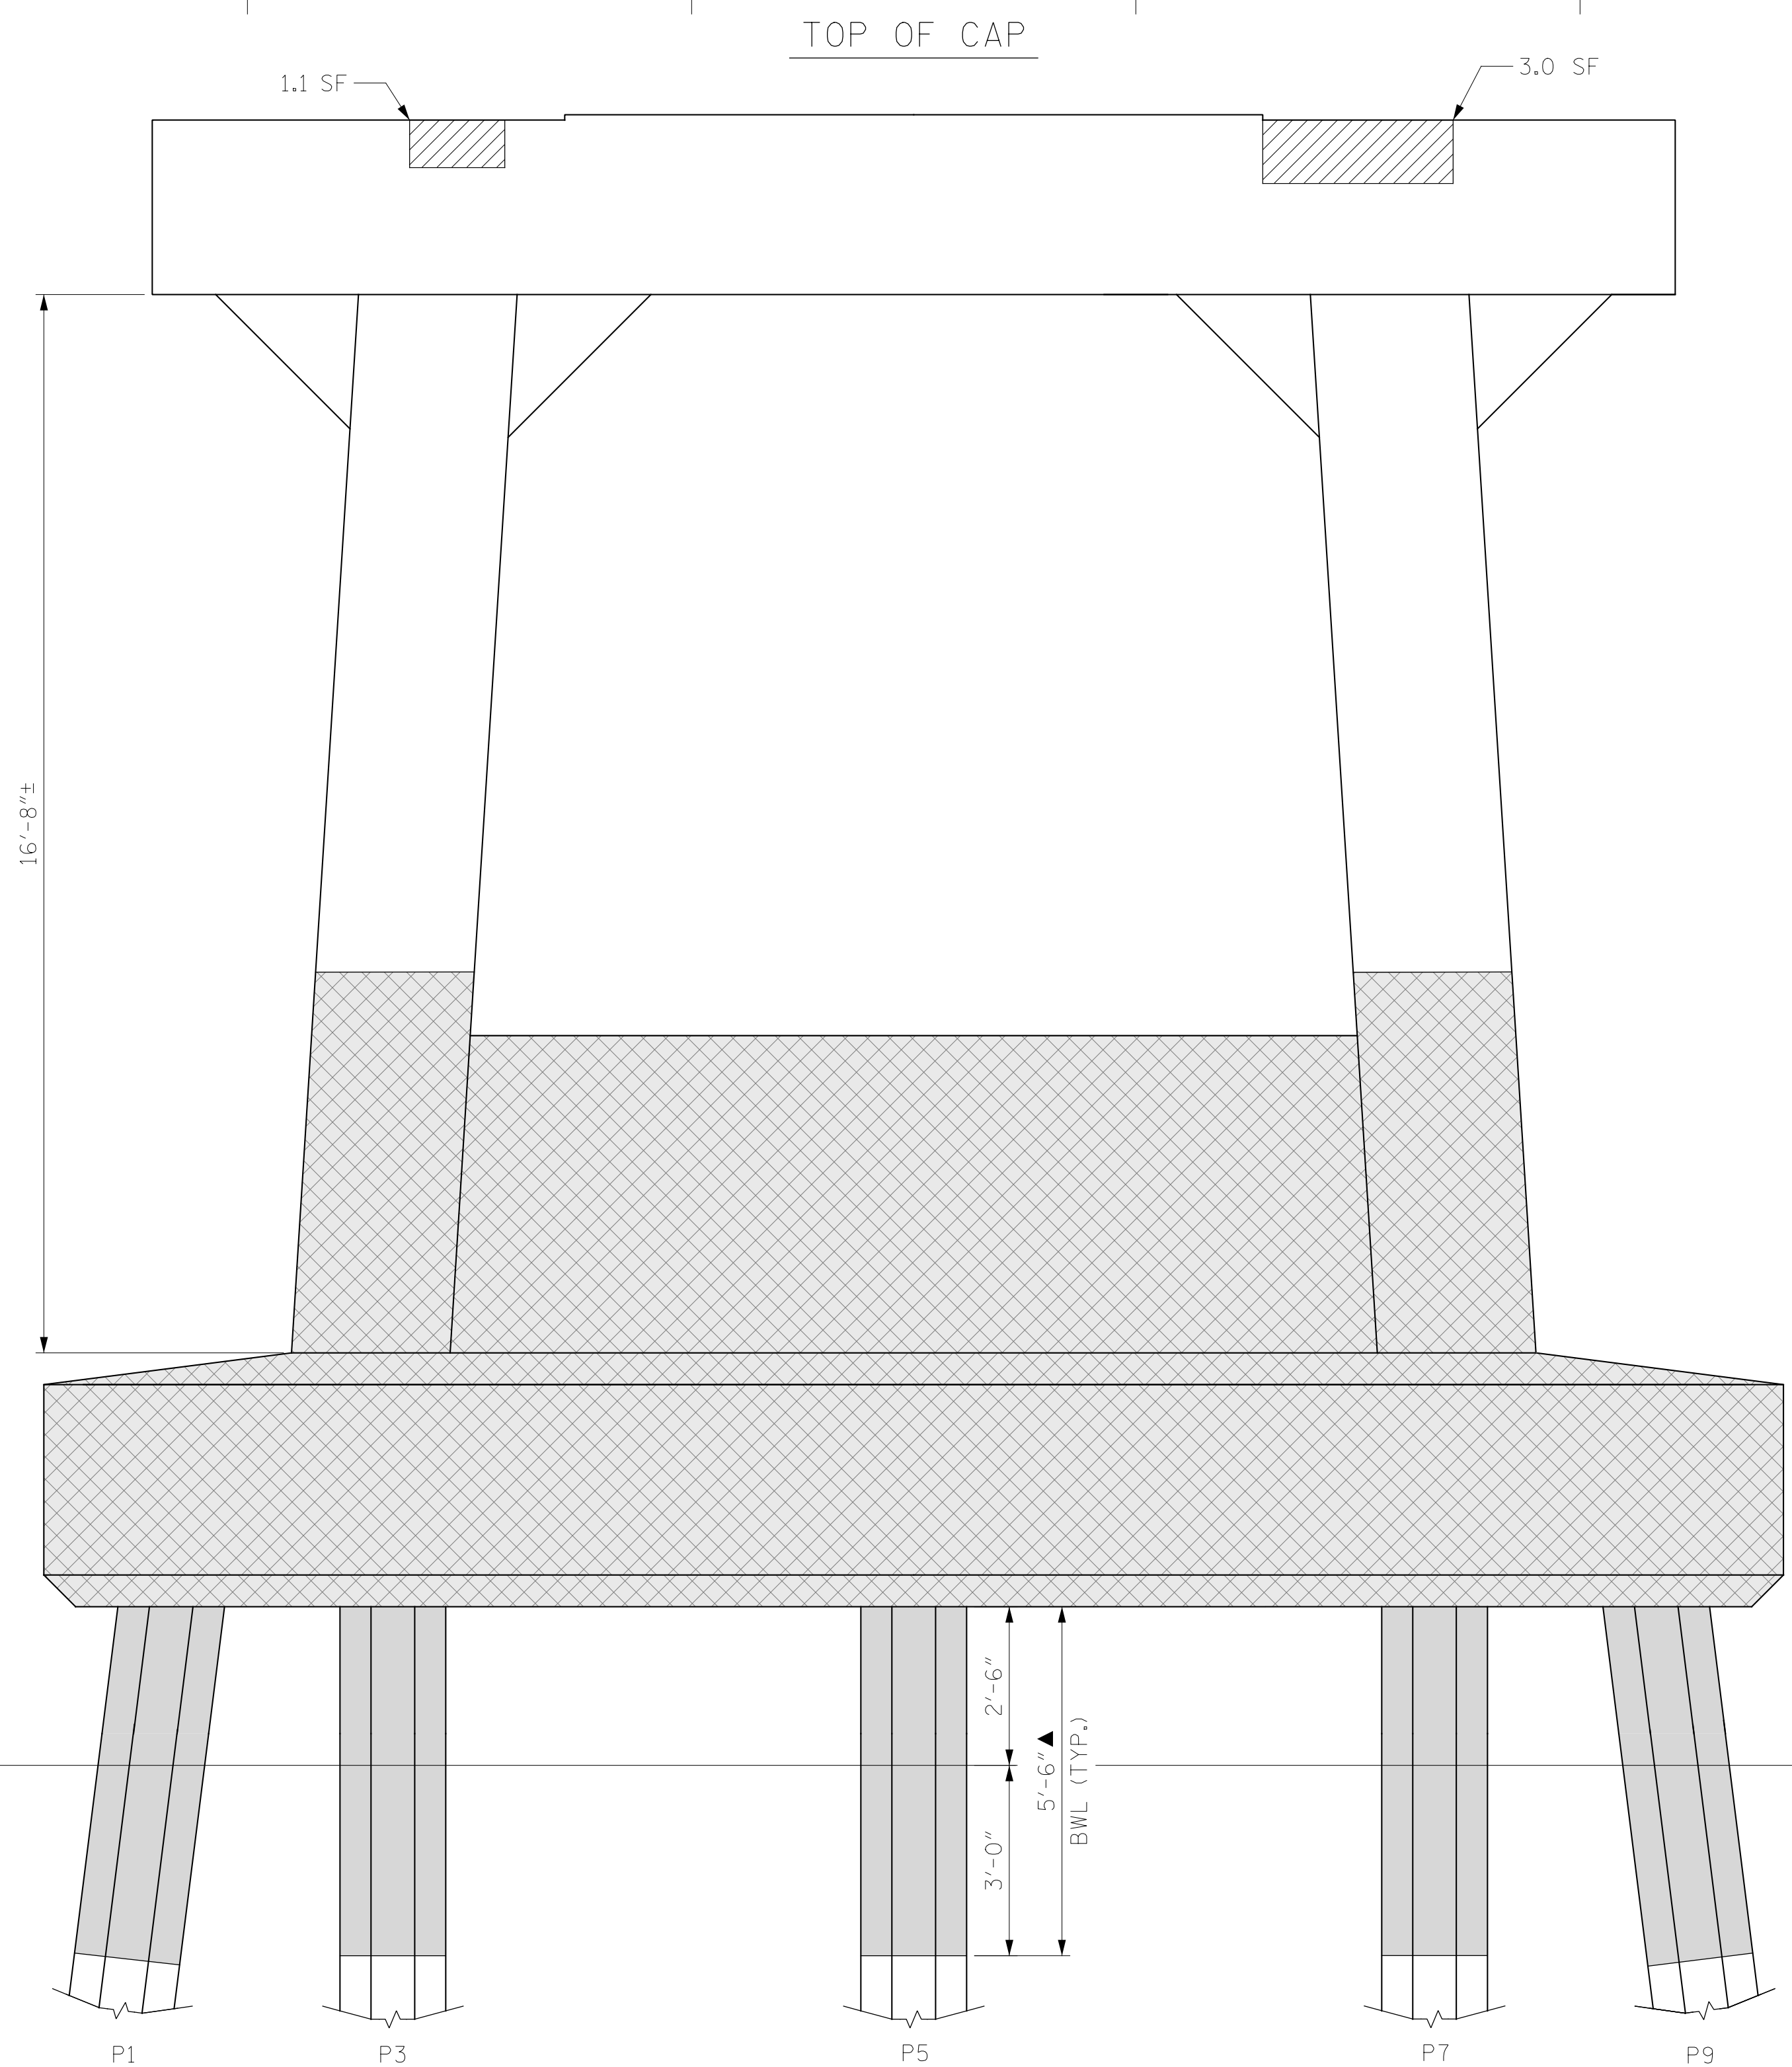
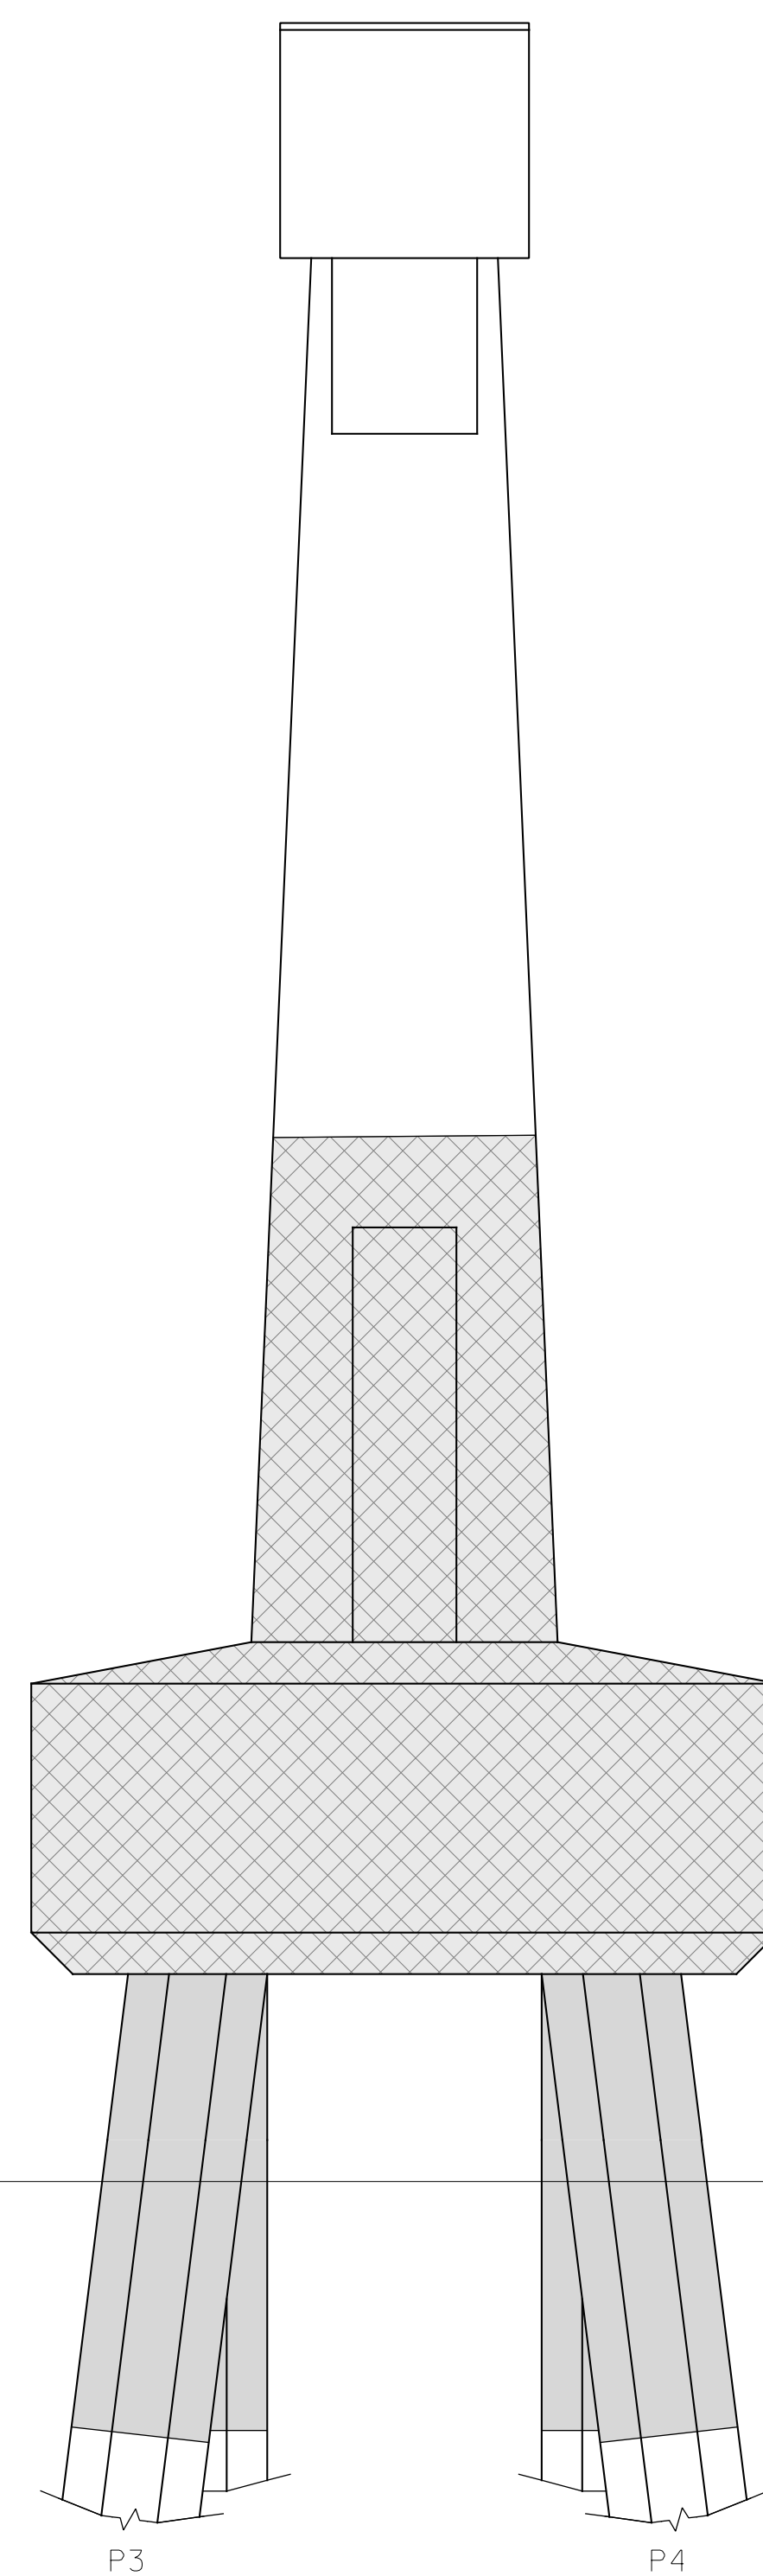
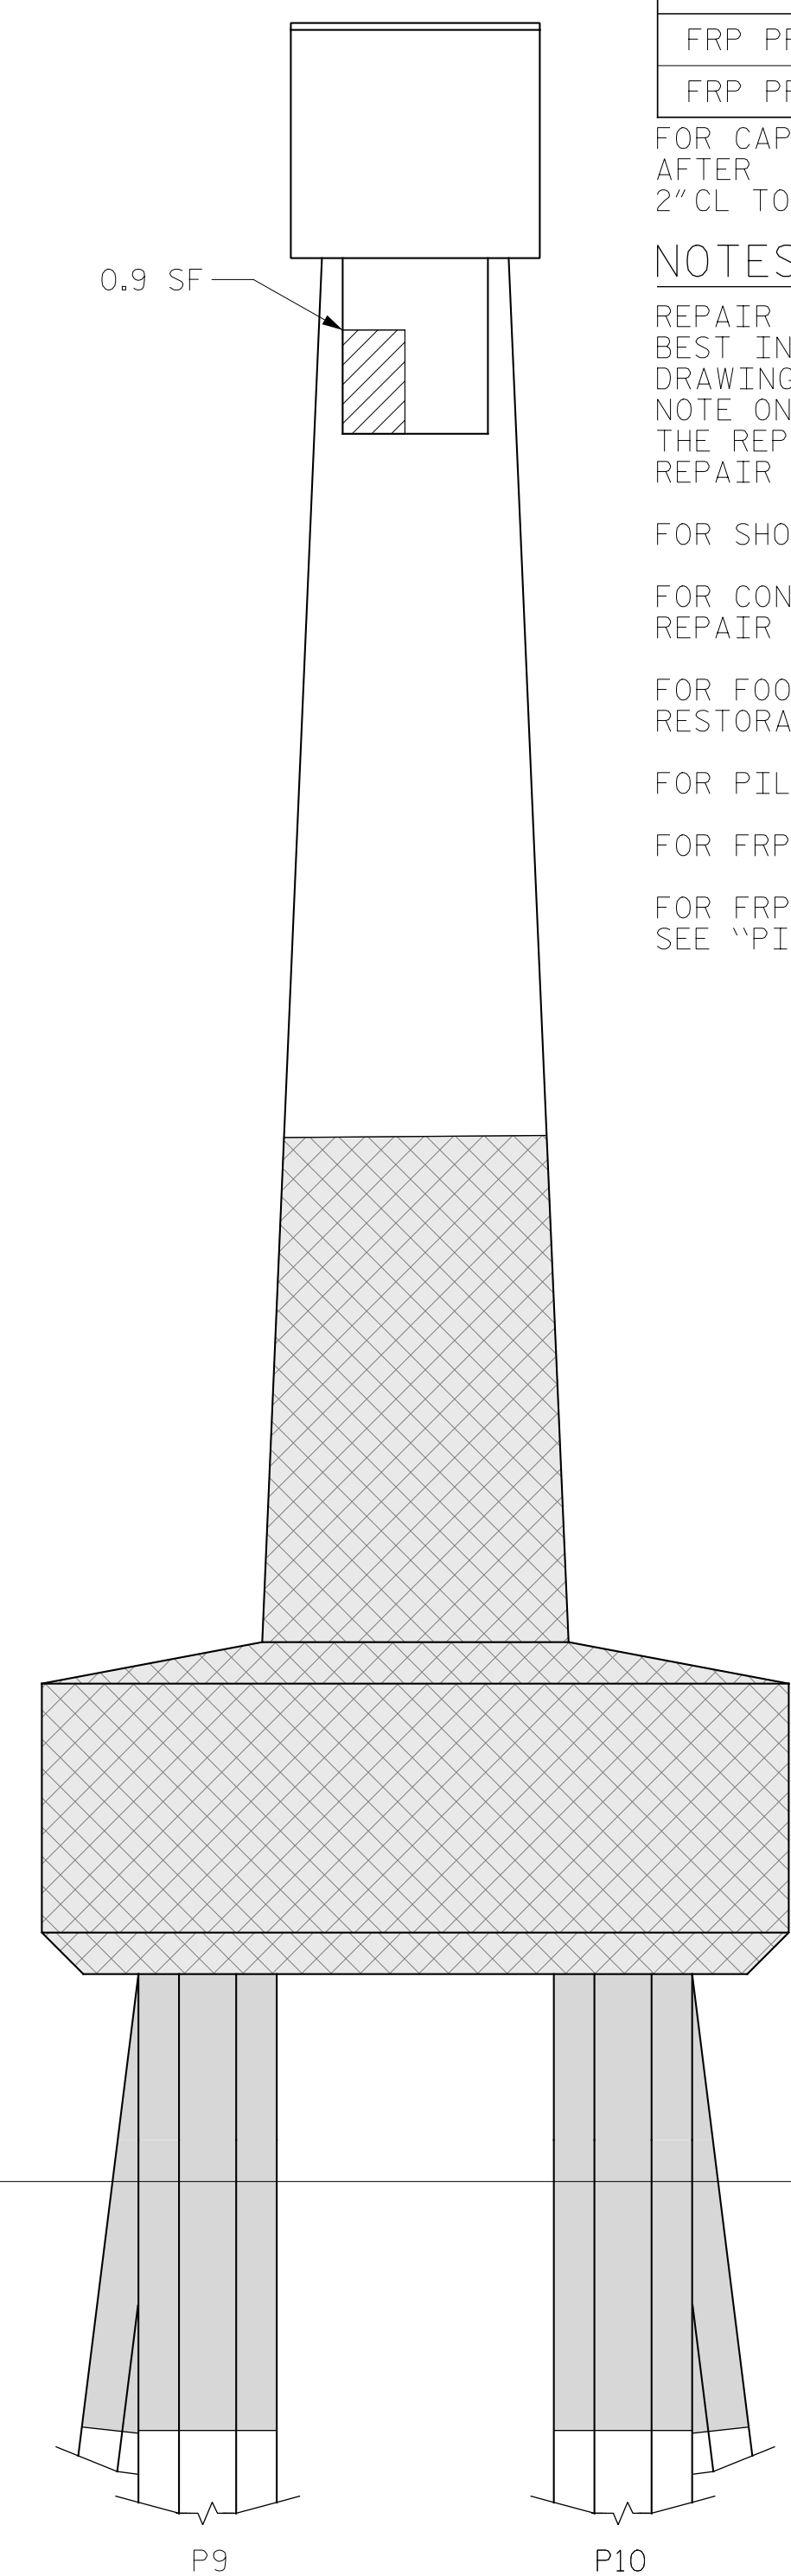
STATE OF NORTH CAROLINA DEPARTMENT OF TRANSPORTATION RALEIGH					
BENT 125 WEST FACE					
REVISIONS					SHEET NO.
NO.	BY:	DATE:	NO.	BY:	DATE:
1			3		
2			4		
TOTAL SHEETS					355

CAP REPAIRS		ESTIMATE		ACTUAL	
SHOTCRETE REPAIRS	5.8 SF	2.9 CF	SF	CF	
EPOXY RESIN INJECTION	- LF				LF
COLUMN REPAIRS		ESTIMATE		ACTUAL	
SHOTCRETE REPAIRS	3.2 SF	1.6 CF	SF	CF	
EPOXY RESIN INJECTION	- LF				LF
PILE REPAIRS		ESTIMATE		ACTUAL	
FRP PROTECTIVE SYSTEM AWL	- SF				SF
FRP PROTECTIVE SYSTEM BWL	302.5 SF				SF
