AS-BUILT REPAIR QUANTITY TABLE

PROJECT NO. HB-0017
DARE COUNTY
BRIDGE NO. 270009

BENT 73 & BENT 74

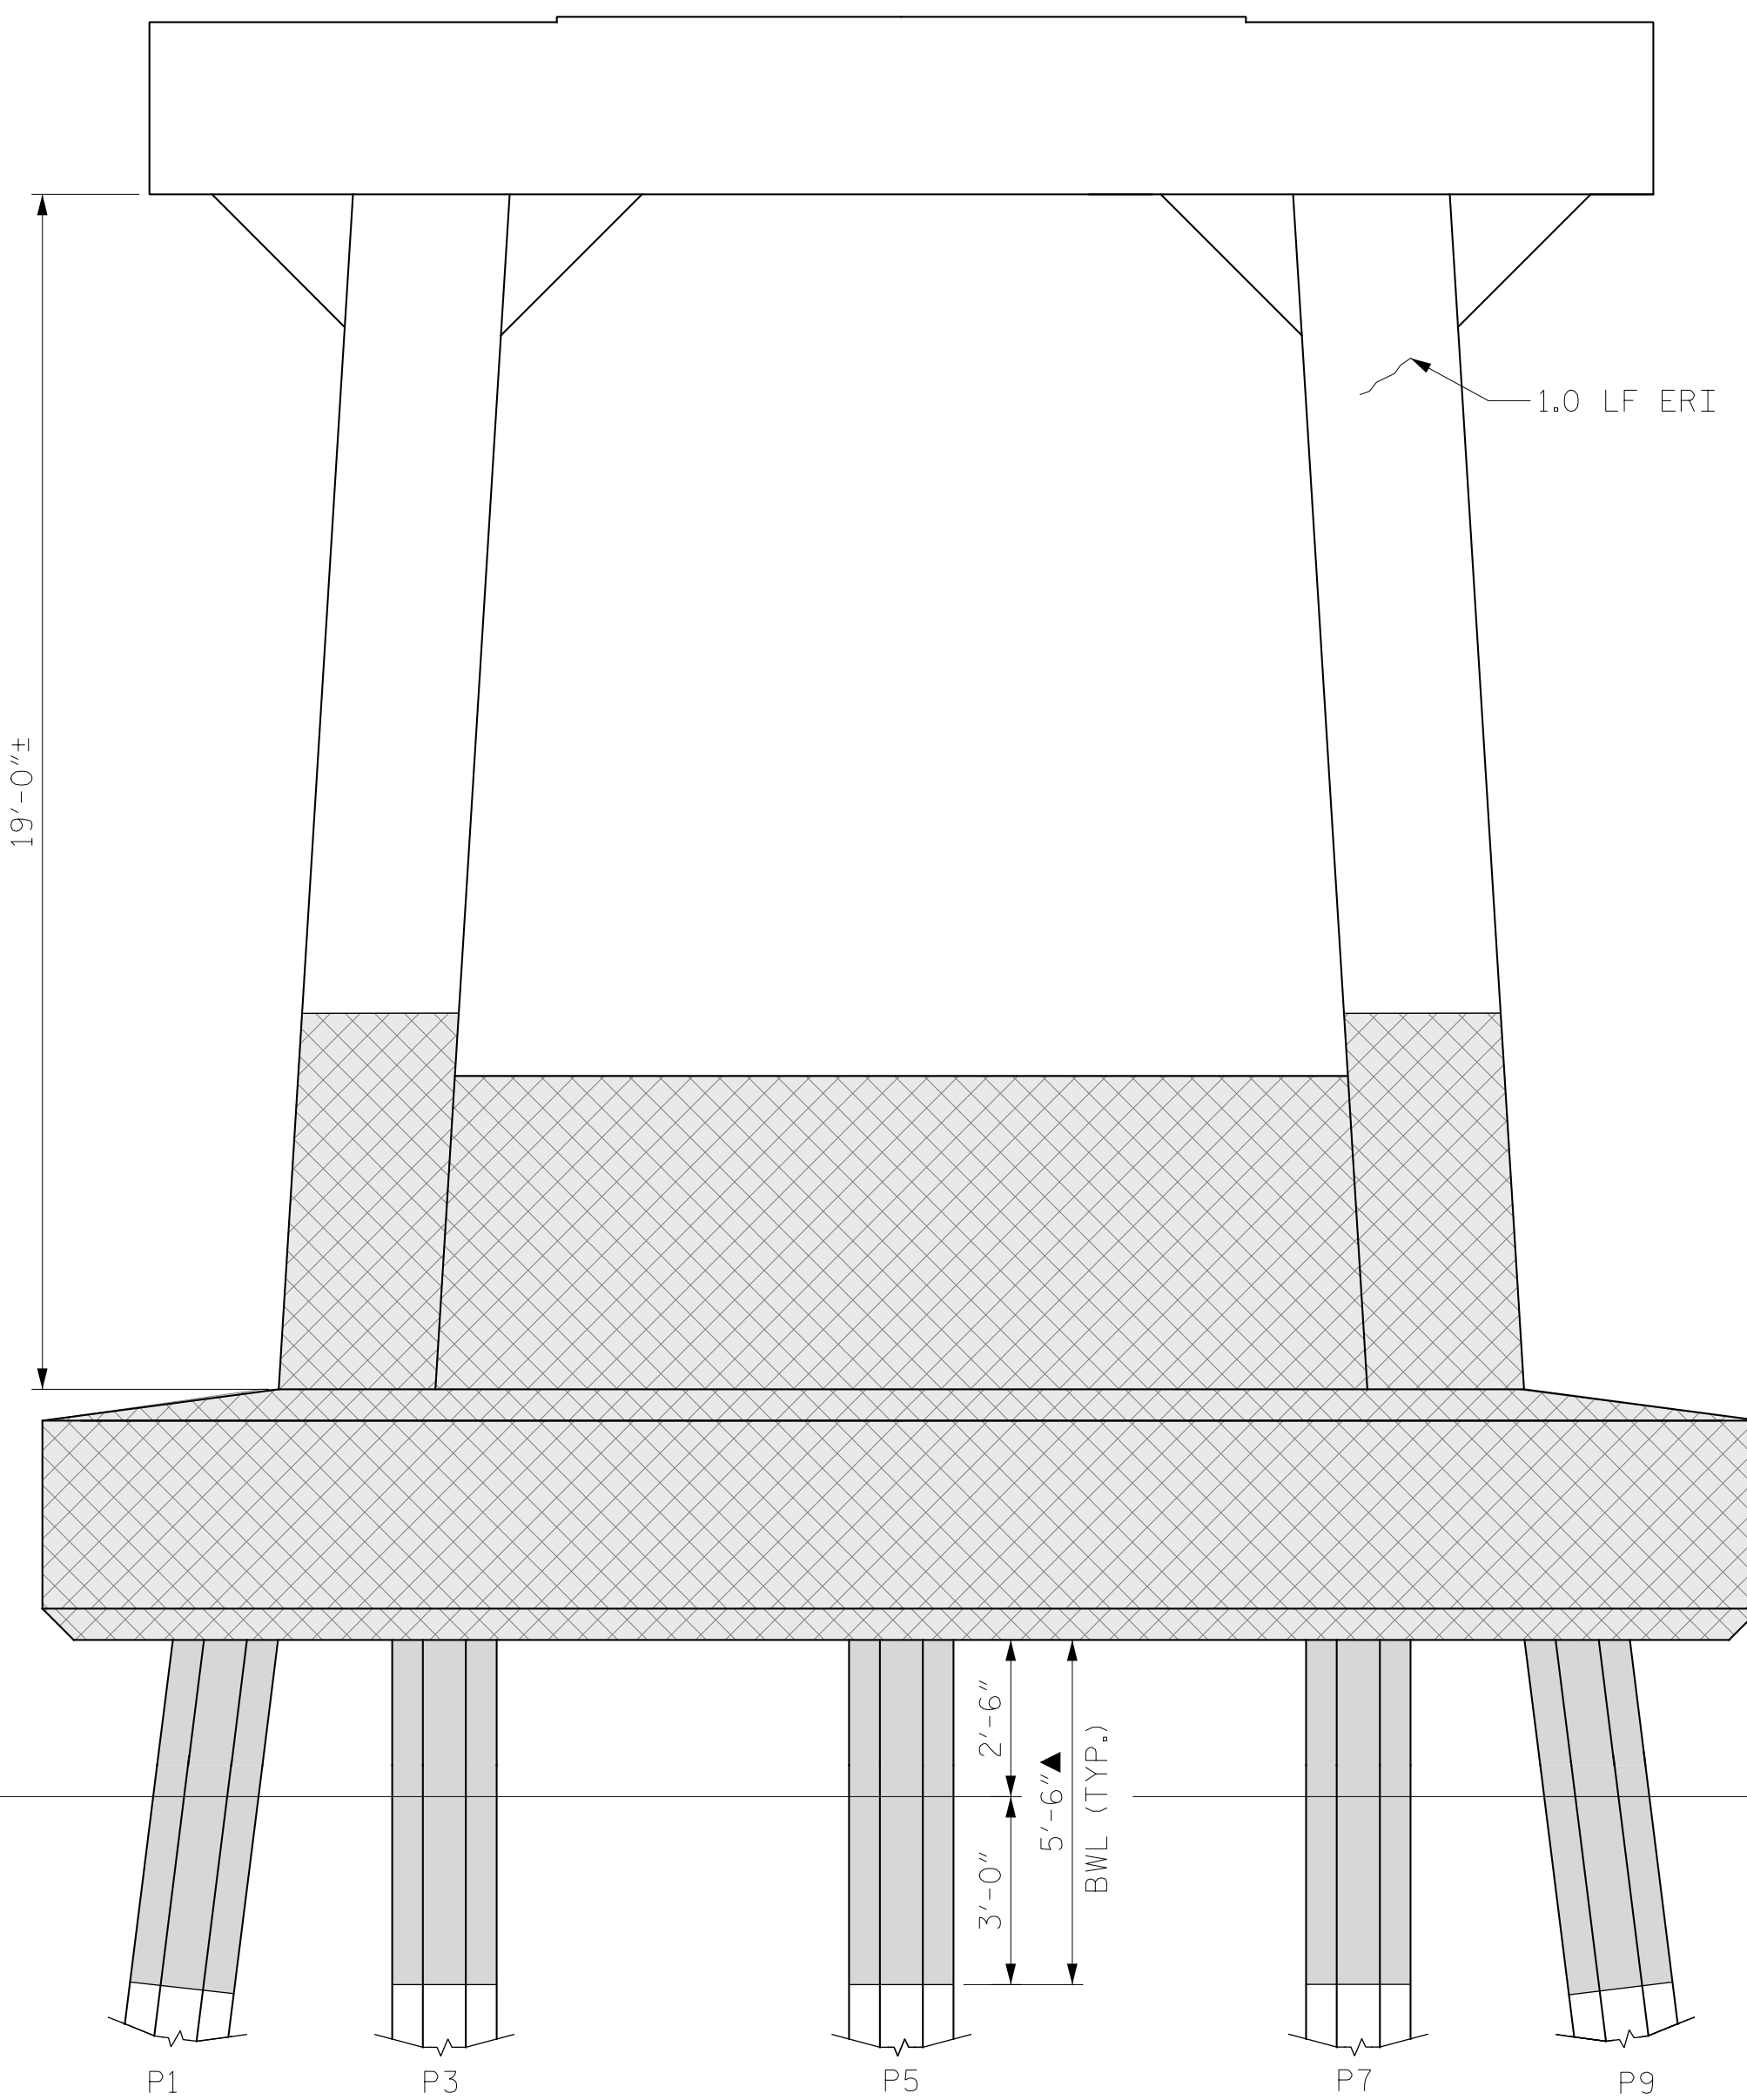
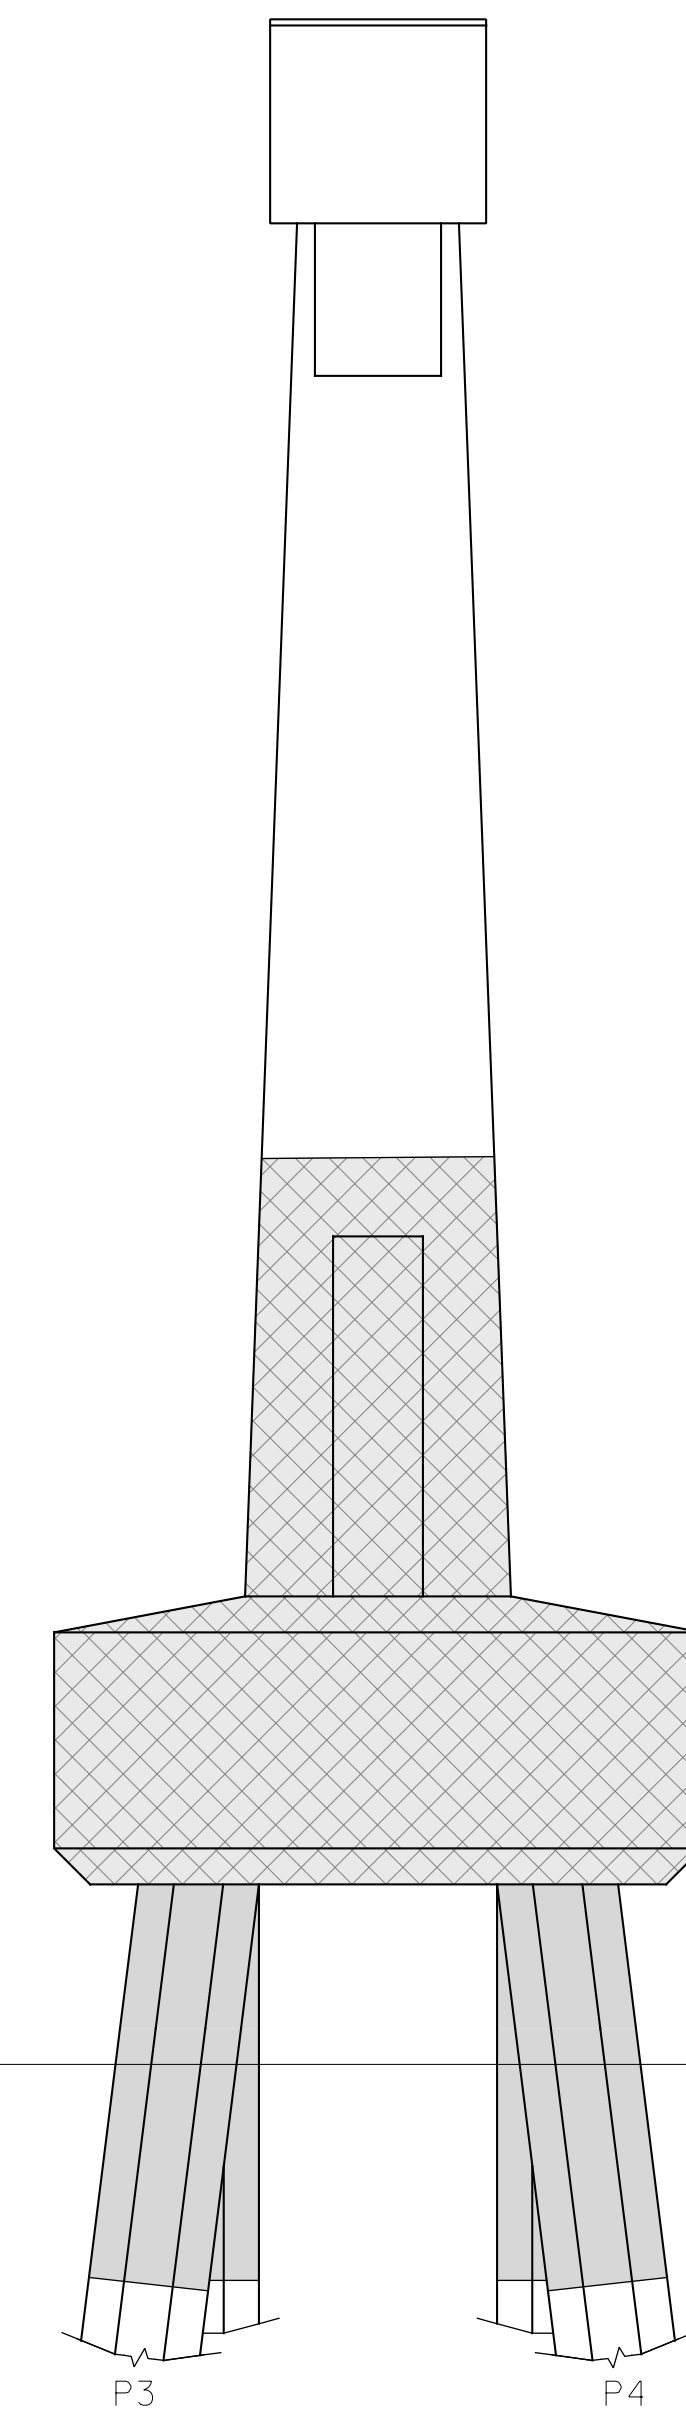
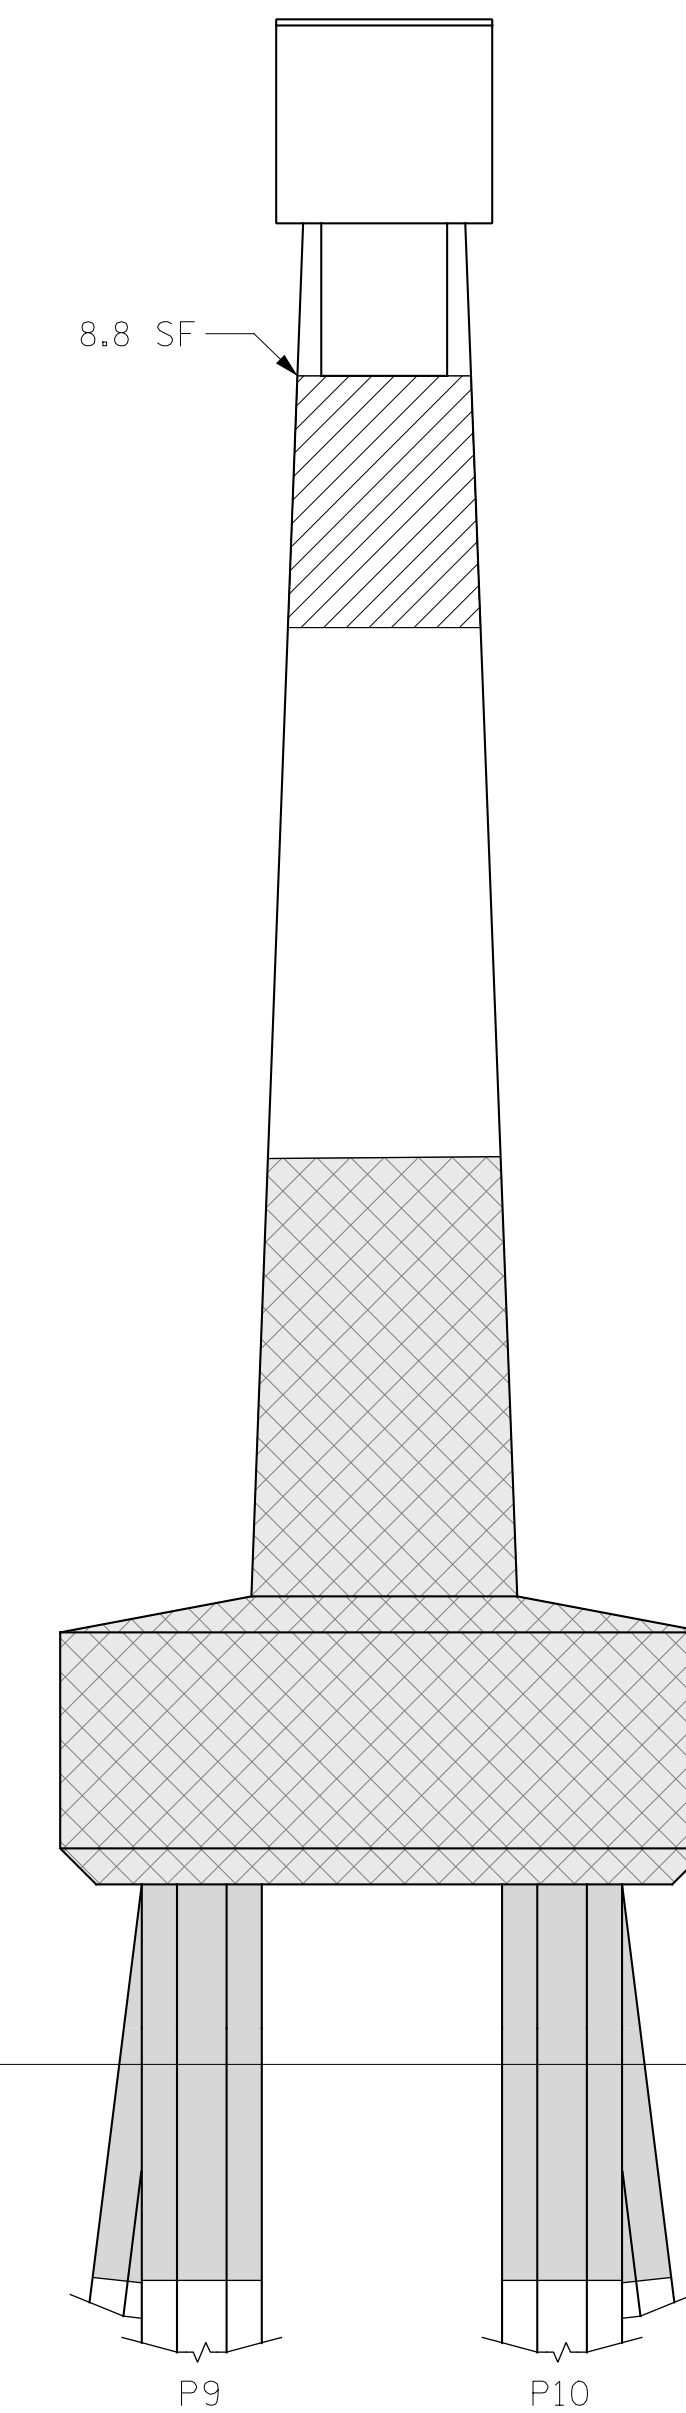
BENT 126
 WEST FACE

CAP REPAIRS		ESTIMATE		ACTUAL	
SHOTCRETE REPAIRS	6.2 SF	3.1 CF	SF	CF	
EPOXY RESIN INJECTION	- LF				LF
COLUMN REPAIRS		ESTIMATE		ACTUAL	
SHOTCRETE REPAIRS	11.3 SF	5.7 CF	SF	CF	
EPOXY RESIN INJECTION	1.0 LF				LF
PILE REPAIRS		ESTIMATE		ACTUAL	
FRP PROTECTIVE SYSTEM AWL	- SF				SF
FRP PROTECTIVE SYSTEM BWL	302.5 SF				SF

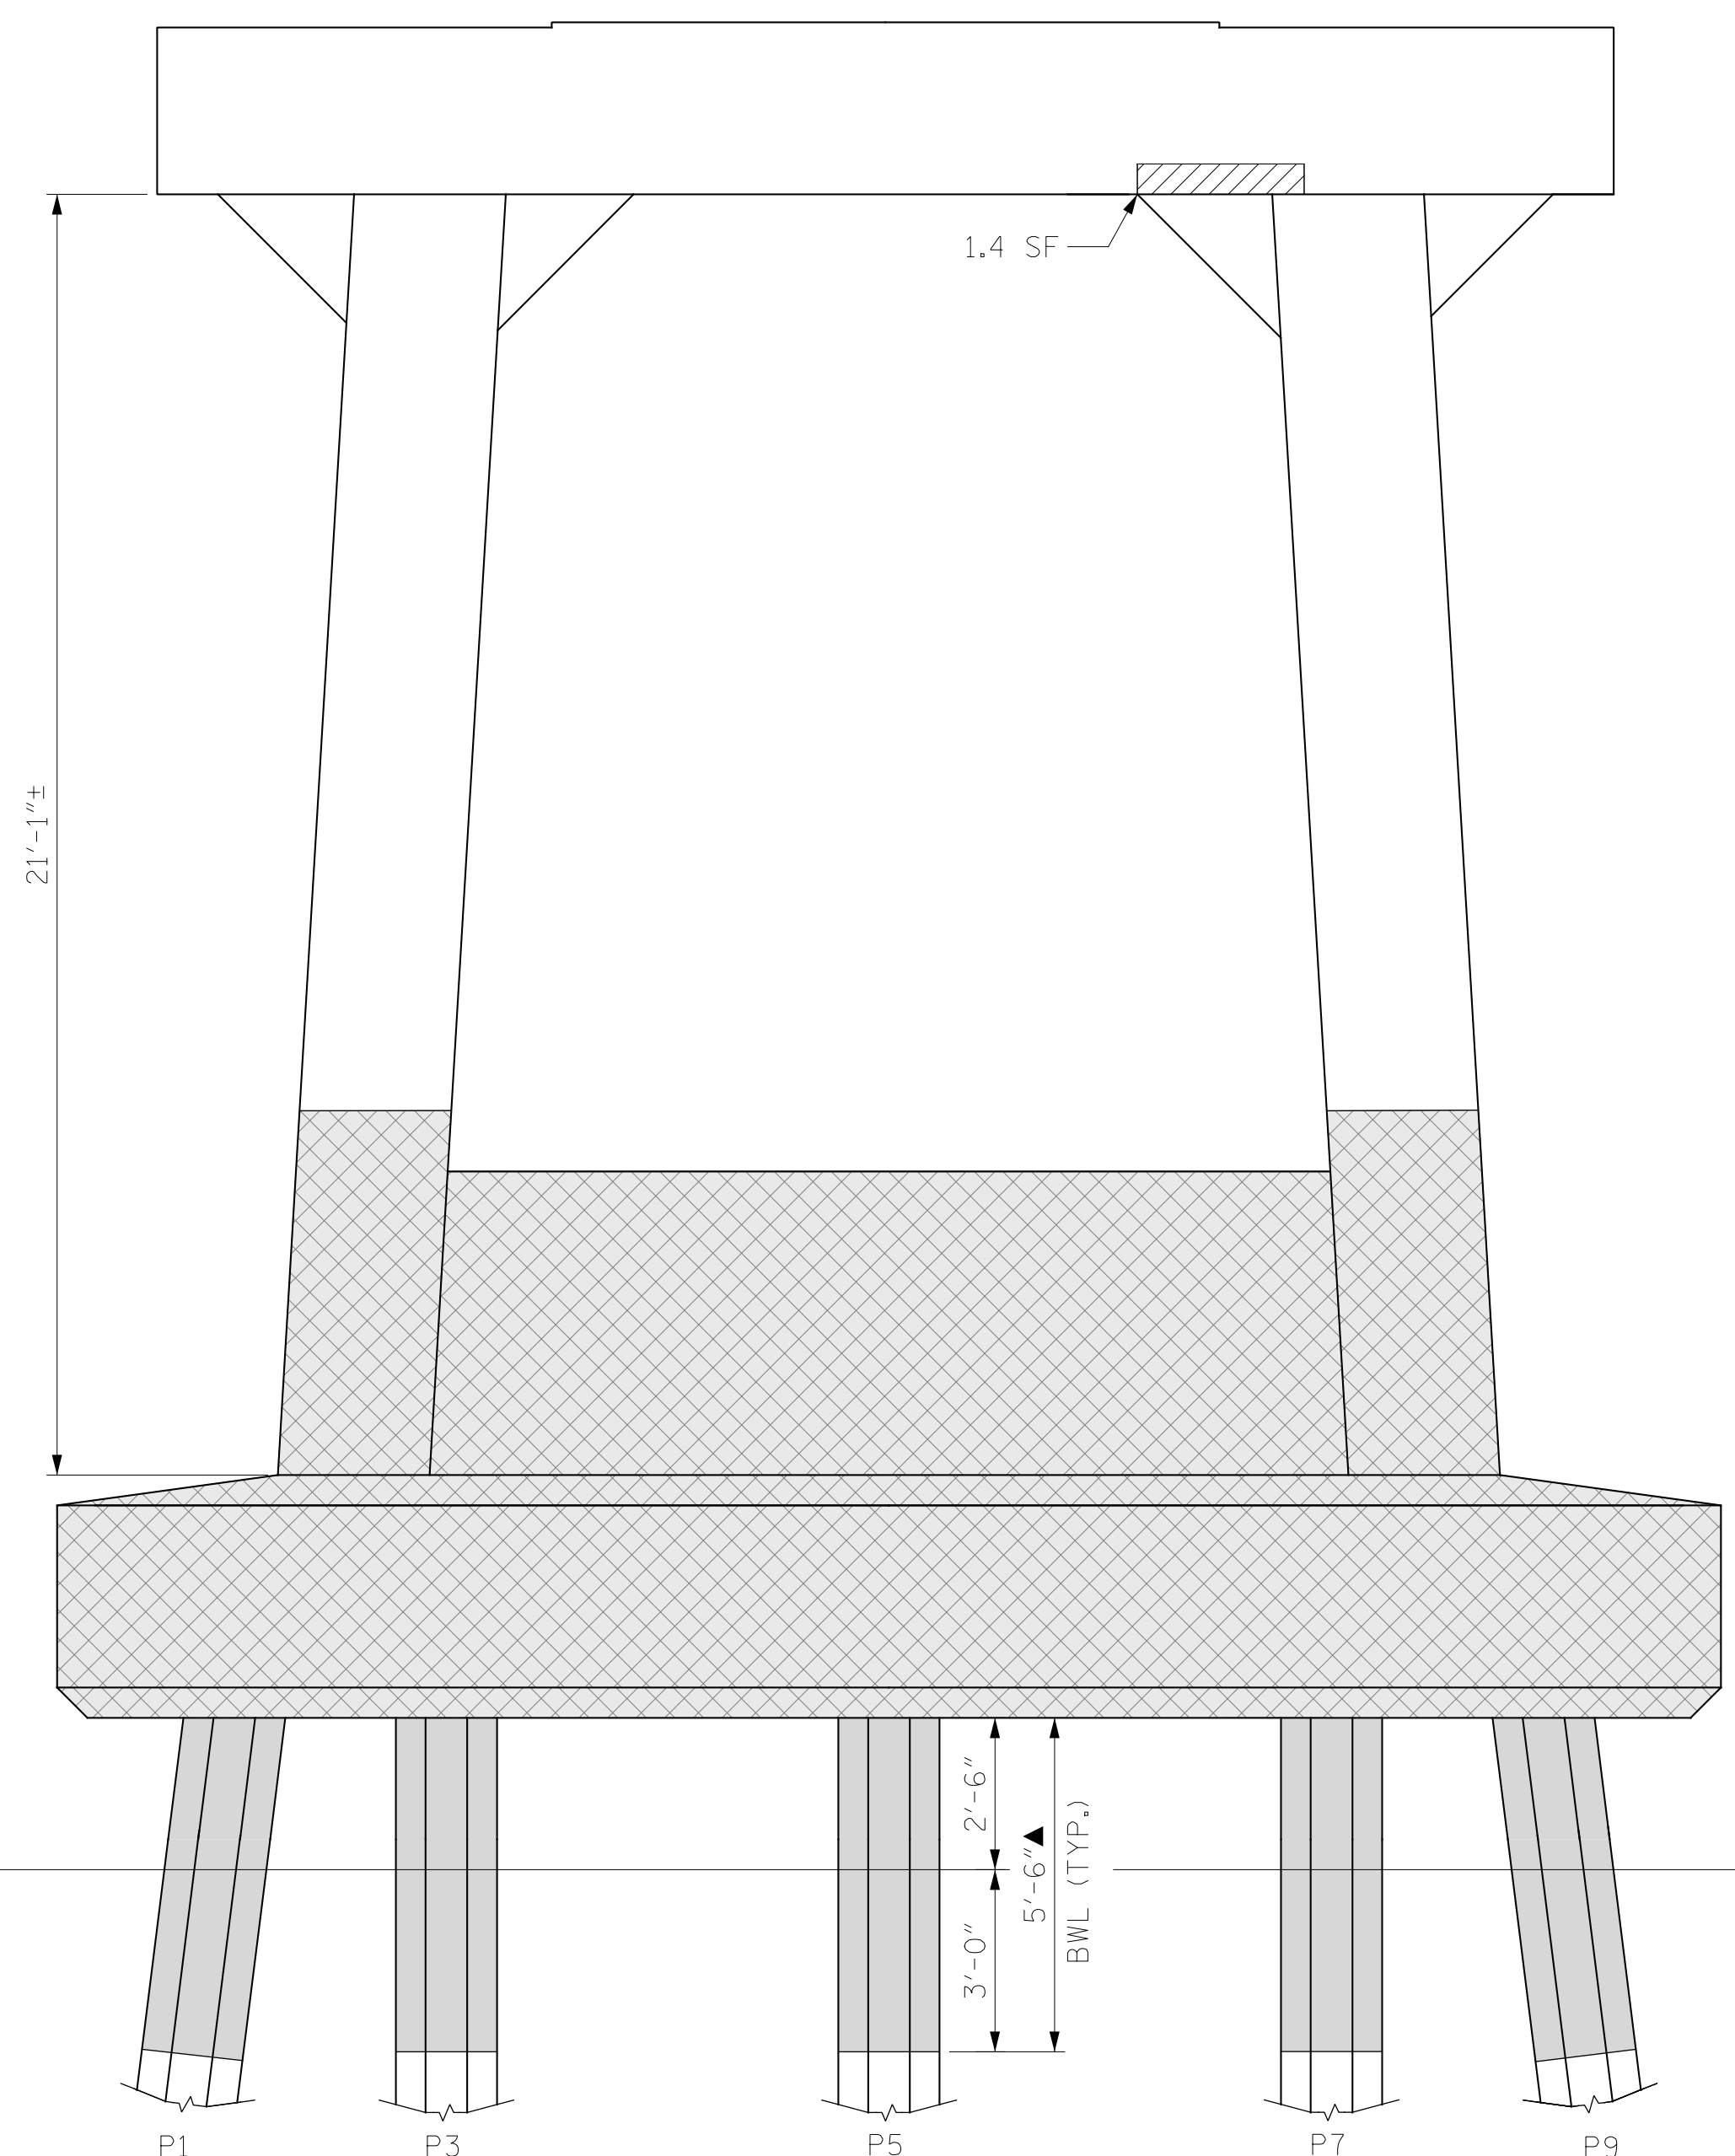
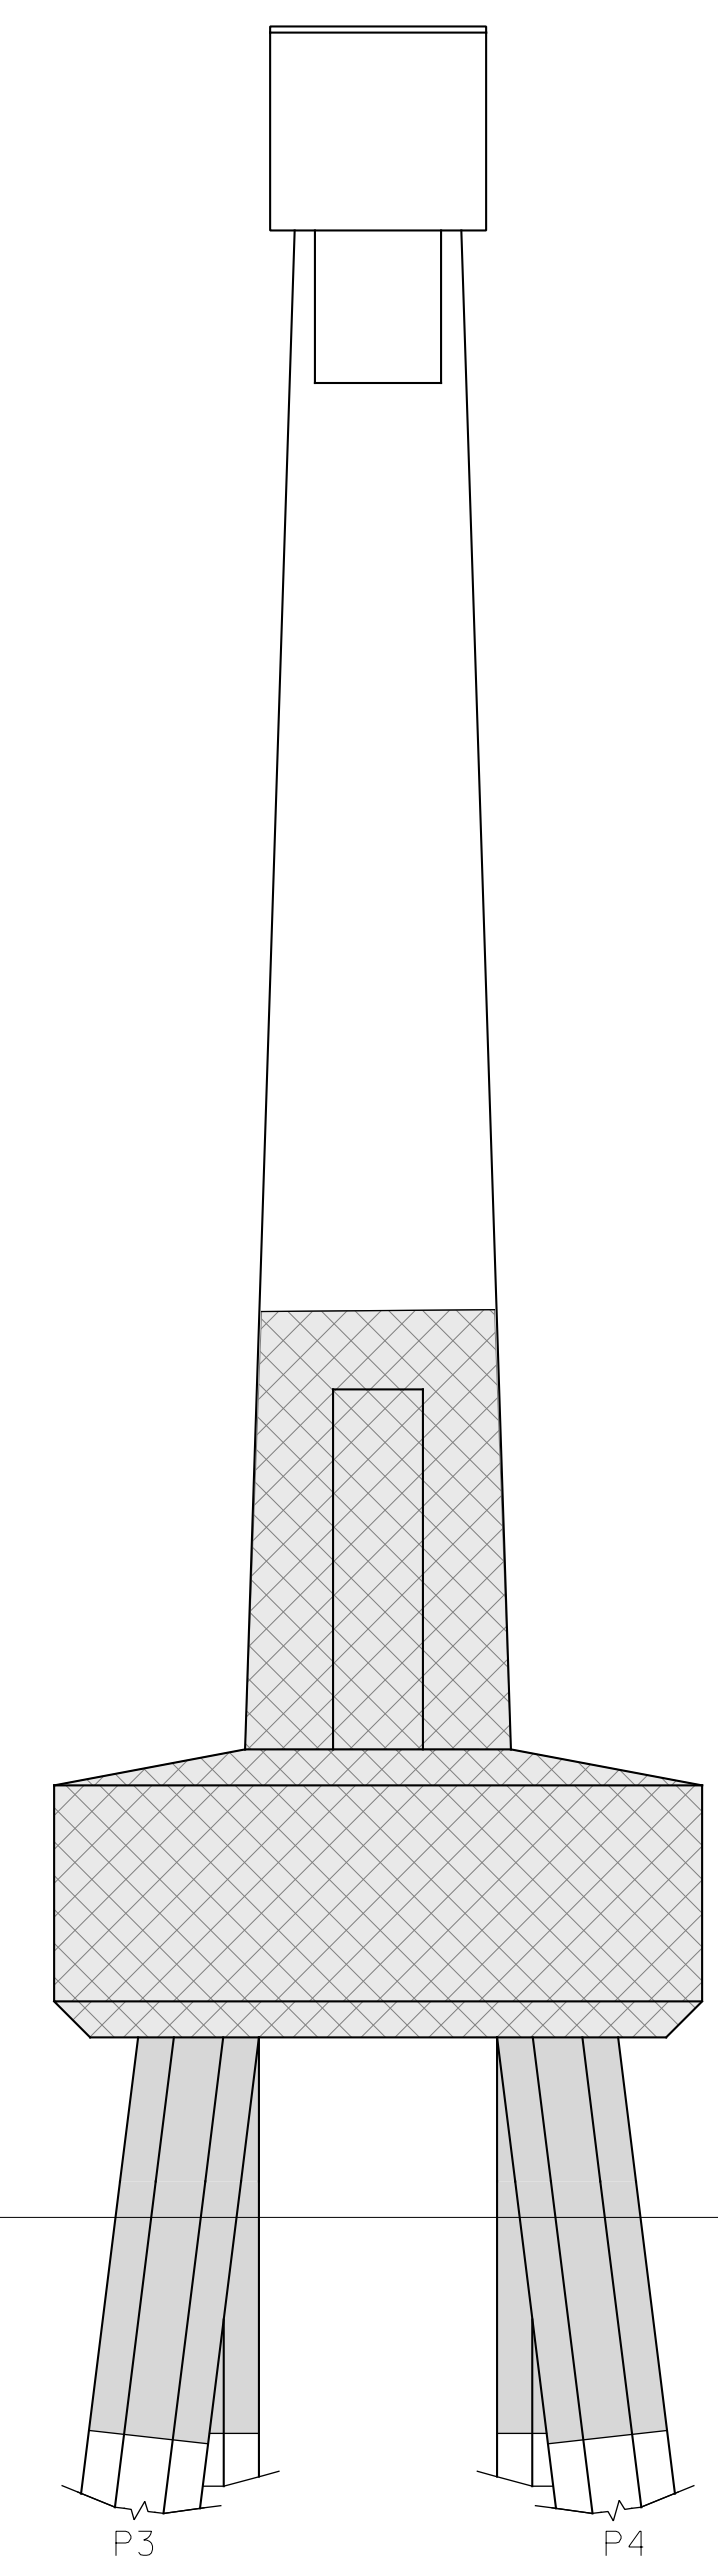
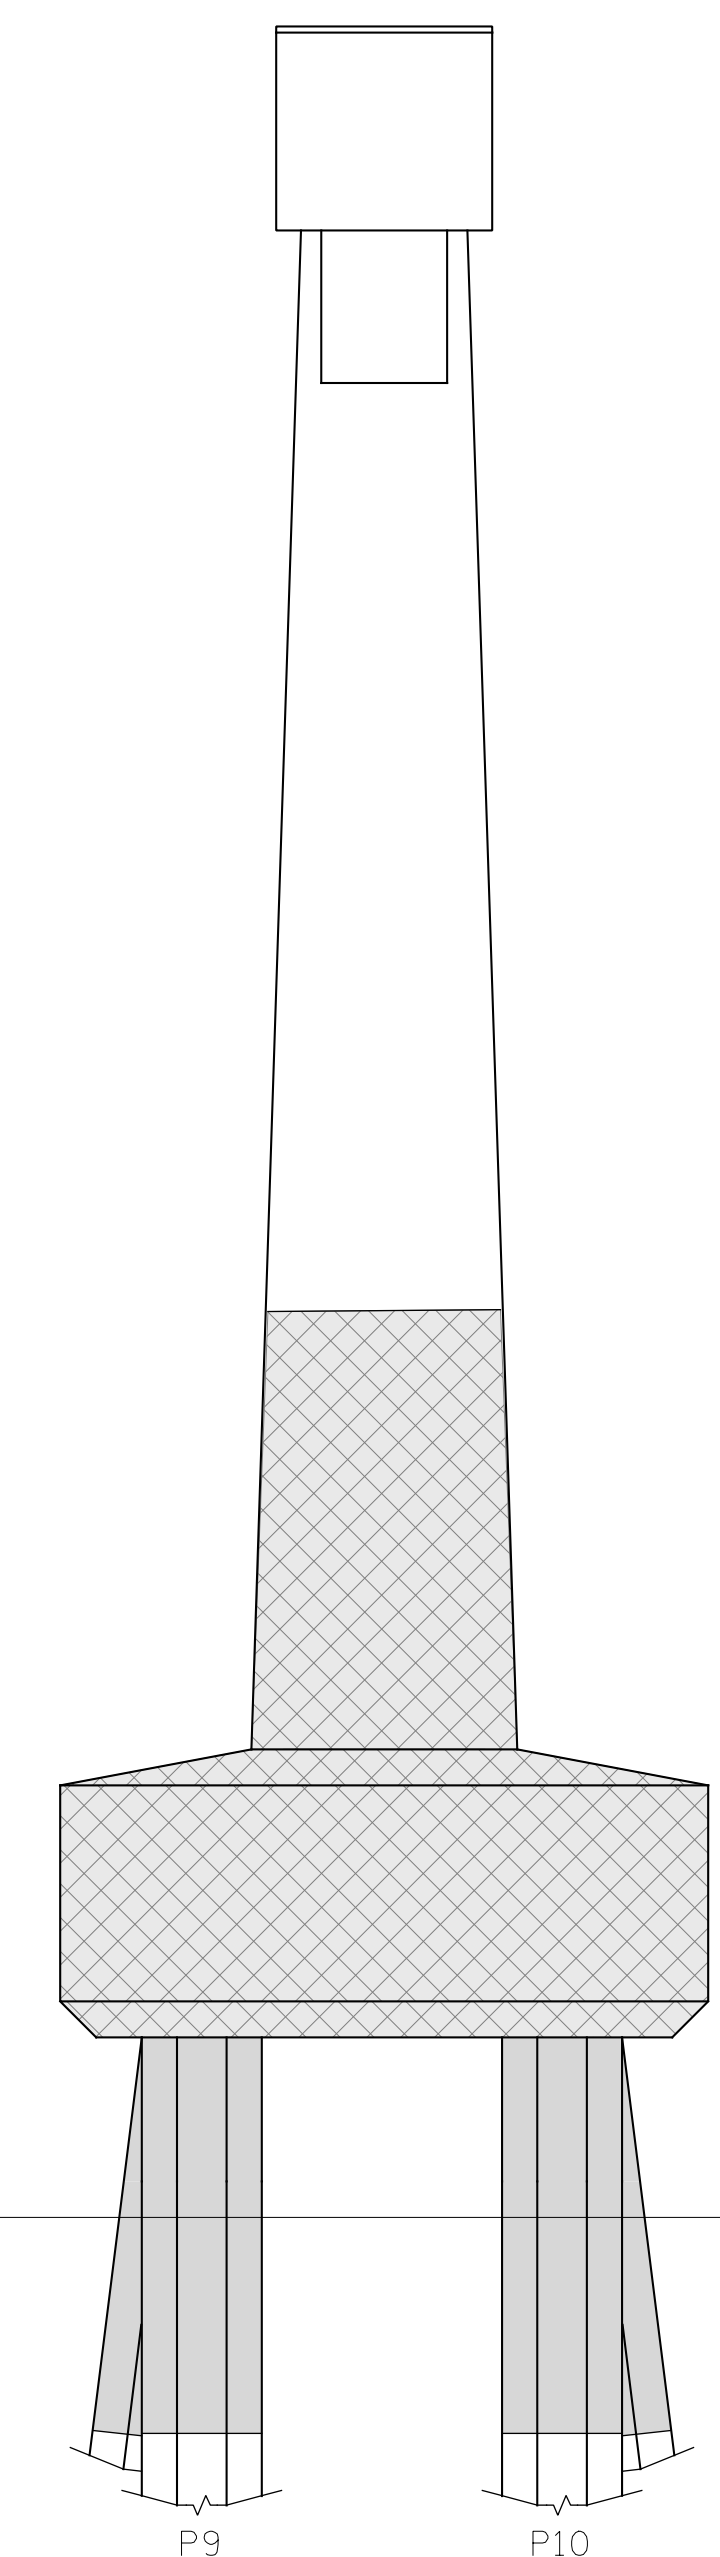
BENT 127 WEST FACE

CAP REPAIRS		ESTIMATE		ACTUAL	
SHOTCRETE REPAIRS	3.3 SF	1.7 CF	SF	CF	
EPOXY RESIN INJECTION	- LF				LF
COLUMN REPAIRS		ESTIMATE		ACTUAL	
SHOTCRETE REPAIRS	10.0 SF	5.0 CF	SF	CF	
EPOXY RESIN INJECTION	- LF				LF
PILE REPAIRS		ESTIMATE		ACTUAL	
FRP PROTECTIVE SYSTEM AWL	- SF				SF
FRP PROTECTIVE SYSTEM BWL	302.5 SF				SF

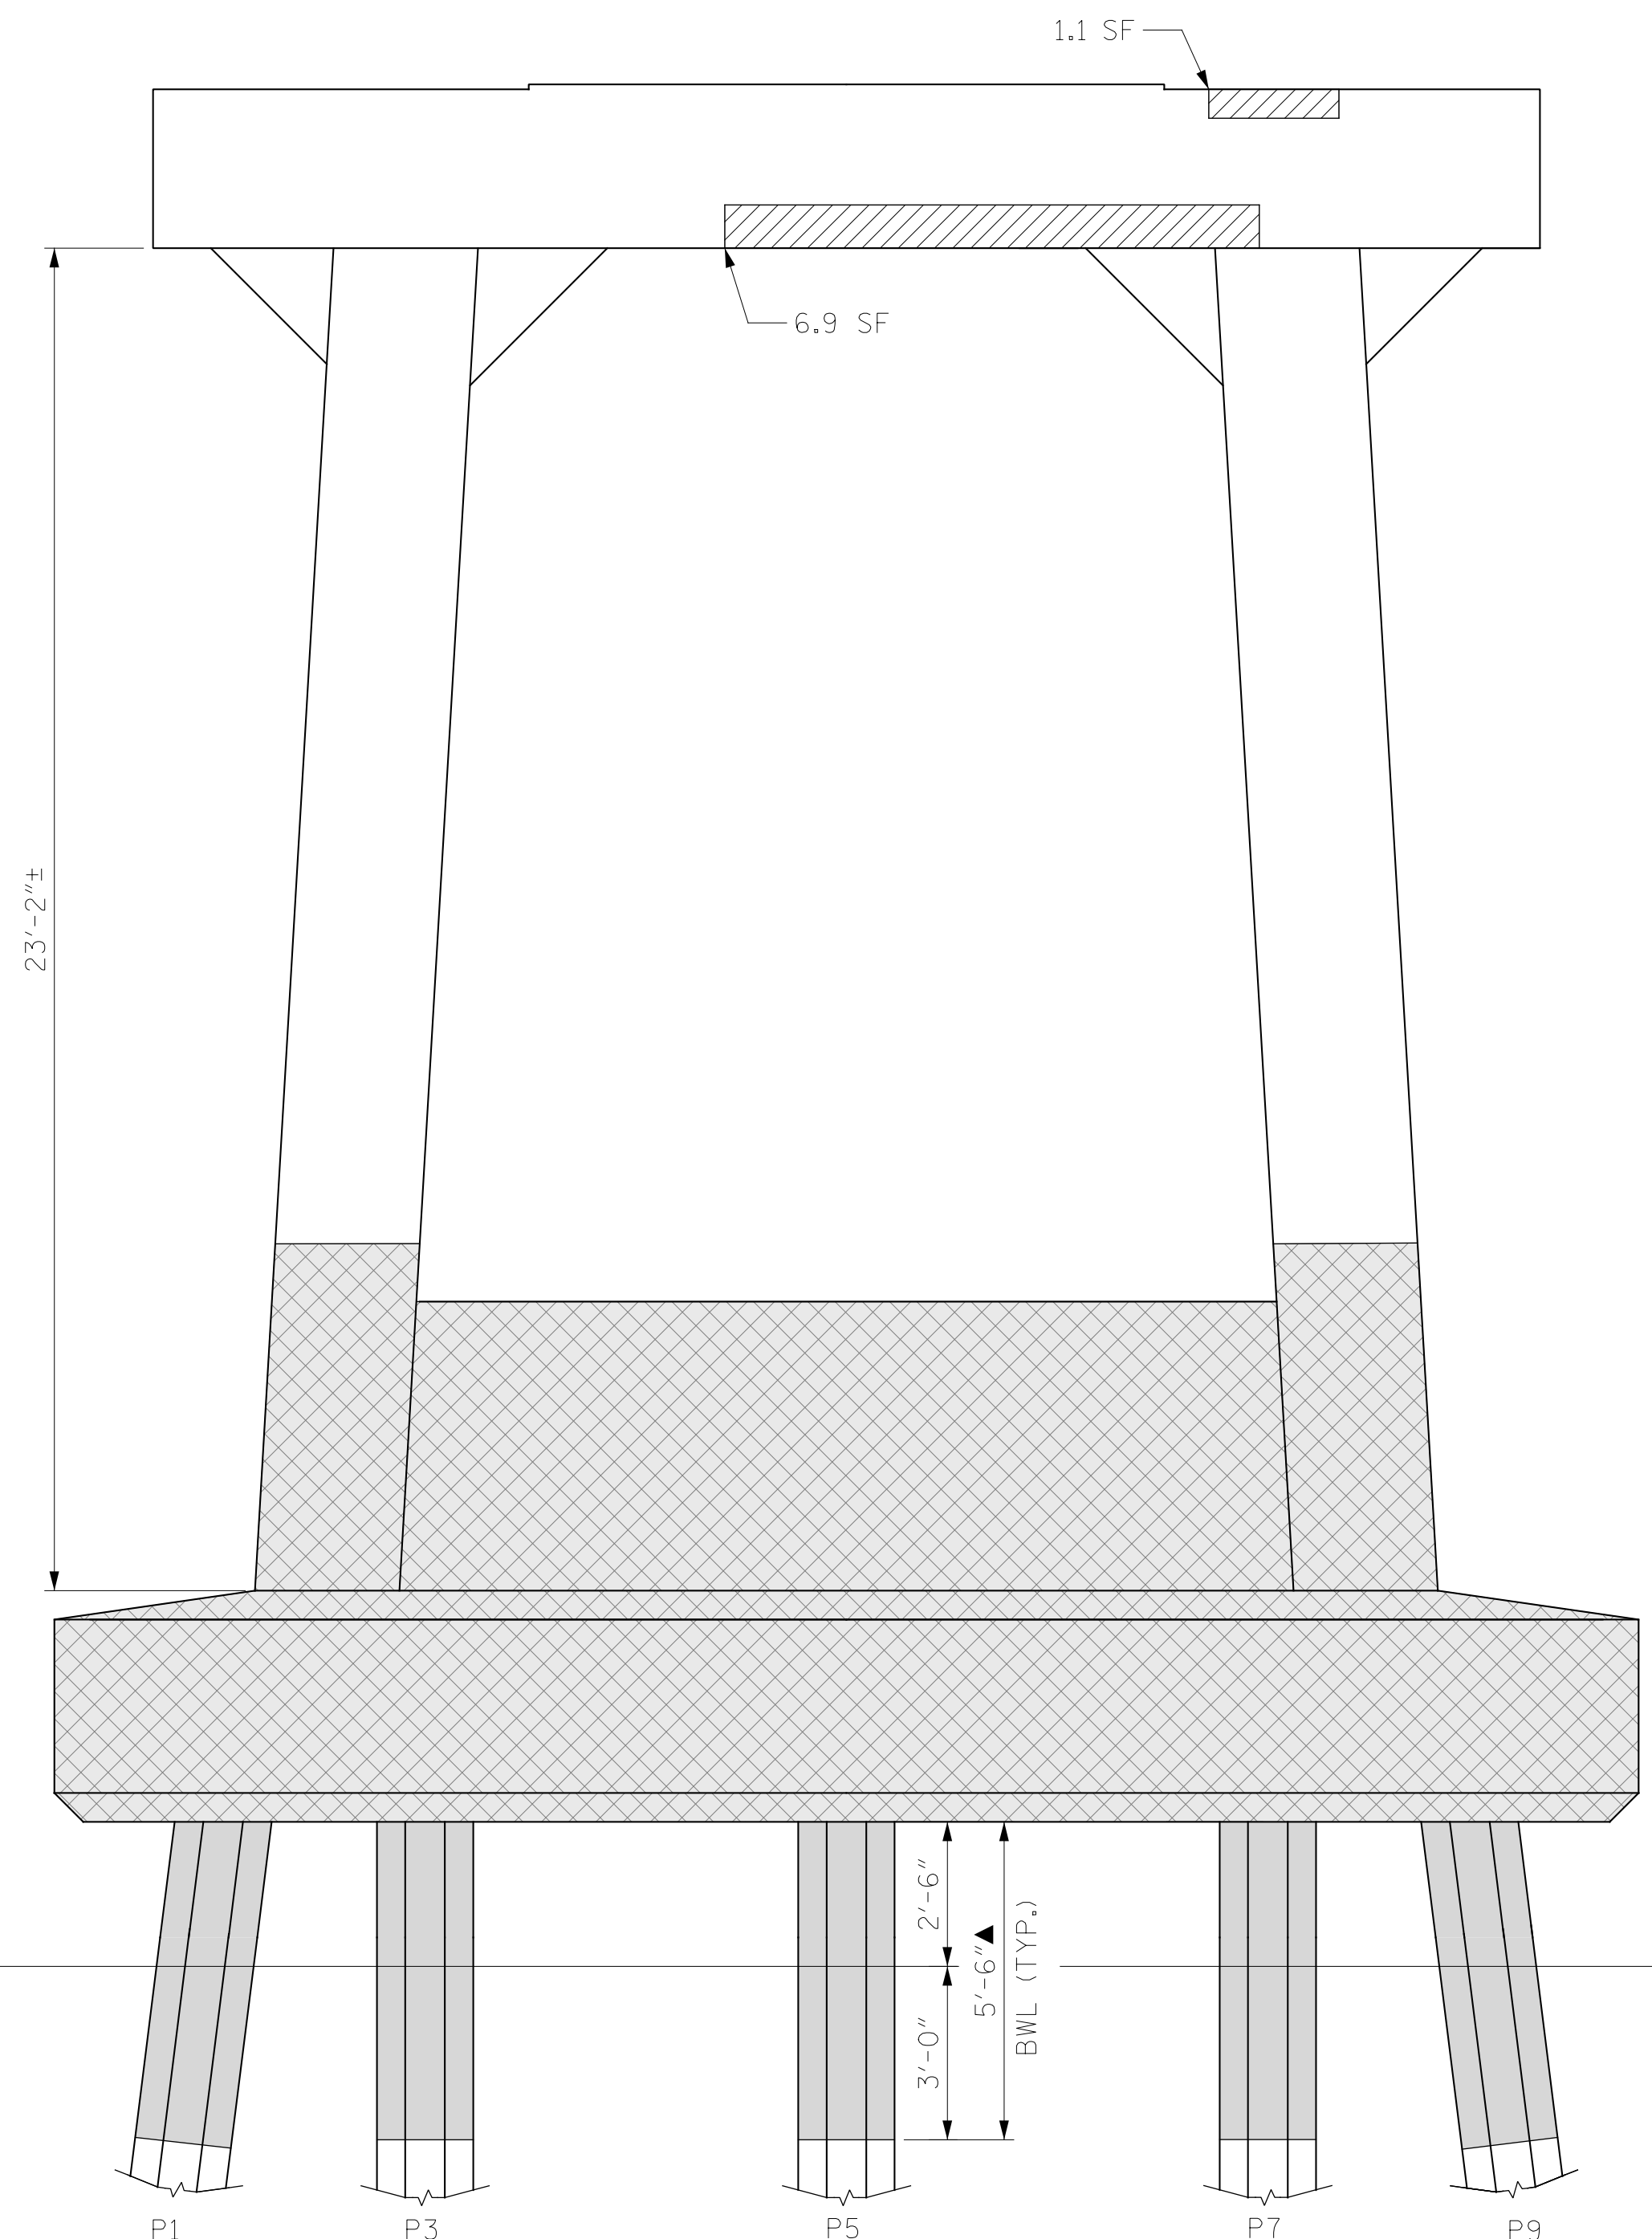
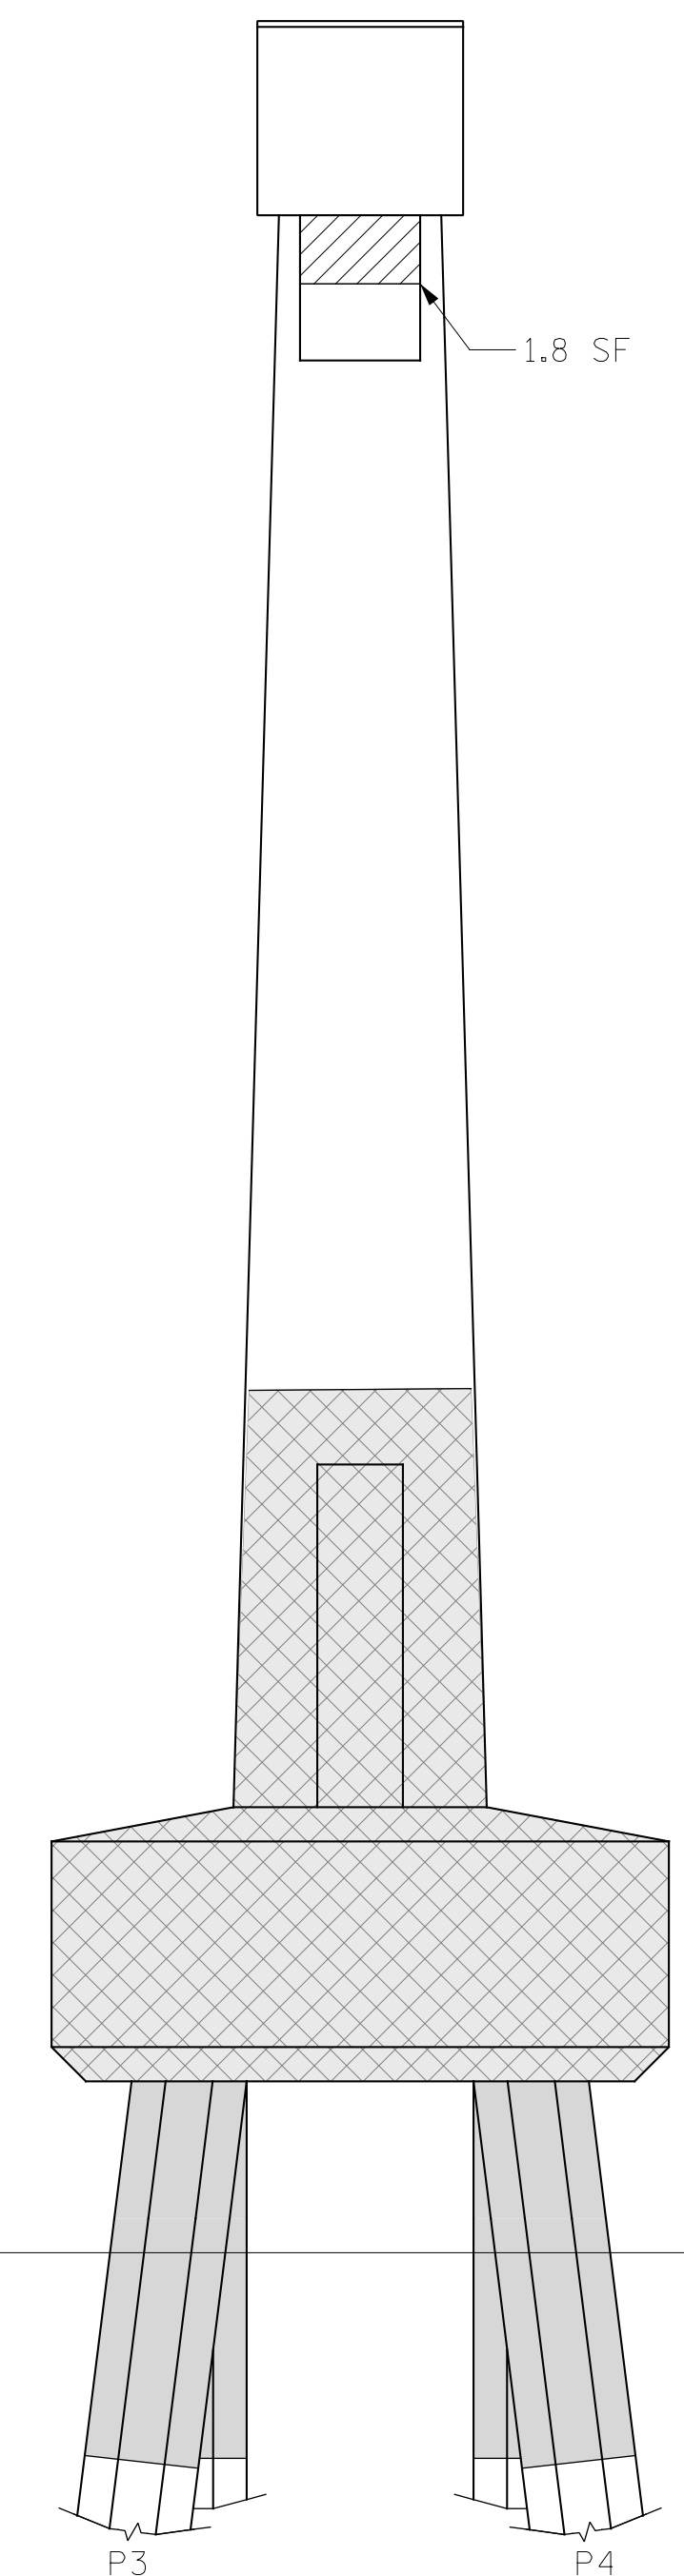
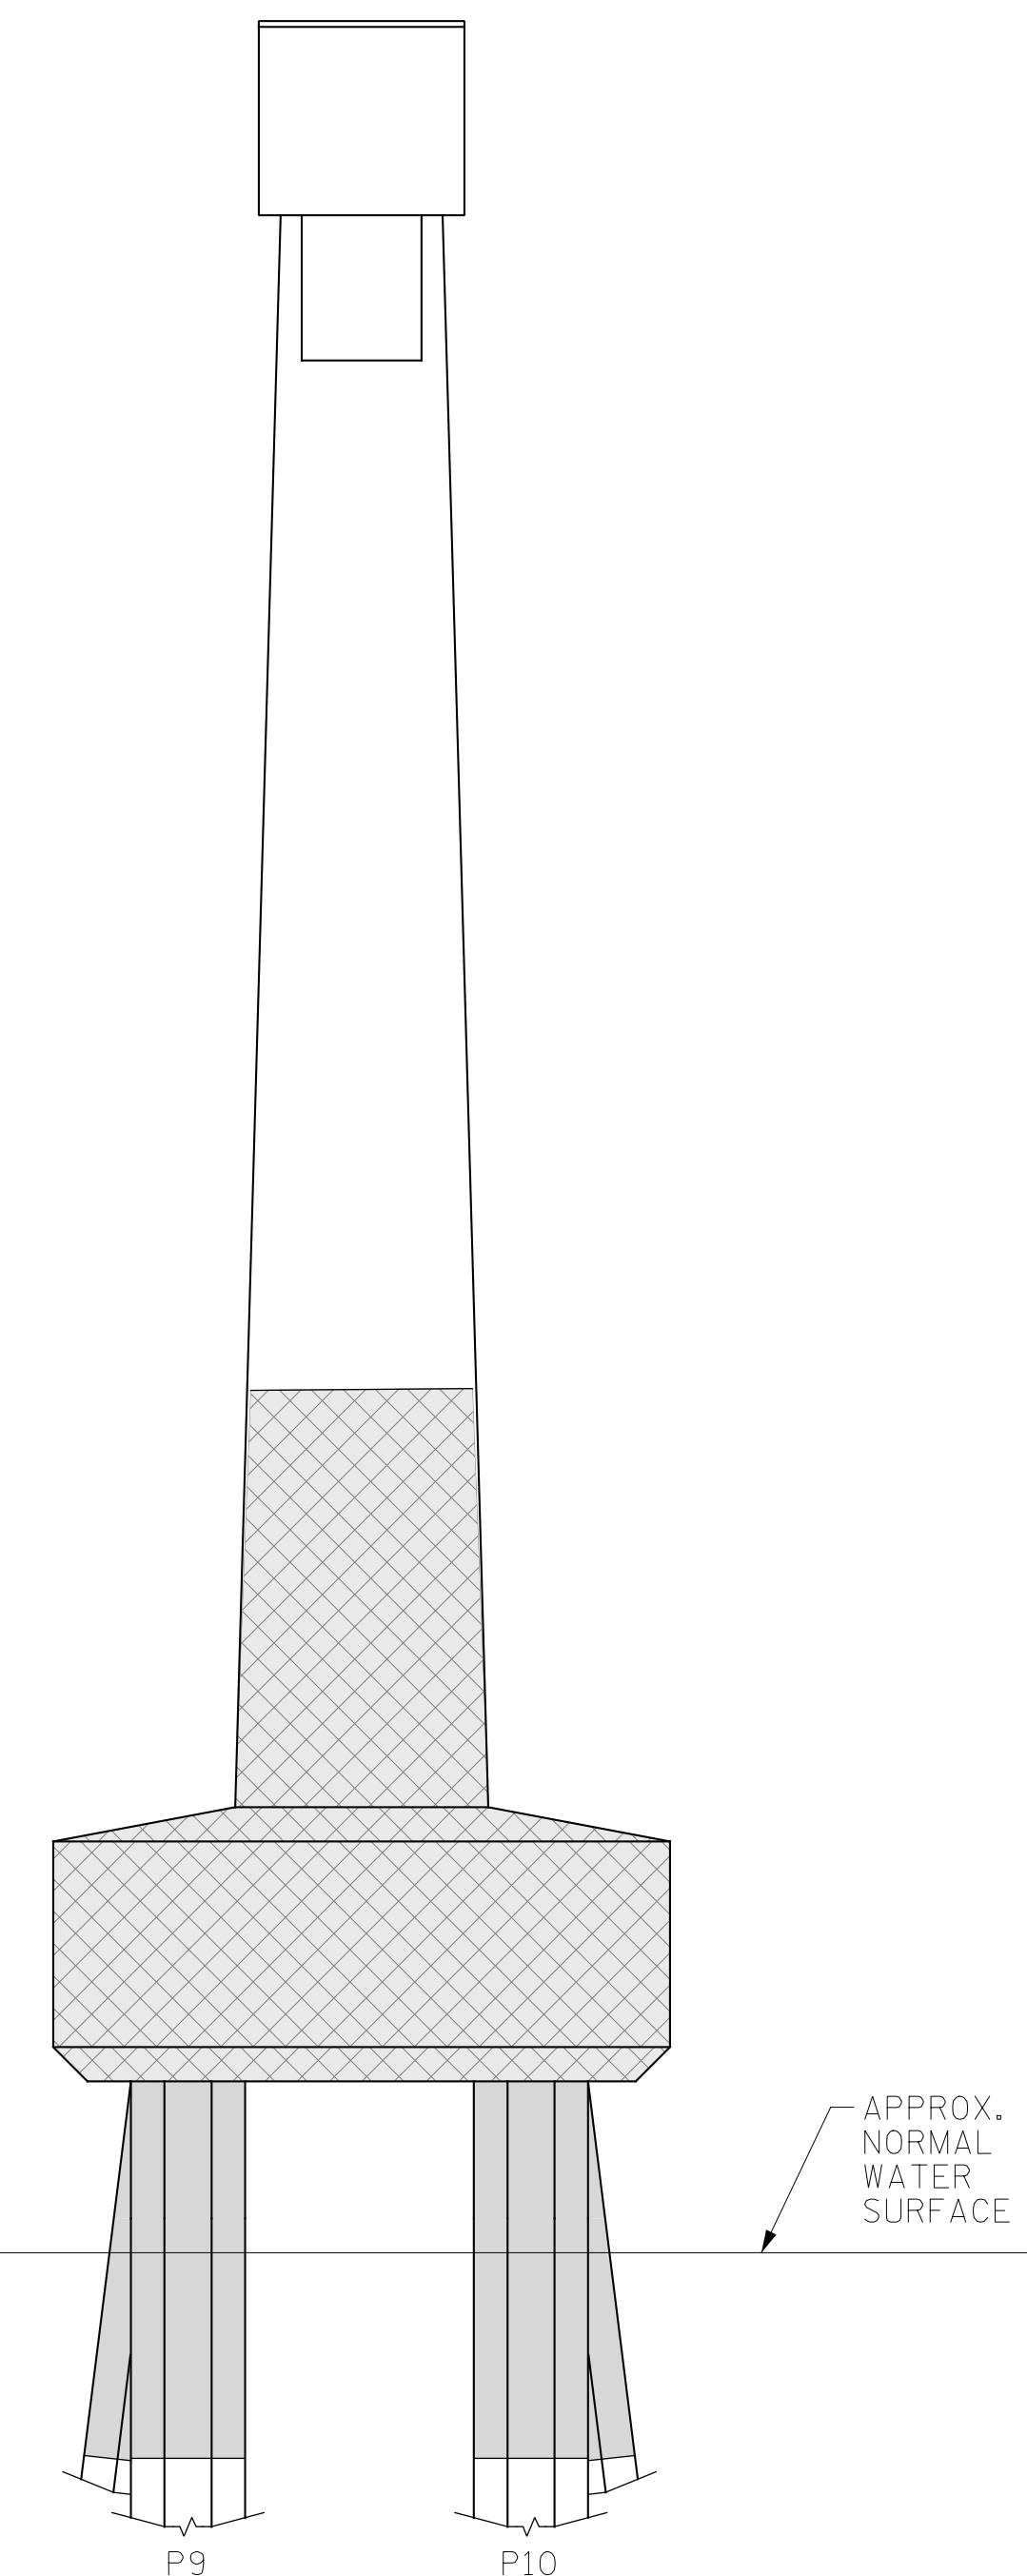
BENT 128 WEST FACE

CAP REPAIRS		ESTIMATE		ACTUAL	
SHOTCRETE REPAIRS	9.8 SF	4.9 CF	SF	CF	
EPOXY RESIN INJECTION	- LF				LF
COLUMN REPAIRS		ESTIMATE		ACTUAL	
SHOTCRETE REPAIRS	44.3 SF	22.2 CF	SF	CF	
EPOXY RESIN INJECTION	- LF				LF
PILE REPAIRS		ESTIMATE		ACTUAL	
FRP PROTECTIVE SYSTEM AWL	- SF				SF
FRP PROTECTIVE SYSTEM BWL	302.5 SF				SF
