AS-BUILT REPAIR QUANTITY TABLE

PROJECT NO. HB-0017
DARE COUNTY
BRIDGE NO. 270009

BENT 73 & BENT 74

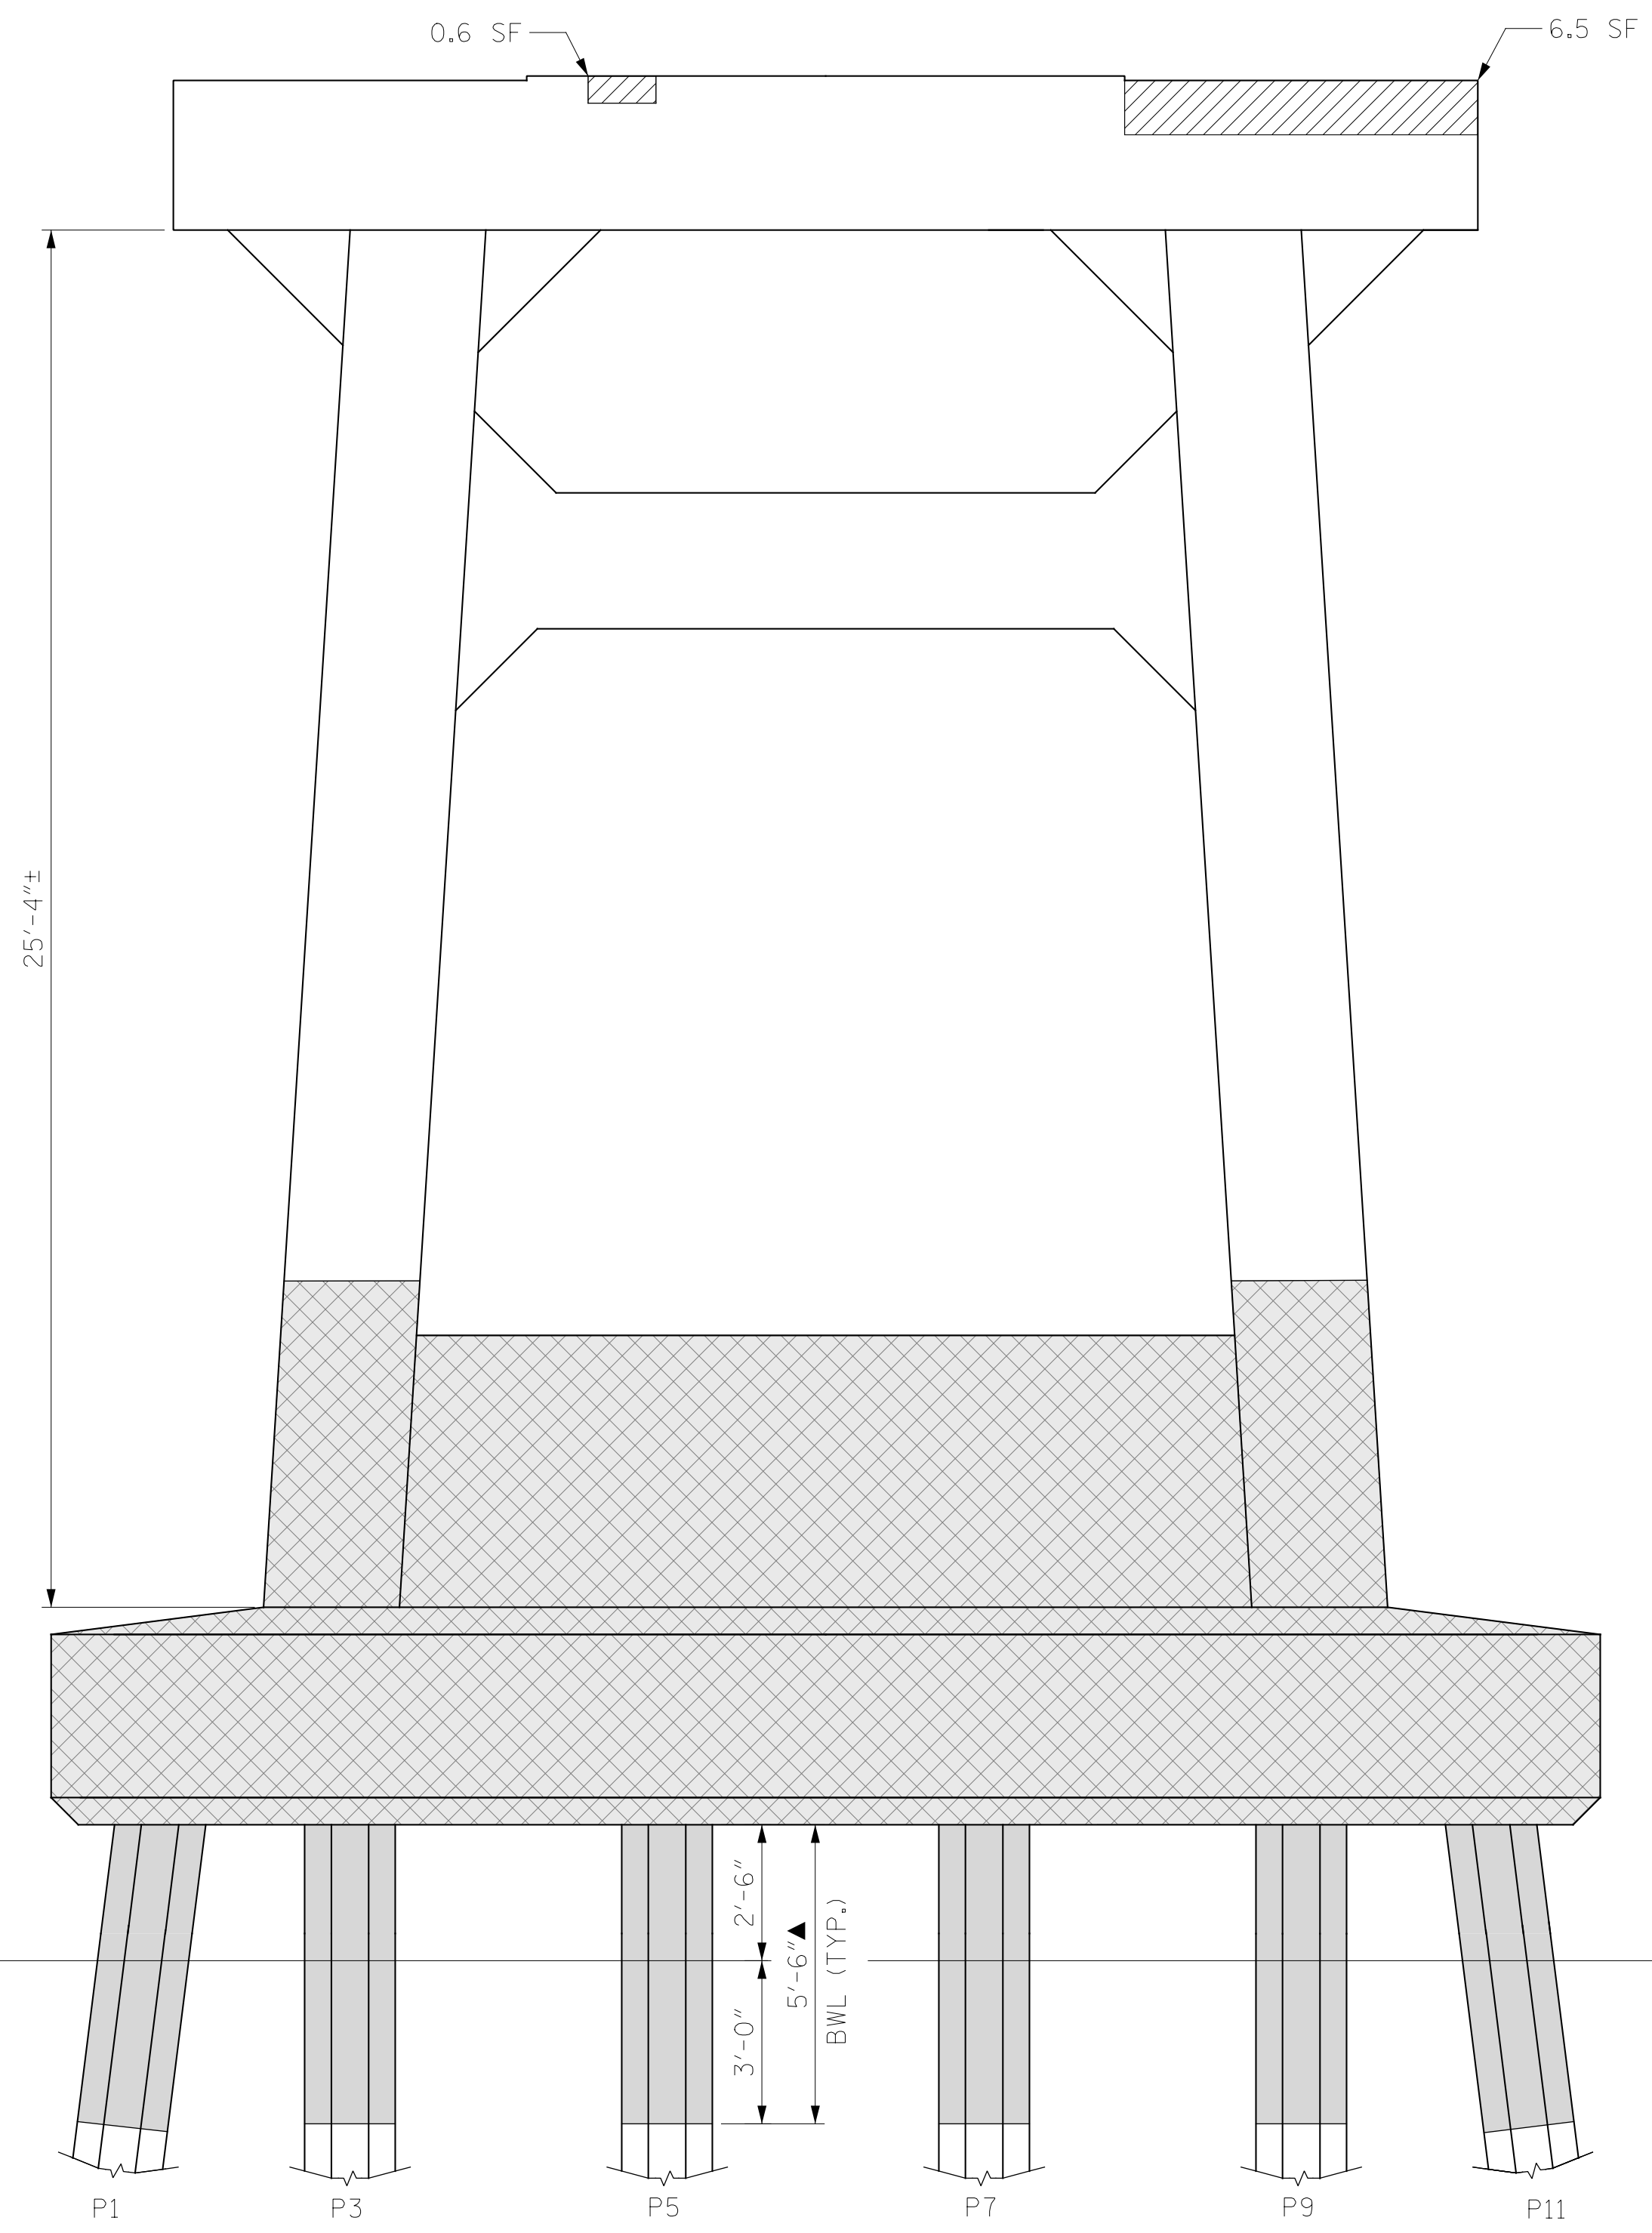
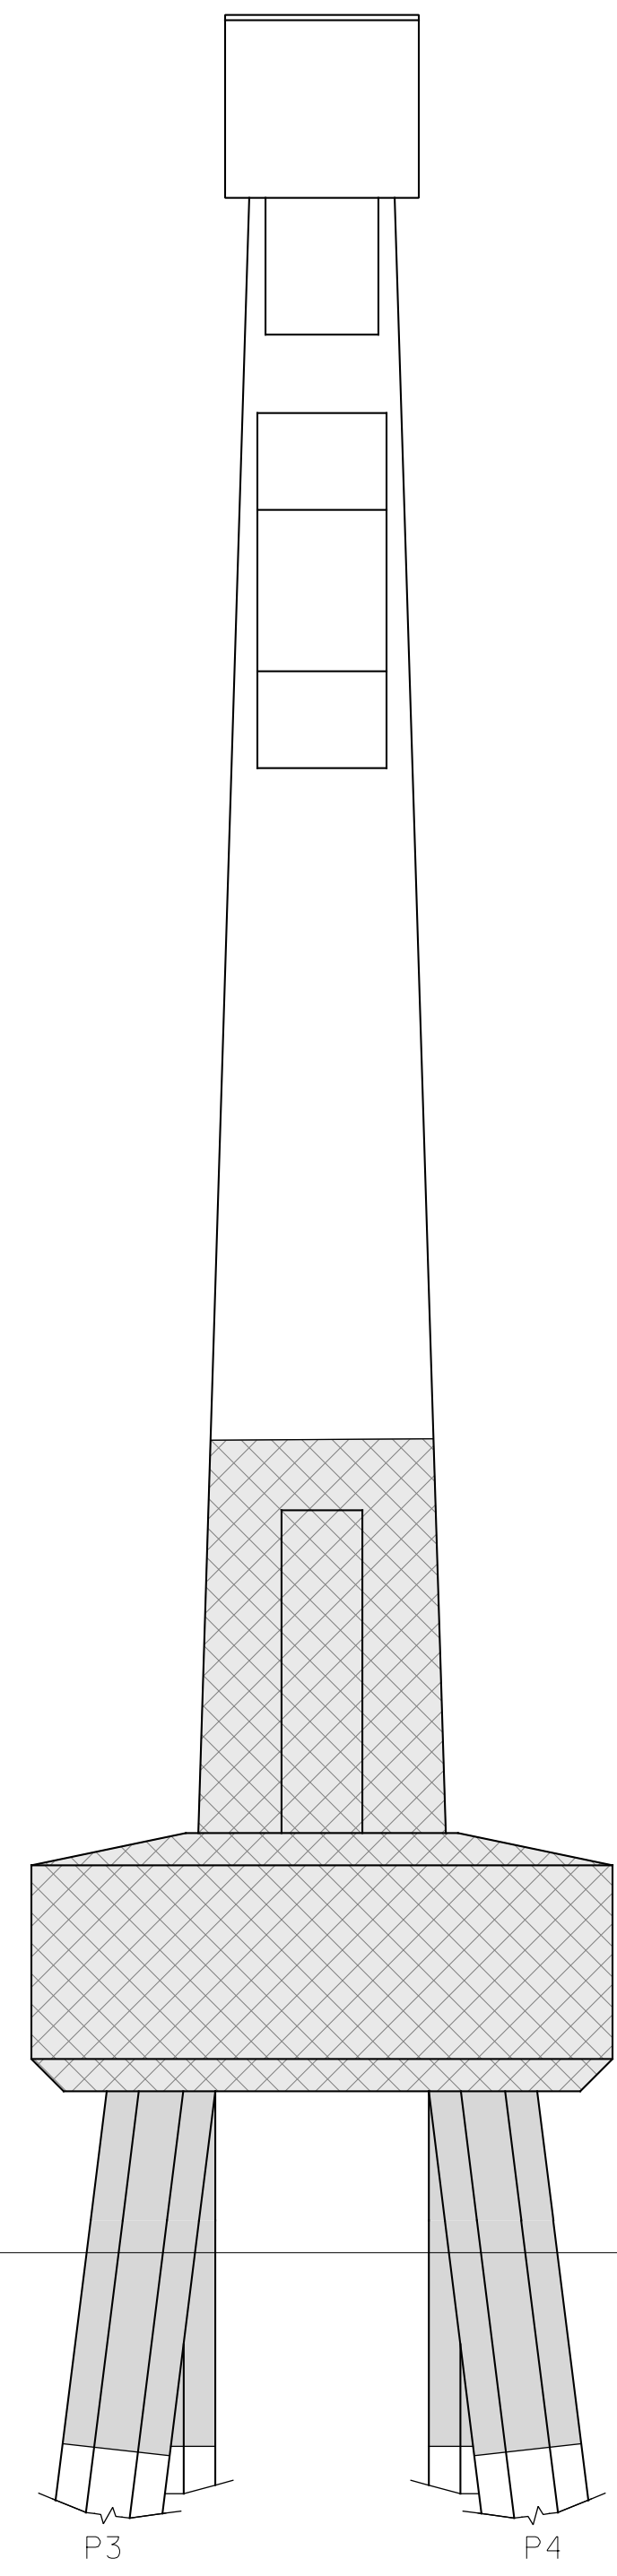
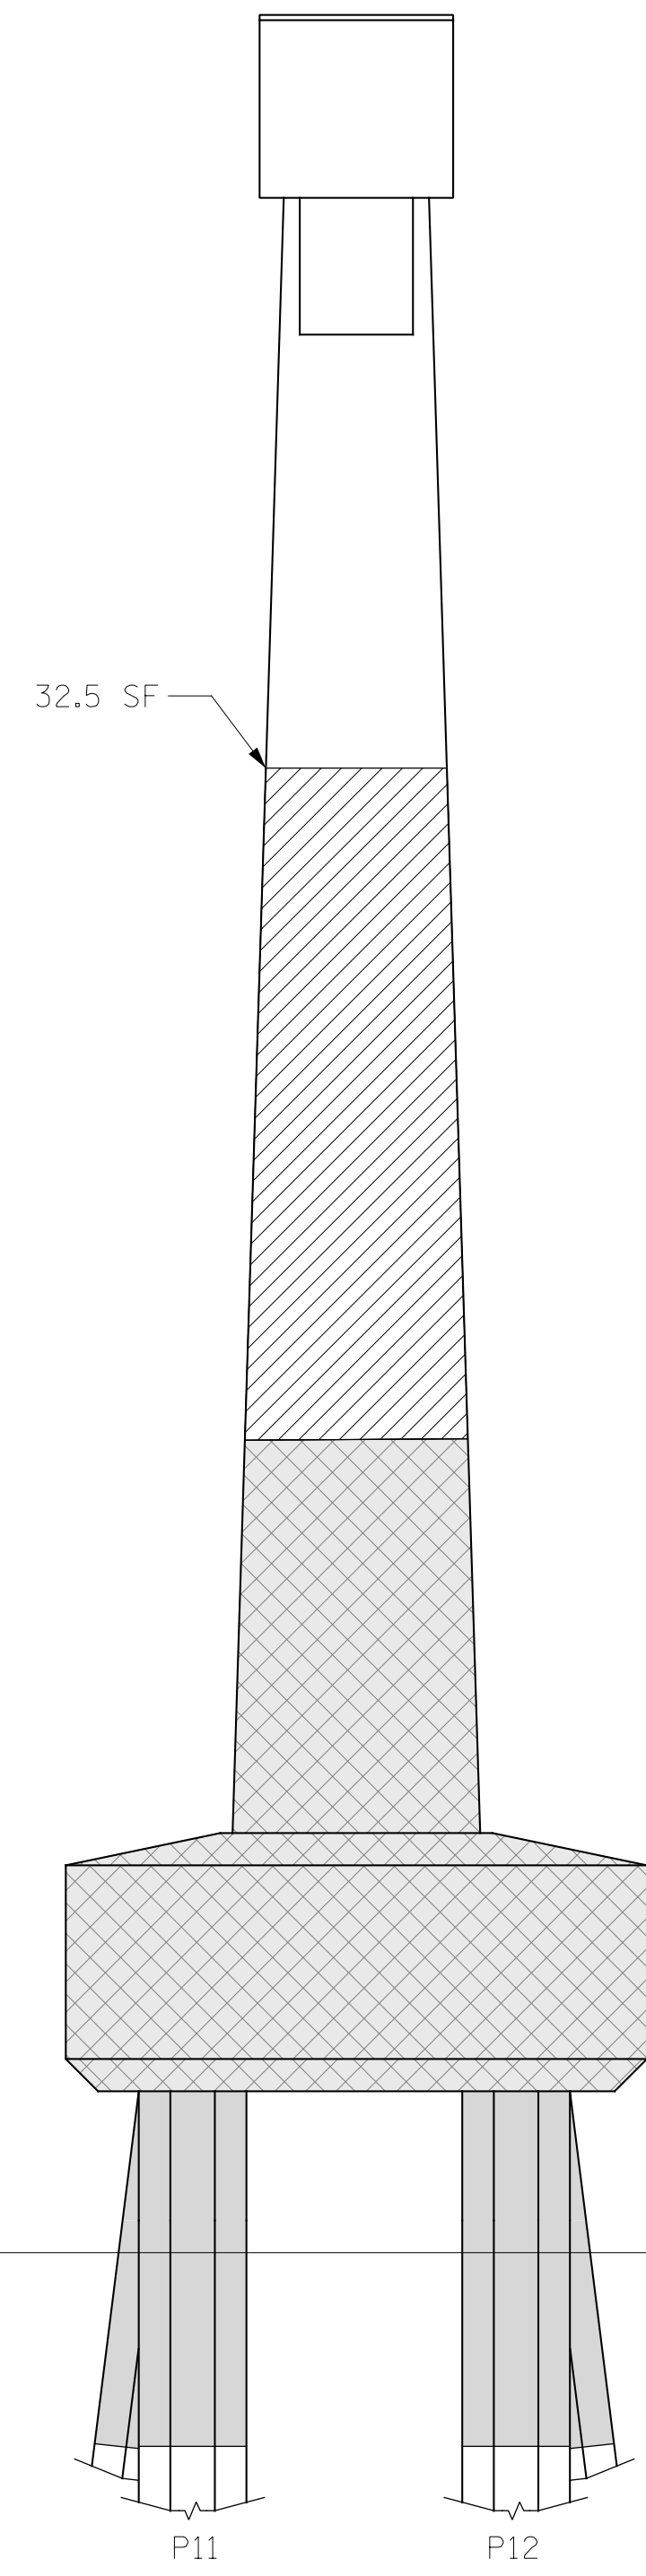
STATE OF NORTH CAROLINA DEPARTMENT OF TRANSPORTATION RALEIGH						SHEET NO.
BENT 129 WEST FACE						S-195
REVISIONS						TOTAL SHEETS
NO.	BY:	DATE:	NO.	BY:	DATE:	355
1			3			
2			4

CAP REPAIRS		ESTIMATE		ACTUAL	
SHOTCRETE REPAIRS	7.1 SF	3.6 CF	SF	CF	
EPOXY RESIN INJECTION	- LF				LF
COLUMN REPAIRS		ESTIMATE		ACTUAL	
SHOTCRETE REPAIRS	50.5 SF	25.3 CF	SF	CF	
EPOXY RESIN INJECTION	4.3 LF				LF
PILE REPAIRS		ESTIMATE		ACTUAL	
FRP PROTECTIVE SYSTEM AWL	- SF				SF
FRP PROTECTIVE SYSTEM BWL	363.0 SF				SF

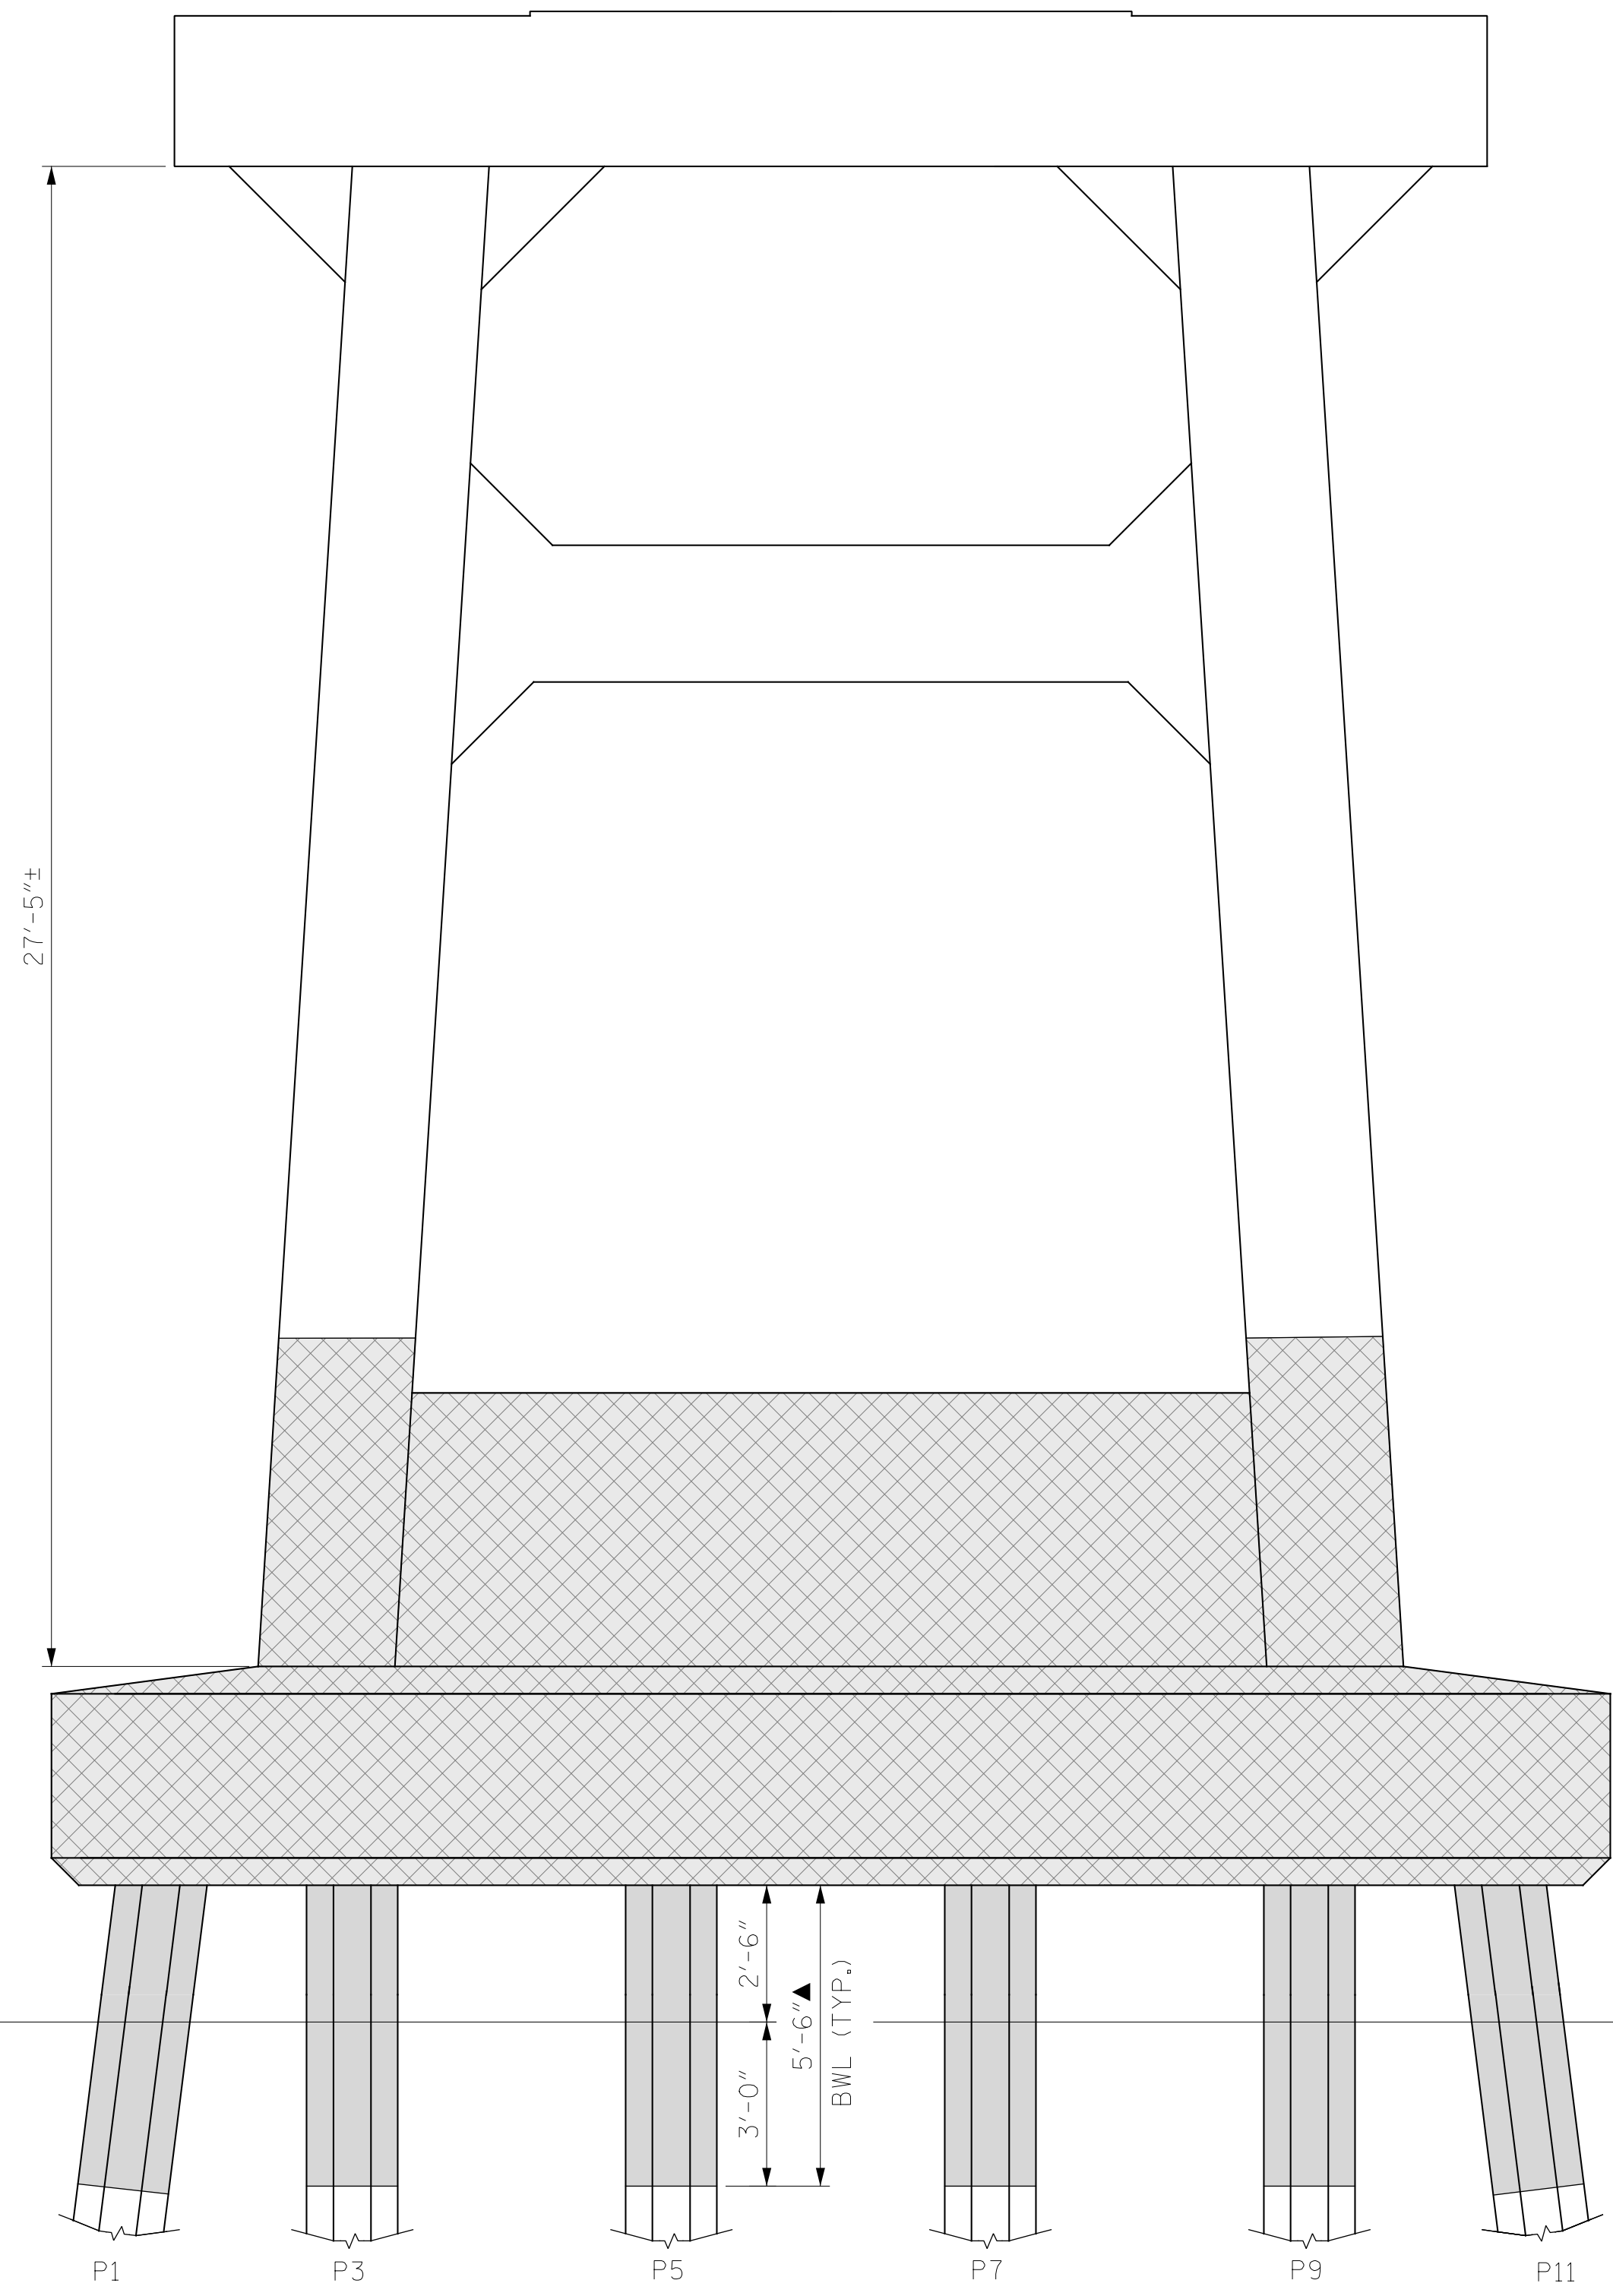
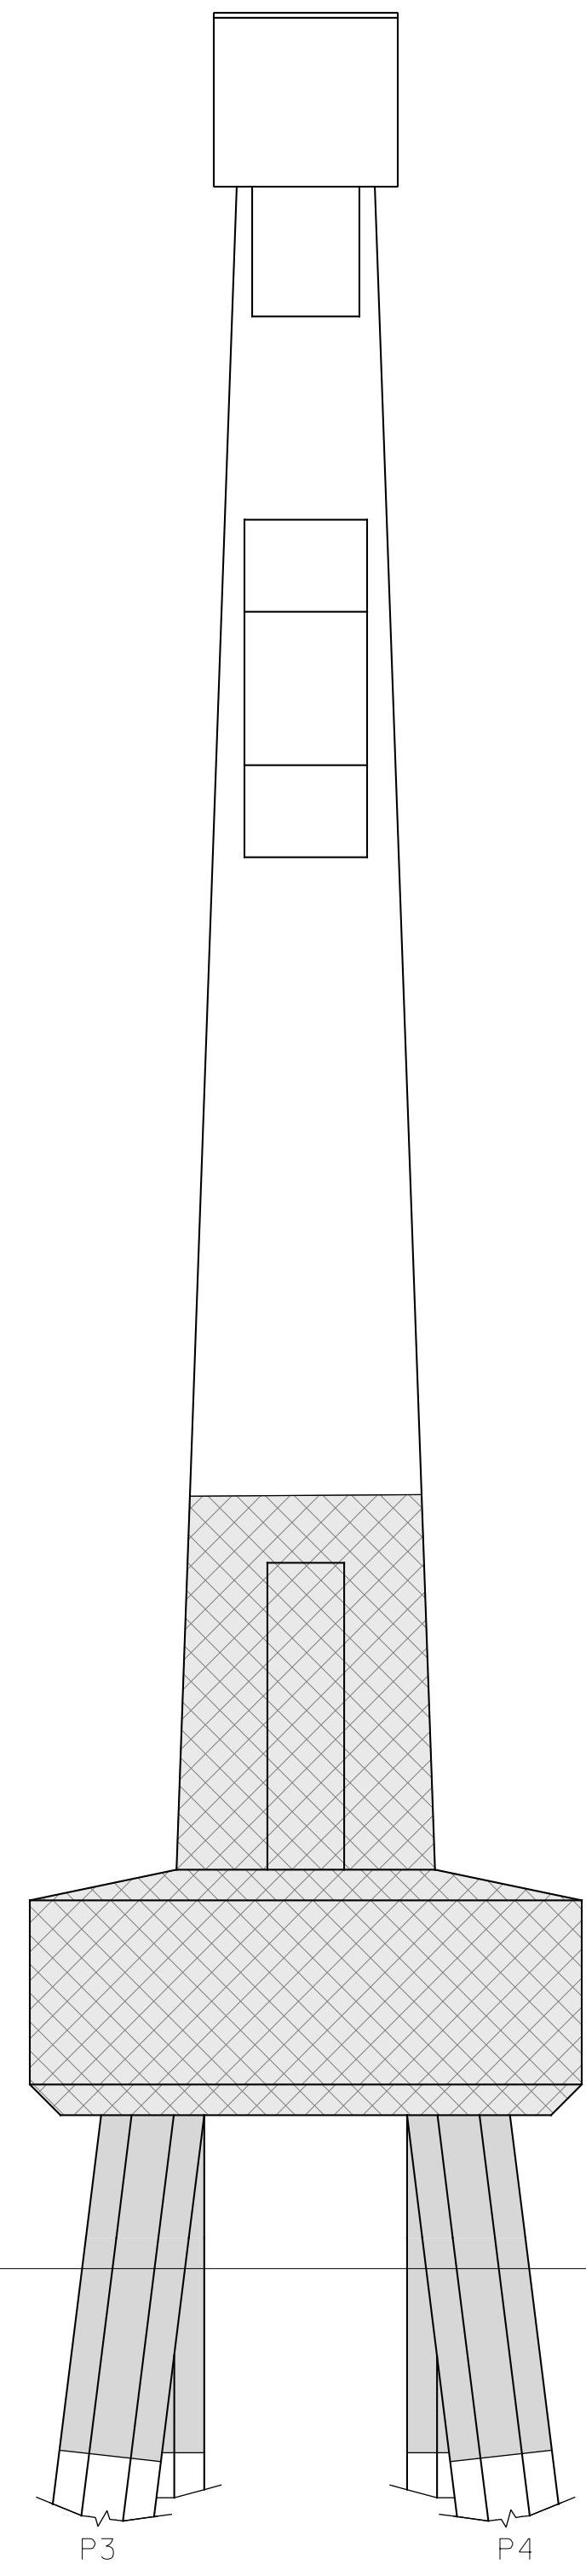
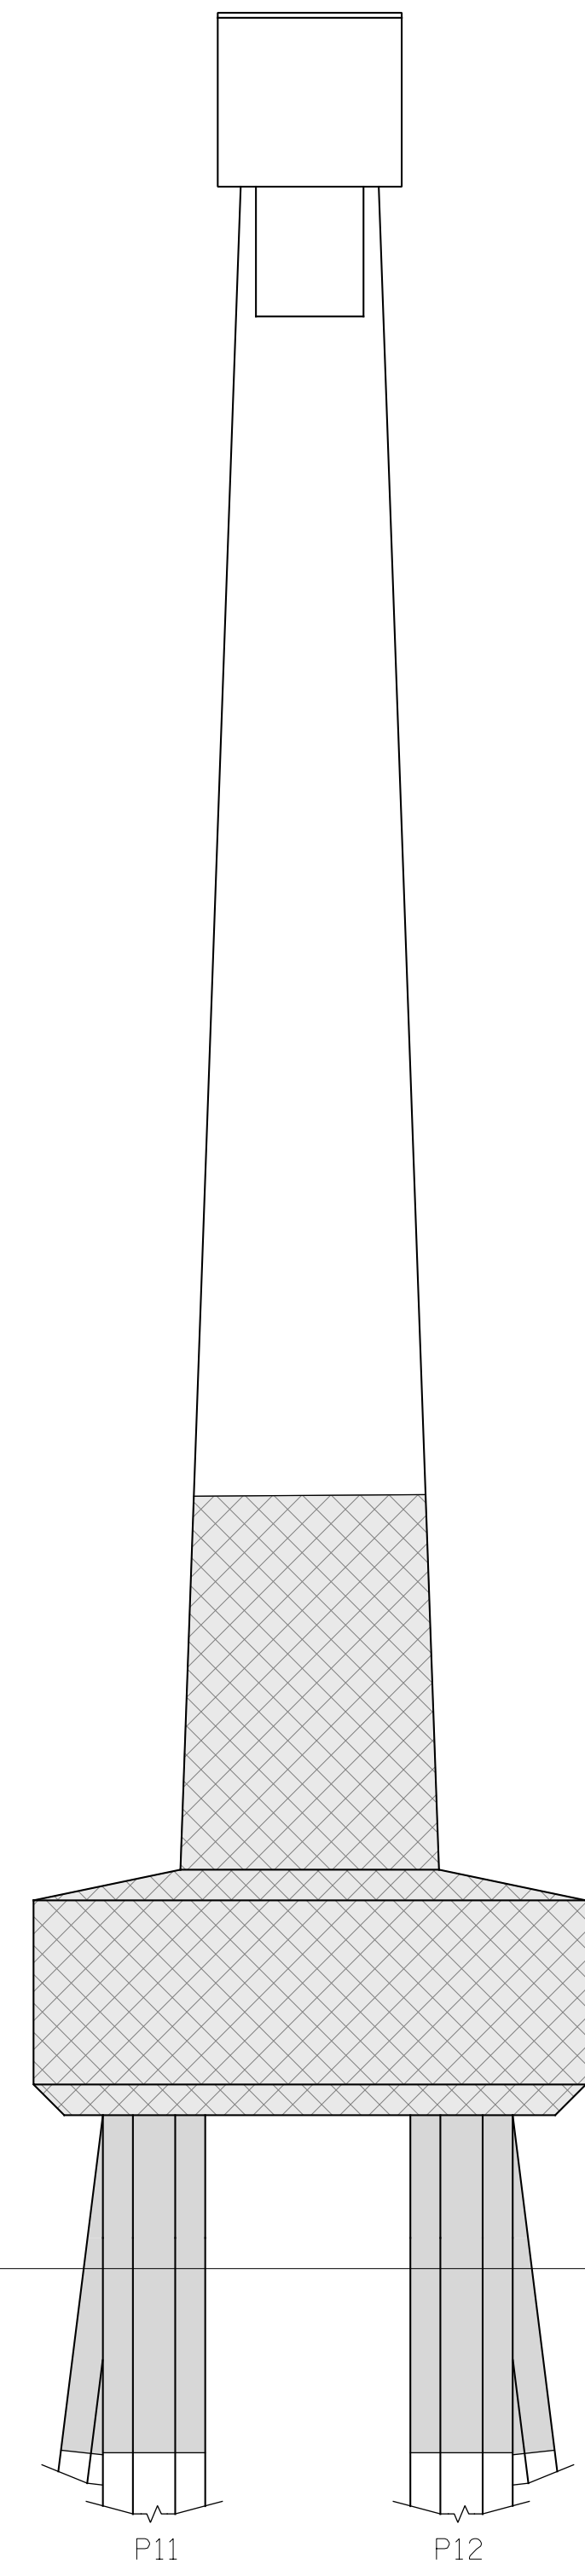
STATE OF NORTH CAROLINA DEPARTMENT OF TRANSPORTATION RALEIGH					
BENT 130 WEST FACE					
REVISIONS					SHEET NO.
NO.	BY:	DATE:	NO.	BY:	DATE:
1			3		
2			4		
TOTAL SHEETS					355

CAP REPAIRS		ESTIMATE		ACTUAL	
SHOTCRETE REPAIRS	- SF	- CF	SF	CF	
EPOXY RESIN INJECTION	- LF			LF	
COLUMN REPAIRS		ESTIMATE		ACTUAL	
SHOTCRETE REPAIRS	33.0 SF	16.5 CF	SF	CF	
EPOXY RESIN INJECTION	- LF			LF	
PILE REPAIRS		ESTIMATE		ACTUAL	
FRP PROTECTIVE SYSTEM AWL	- SF			SF	
FRP PROTECTIVE SYSTEM BWL	363.0 SF			SF

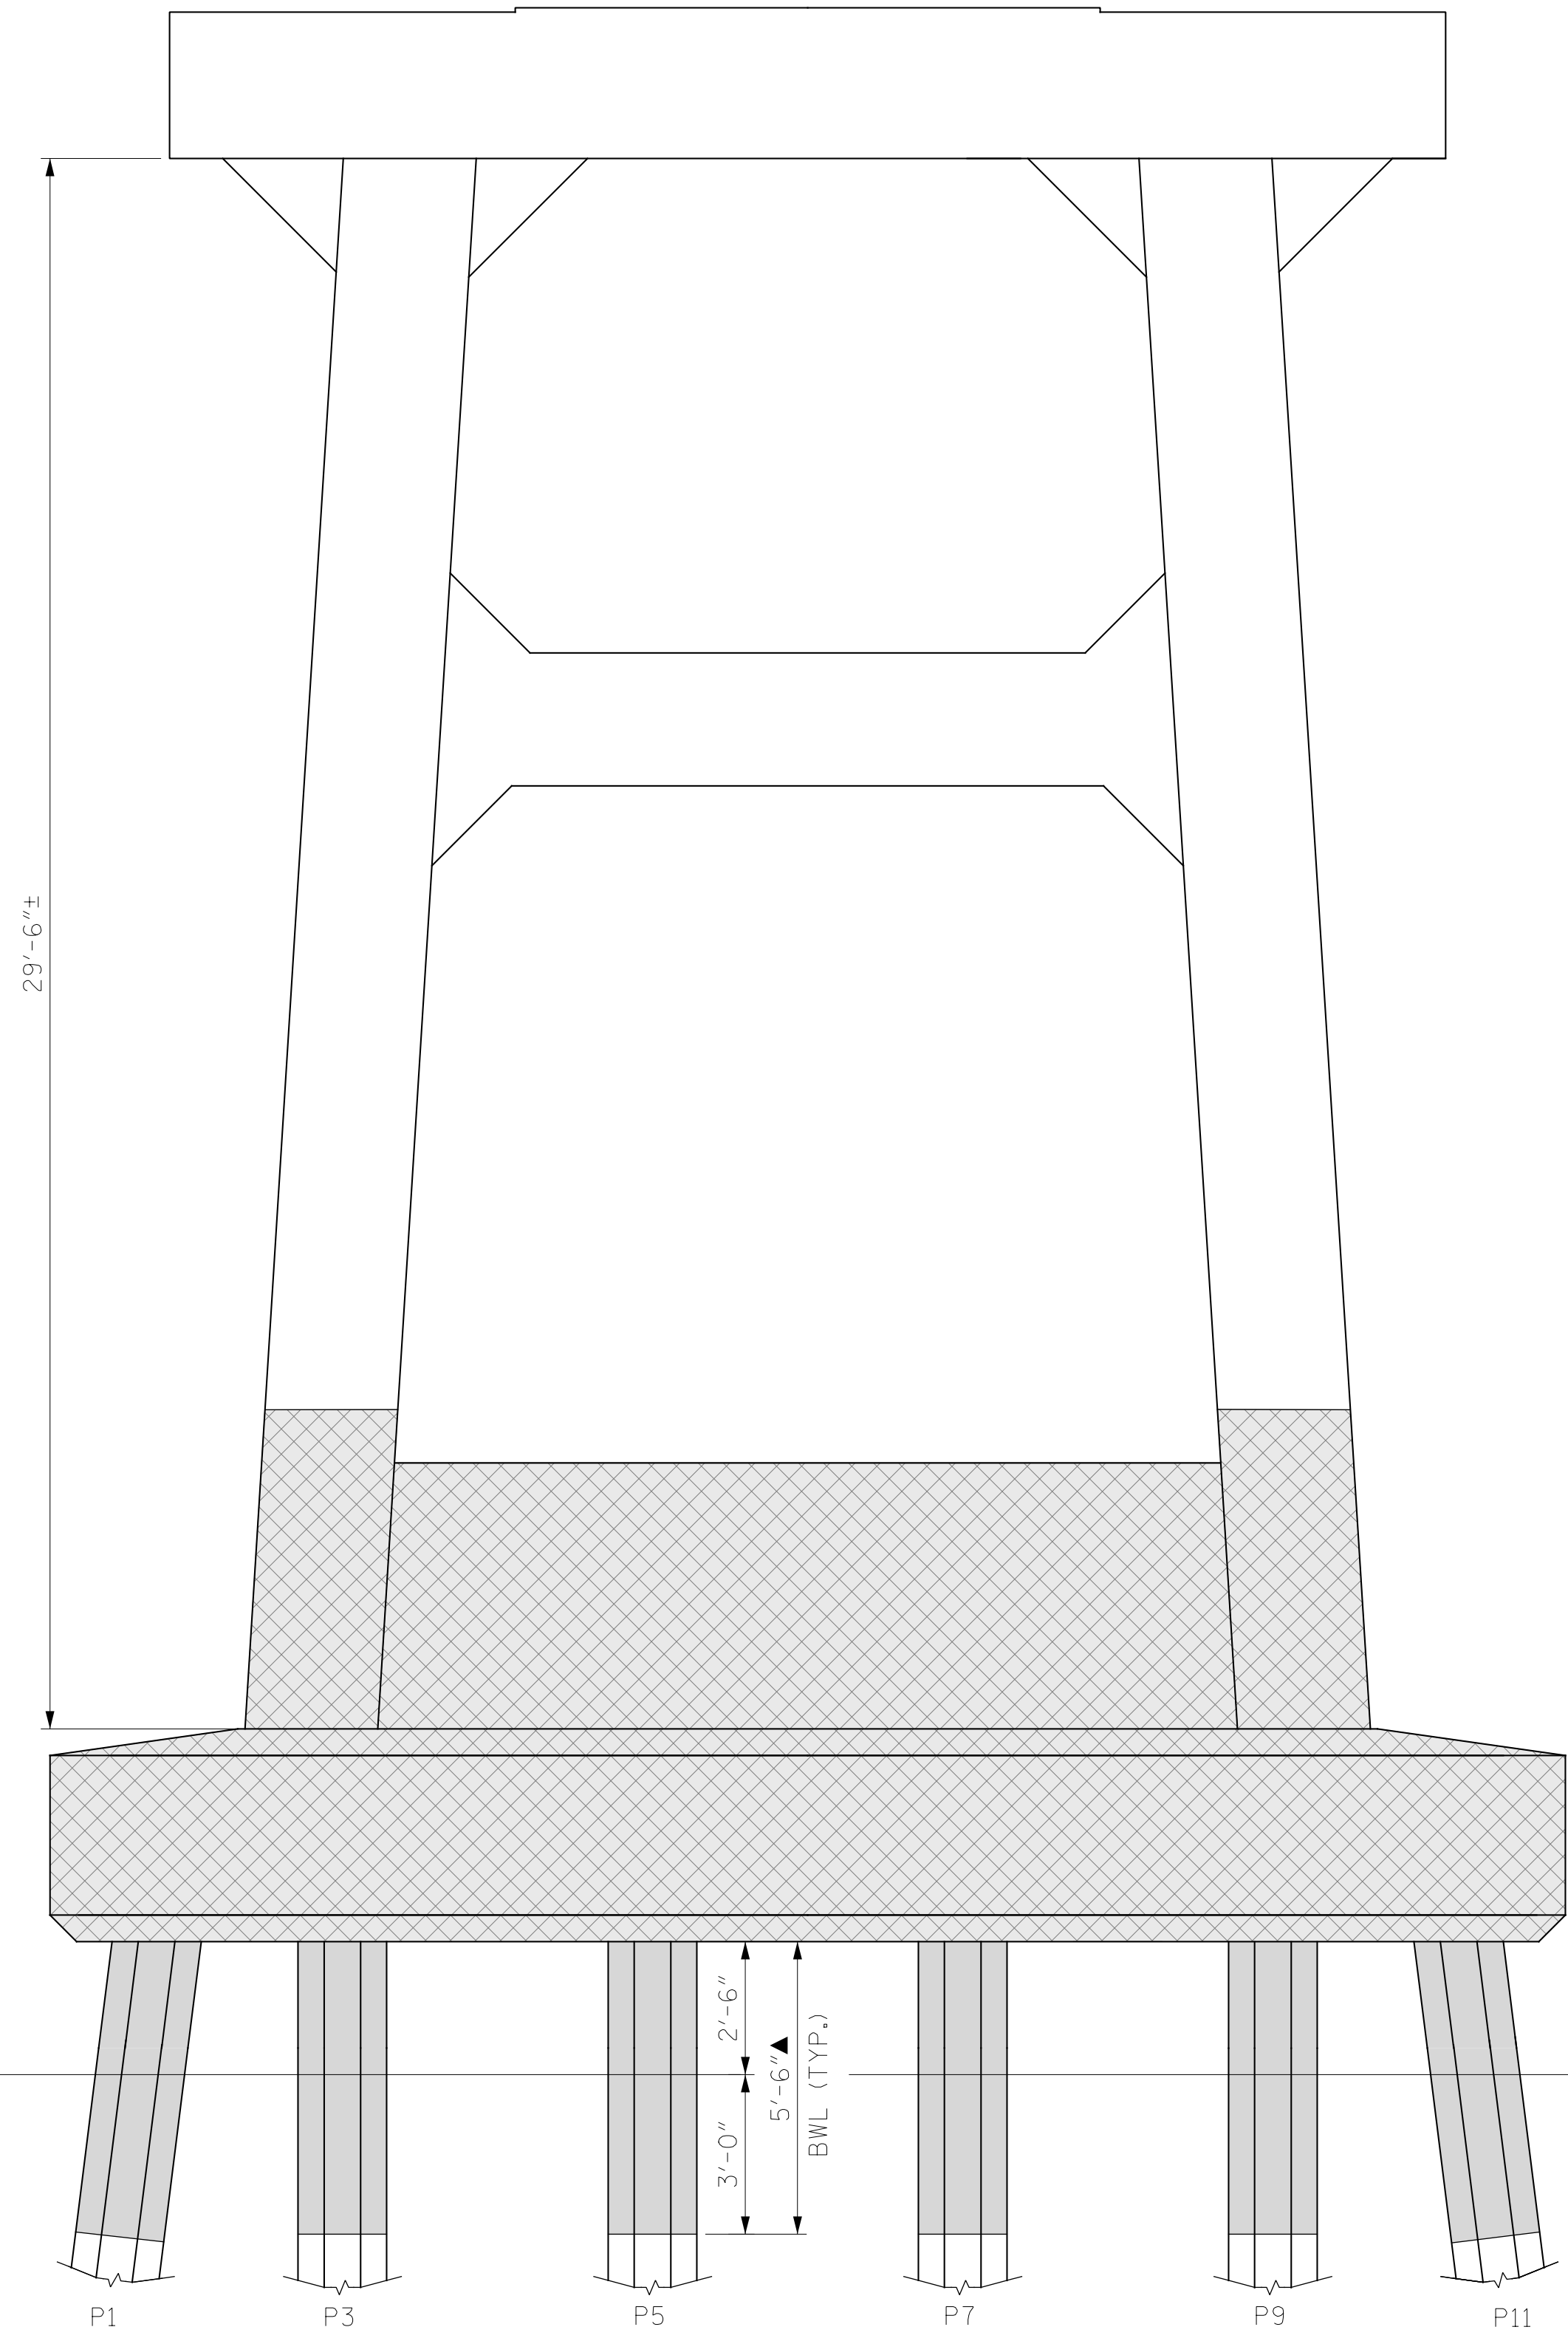
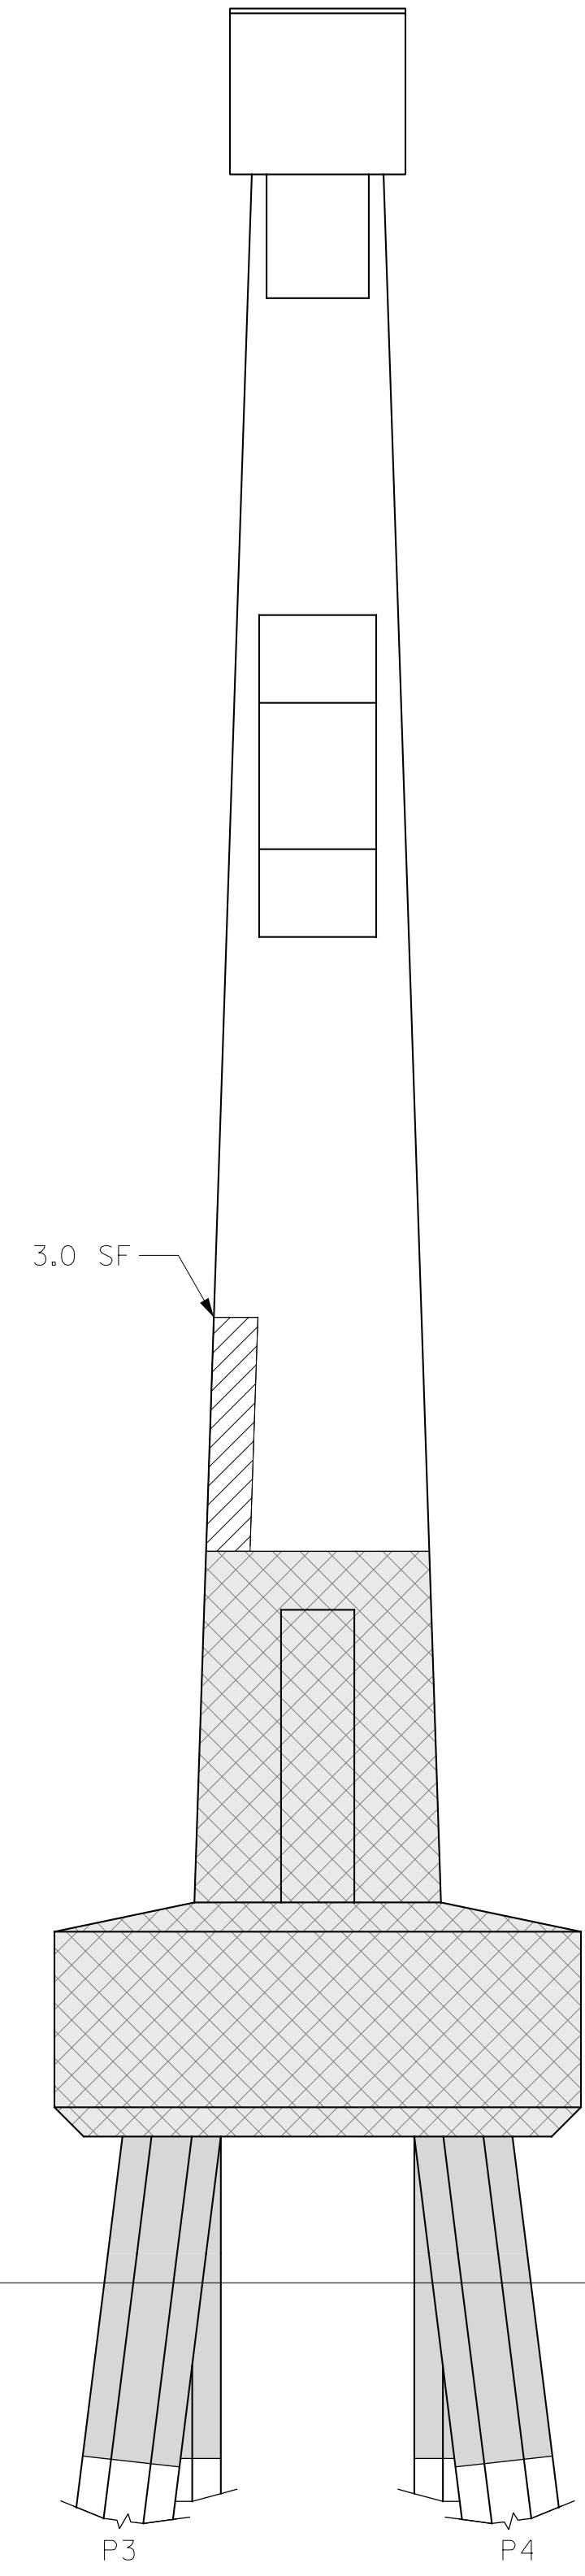
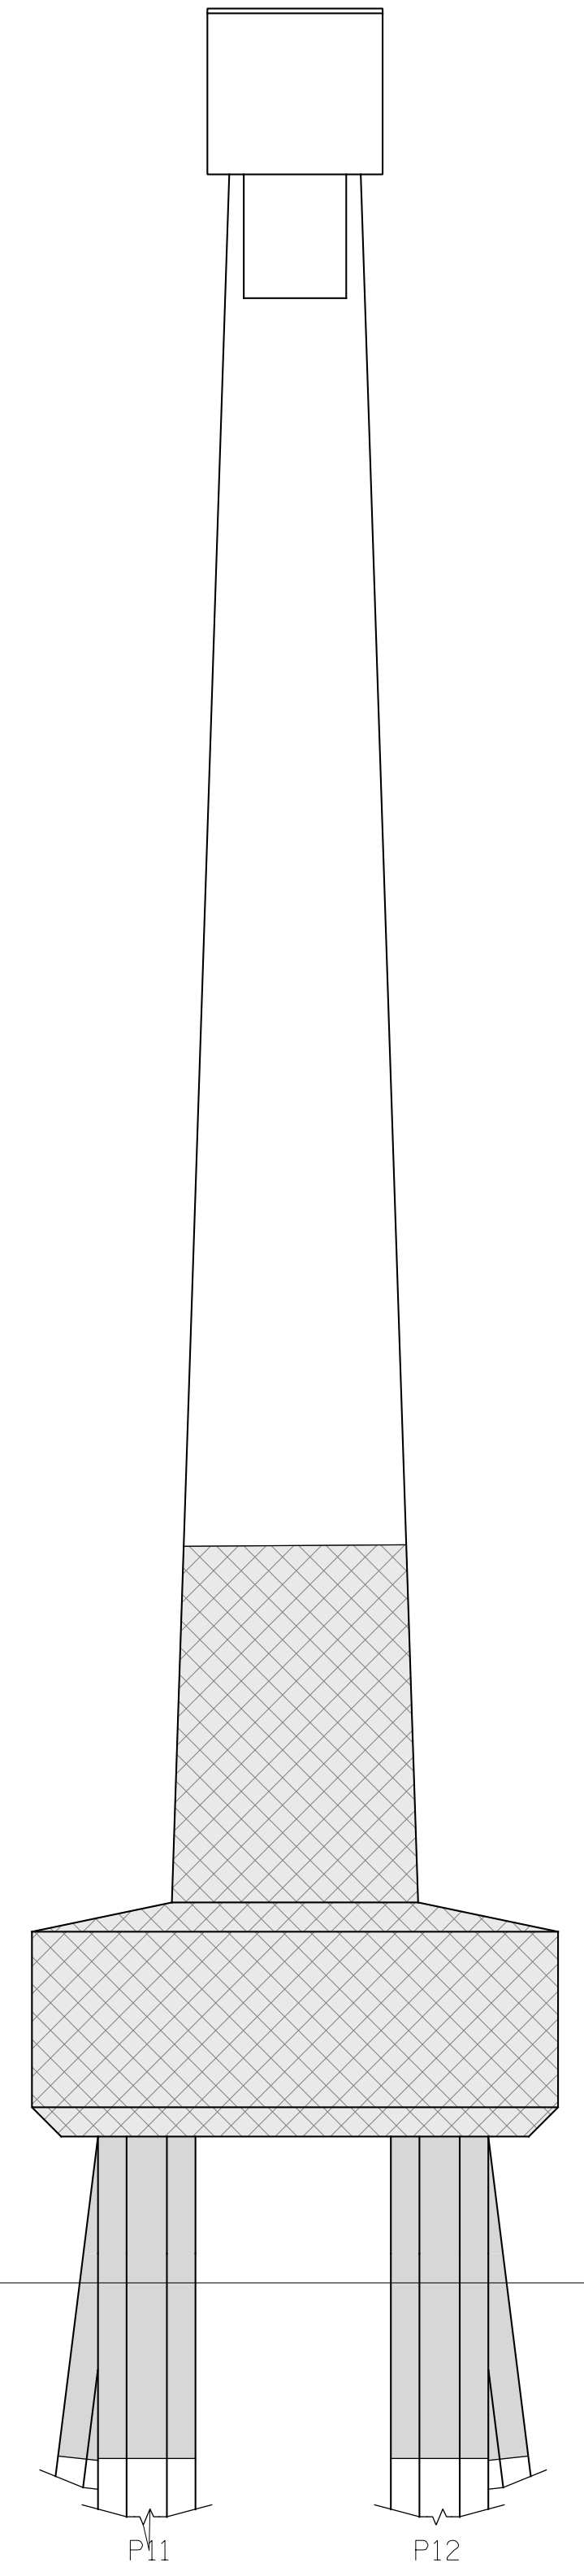
STATE OF NORTH CAROLINA DEPARTMENT OF TRANSPORTATION RALEIGH					
BENT 131 WEST FACE					
REVISIONS					SHEET NO.
NO.	BY:	DATE:	NO.	BY:	DATE:
1			3		
2			4		
TOTAL SHEETS					355

CAP REPAIRS		ESTIMATE		ACTUAL	
SHOTCRETE REPAIRS	- SF	- CF	SF	CF	
EPOXY RESIN INJECTION	- LF			LF	
COLUMN REPAIRS		ESTIMATE		ACTUAL	
SHOTCRETE REPAIRS	3.0 SF	1.5 CF	SF	CF	
EPOXY RESIN INJECTION	- LF			LF	
PILE REPAIRS		ESTIMATE		ACTUAL	
FRP PROTECTIVE SYSTEM AWL	- SF			SF	
FRP PROTECTIVE SYSTEM BWL	363.0 SF			SF
