AS-BUILT REPAIR QUANTITY TABLE

PROJECT NO. HB-0017
DARE COUNTY
BRIDGE NO. 270009

BENT 73 & BENT 74

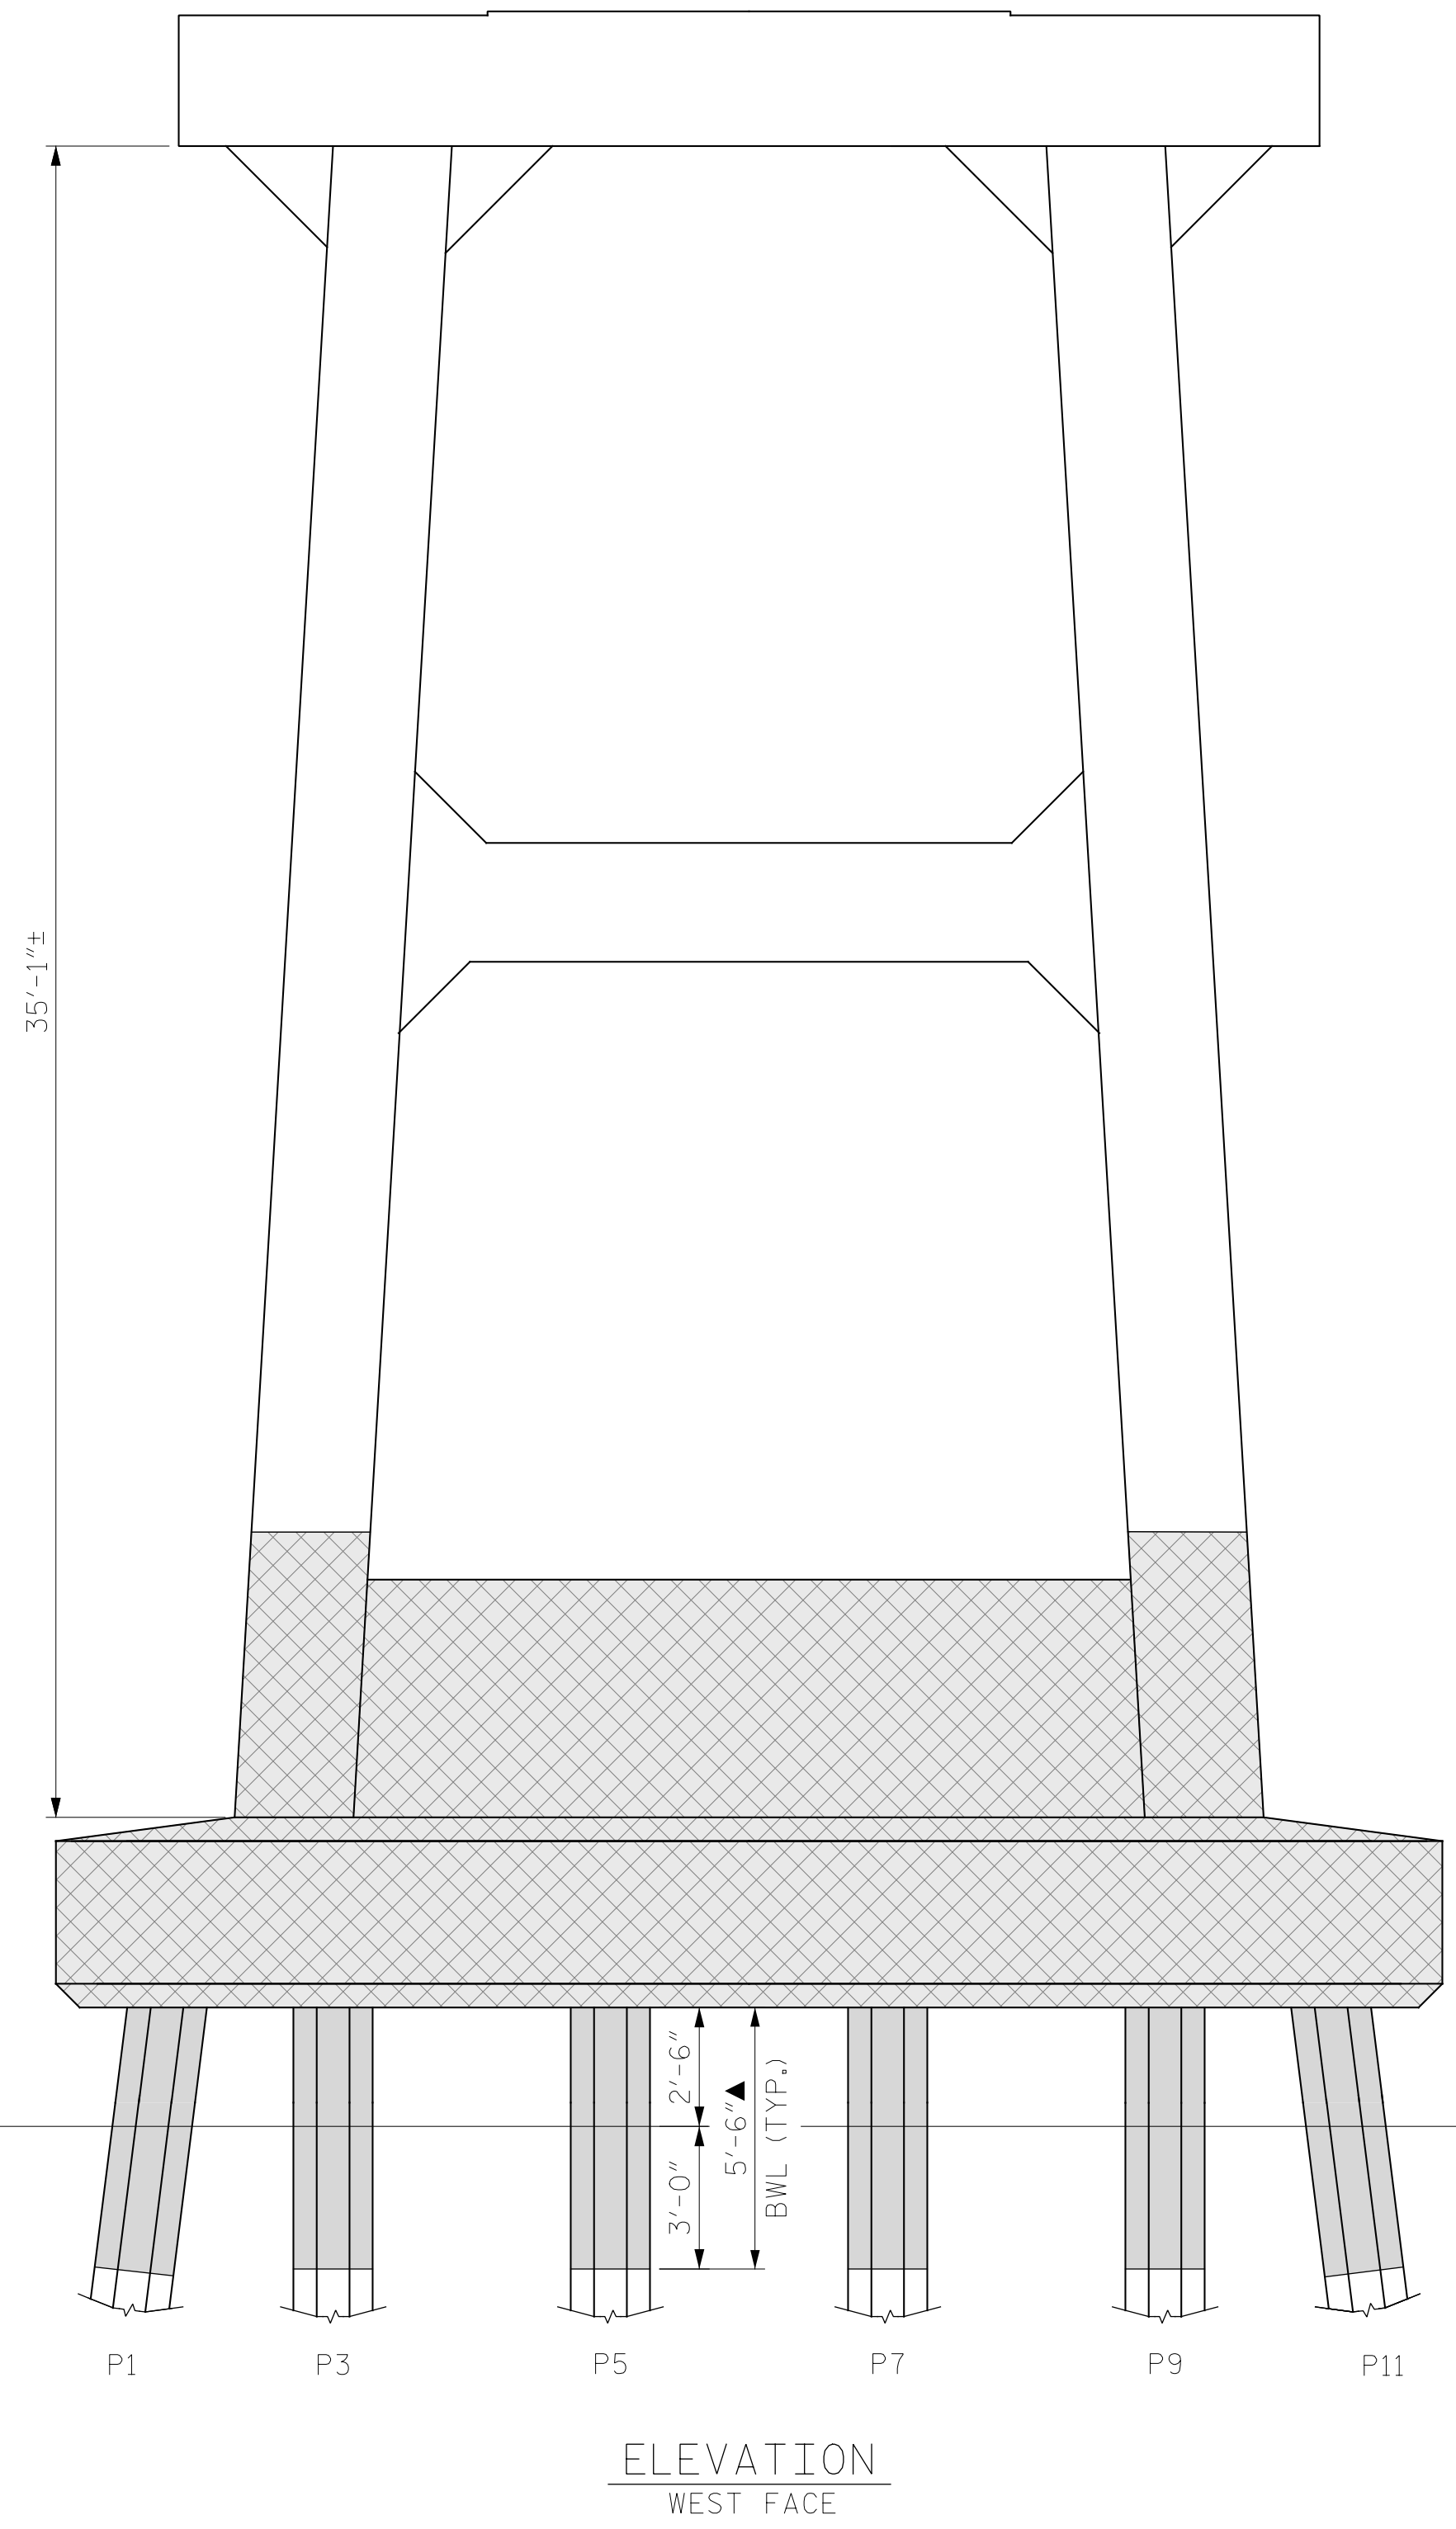
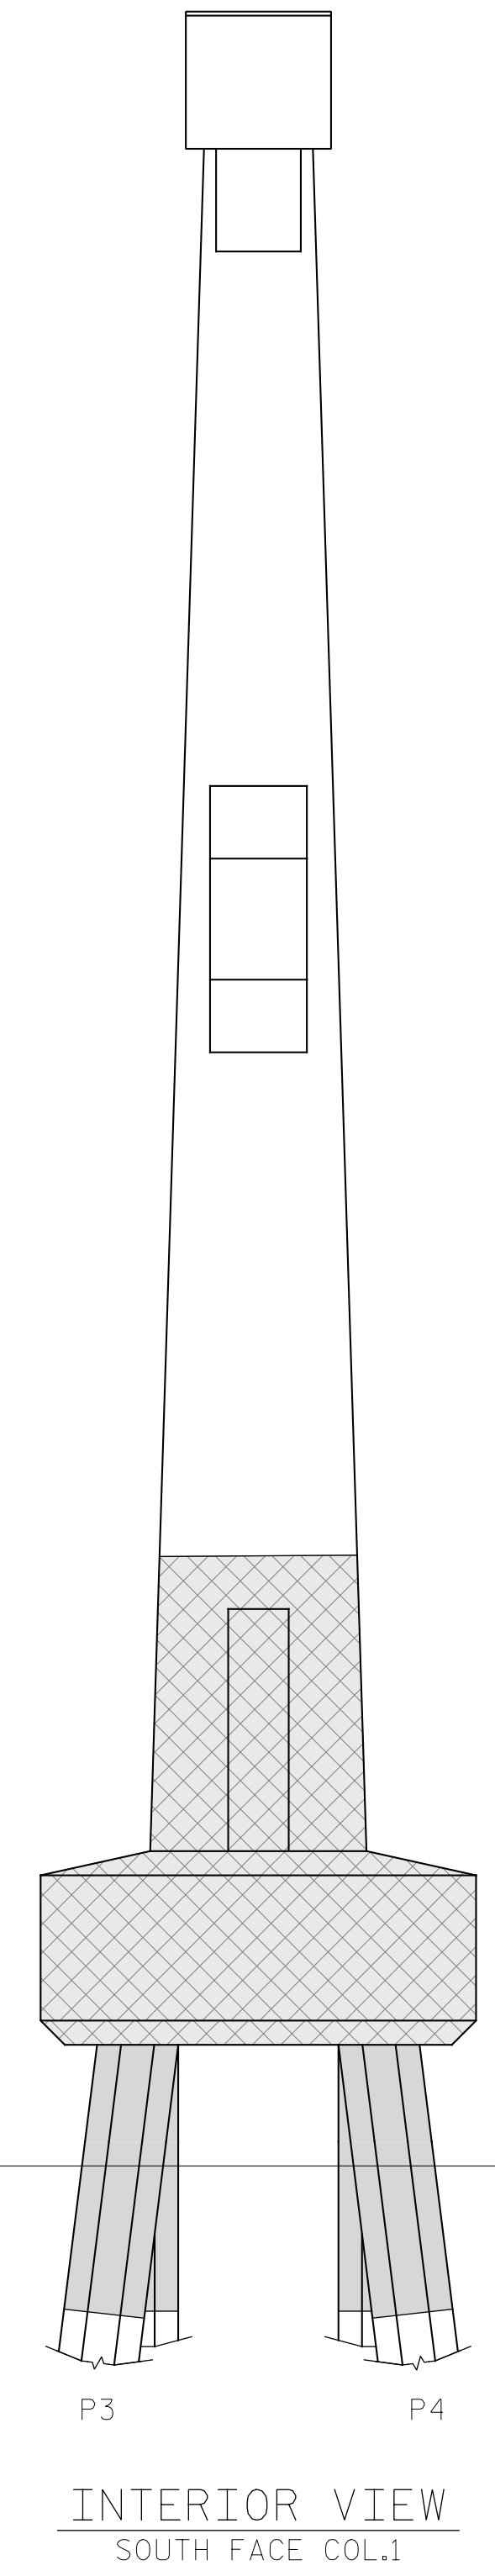
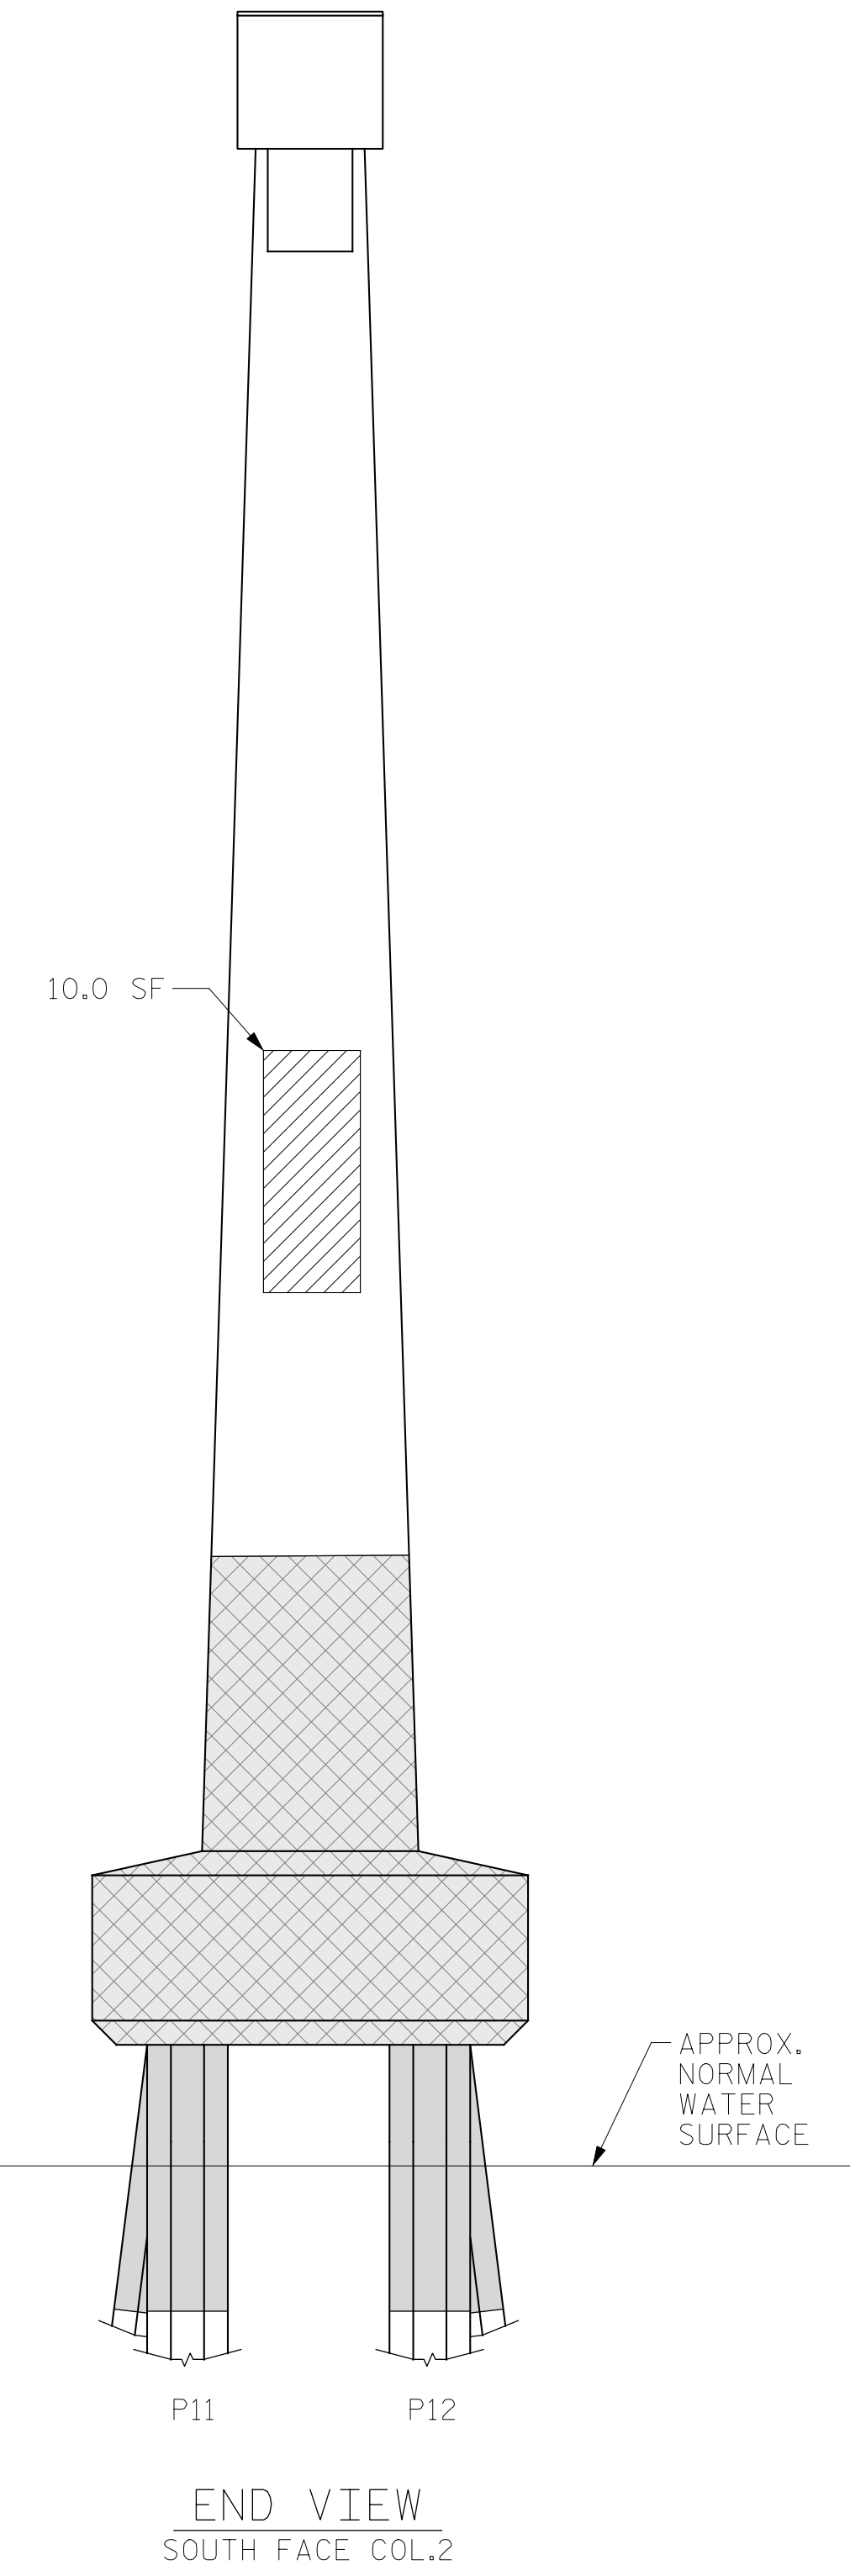
**BENT 133
WEST FACE**

CAP REPAIRS		ESTIMATE		ACTUAL	
SHOTCRETE REPAIRS	- SF	- CF	SF	CF	
EPOXY RESIN INJECTION	1.5 LF				LF
COLUMN REPAIRS		ESTIMATE		ACTUAL	
SHOTCRETE REPAIRS	14.0 SF	7.0 CF	SF	CF	
EPOXY RESIN INJECTION	2.5 LF				LF
PILE REPAIRS		ESTIMATE		ACTUAL	
FRP PROTECTIVE SYSTEM AWL	- SF				SF
FRP PROTECTIVE SYSTEM BWL	363.0 SF				SF

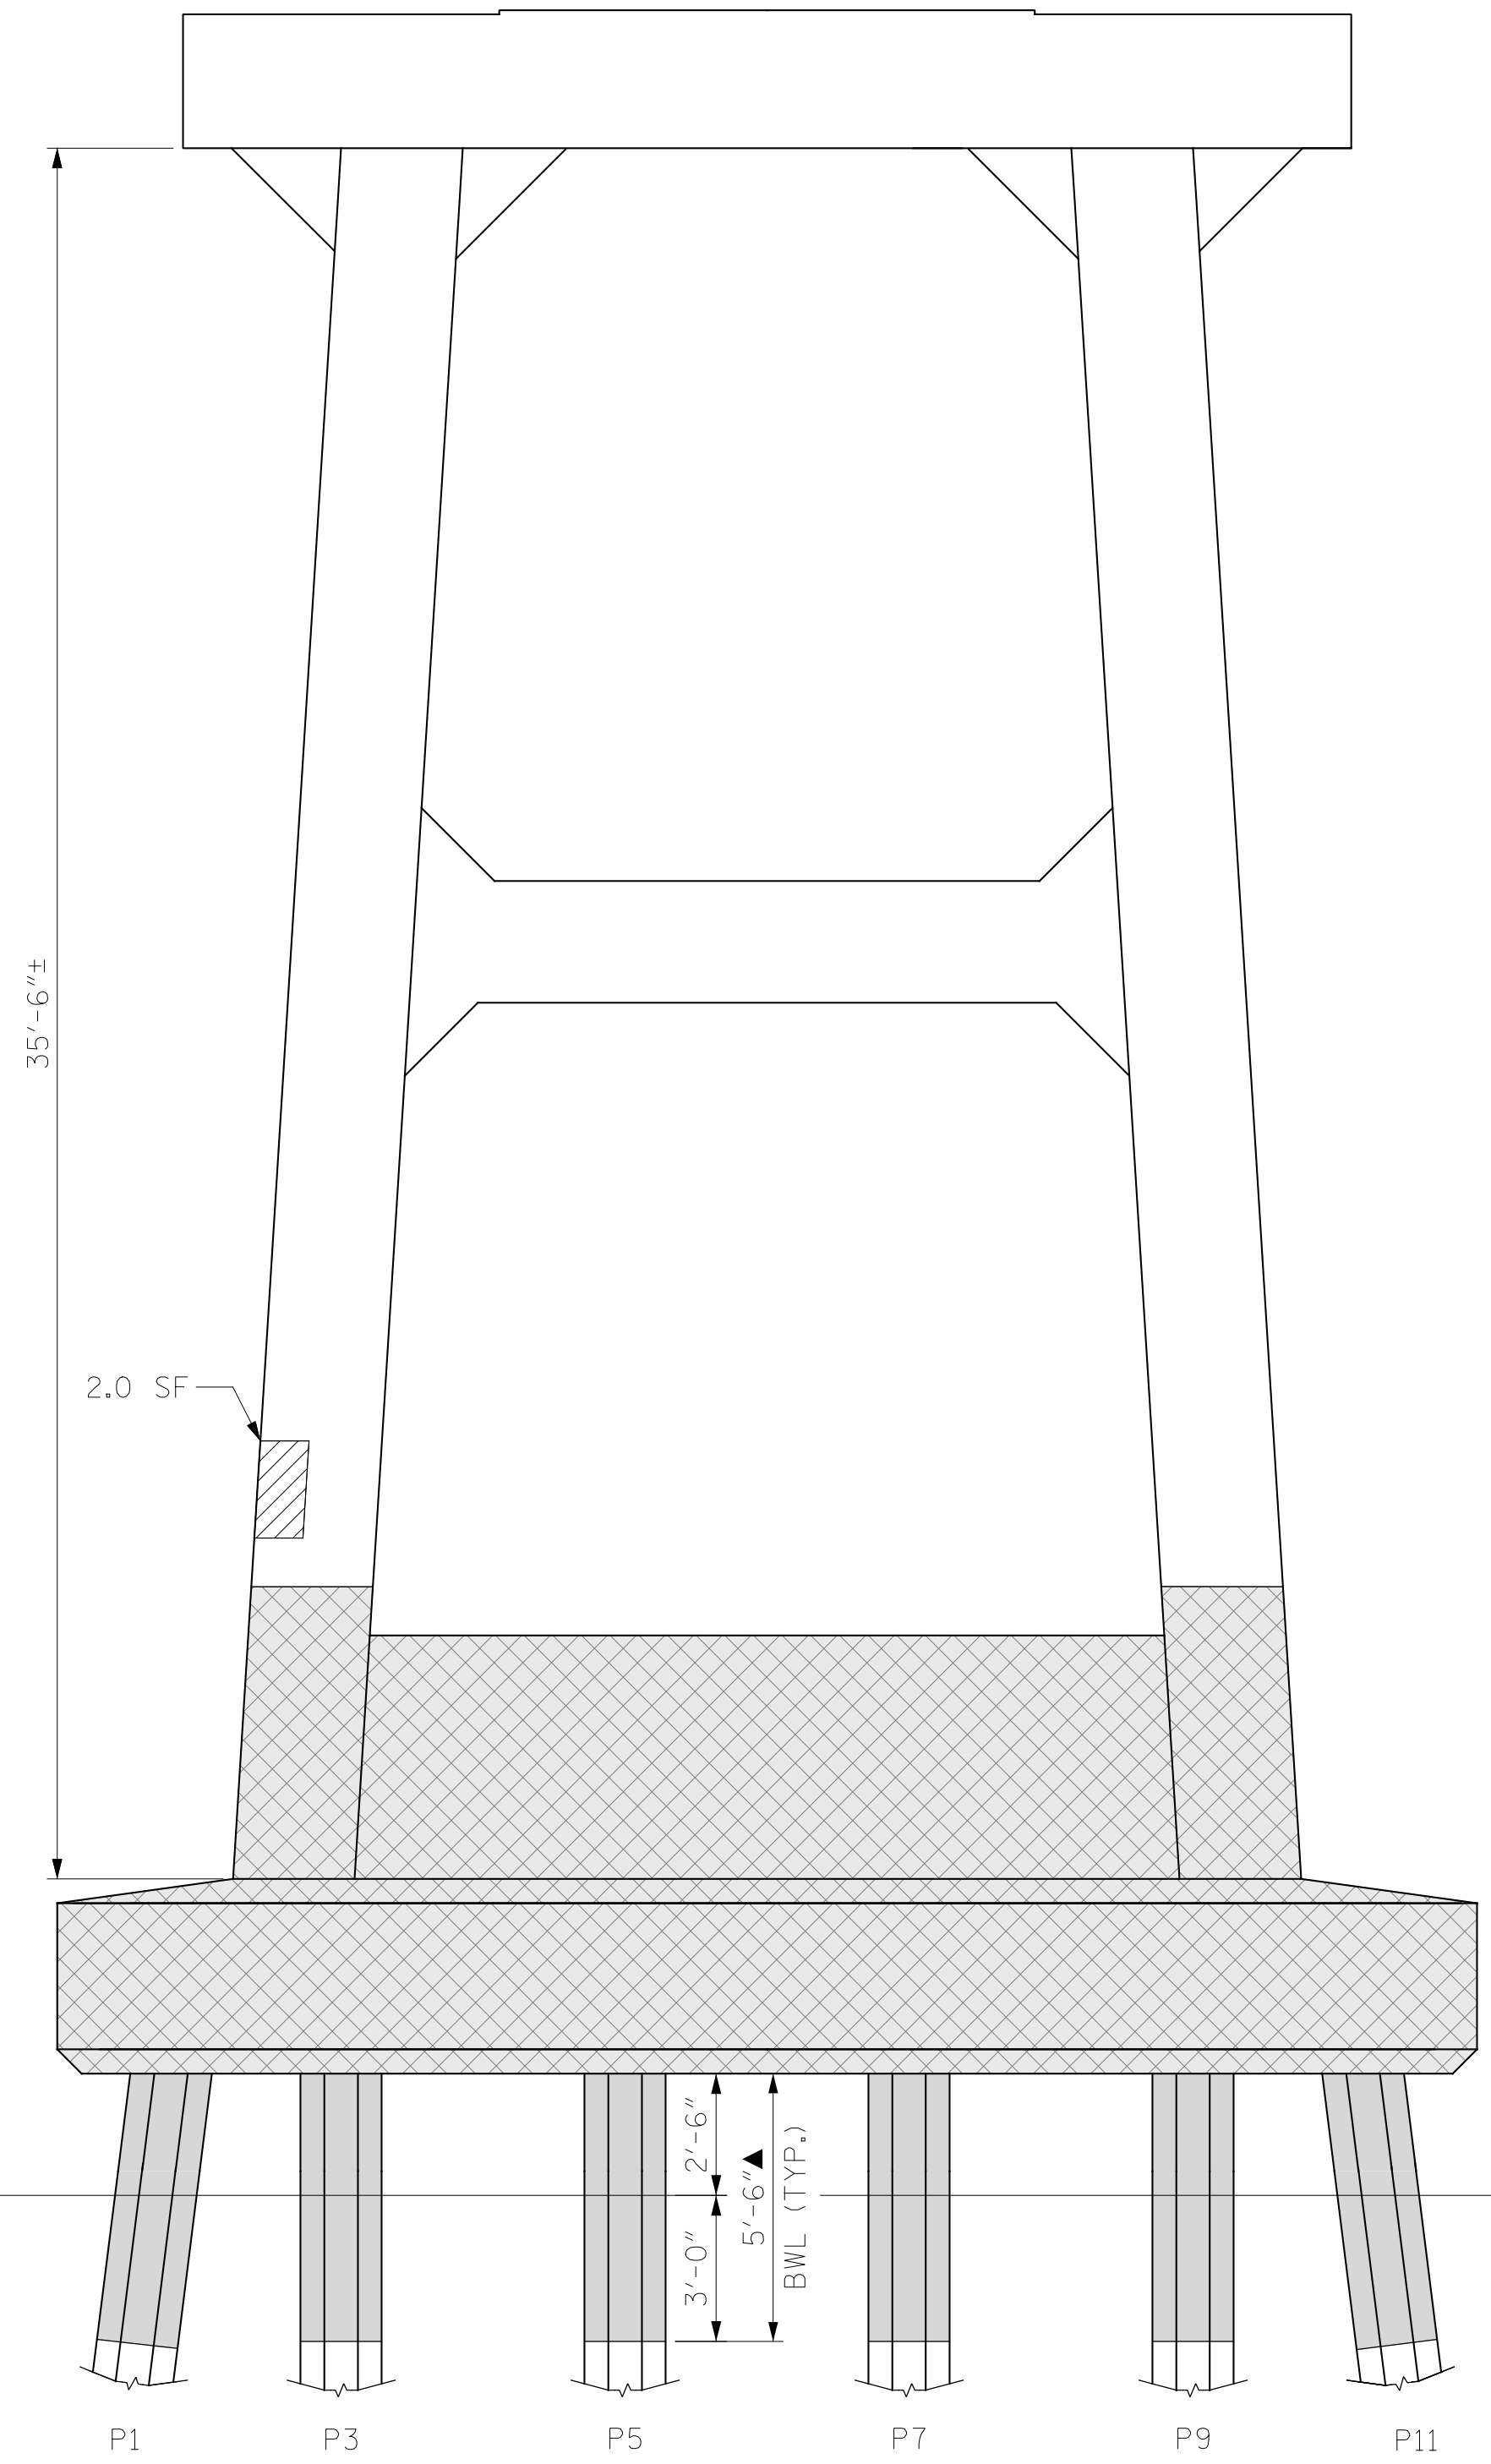
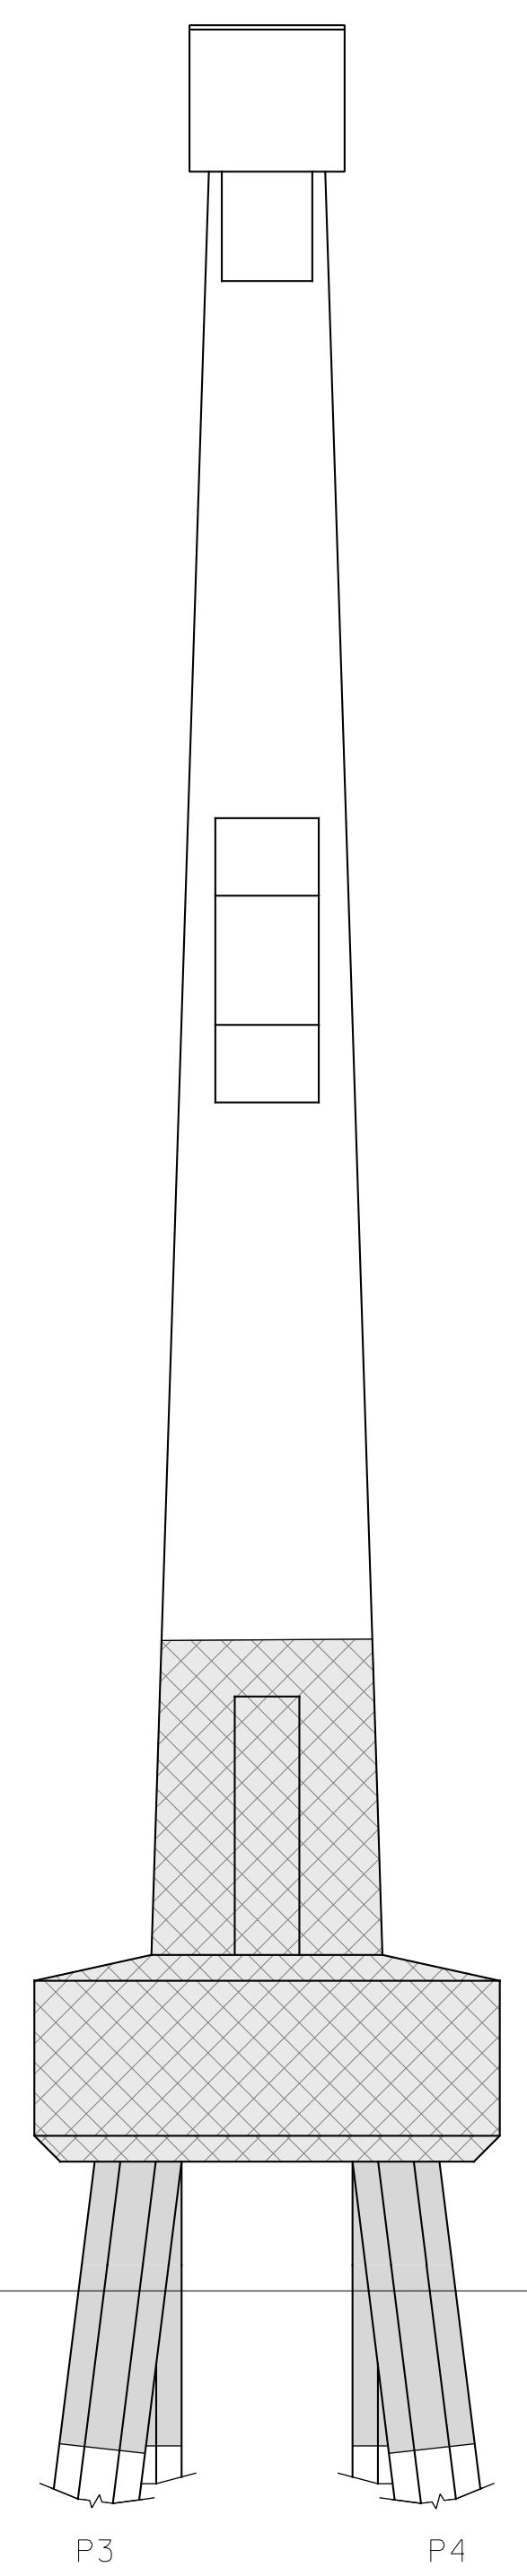
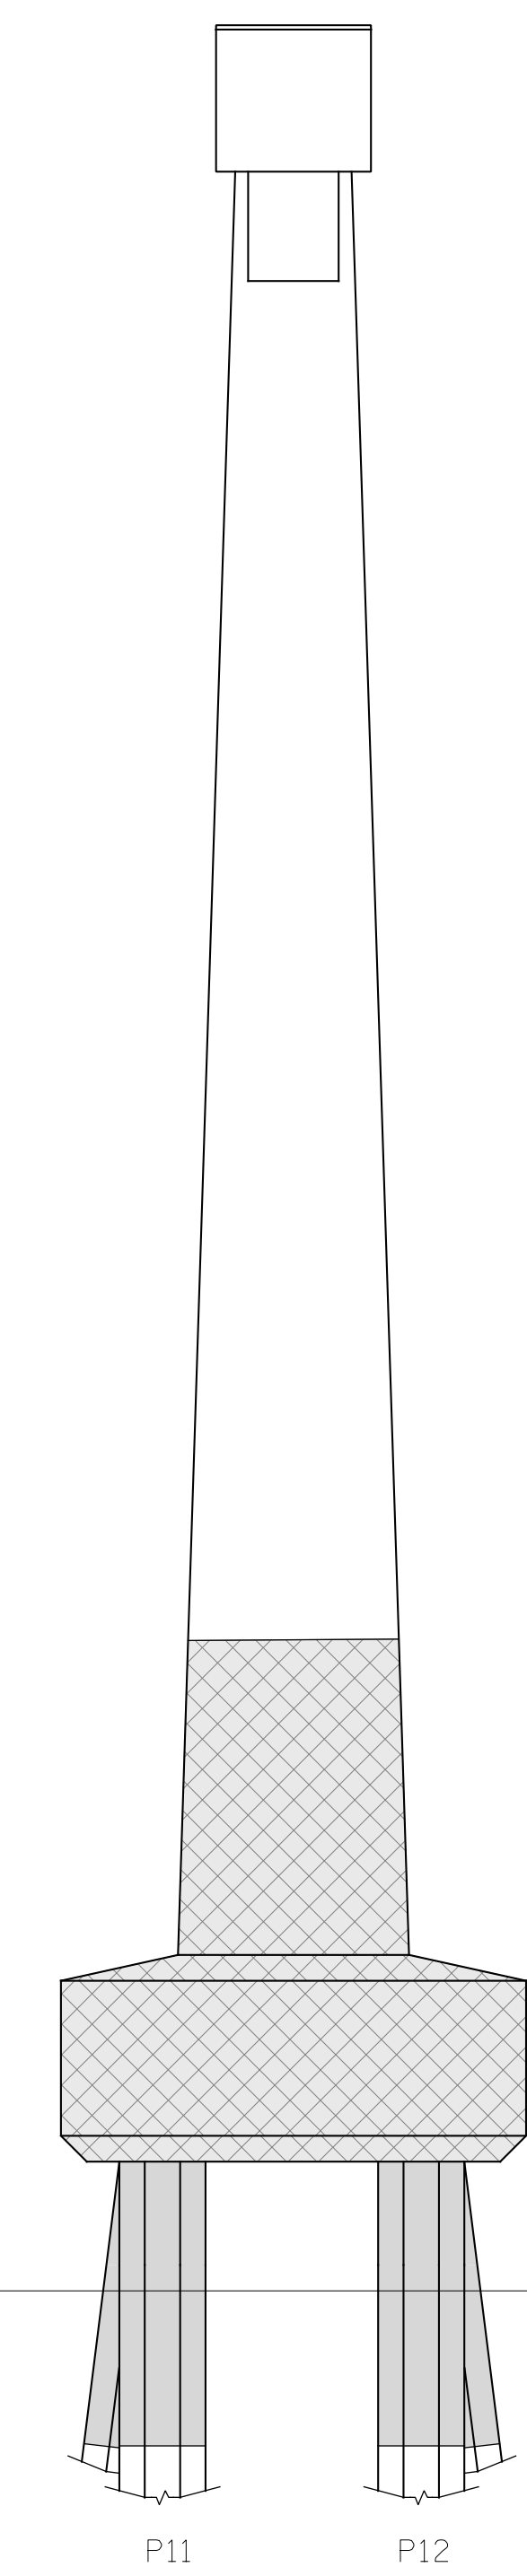
BENT 134
 (AWL = ABOVE WATERLINE)
 (BWL = BELOW WATERLINE)

CAP REPAIRS		ESTIMATE		ACTUAL	
SHOTCRETE REPAIRS	- SF	- CF	SF	CF	
EPOXY RESIN INJECTION	- LF			LF	
COLUMN REPAIRS		ESTIMATE		ACTUAL	
SHOTCRETE REPAIRS	49.4 SF	24.7 CF	SF	CF	
EPOXY RESIN INJECTION	- LF			LF	
PILE REPAIRS		ESTIMATE		ACTUAL	
FRP PROTECTIVE SYSTEM AWL	- SF			SF	
FRP PROTECTIVE SYSTEM BWL	363.0 SF			SF

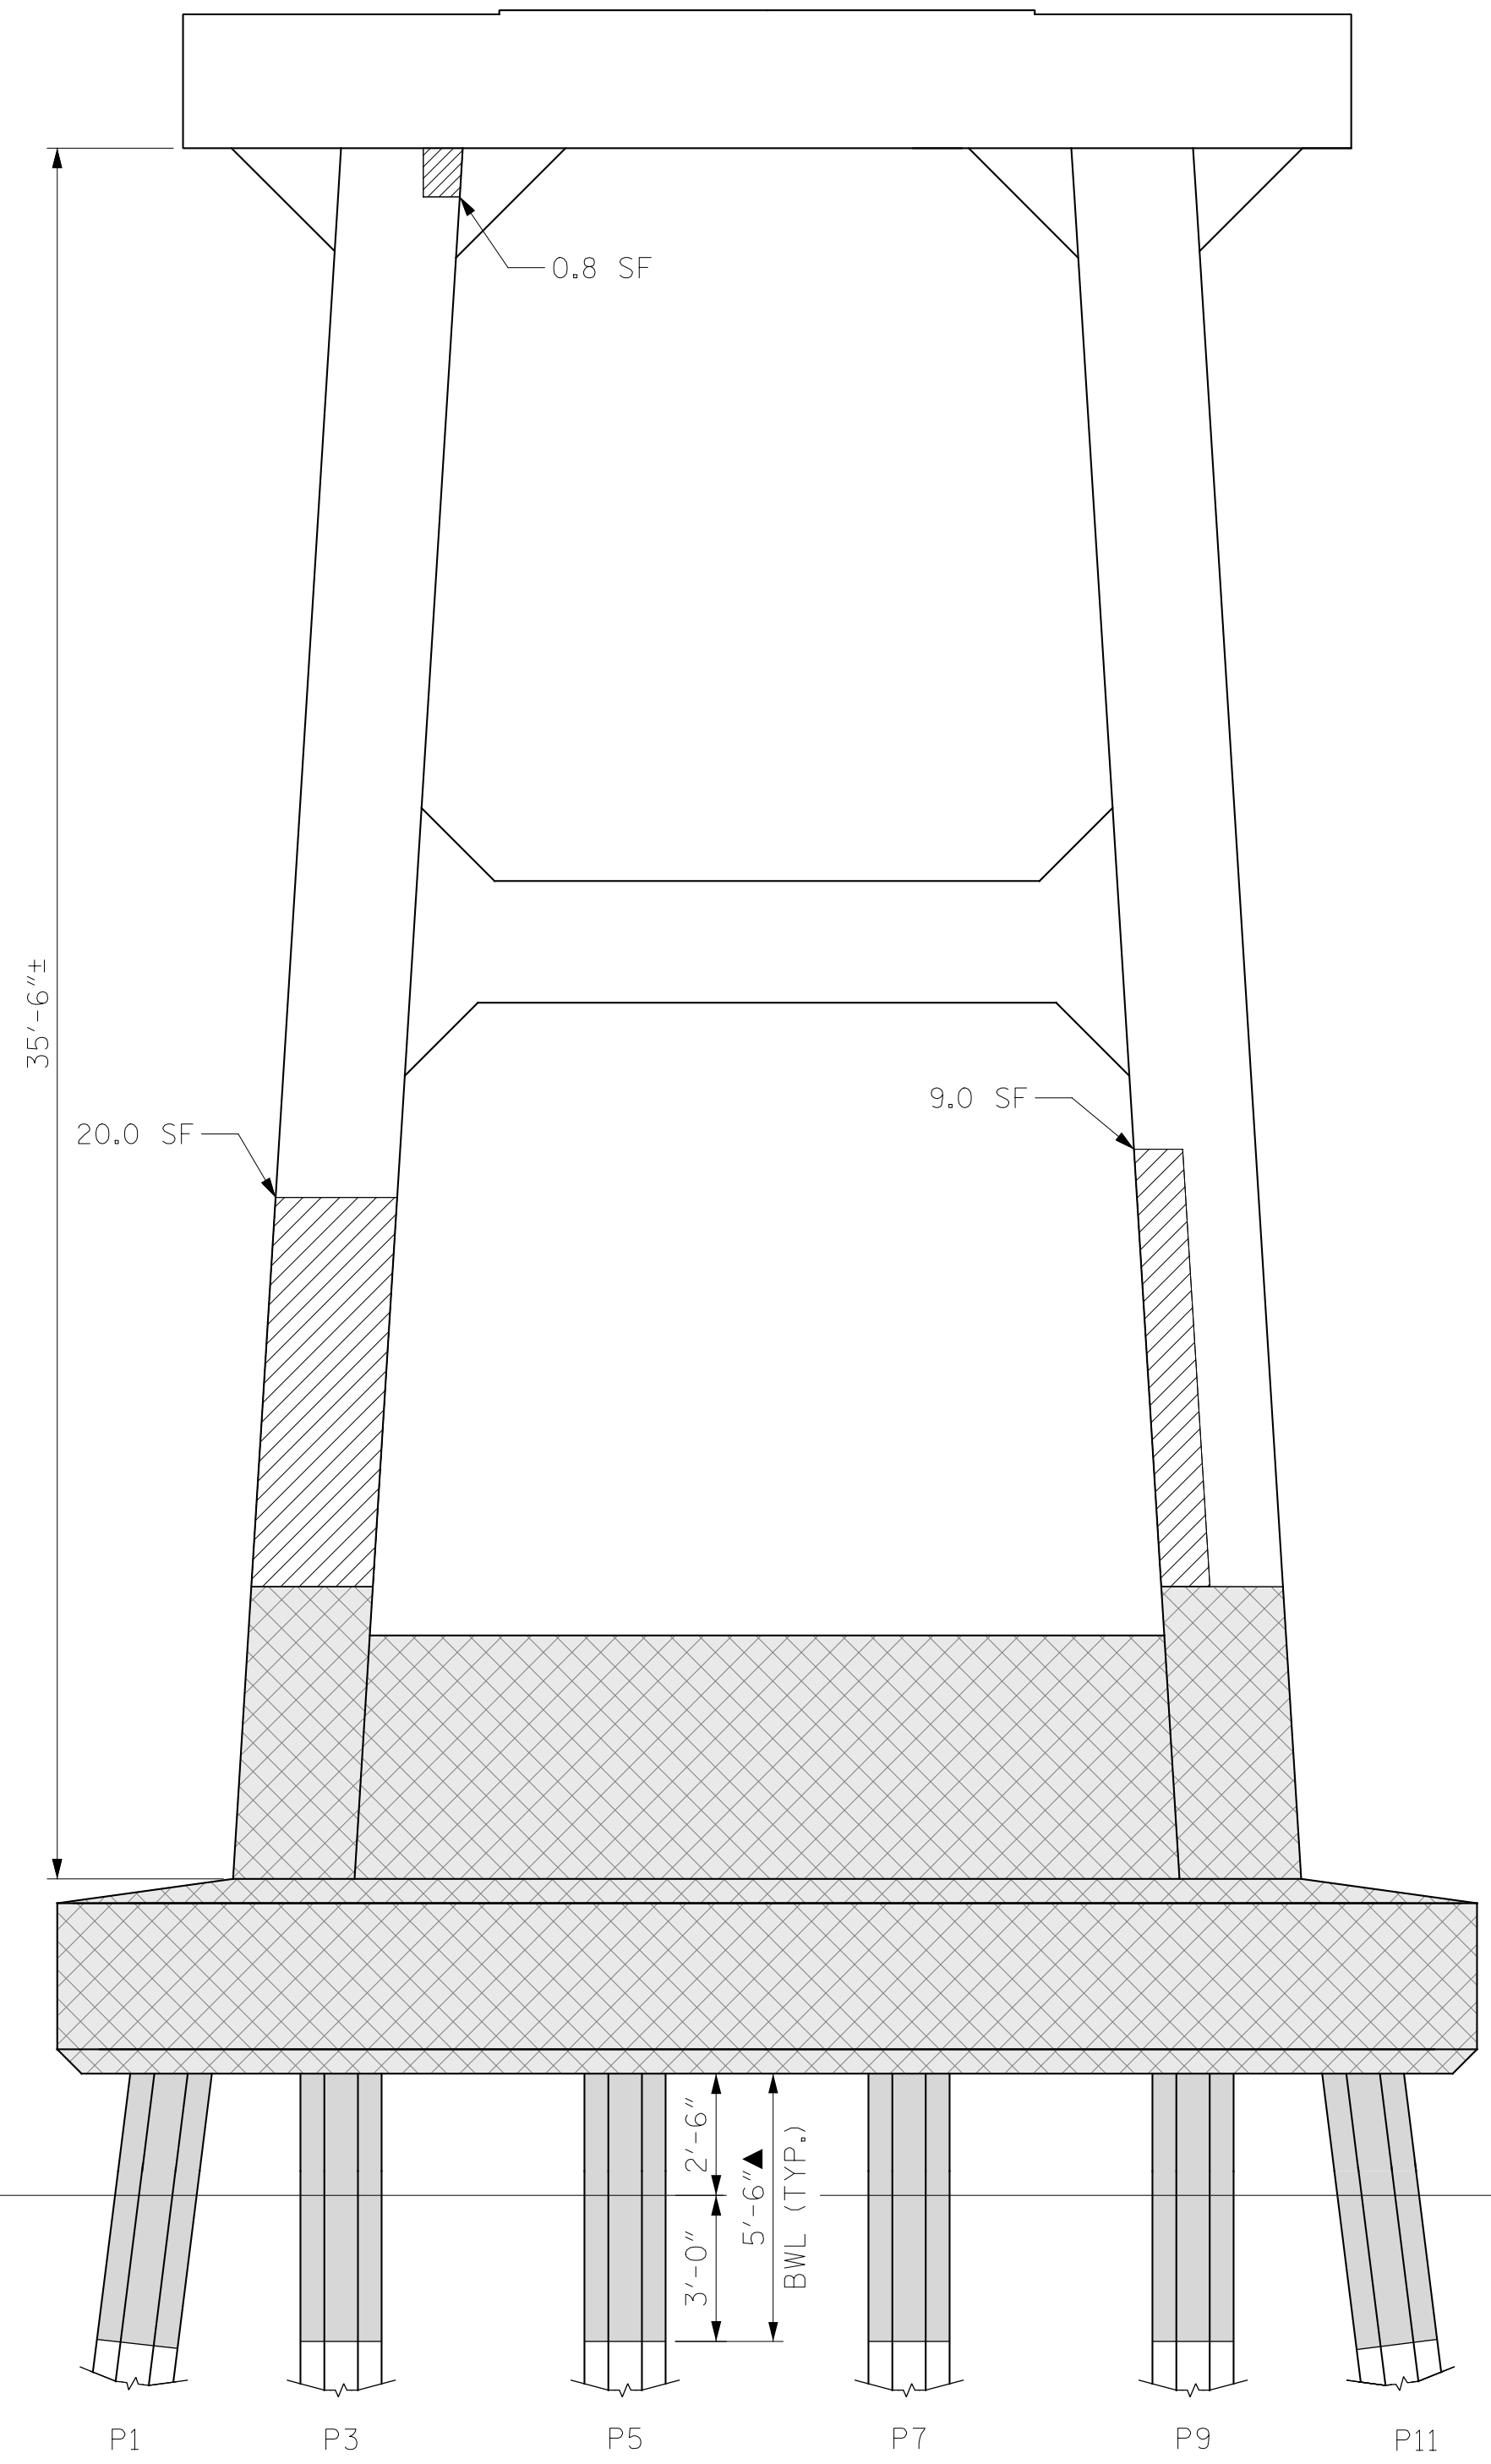
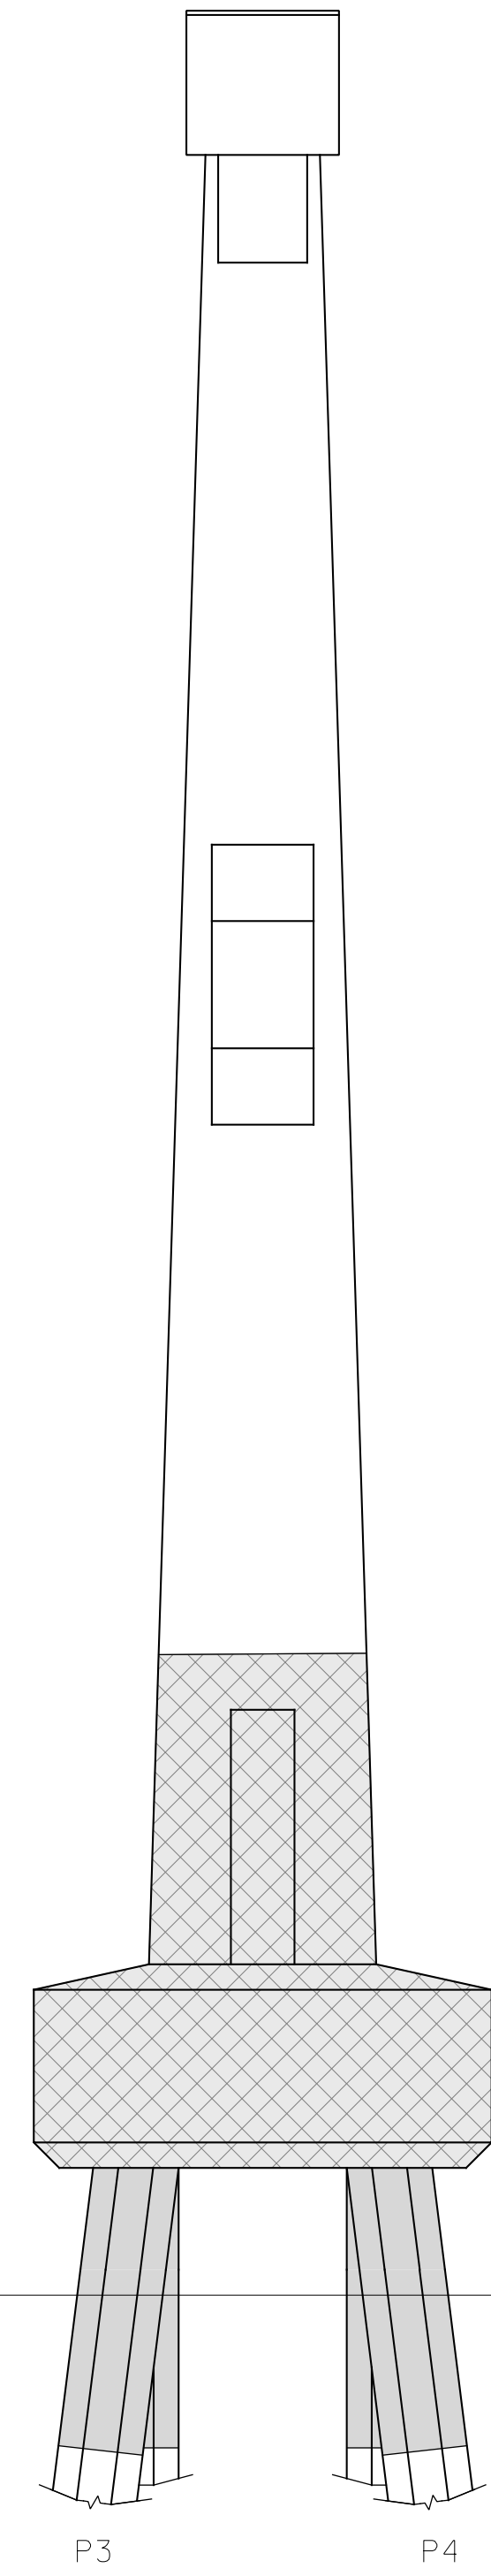
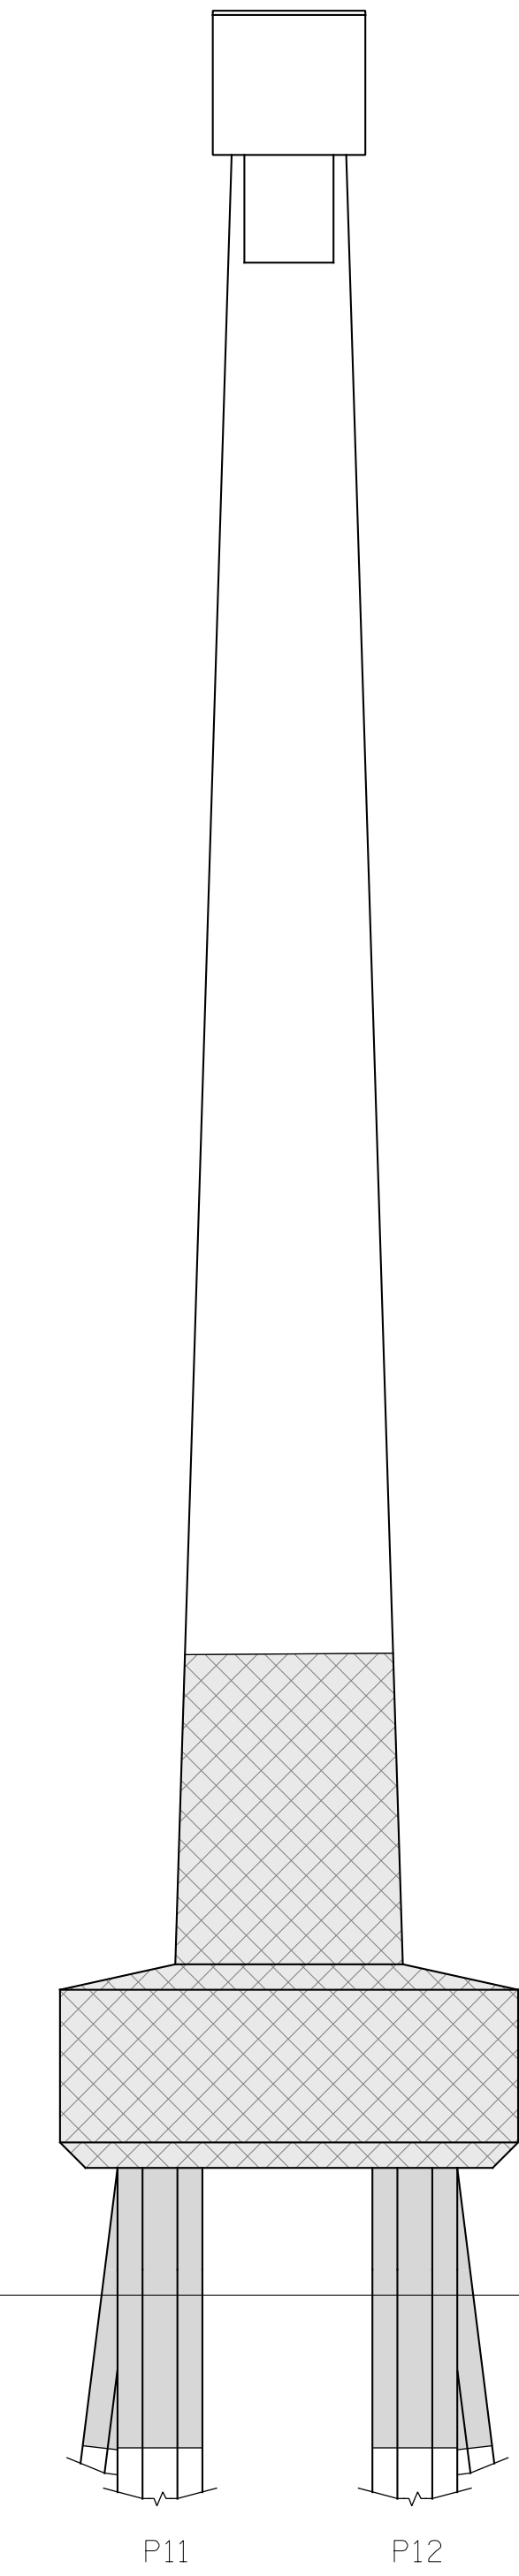
STATE OF NORTH CAROLINA DEPARTMENT OF TRANSPORTATION RALEIGH					
BENT 135 WEST FACE					
REVISIONS					SHEET NO.
NO.	BY:	DATE:	NO.	BY:	DATE:
1			3		
2			4		
TOTAL SHEETS					355

CAP REPAIRS		ESTIMATE		ACTUAL	
SHOTCRETE REPAIRS	- SF	- CF	SF	CF	
EPOXY RESIN INJECTION	- LF			LF	
COLUMN REPAIRS		ESTIMATE		ACTUAL	
SHOTCRETE REPAIRS	29.8 SF	14.9 CF	SF	CF	
EPOXY RESIN INJECTION	- LF			LF	
PILE REPAIRS		ESTIMATE		ACTUAL	
FRP PROTECTIVE SYSTEM AWL	- SF			SF	
FRP PROTECTIVE SYSTEM BWL	363.0 SF			SF
