AS-BUILT REPAIR QUANTITY TABLE

PROJECT NO. HB-0017
DARE COUNTY
BRIDGE NO. 270009

BENT 73 & BENT 74

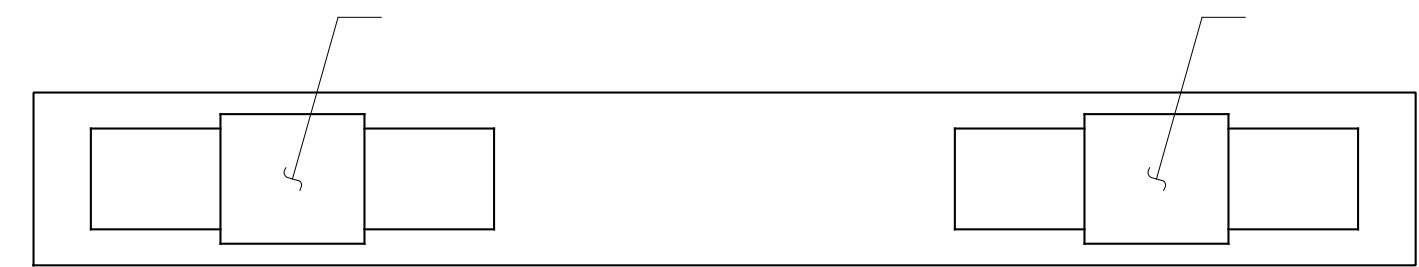
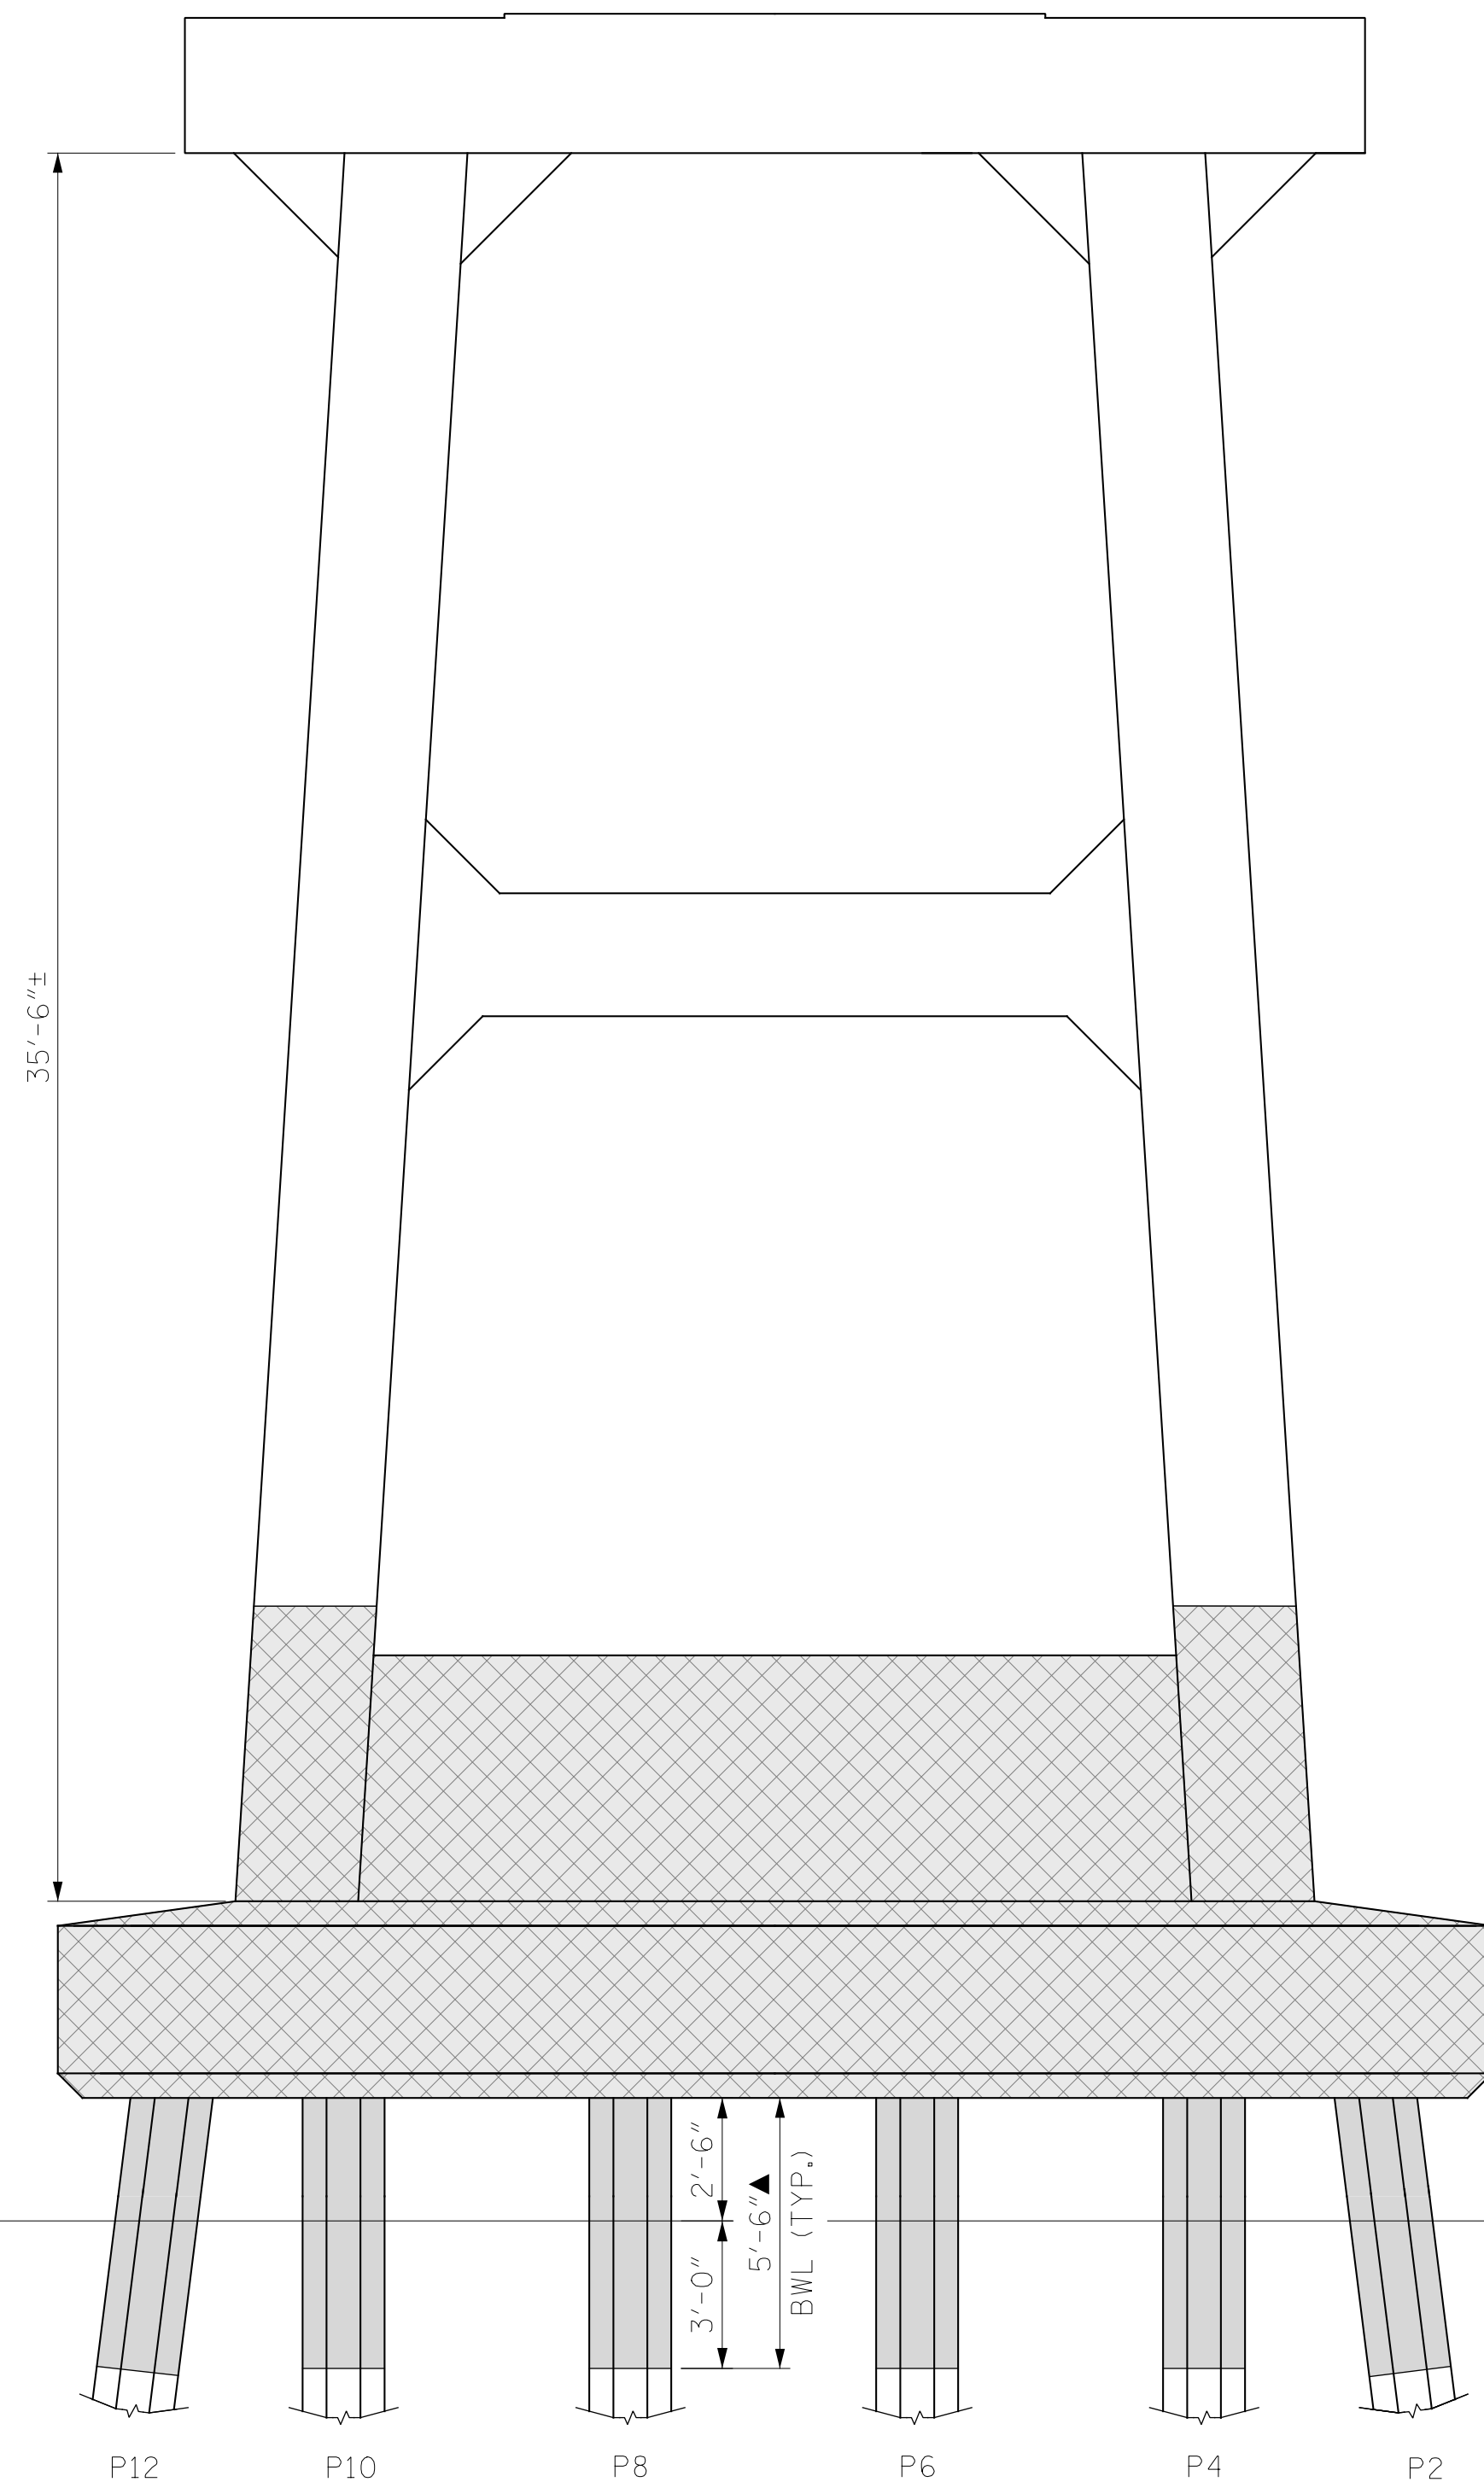
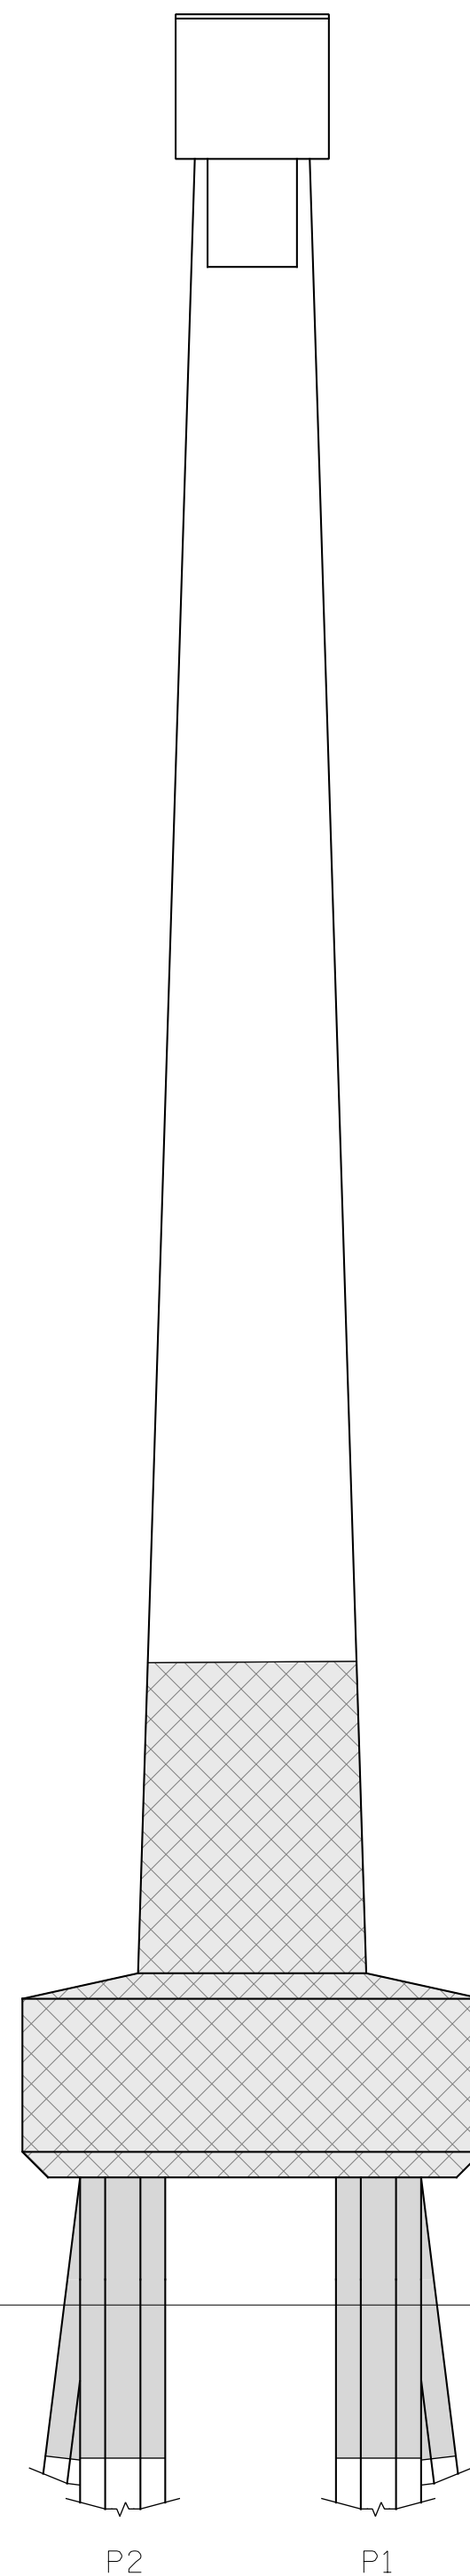
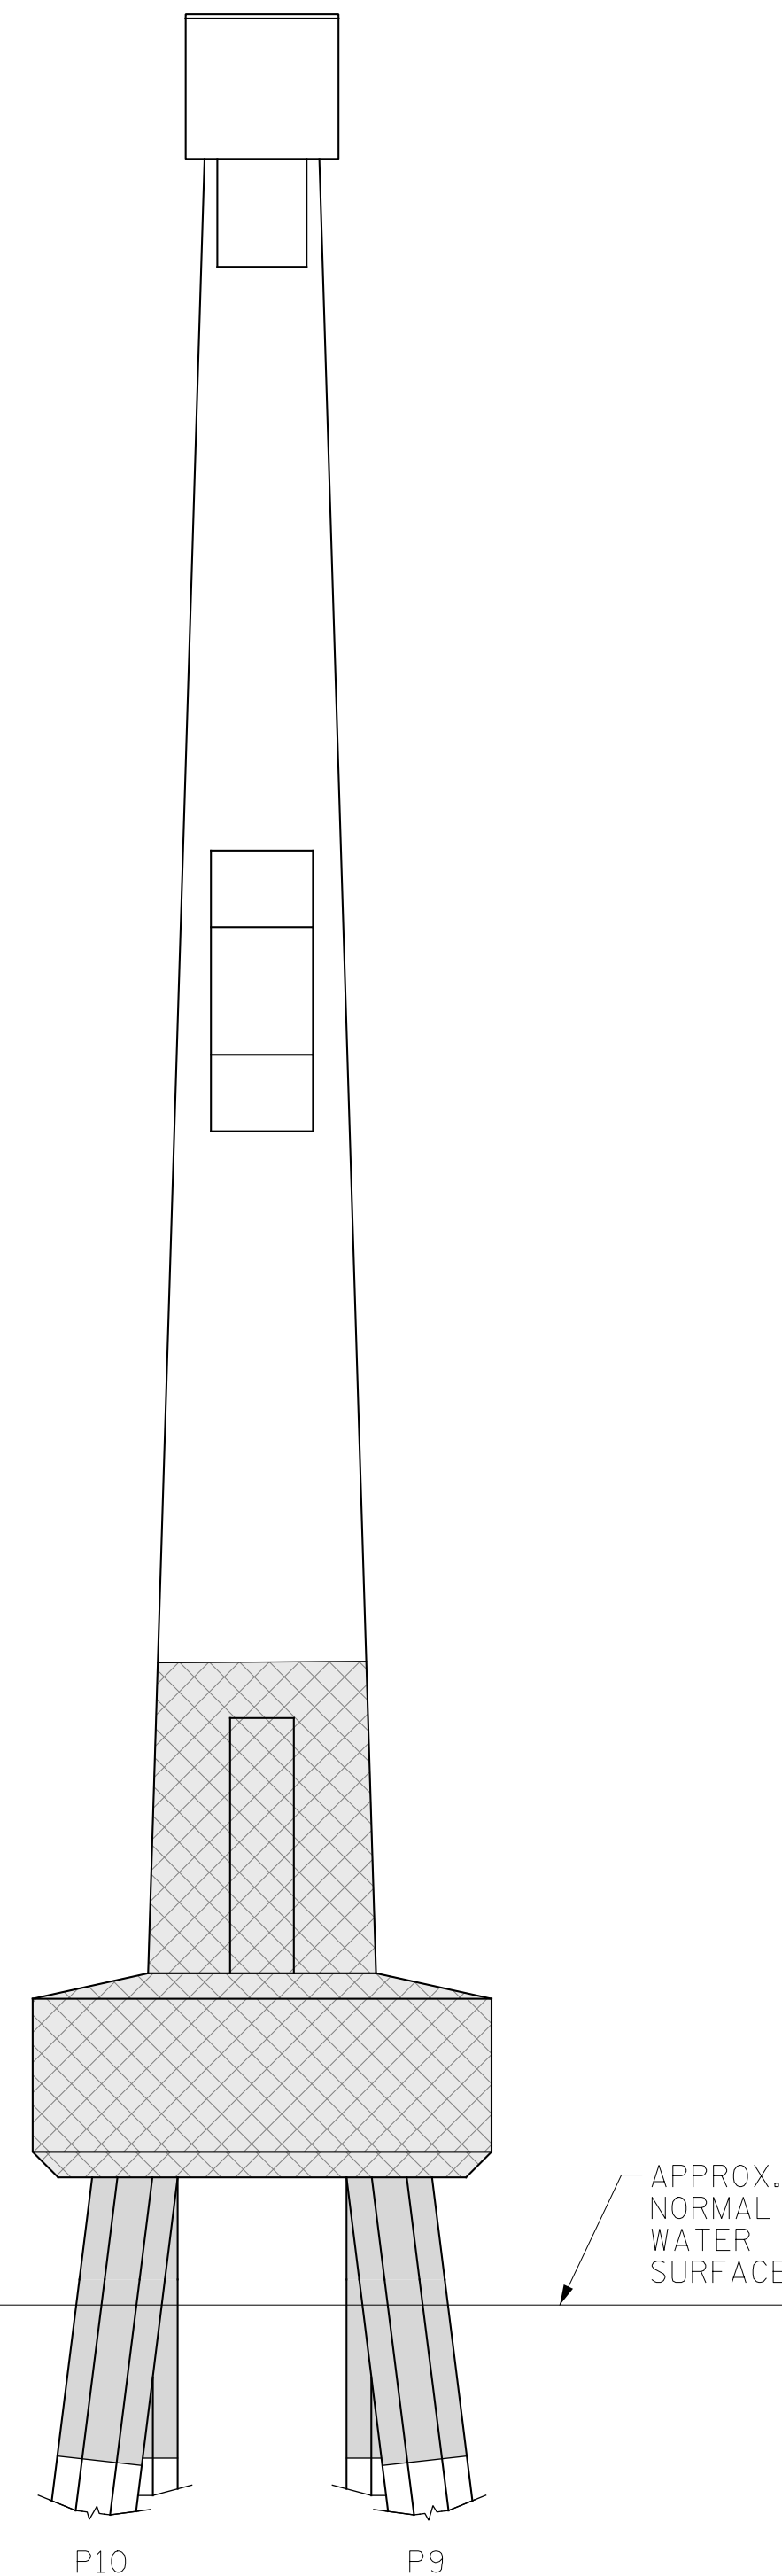
BENT 135
 EAST FACE

CAP REPAIRS		ESTIMATE		ACTUAL	
SHOTCRETE REPAIRS	- SF	- CF	SF	CF	
EPOXY RESIN INJECTION	- LF			LF	
COLUMN REPAIRS		ESTIMATE		ACTUAL	
SHOTCRETE REPAIRS	29.8 SF	14.9 CF	SF	CF	
EPOXY RESIN INJECTION	- LF			LF	
PILE REPAIRS		ESTIMATE		ACTUAL	
FRP PROTECTIVE SYSTEM AWL	- SF			SF	
FRP PROTECTIVE SYSTEM BWL	363.0 SF			SF

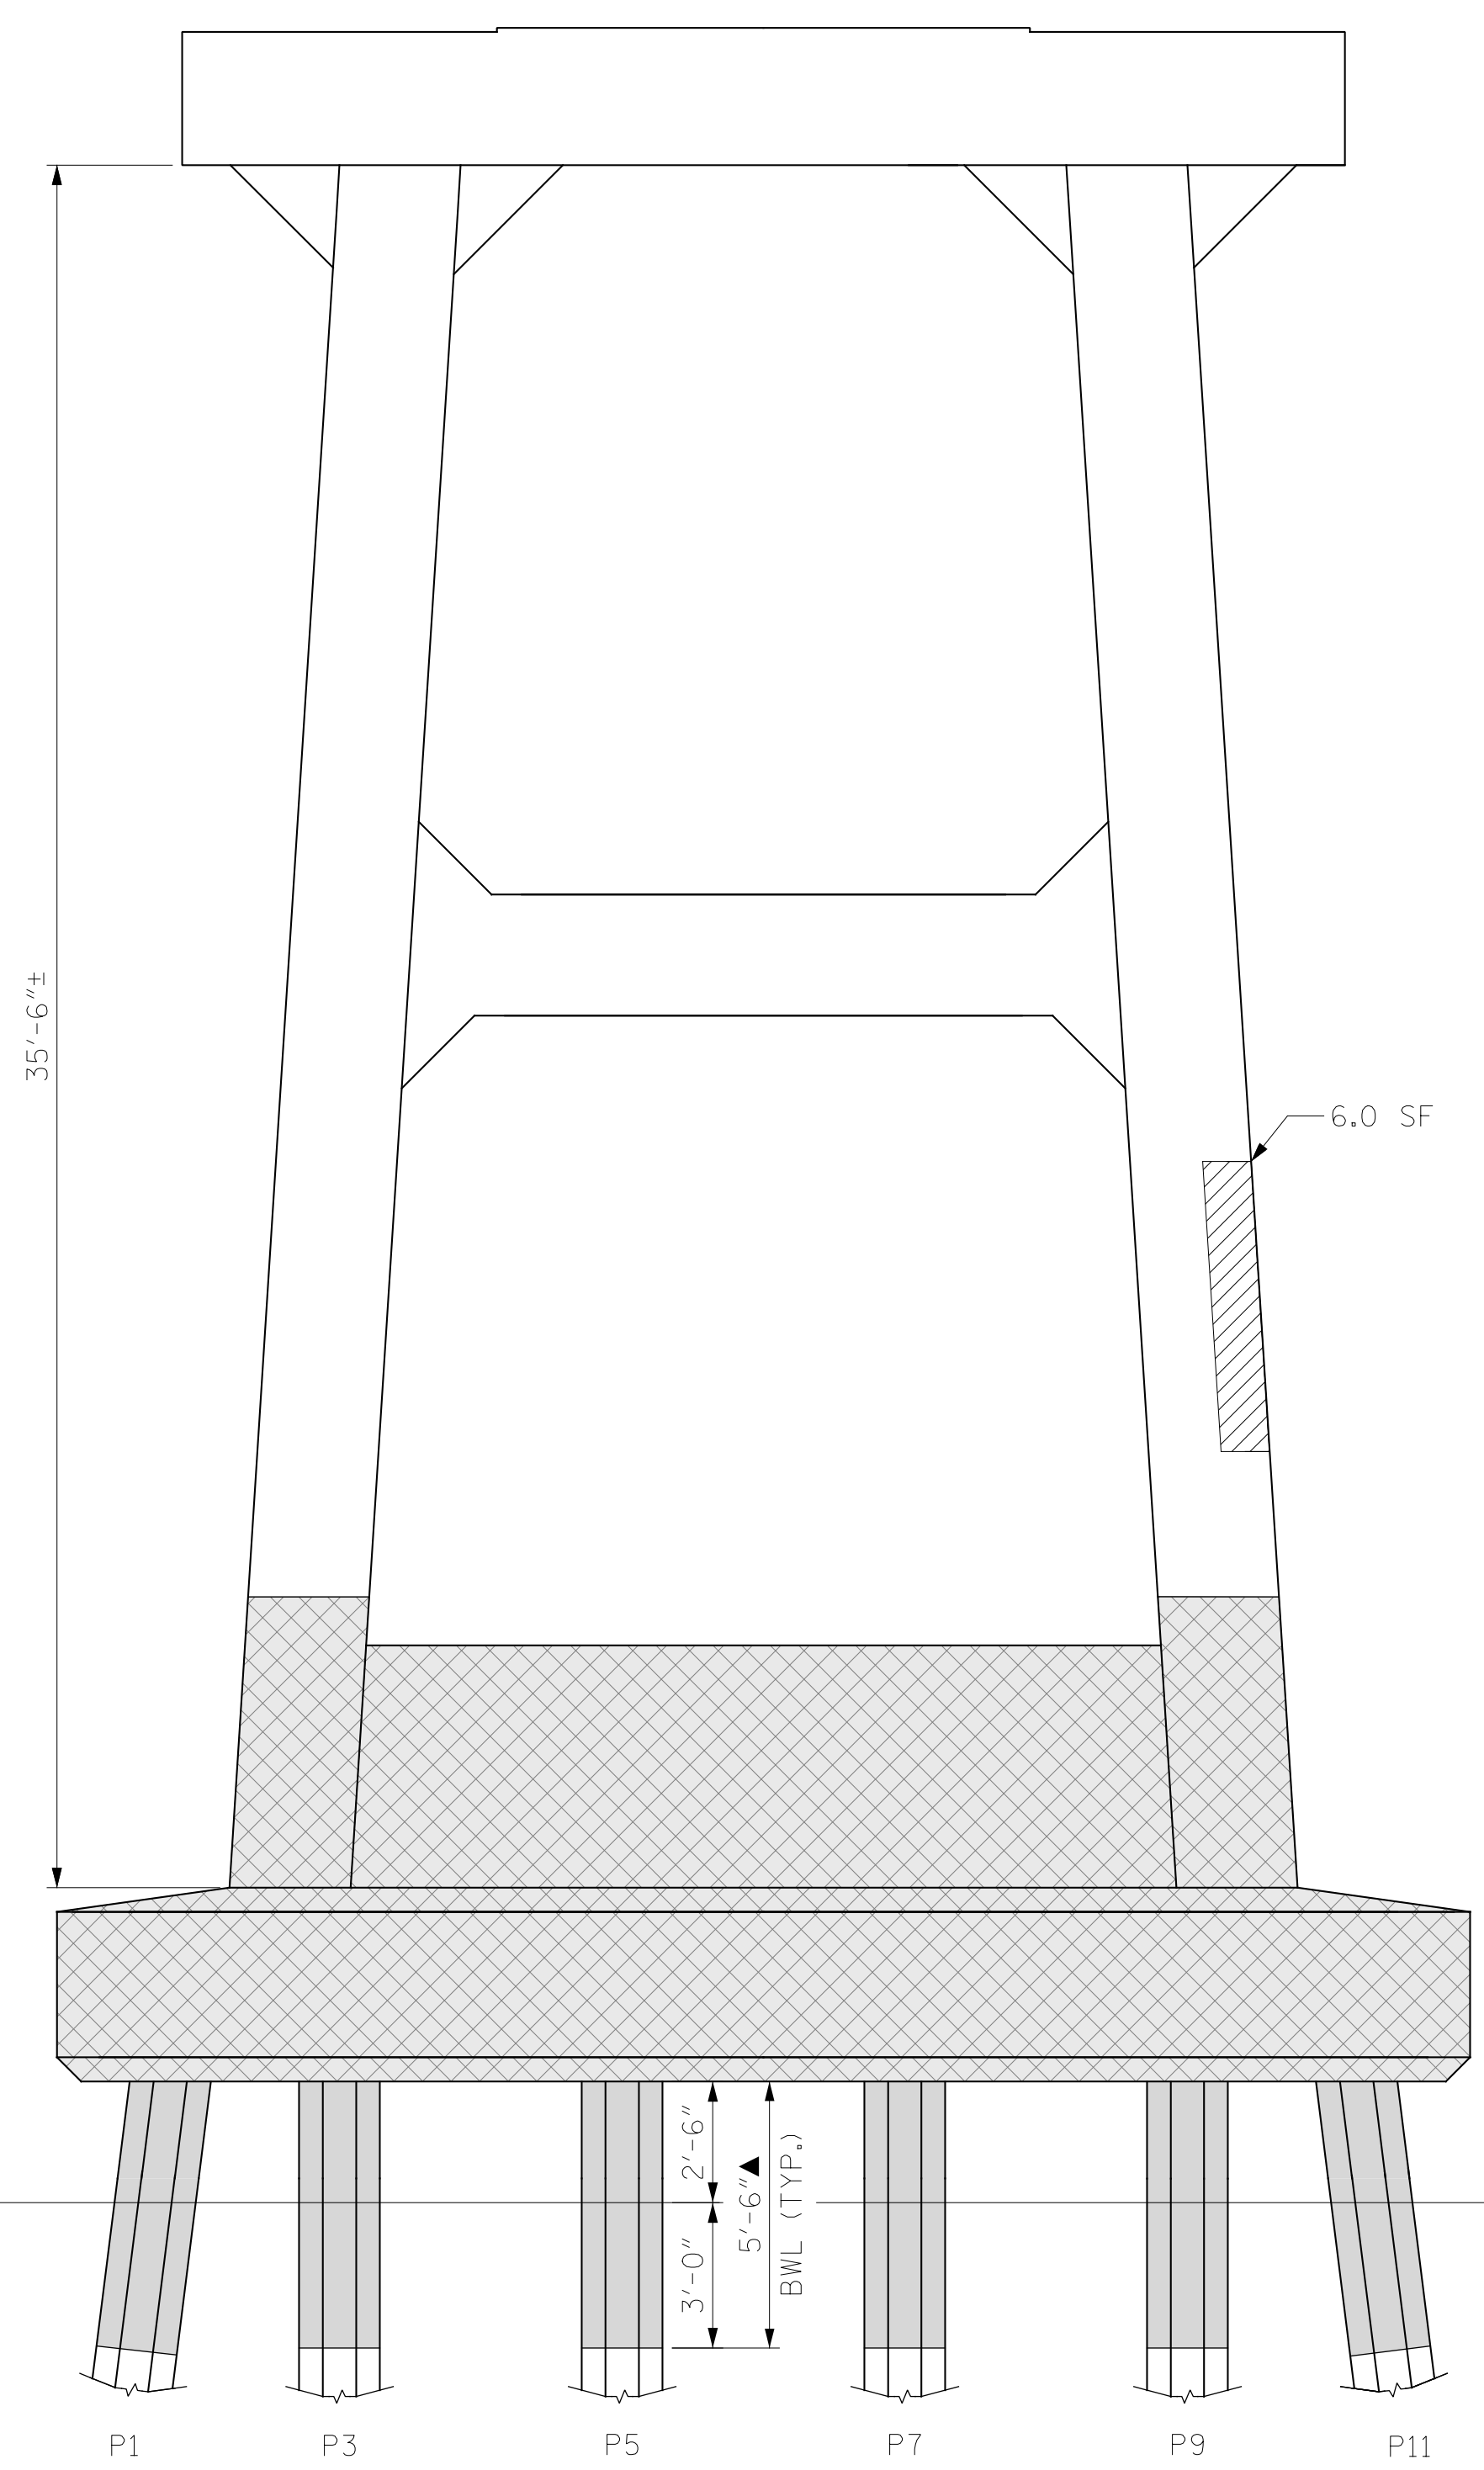
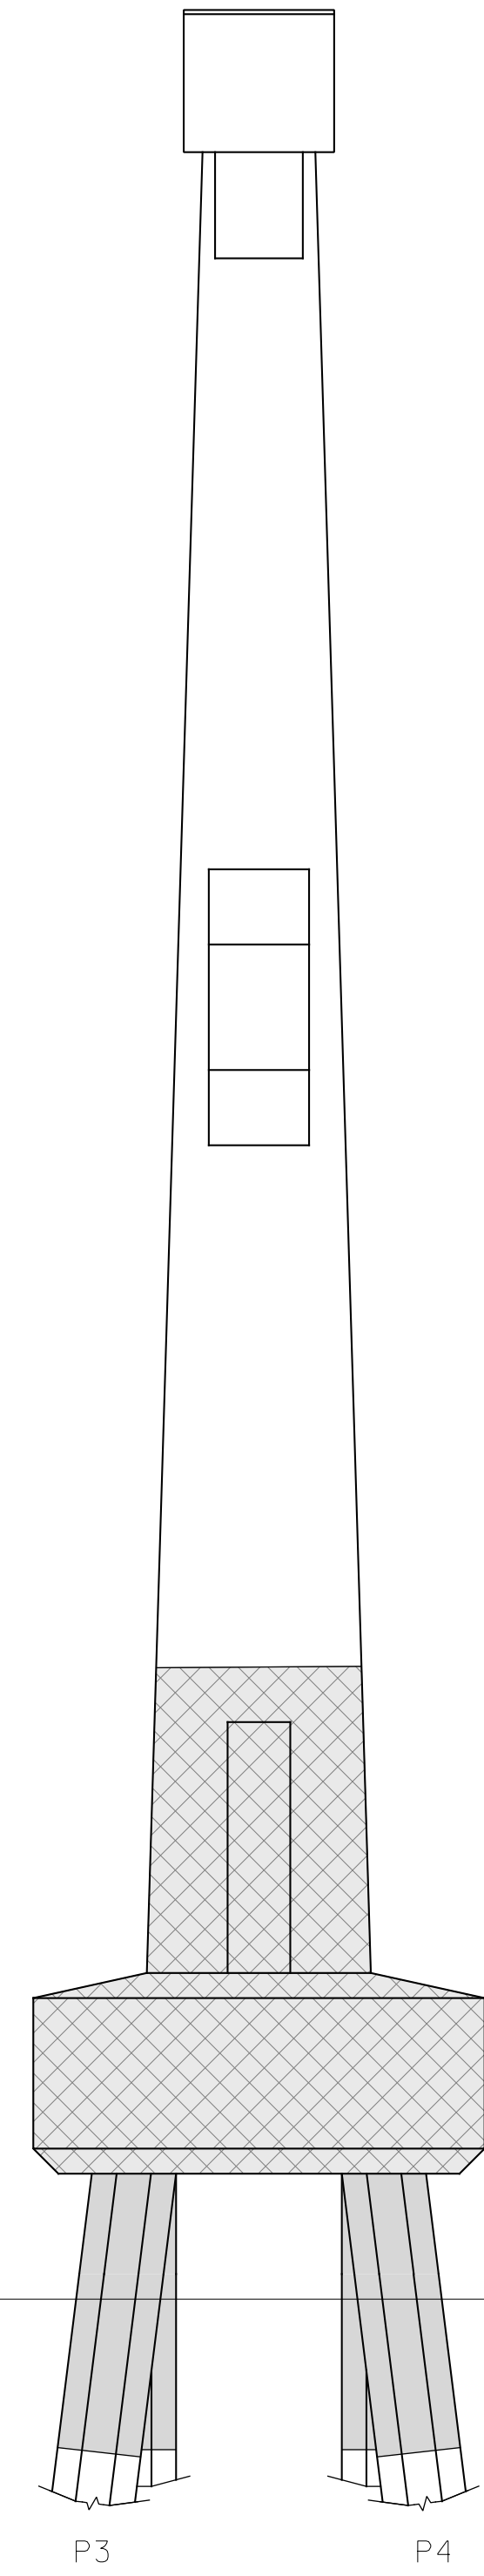
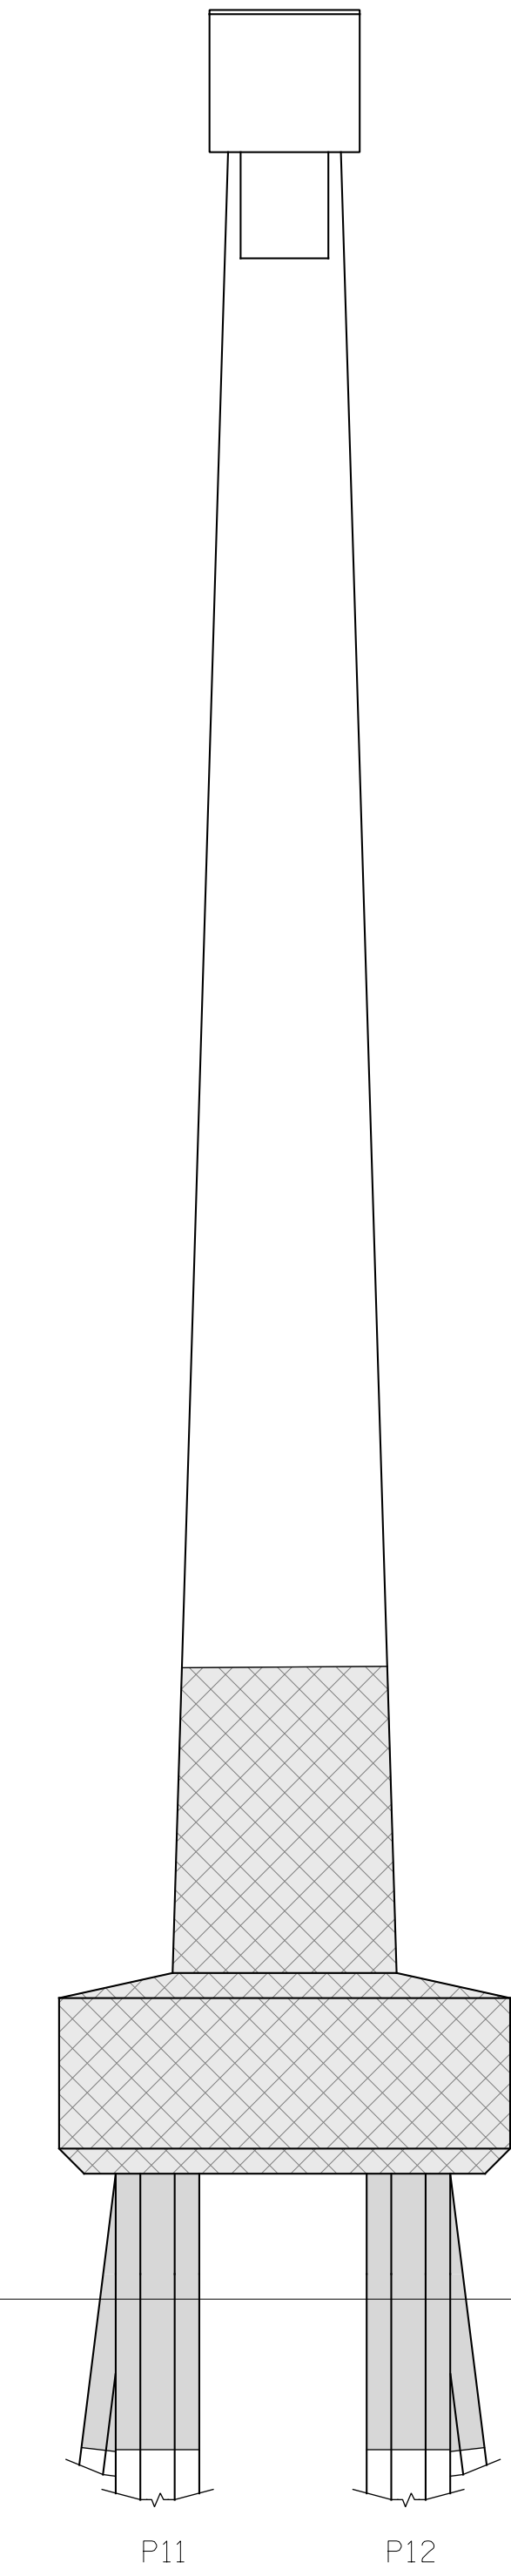
BENT 136

CAP REPAIRS		ESTIMATE		ACTUAL	
SHOTCRETE REPAIRS	0.8 SF	0.4 CF	SF	CF	
EPOXY RESIN INJECTION	- LF				LF
COLUMN REPAIRS		ESTIMATE		ACTUAL	
SHOTCRETE REPAIRS	46.0 SF	23.0 CF	SF	CF	
EPOXY RESIN INJECTION	5.3 LF				LF
PILE REPAIRS		ESTIMATE		ACTUAL	
FRP PROTECTIVE SYSTEM AWL	- SF				SF
FRP PROTECTIVE SYSTEM BWL	363.0 SF				SF

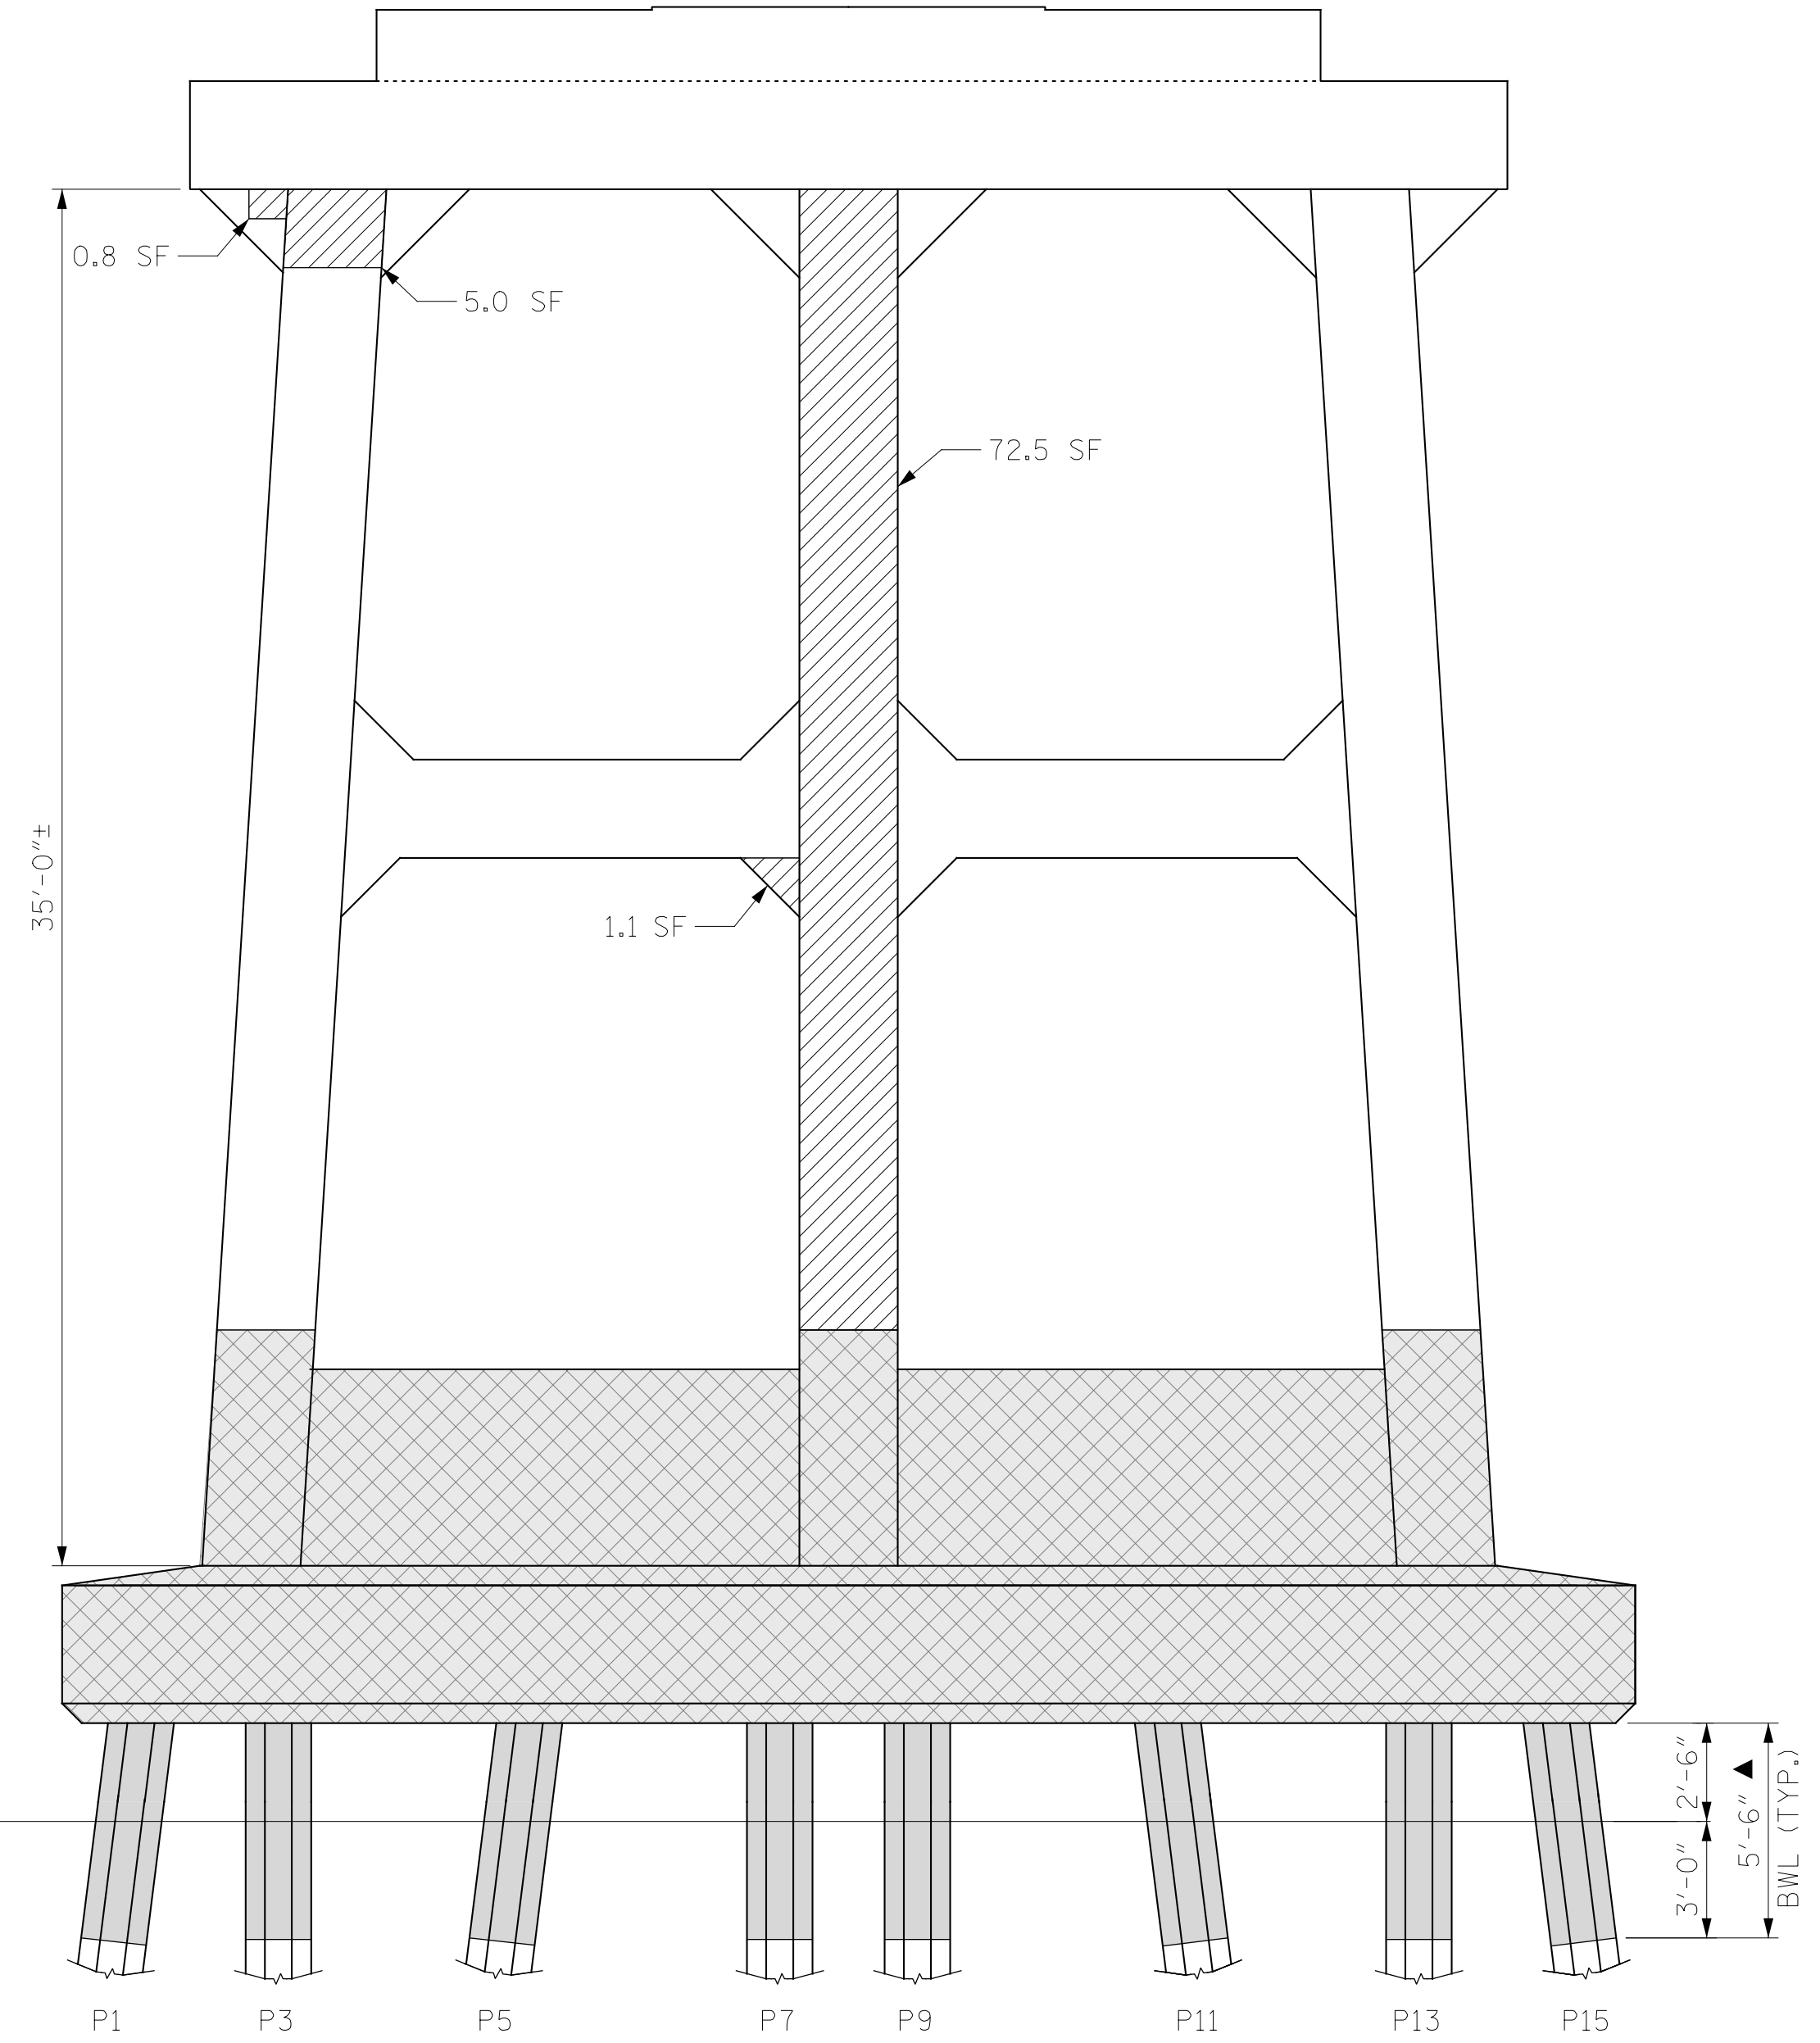
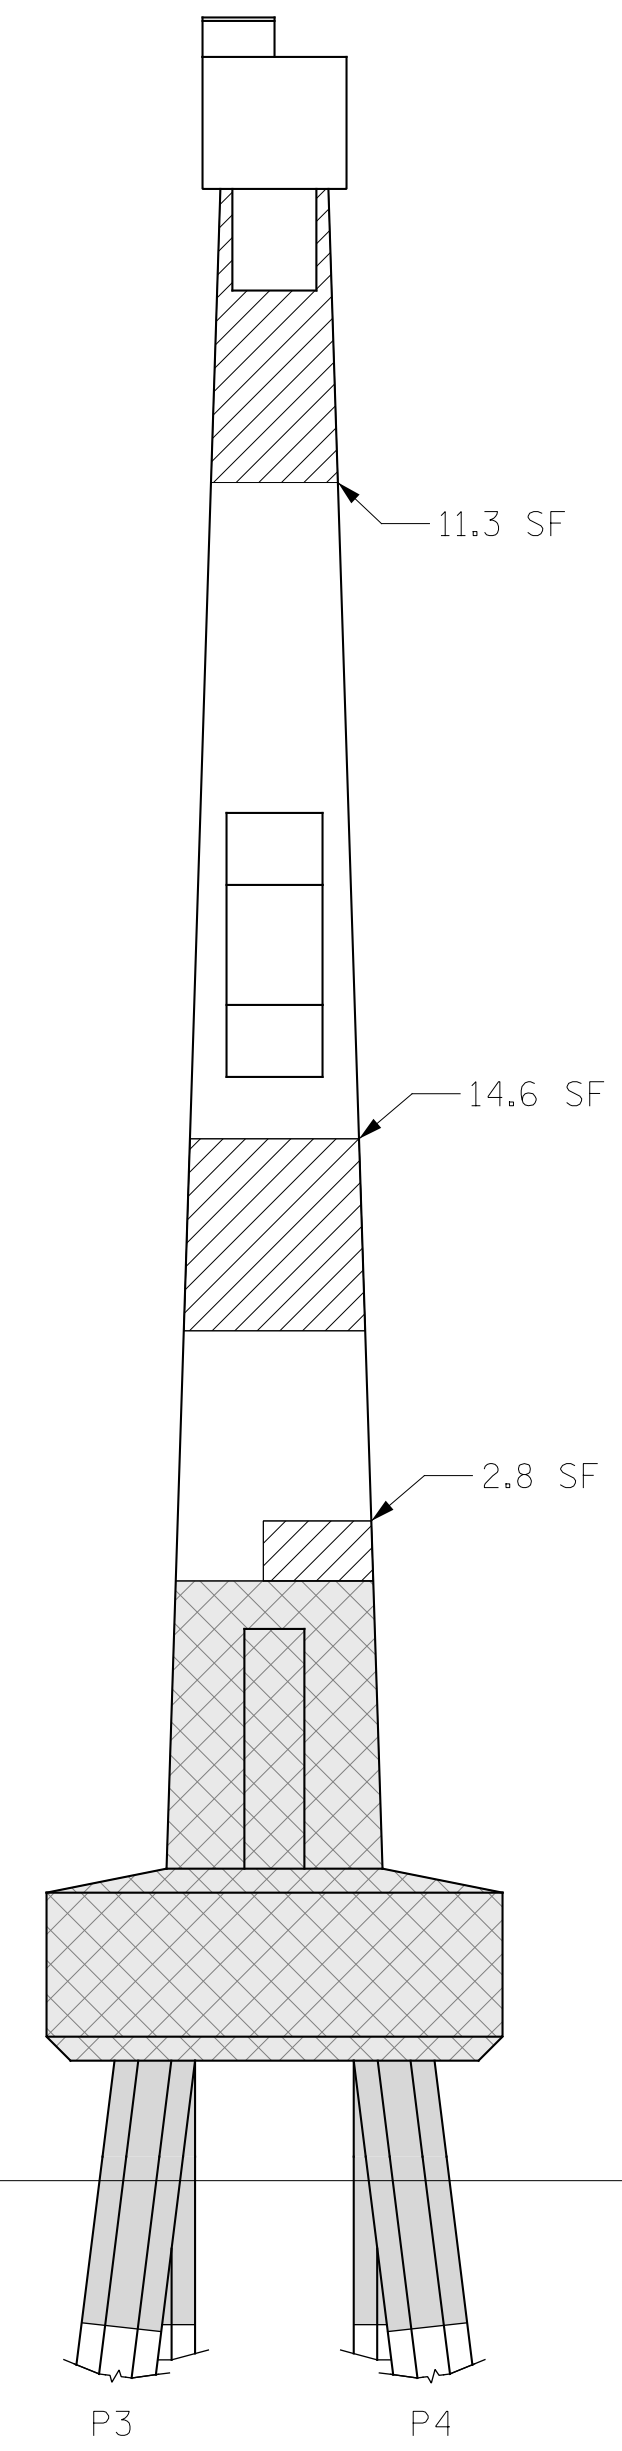
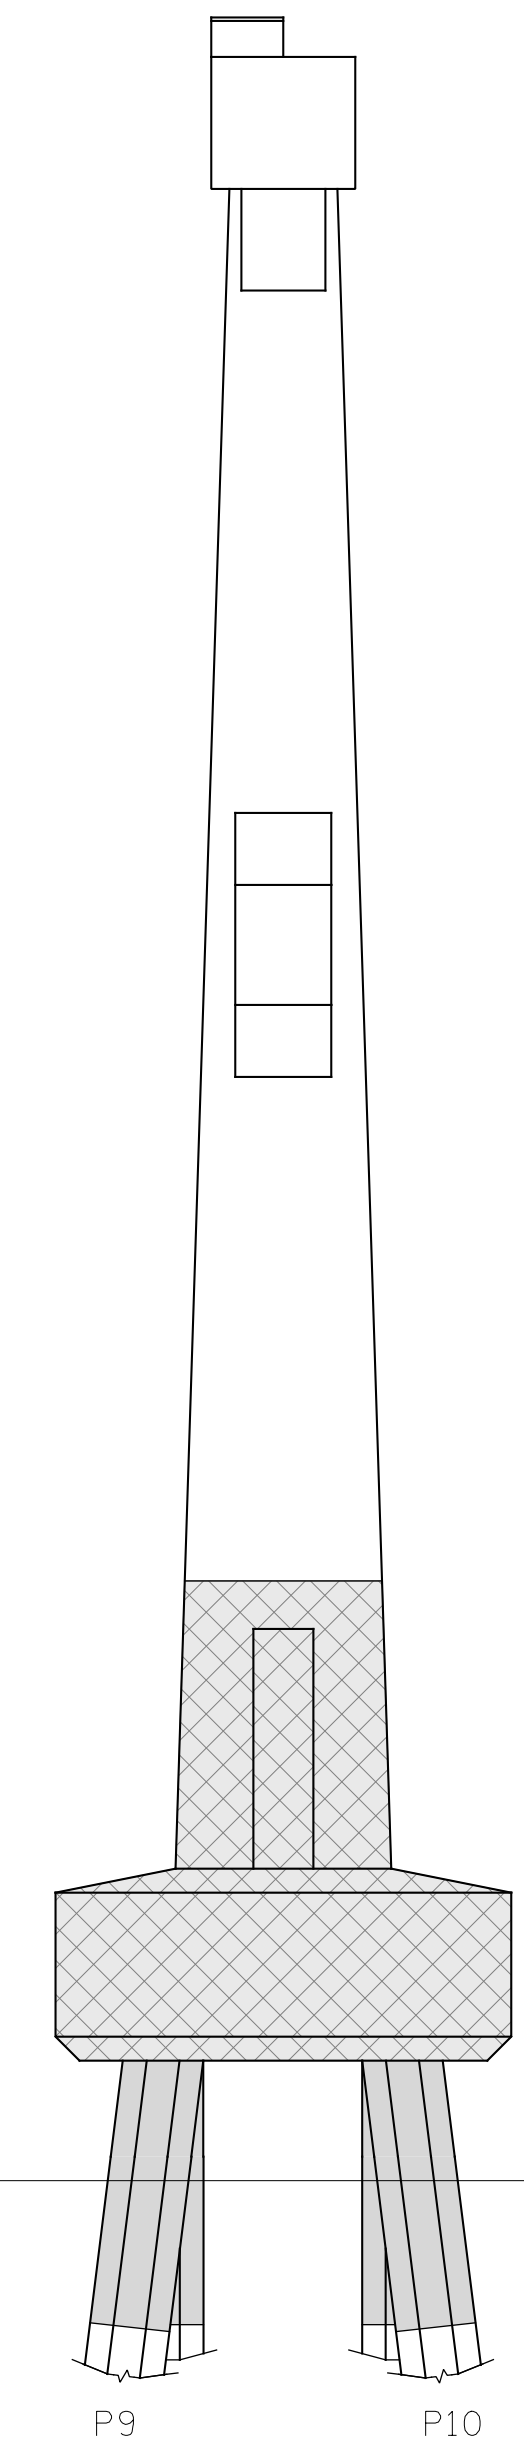
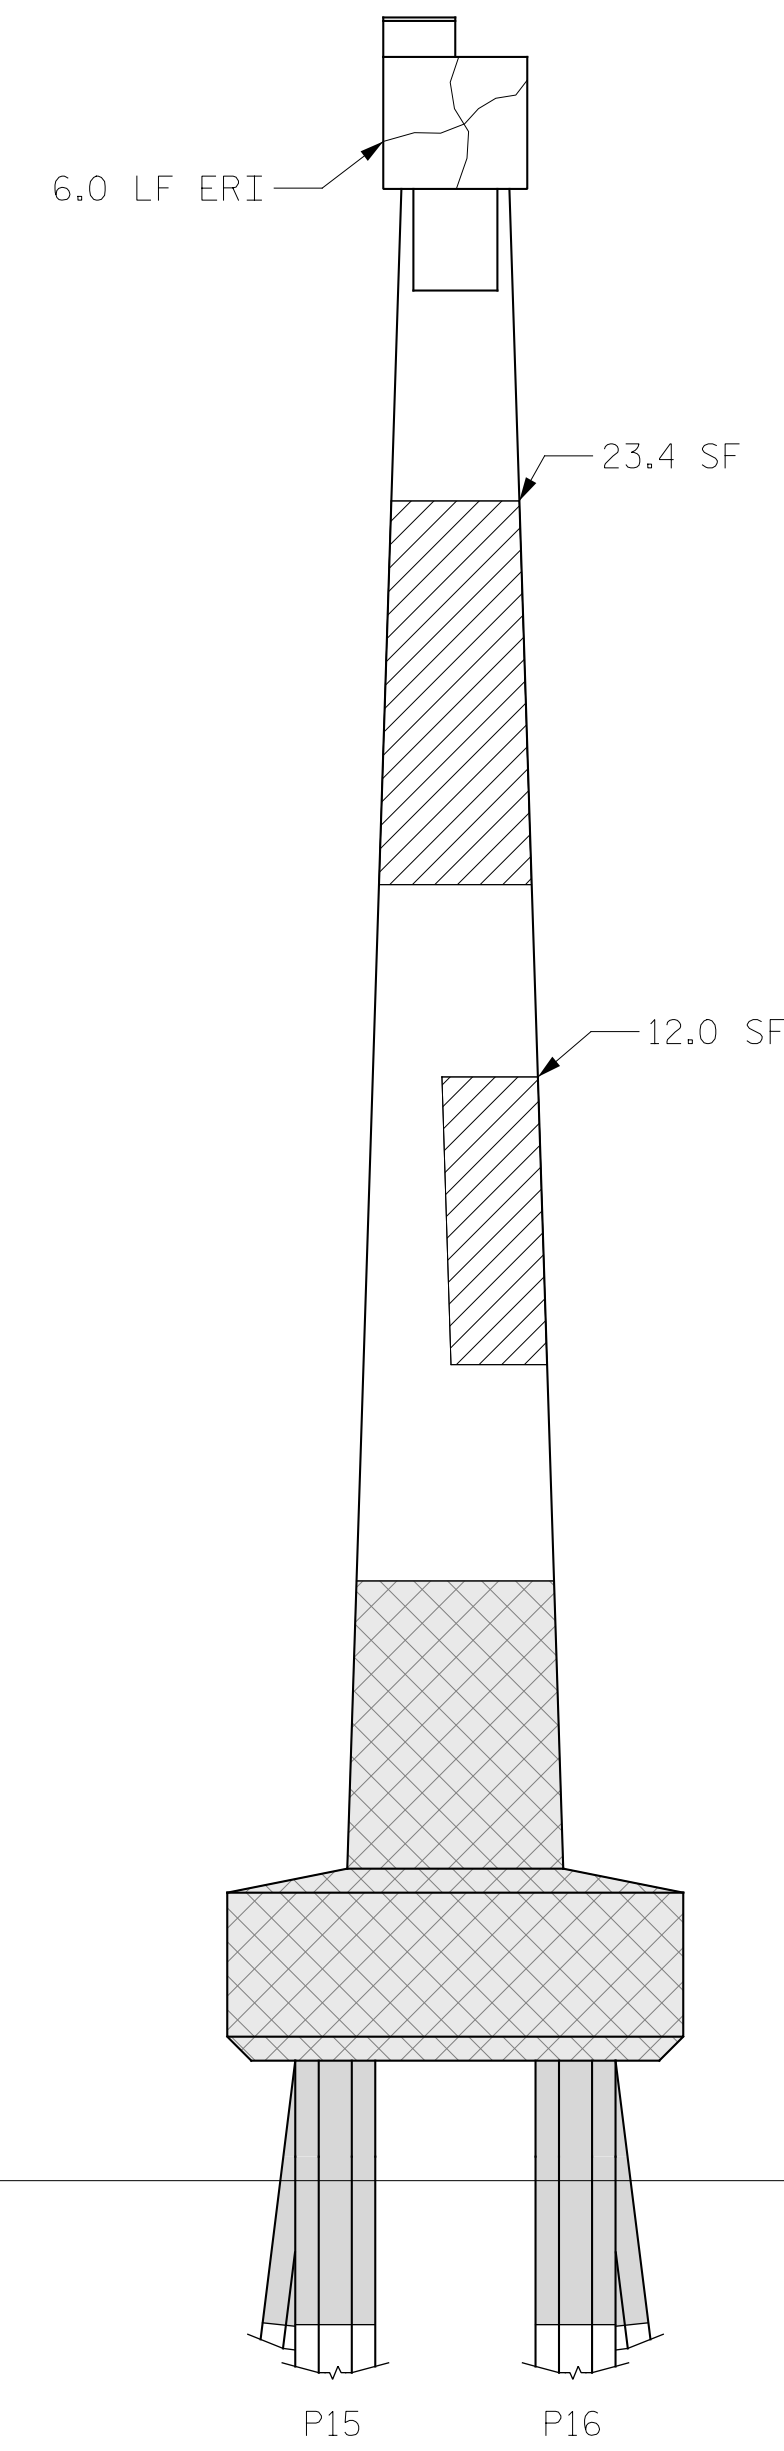
BENT 137
WEST FACE

CAP REPAIRS		ESTIMATE		ACTUAL	
SHOTCRETE REPAIRS	8.3 SF	4.2 CF	SF	CF	
EPOXY RESIN INJECTION	21.0 LF				LF
COLUMN REPAIRS		ESTIMATE		ACTUAL	
SHOTCRETE REPAIRS	227.7 SF	113.9 CF	SF	CF	
EPOXY RESIN INJECTION	- LF				LF
PILE REPAIRS		ESTIMATE		ACTUAL	
FRP PROTECTIVE SYSTEM AWL	- SF				SF
FRP PROTECTIVE SYSTEM BWL	484.0 SF				SF
