AS-BUILT REPAIR QUANTITY TABLE

PROJECT NO. HB-0017
DARE COUNTY
BRIDGE NO. 270009

BENT 73 & BENT 74

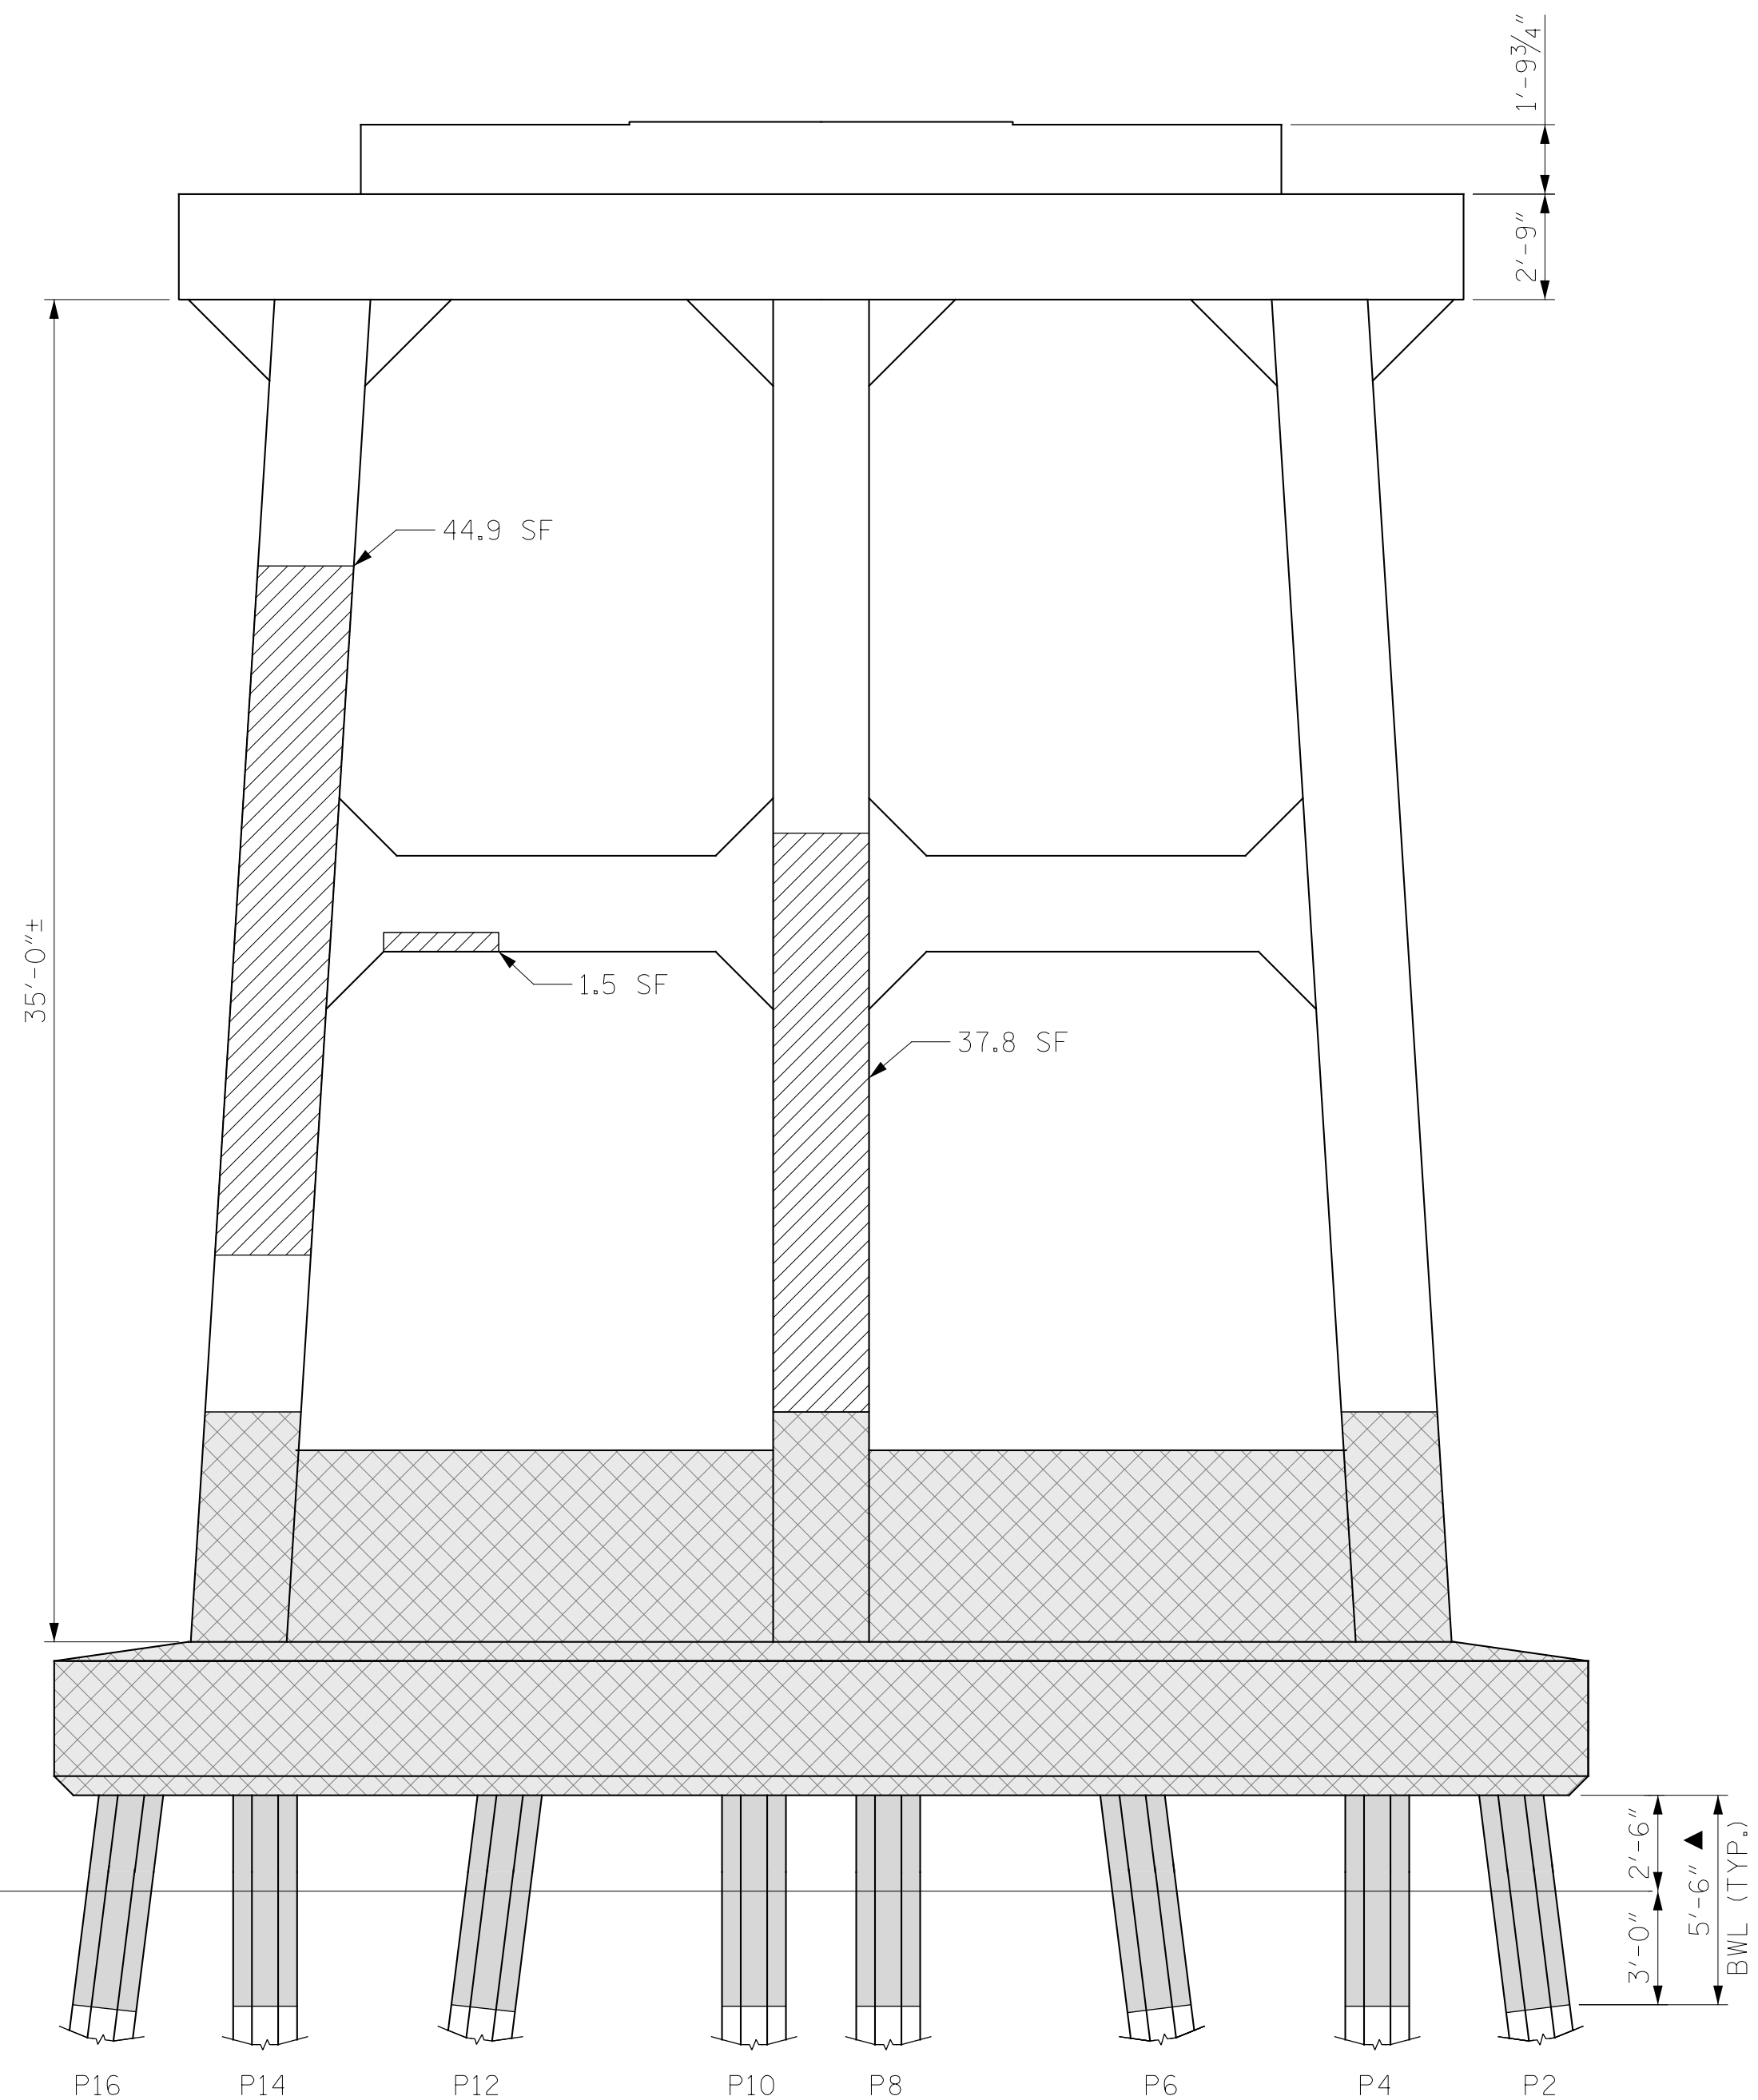
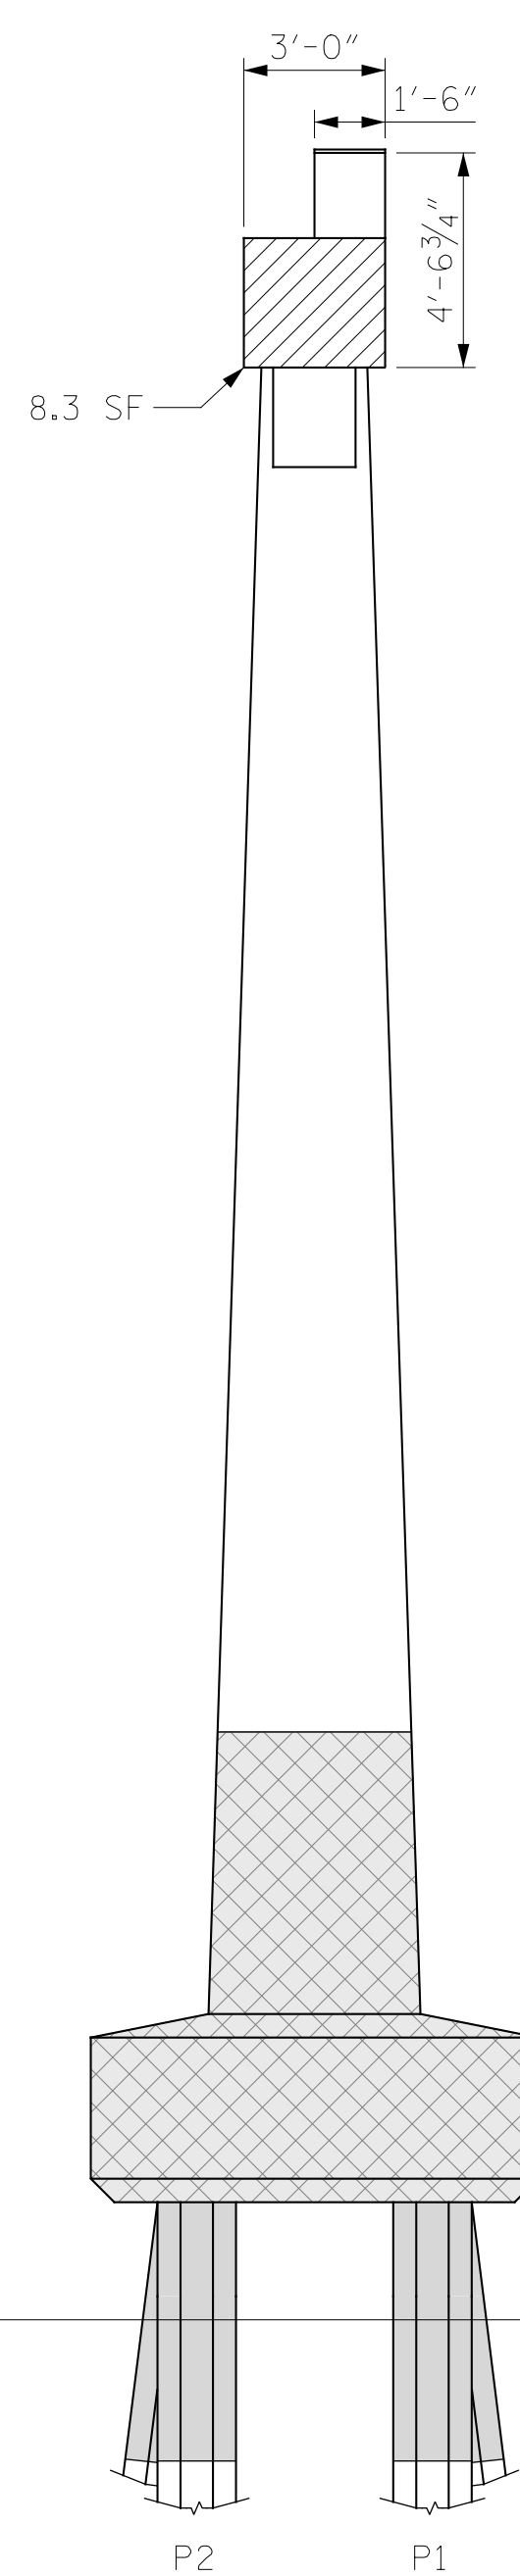
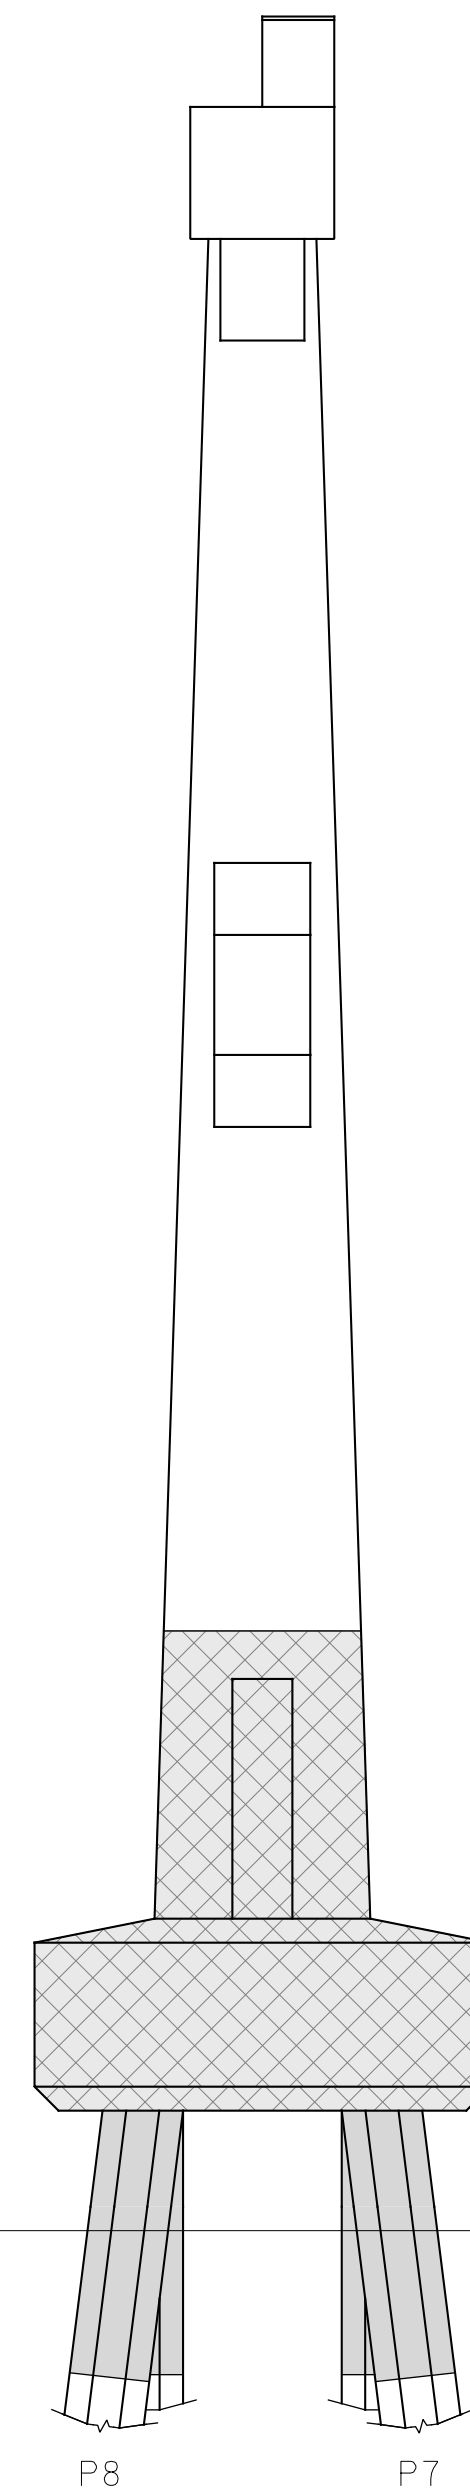
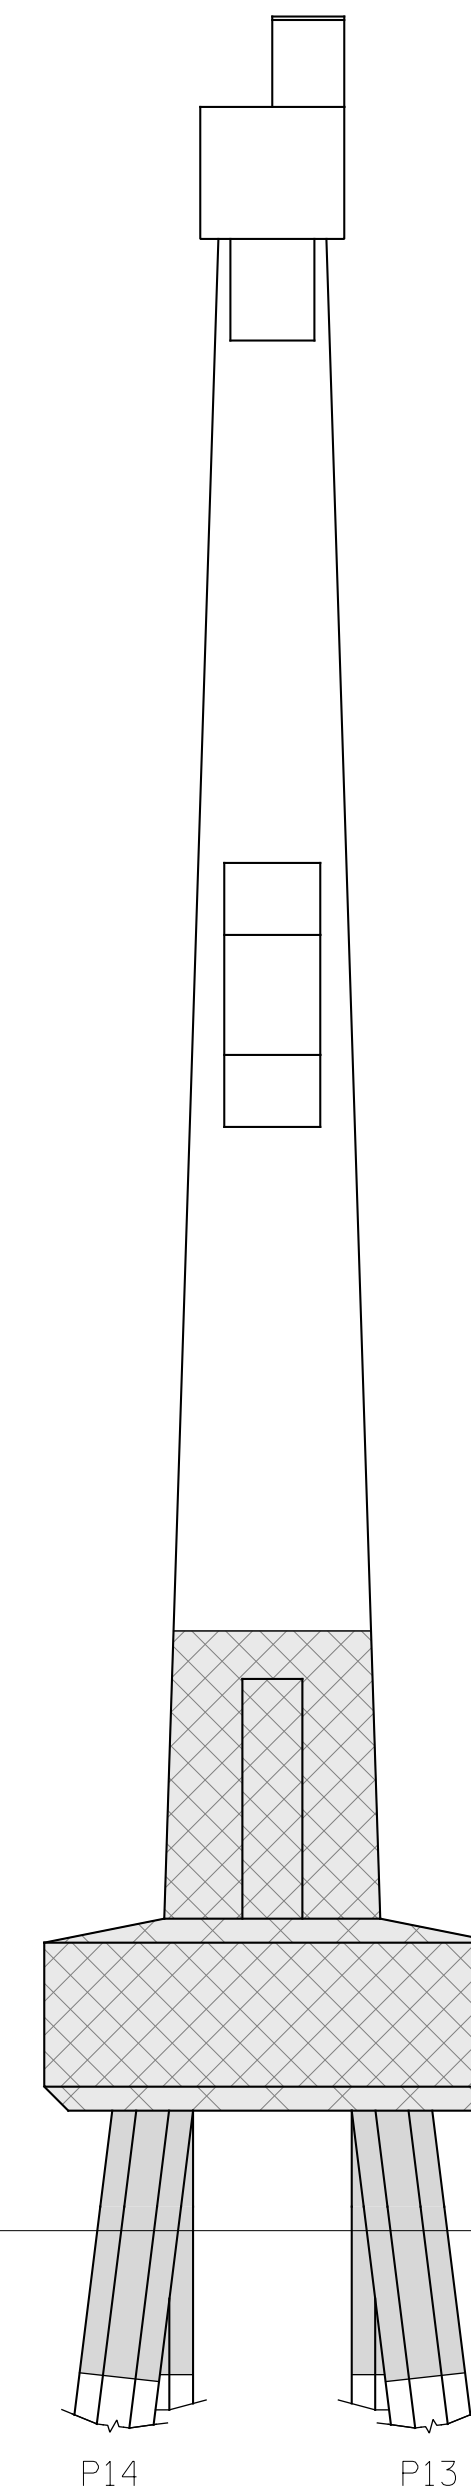
**BENT 137
 EAST FACE**

CAP REPAIRS		ESTIMATE		ACTUAL	
SHOTCRETE REPAIRS	8.3 SF	4.2 CF	SF	CF	
EPOXY RESIN INJECTION	21.0 LF				LF
COLUMN REPAIRS		ESTIMATE		ACTUAL	
SHOTCRETE REPAIRS	227.7 SF	113.9 CF	SF	CF	
EPOXY RESIN INJECTION	- LF				LF
PILE REPAIRS		ESTIMATE		ACTUAL	
FRP PROTECTIVE SYSTEM AWL	- SF				SF
FRP PROTECTIVE SYSTEM BWL	484.0 SF				SF

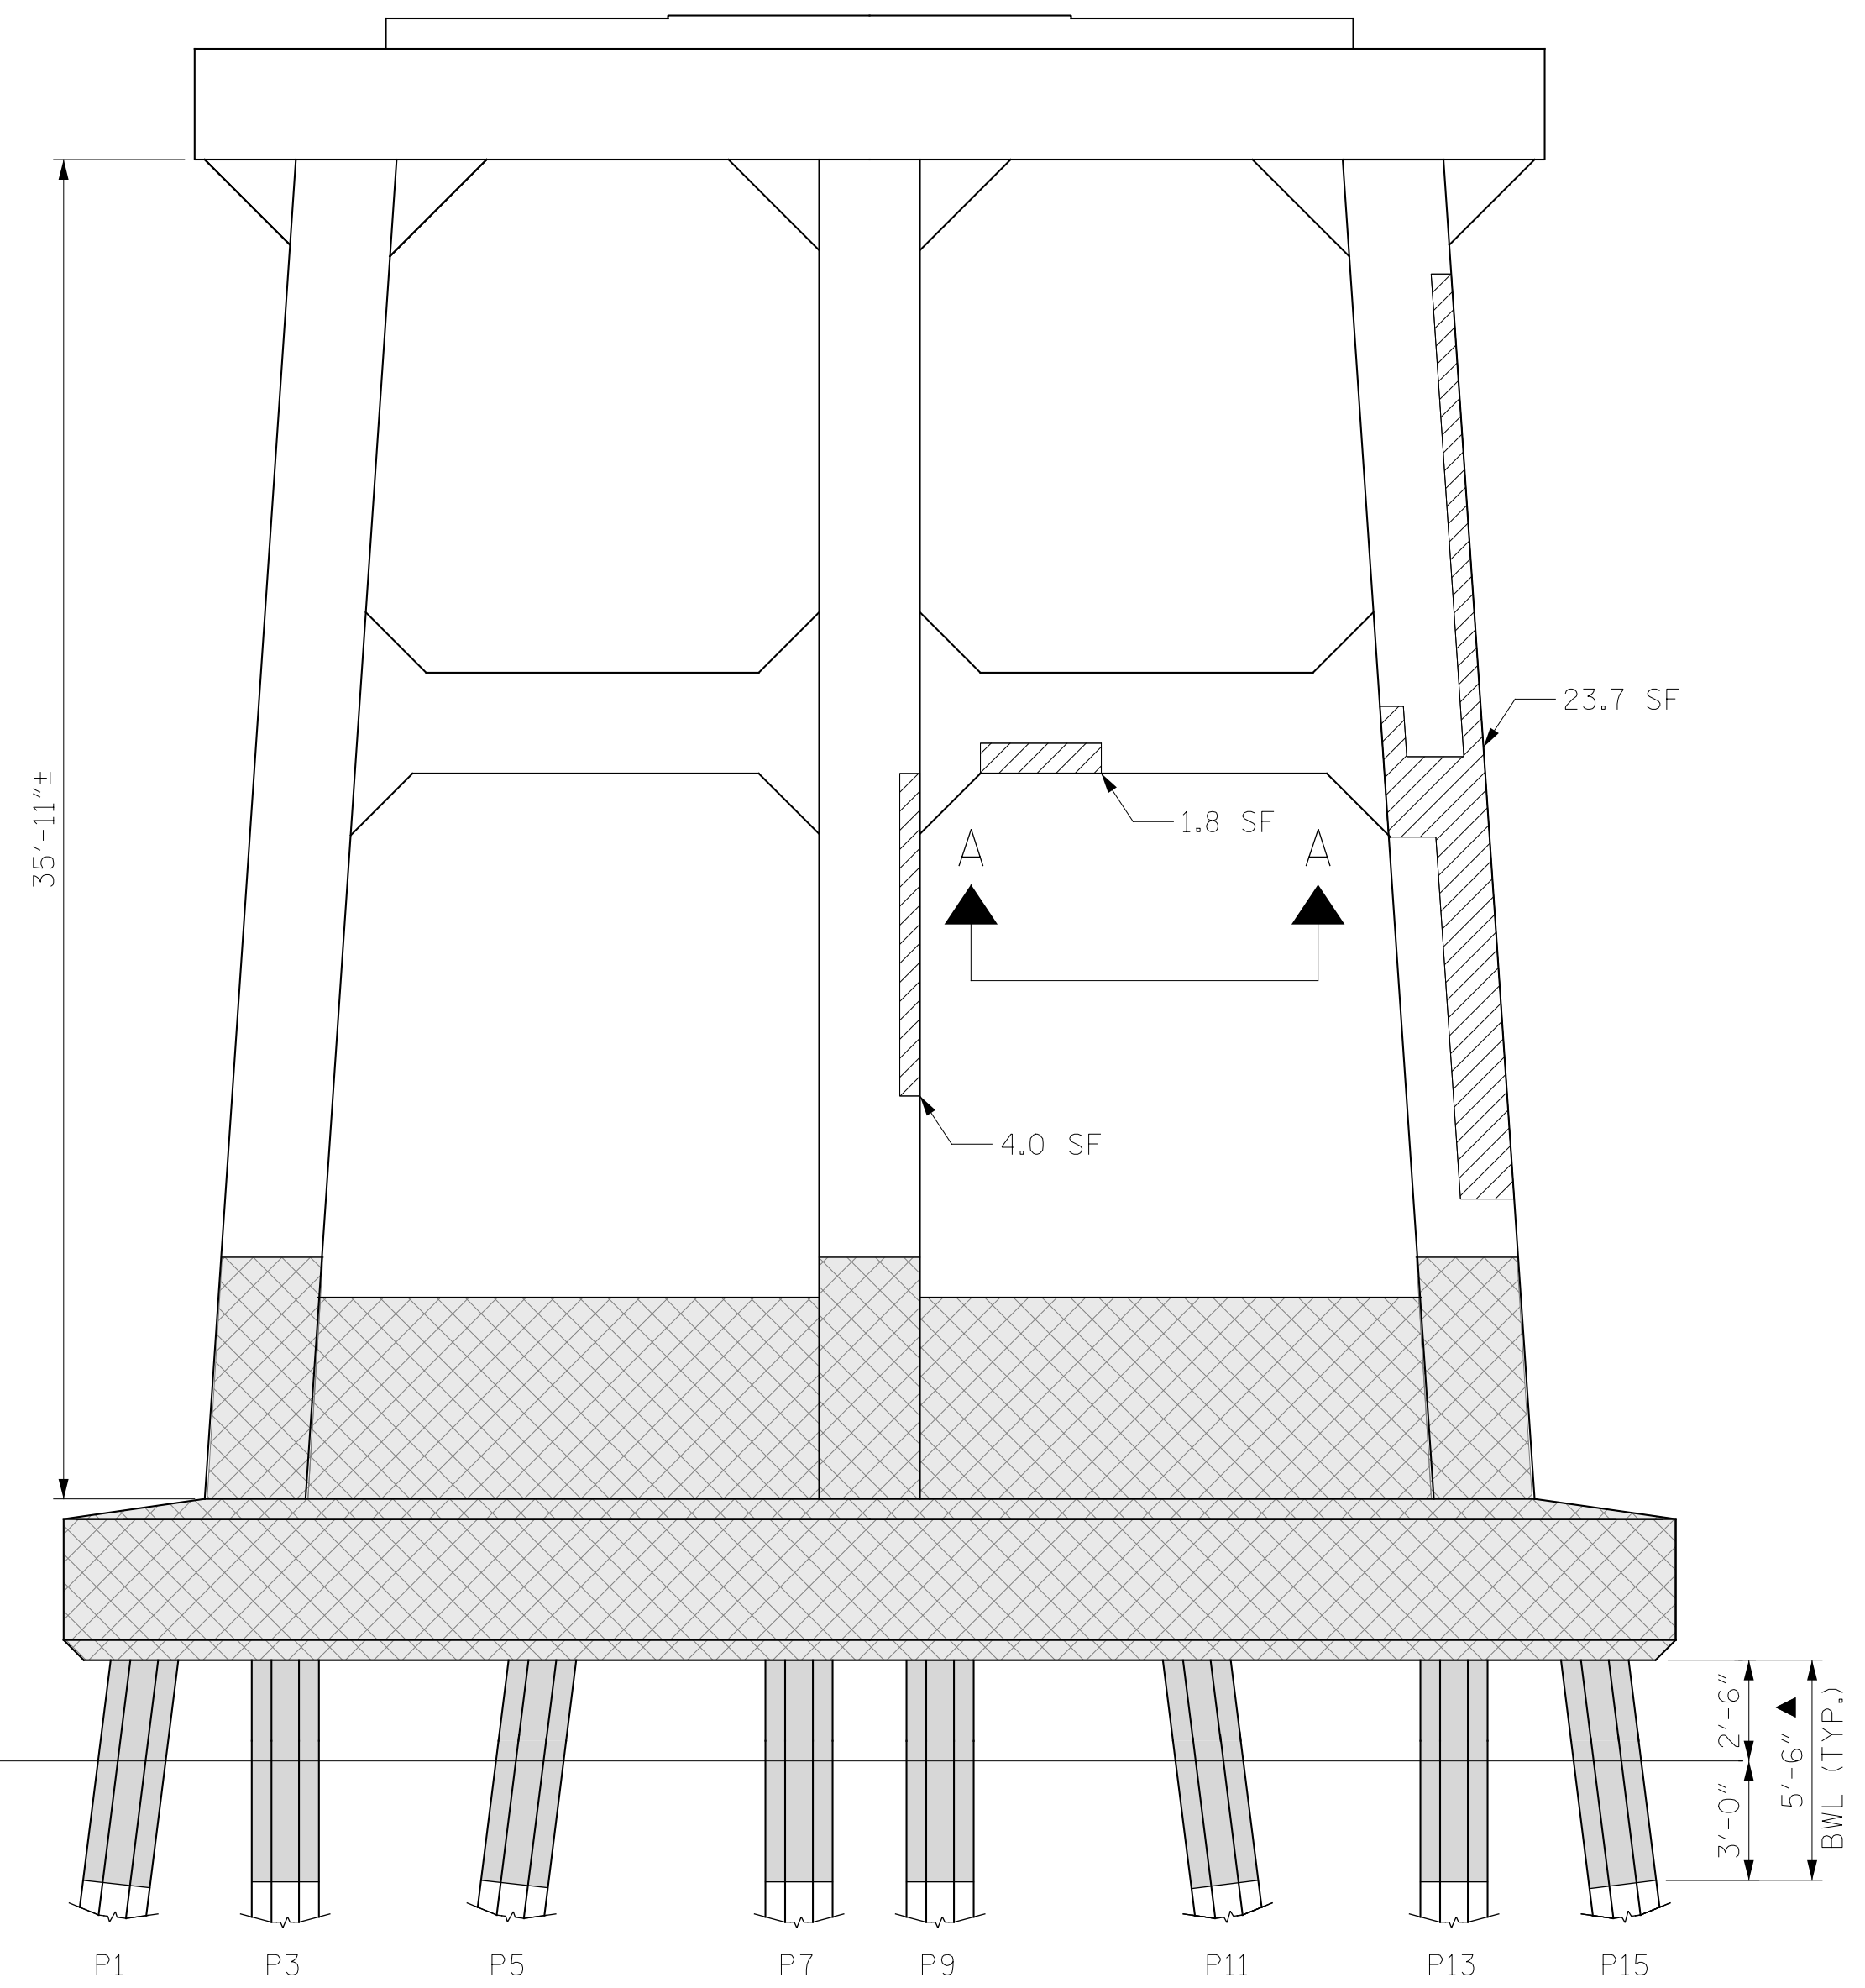
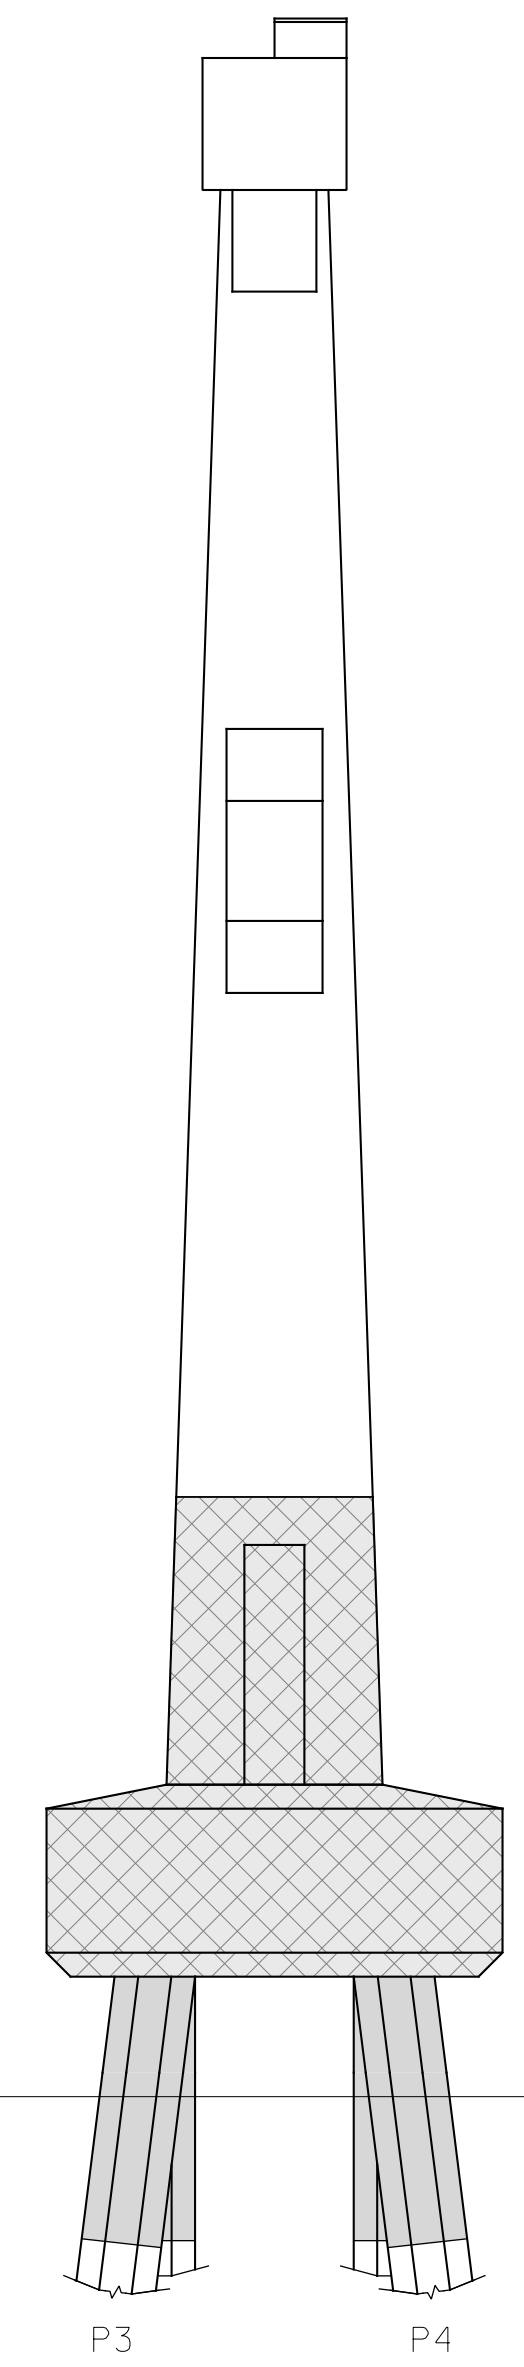
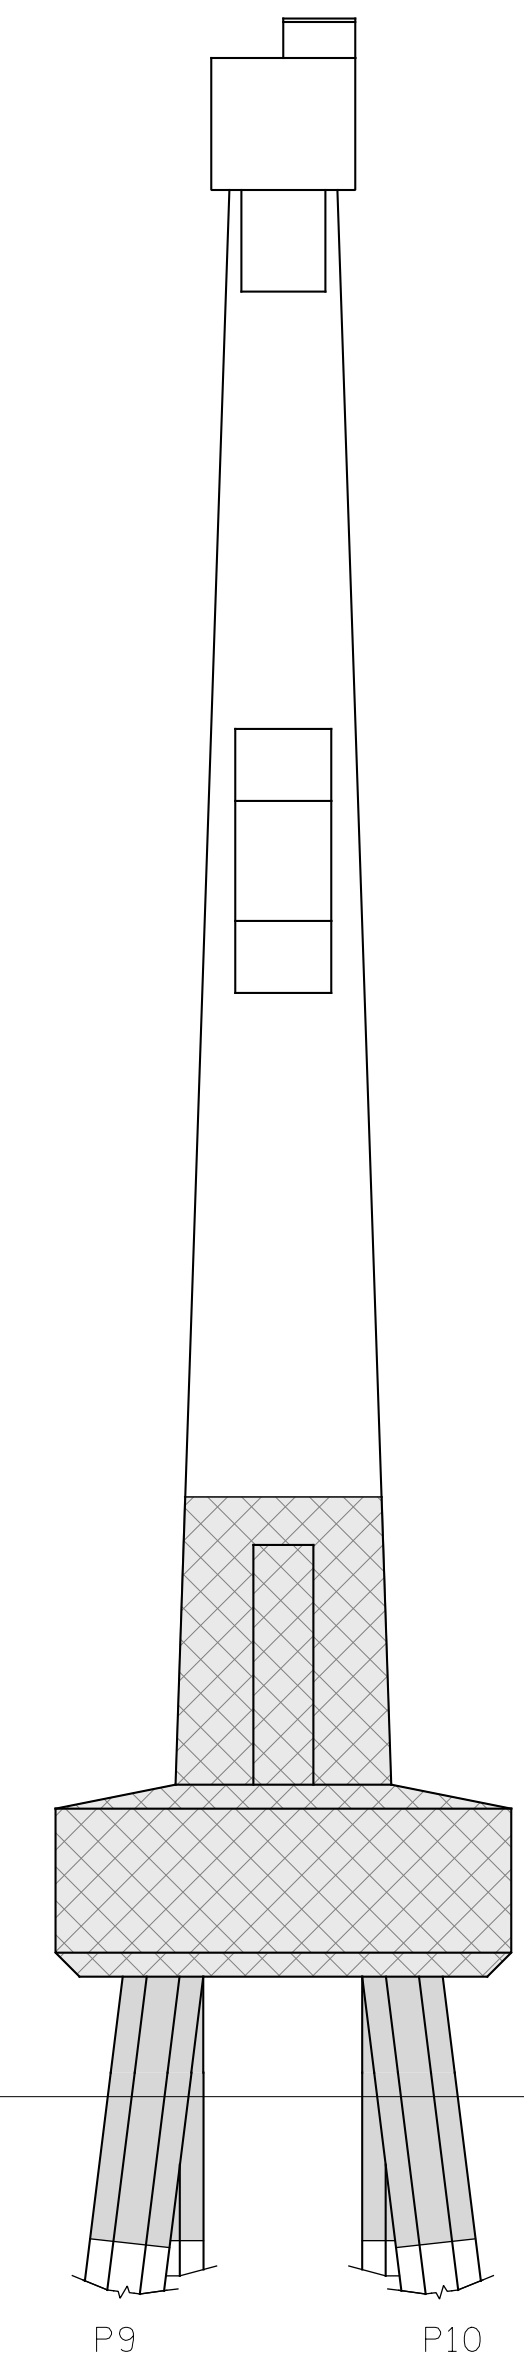
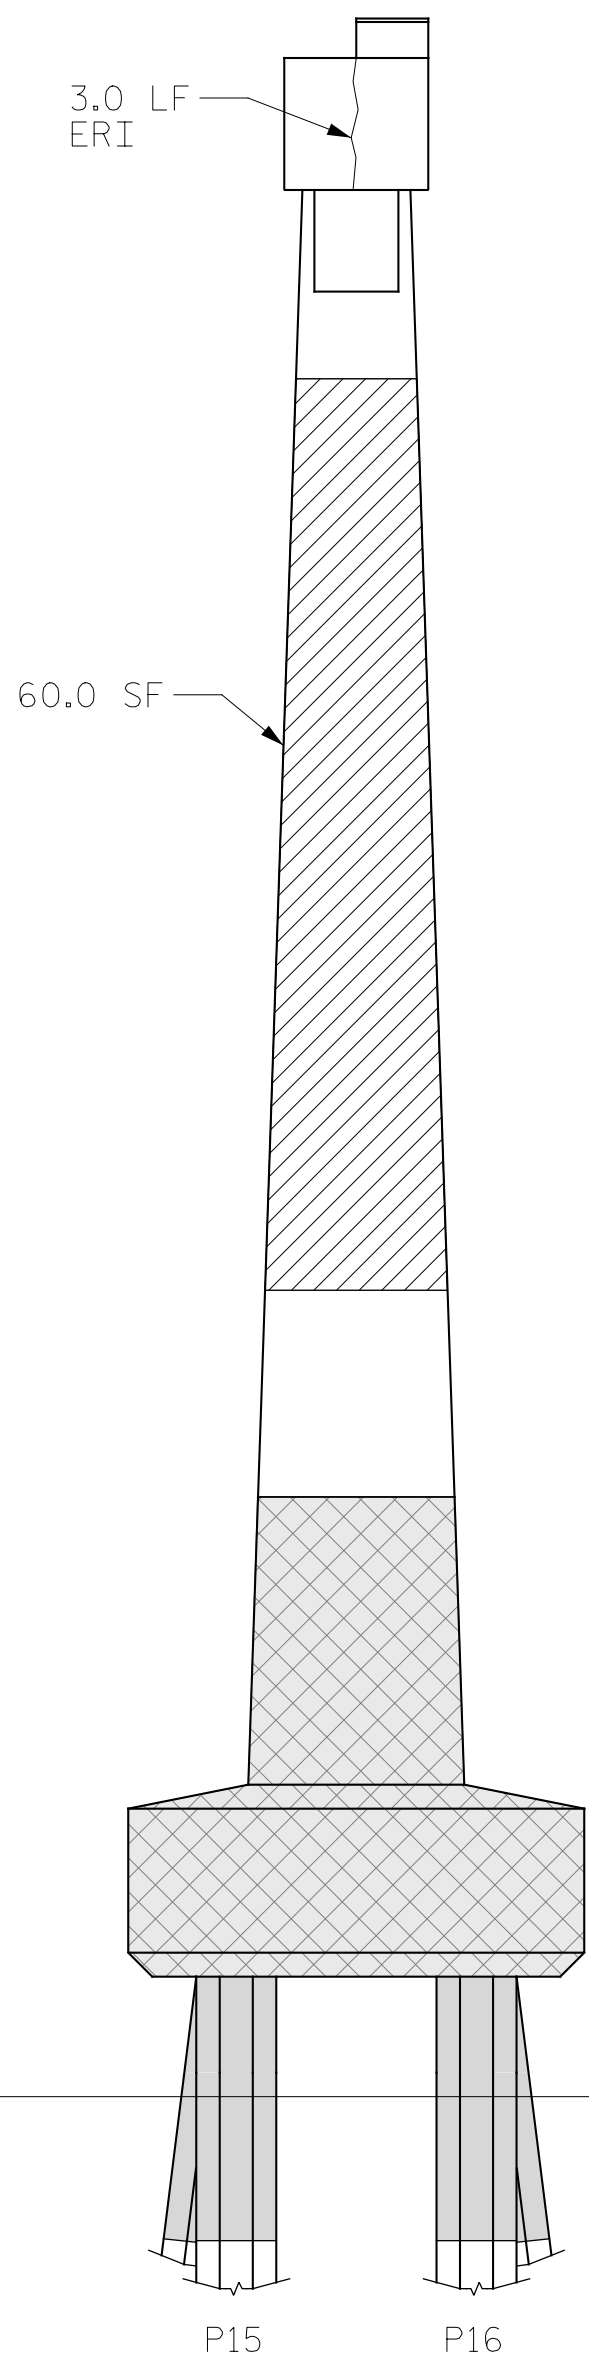
STATE OF NORTH CAROLINA DEPARTMENT OF TRANSPORTATION RALEIGH					
BENT 138 WEST FACE					
REVISIONS					SHEET NO.
NO.	BY:	DATE:	NO.	BY:	DATE:
1			3		
2			4		
TOTAL SHEETS					355

CAP REPAIRS		ESTIMATE		ACTUAL	
SHOTCRETE REPAIRS	- SF	- CF	SF	CF	
EPOXY RESIN INJECTION	5.0 LF				LF
COLUMN REPAIRS		ESTIMATE		ACTUAL	
SHOTCRETE REPAIRS	103.3 SF	51.7 CF	SF	CF	
EPOXY RESIN INJECTION	- LF				LF
PILE REPAIRS		ESTIMATE		ACTUAL	
FRP PROTECTIVE SYSTEM AWL	- SF				SF
FRP PROTECTIVE SYSTEM BWL	484.0 SF				SF

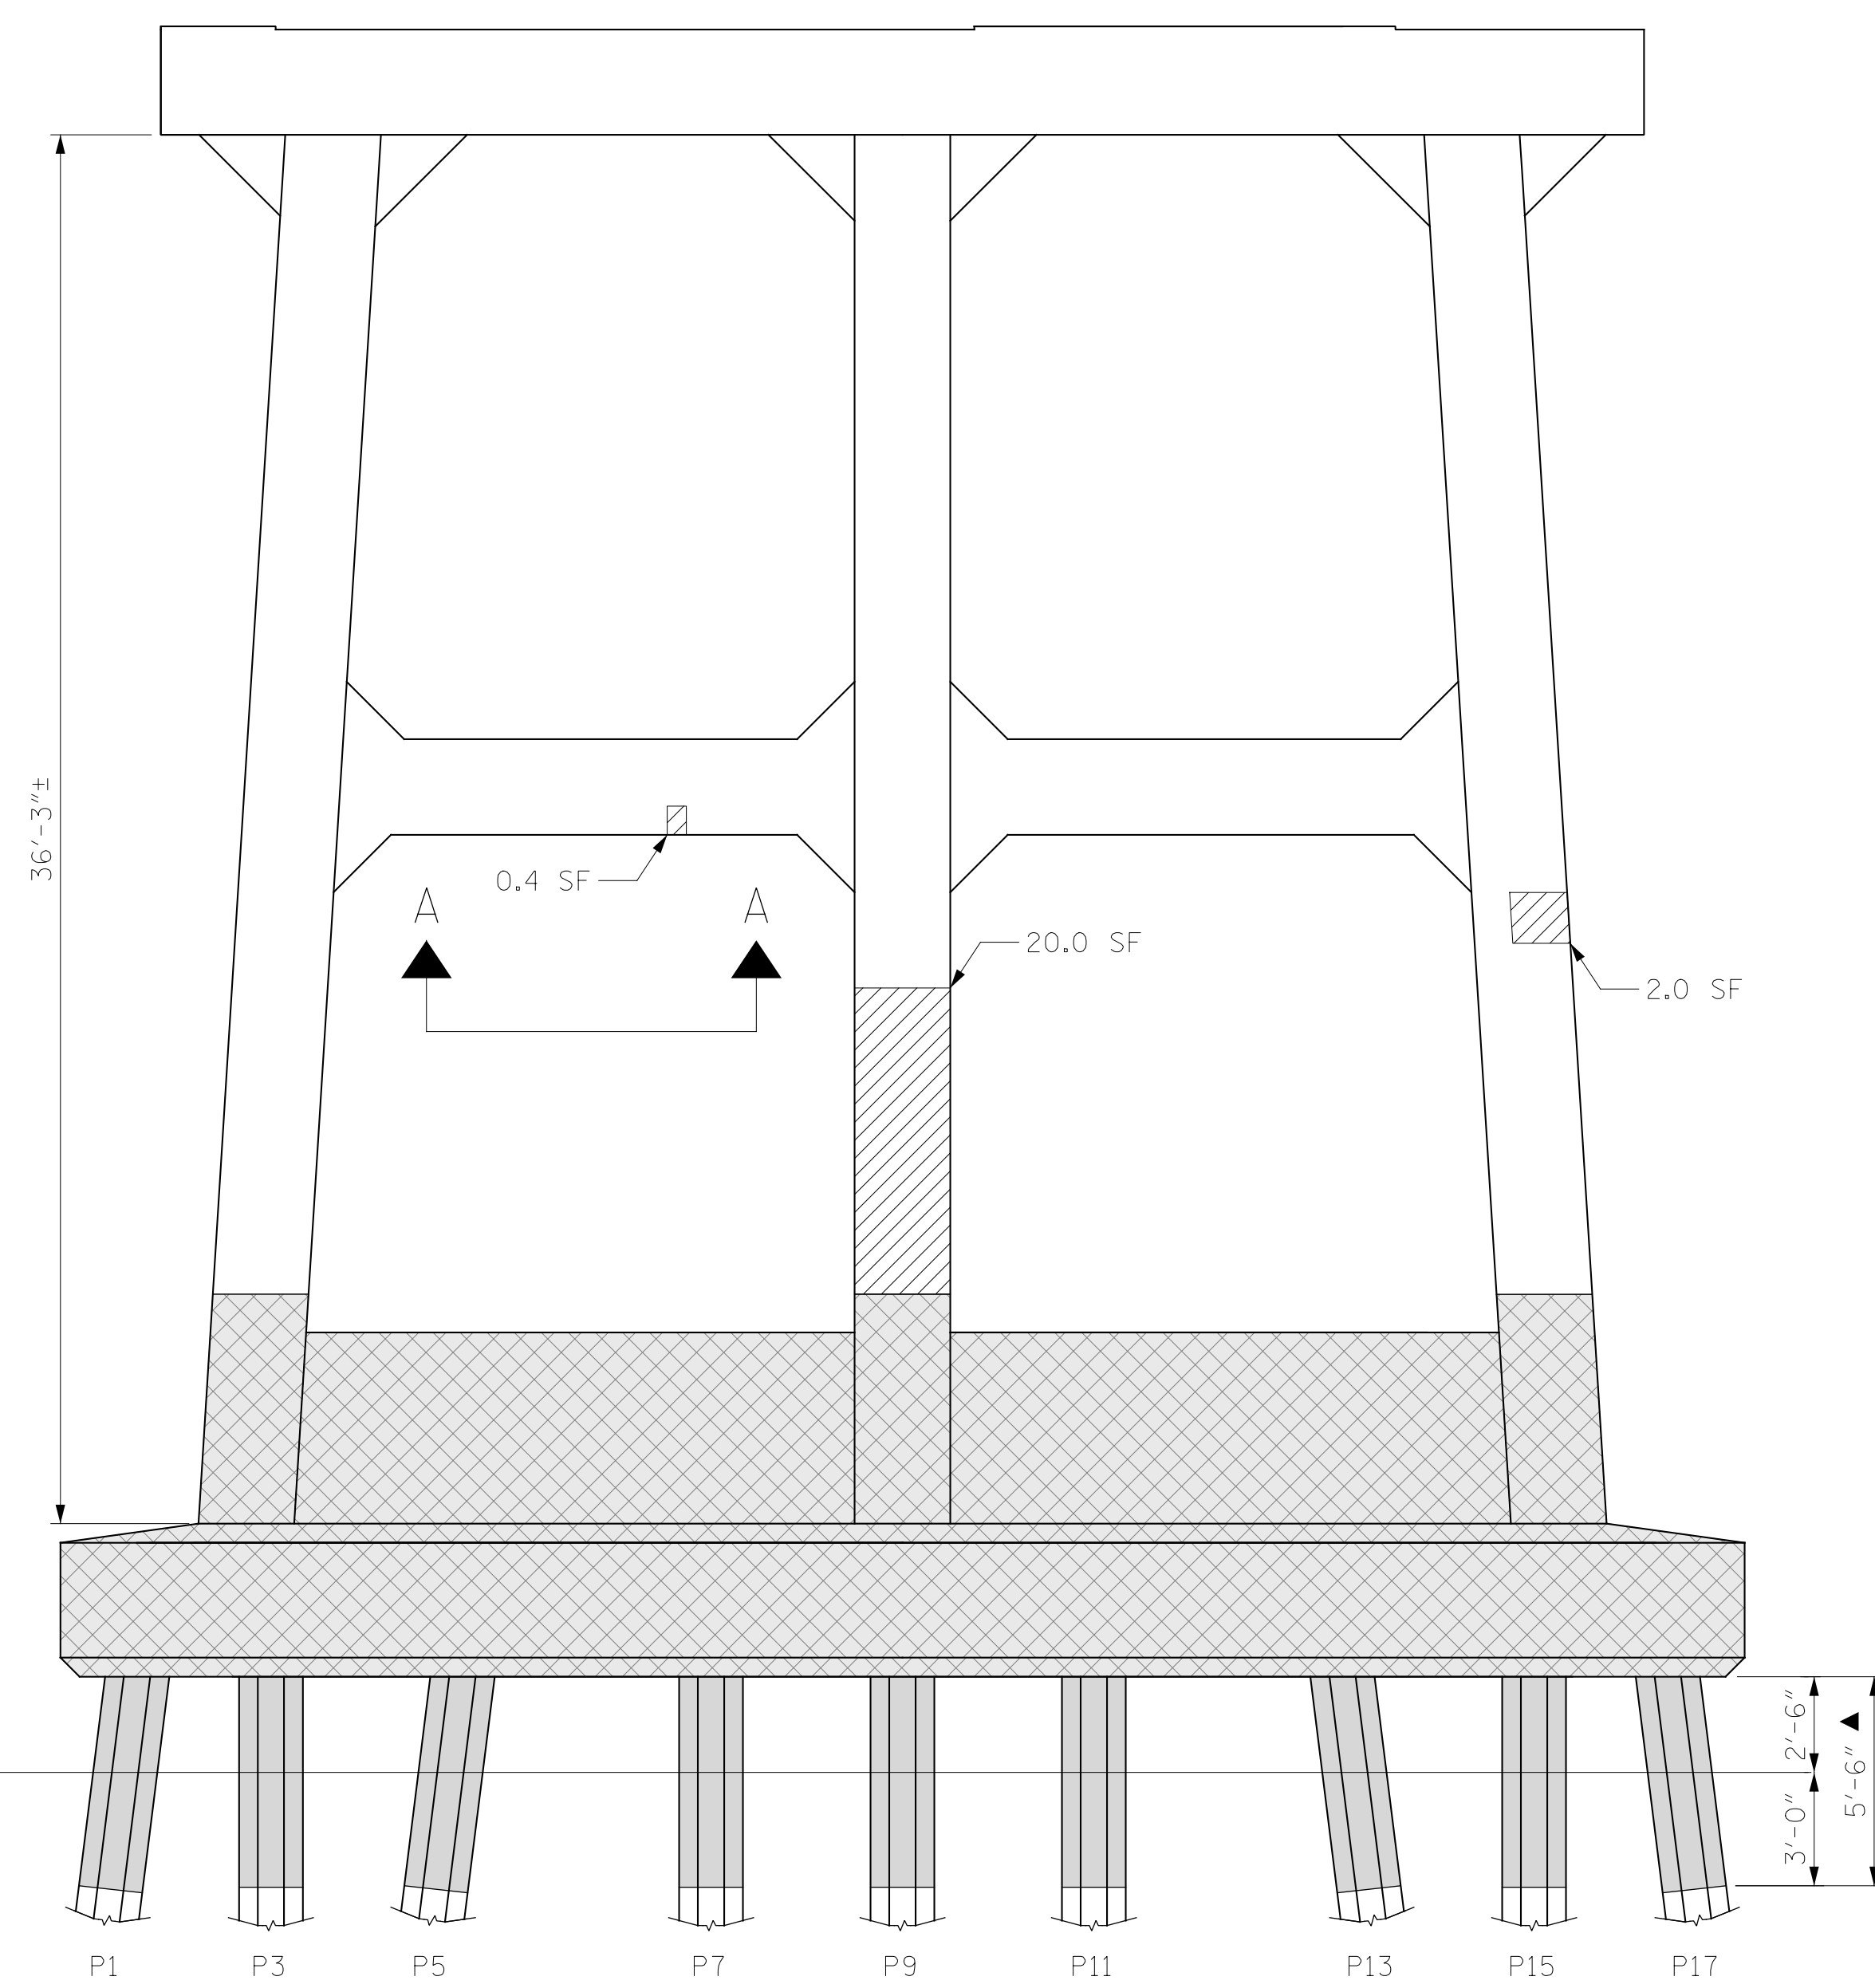
BENT 139
 WEST FACE

CAP REPAIRS		ESTIMATE		ACTUAL	
SHOTCRETE REPAIRS	- SF	- CF		SF	CF
EPOXY RESIN INJECTION		- LF			LF
COLUMN REPAIRS		ESTIMATE		ACTUAL	
SHOTCRETE REPAIRS	92.6 SF	46.3 SF		SF	CF
EPOXY RESIN INJECTION		- LF			LF
PILE REPAIRS		ESTIMATE		ACTUAL	
FRP PROTECTIVE SYSTEM AWL	- SF			SF	
FRP PROTECTIVE SYSTEM BWL	544.5 SF				SF
