AS-BUILT REPAIR QUANTITY TABLE

PROJECT NO. HB-0017
DARE COUNTY
BRIDGE NO. 270009

BENT 73 & BENT 74

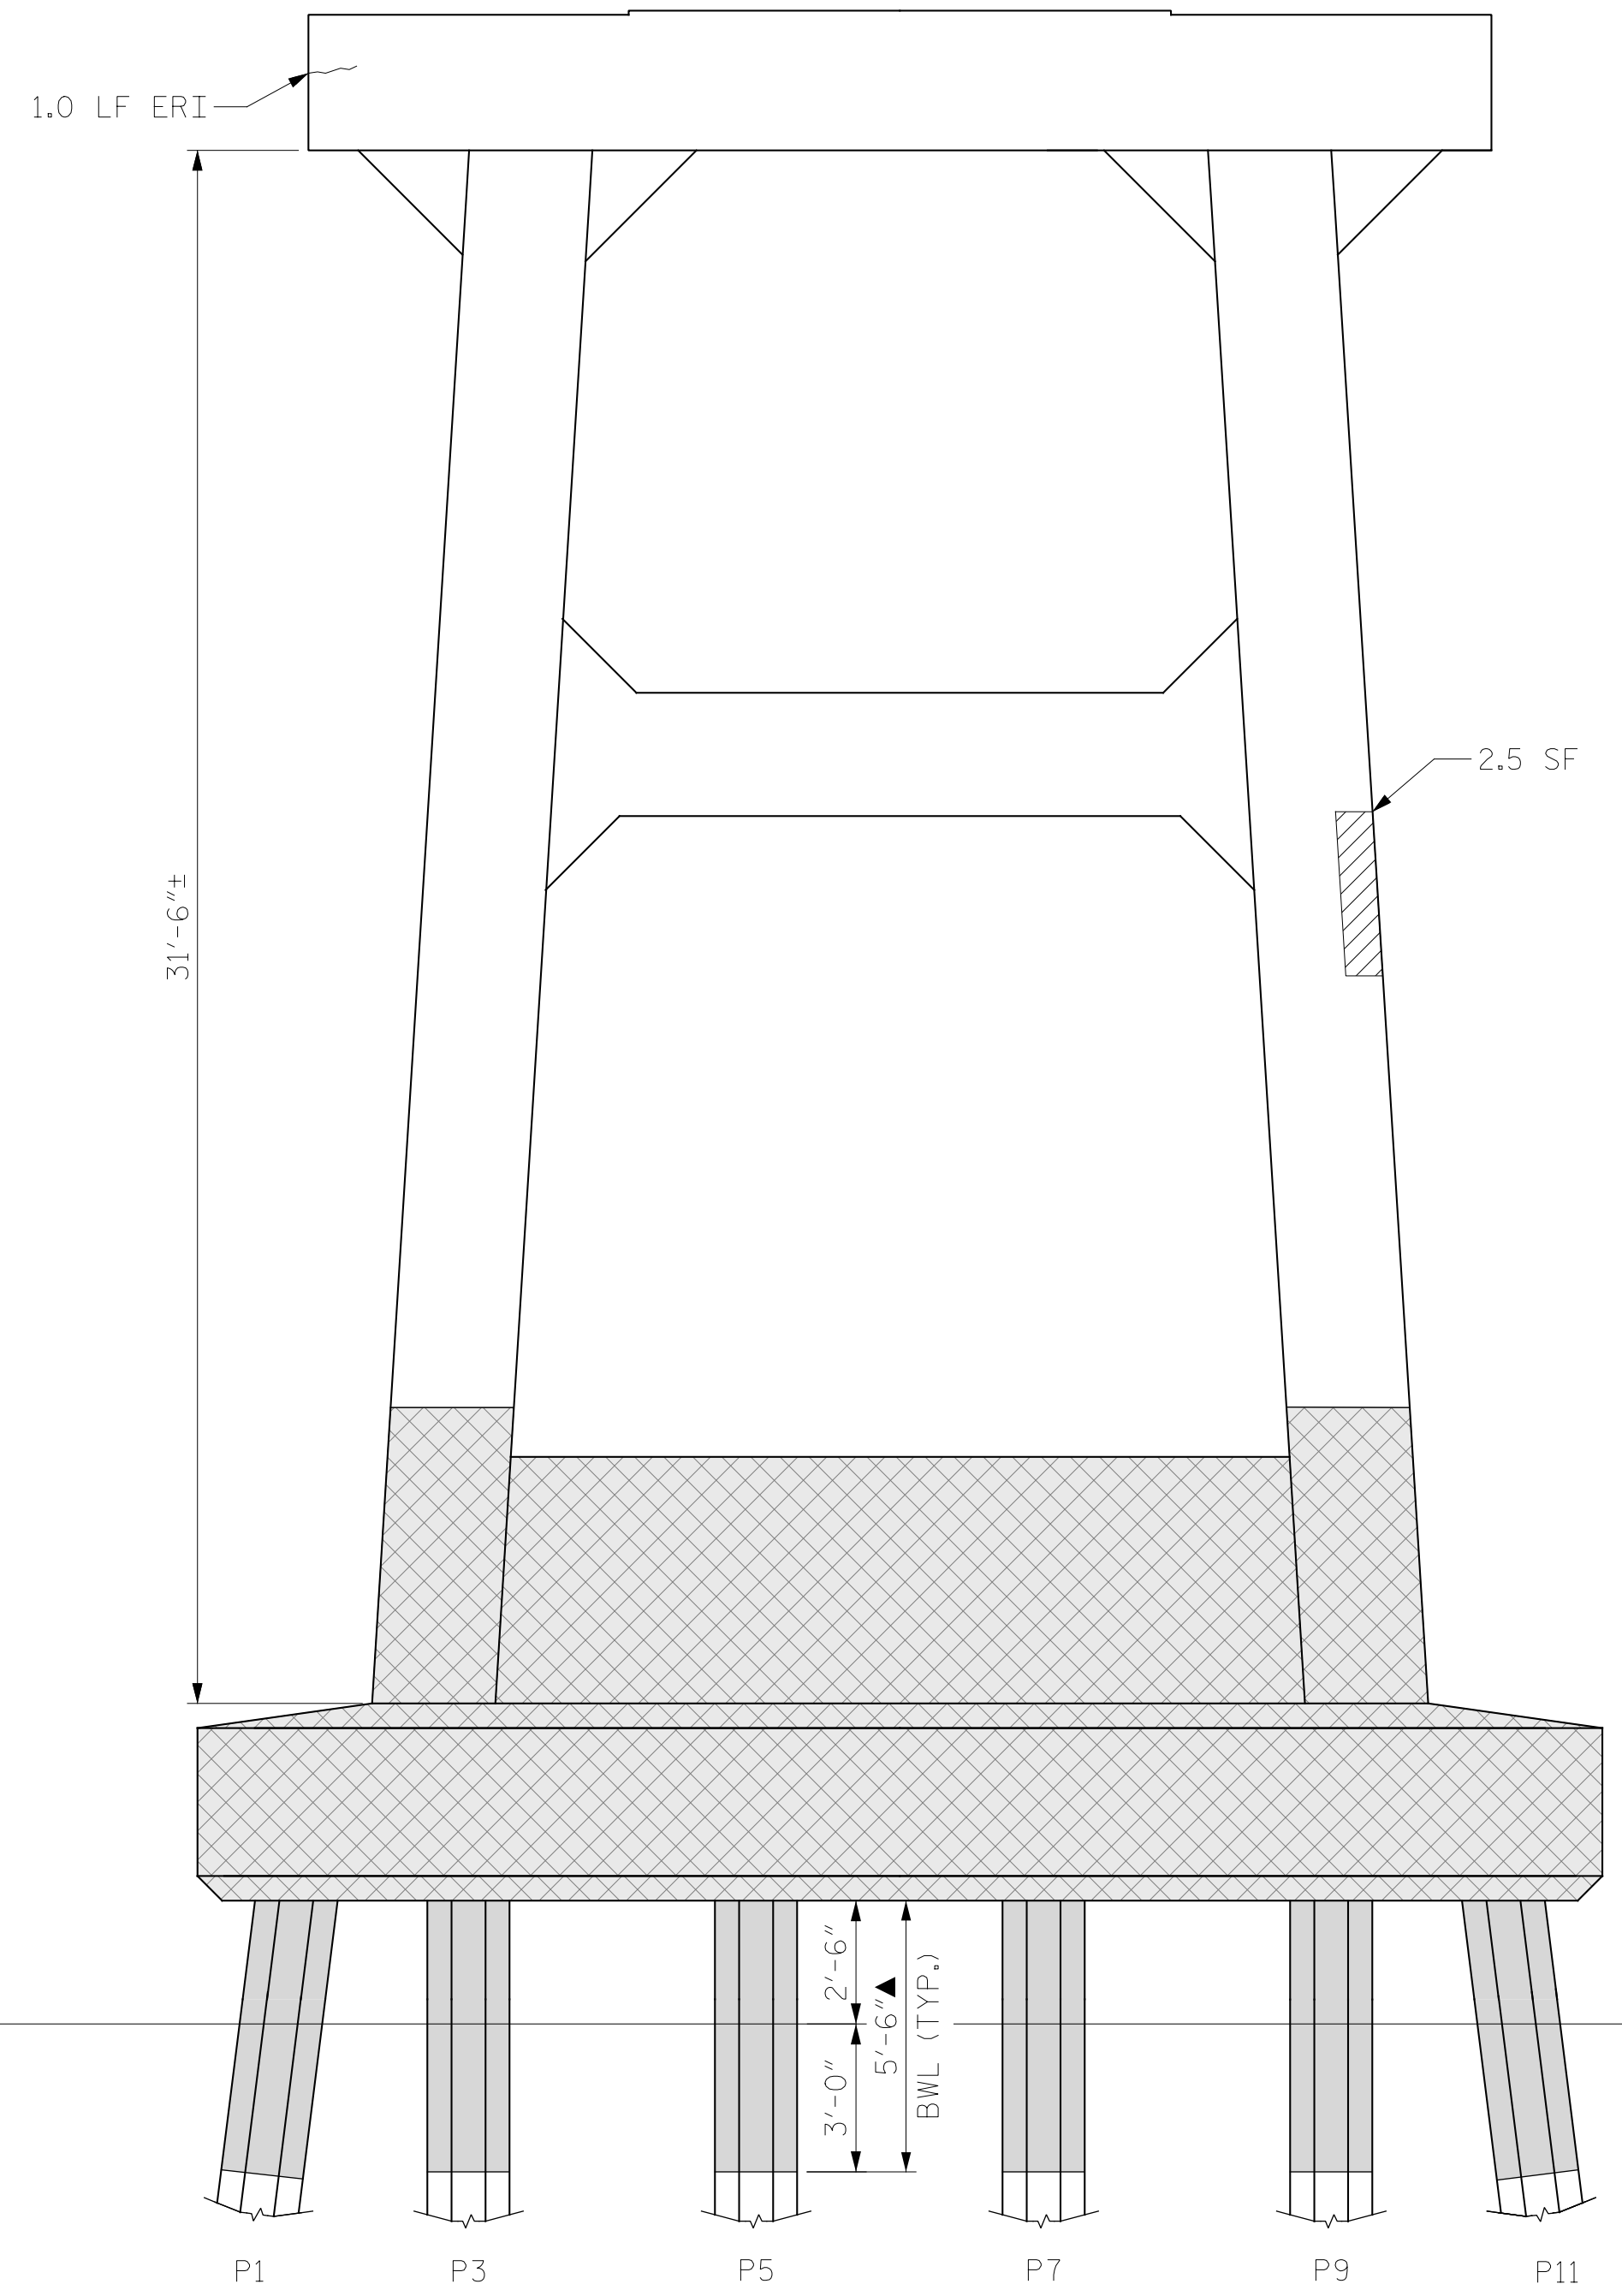
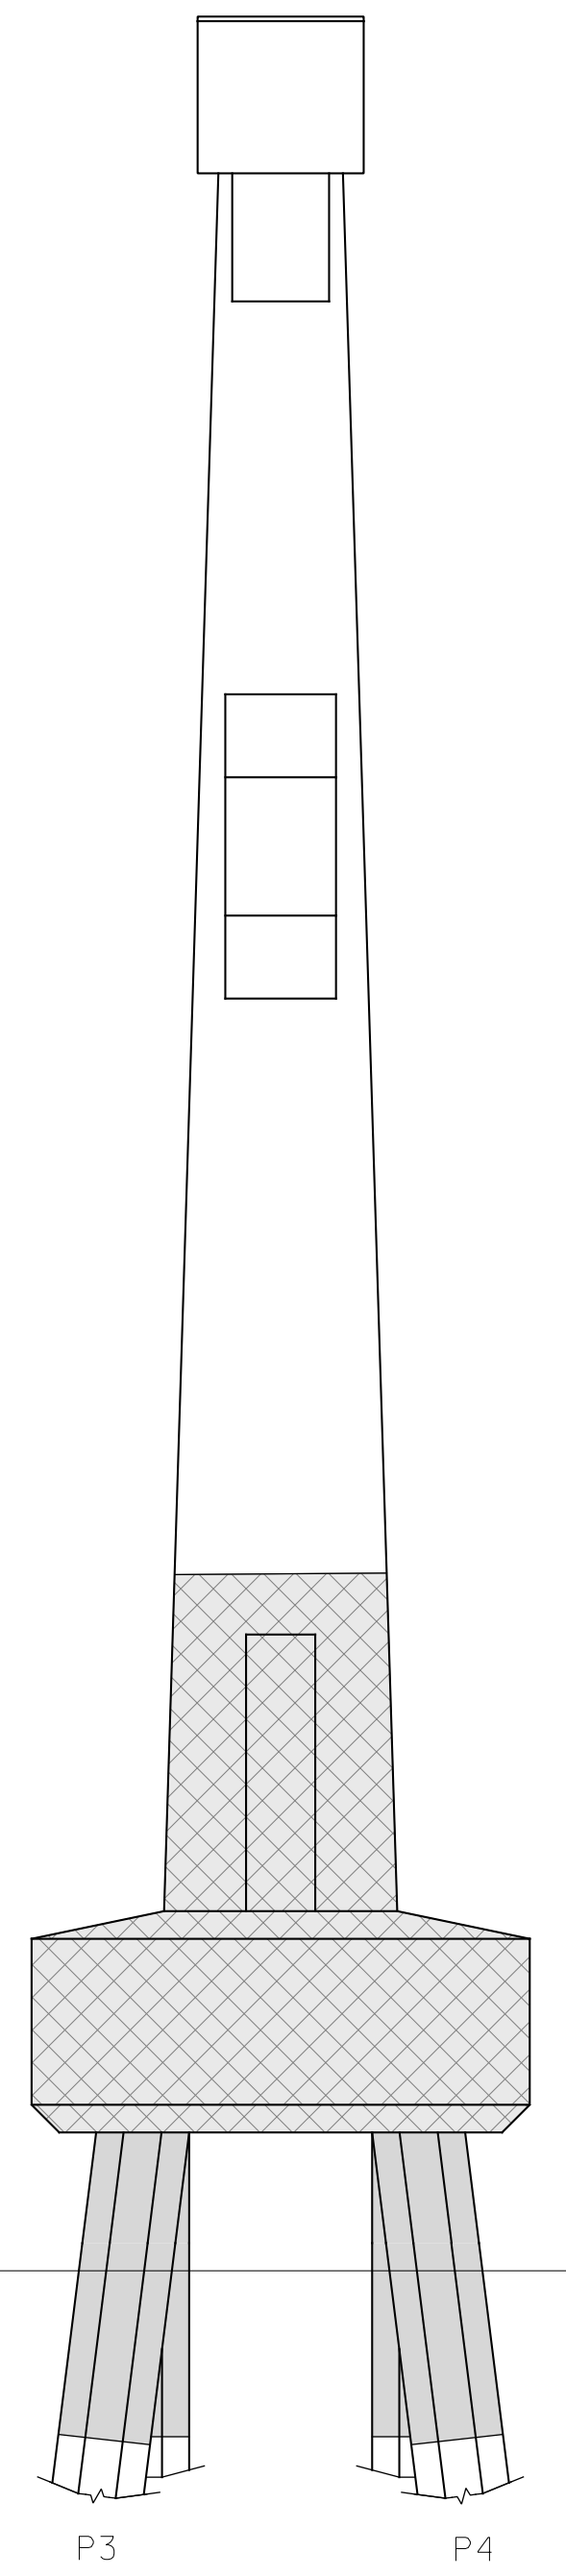
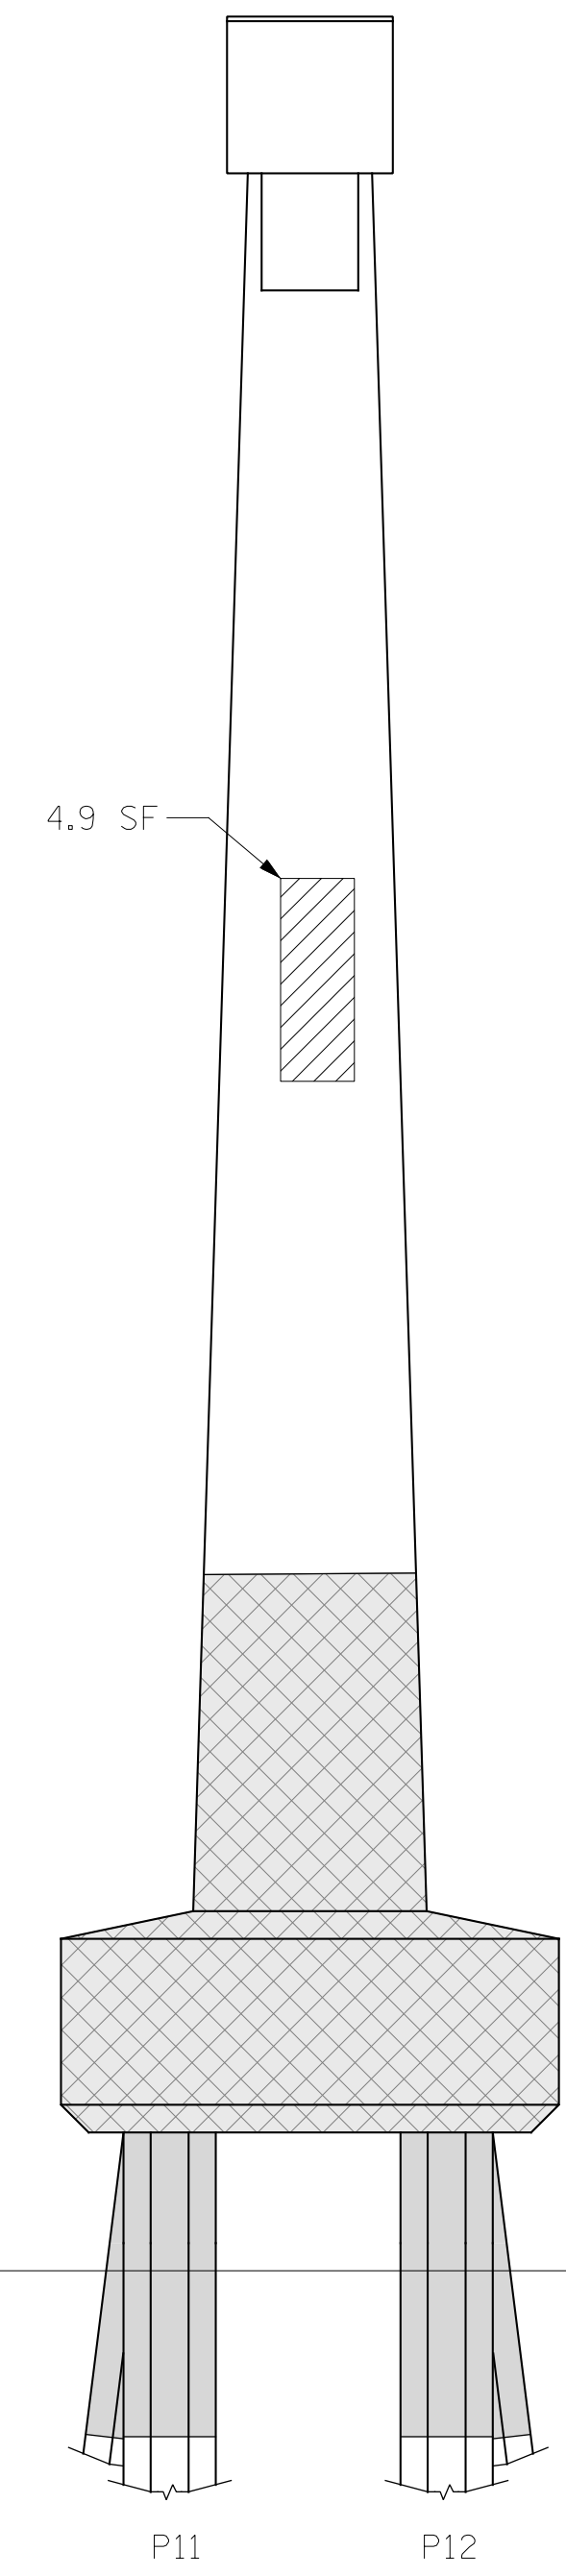
STATE OF NORTH CAROLINA DEPARTMENT OF TRANSPORTATION RALEIGH					
BENT 143 WEST FACE					
REVISIONS					SHEET NO.
NO.	BY:	DATE:	NO.	BY:	DATE:
1			3		
2			4		
TOTAL SHEETS					355

CAP REPAIRS		ESTIMATE		ACTUAL	
SHOTCRETE REPAIRS	- SF	- CF	SF	CF	
EPOXY RESIN INJECTION	4.0 LF				LF
COLUMN REPAIRS		ESTIMATE		ACTUAL	
SHOTCRETE REPAIRS	8.9 SF	4.5 CF	SF	CF	
EPOXY RESIN INJECTION	- LF				LF
PILE REPAIRS		ESTIMATE		ACTUAL	
FRP PROTECTIVE SYSTEM AWL	- SF				SF
FRP PROTECTIVE SYSTEM BWL	363.0 SF				SF

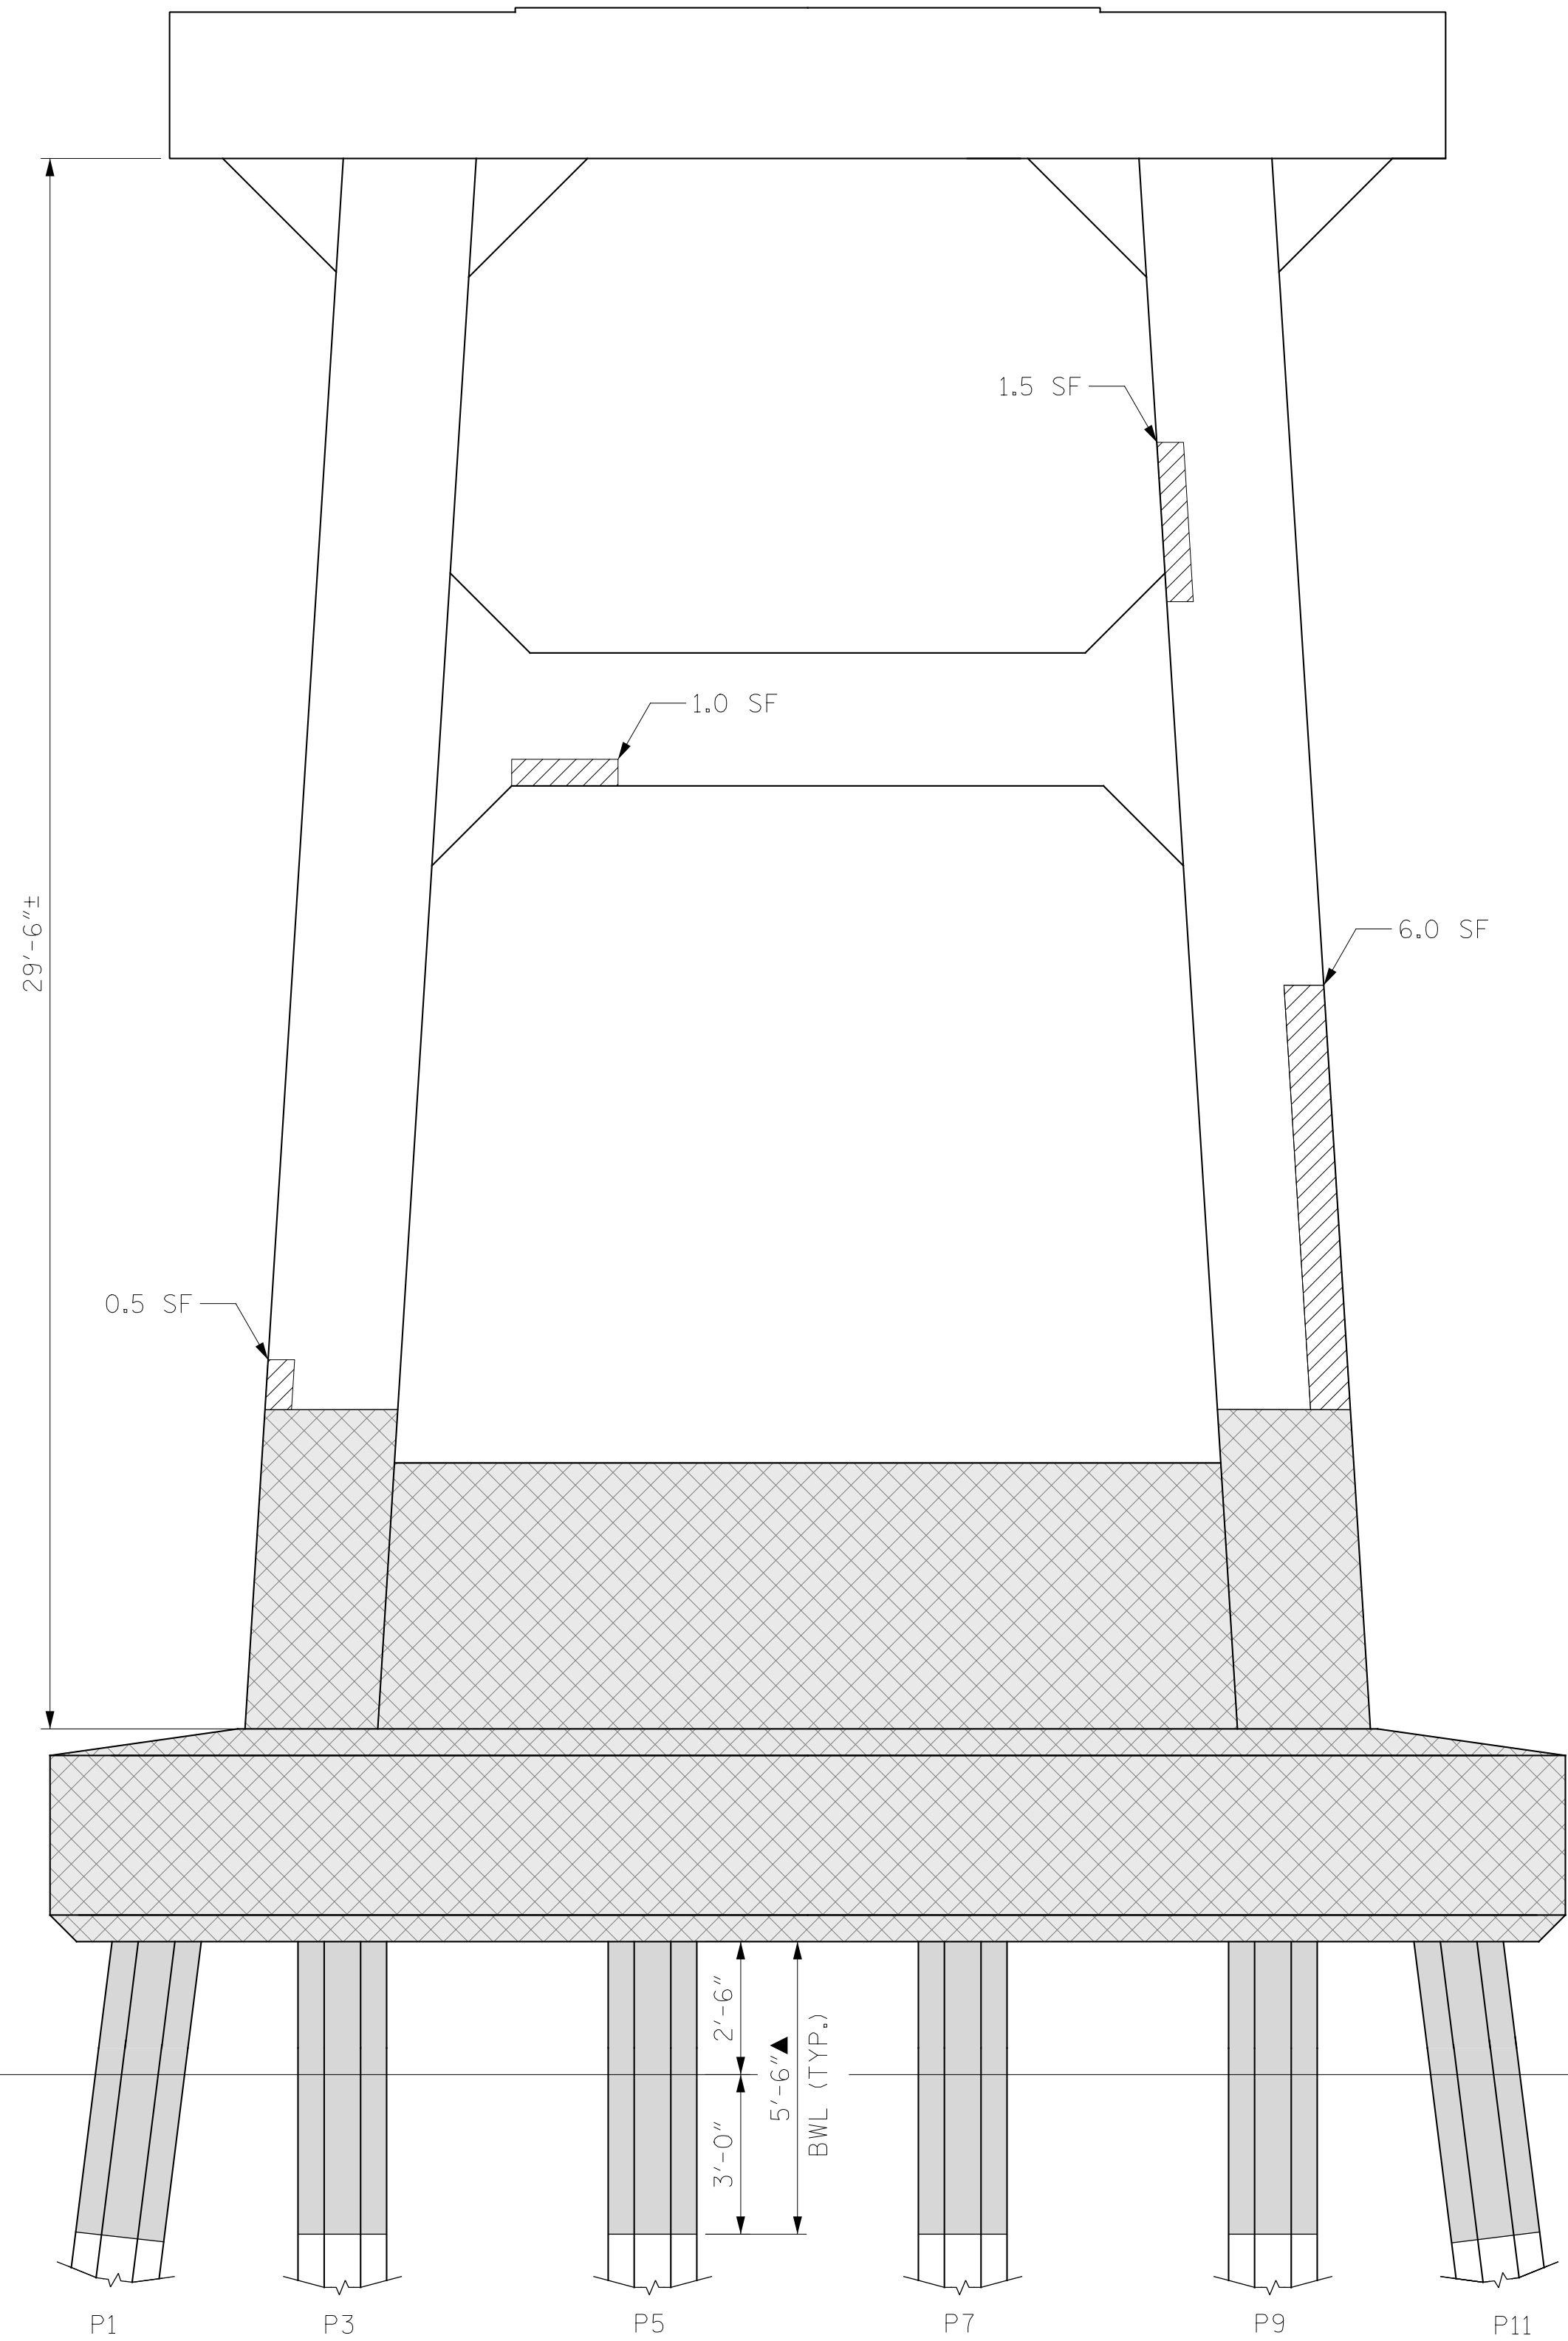
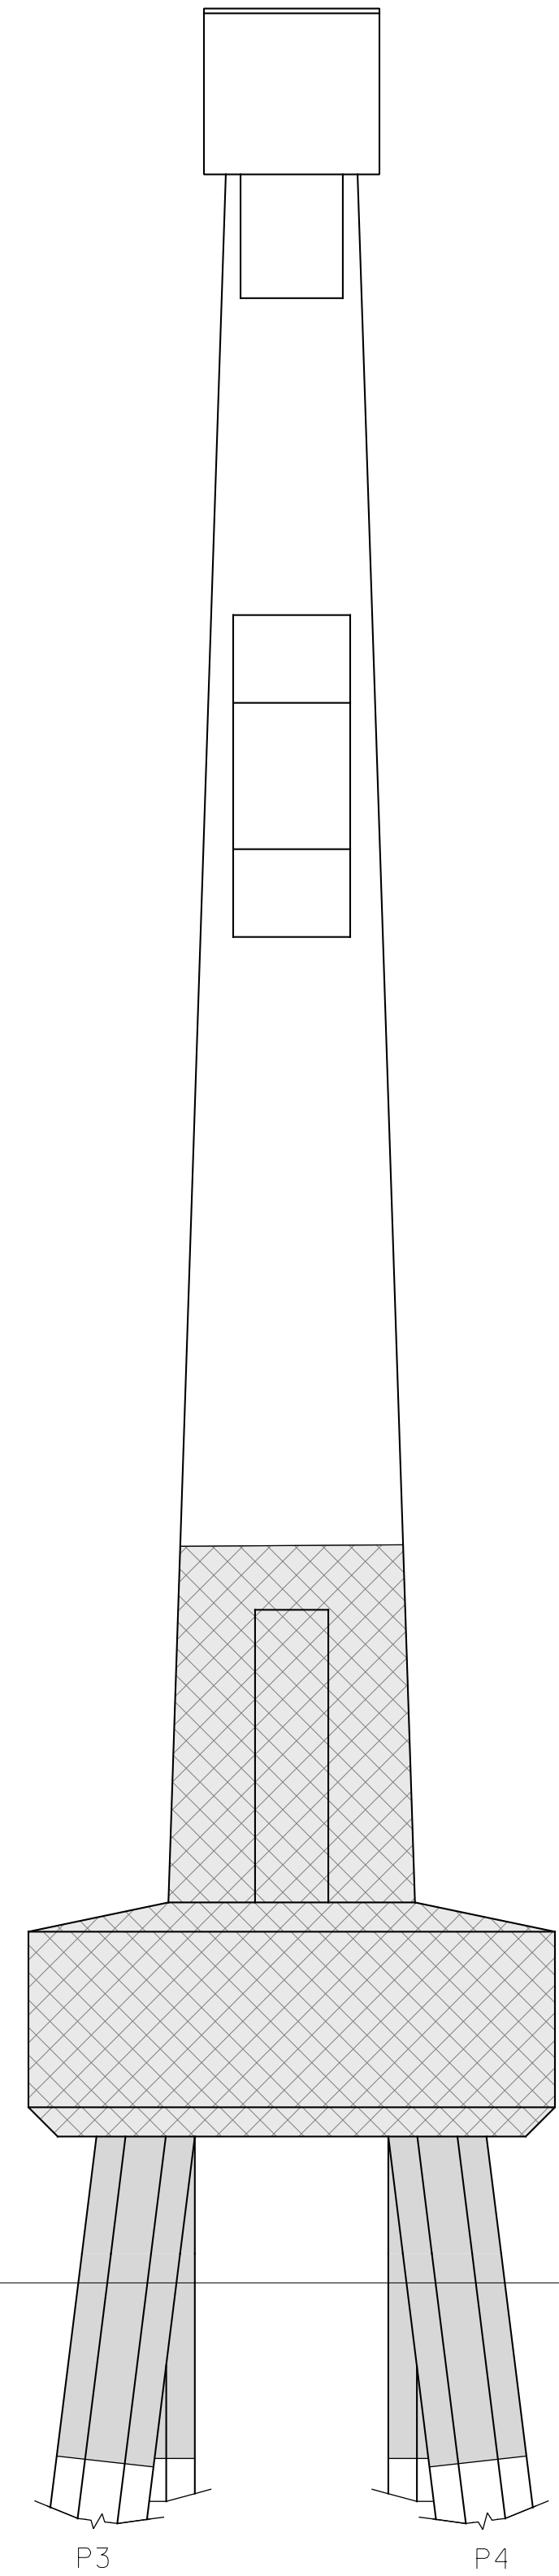
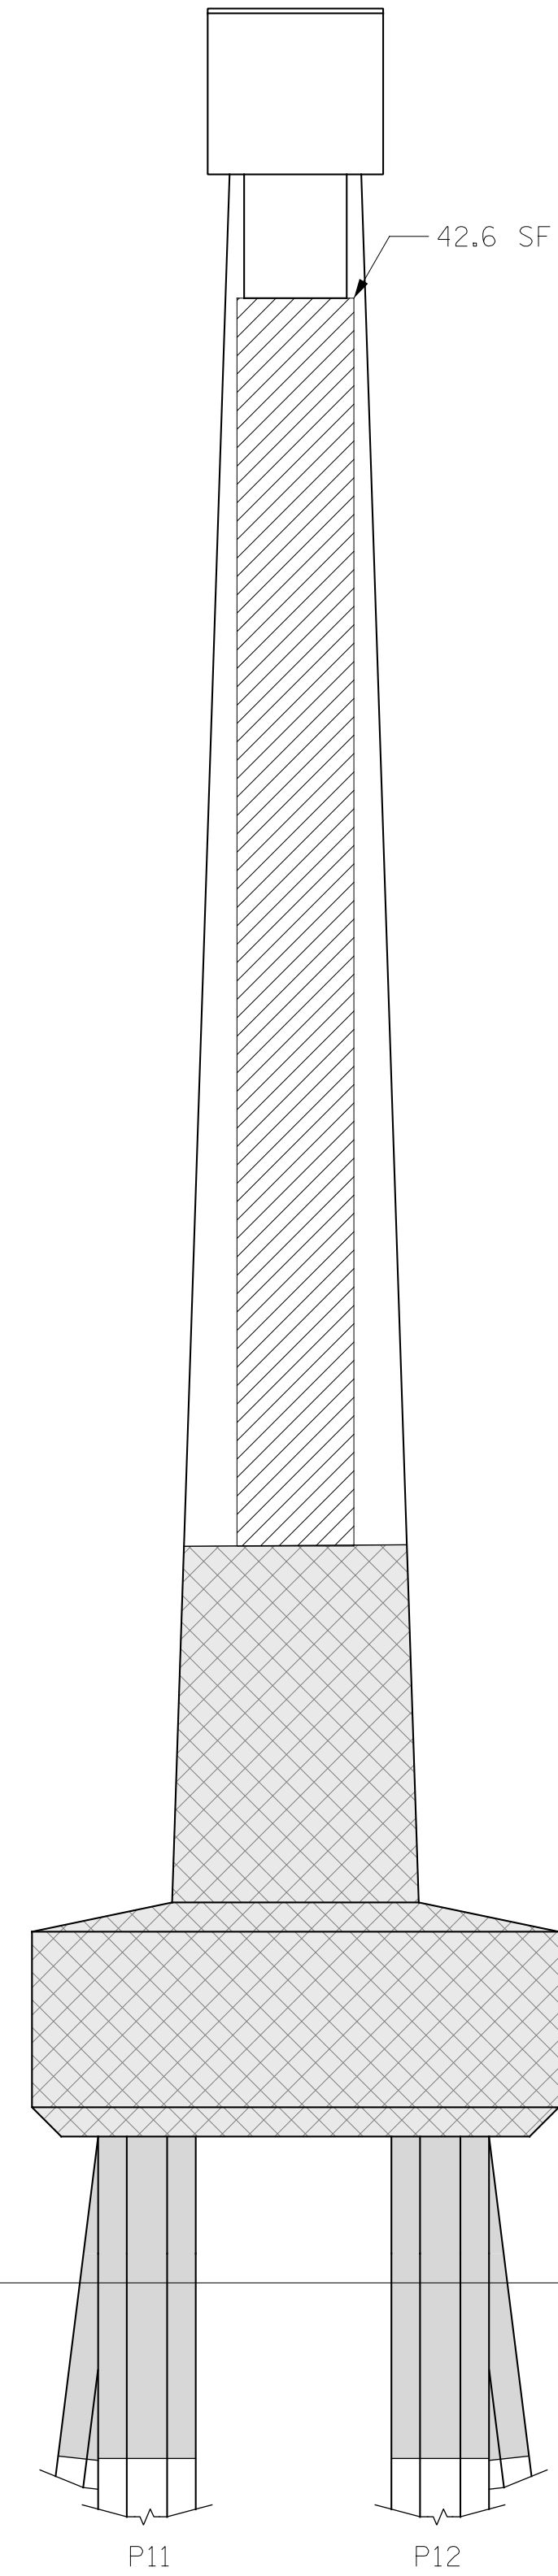
STATE OF NORTH CAROLINA DEPARTMENT OF TRANSPORTATION RALEIGH					
BENT 144 WEST FACE					
REVISIONS					SHEET NO.
NO.	BY:	DATE:	NO.	BY:	DATE:
1			3		
2			4		
TOTAL SHEETS					355

CAP REPAIRS		ESTIMATE		ACTUAL	
SHOTCRETE REPAIRS	- SF	- CF	SF	CF	
EPOXY RESIN INJECTION		- LF		LF	
COLUMN REPAIRS		ESTIMATE		ACTUAL	
SHOTCRETE REPAIRS	57.9 SF	29.0 CF	SF	CF	
EPOXY RESIN INJECTION		- LF		LF	
PILE REPAIRS		ESTIMATE		ACTUAL	
FRP PROTECTIVE SYSTEM AWL	- SF		SF		
FRP PROTECTIVE SYSTEM BWL	363.0 SF		SF

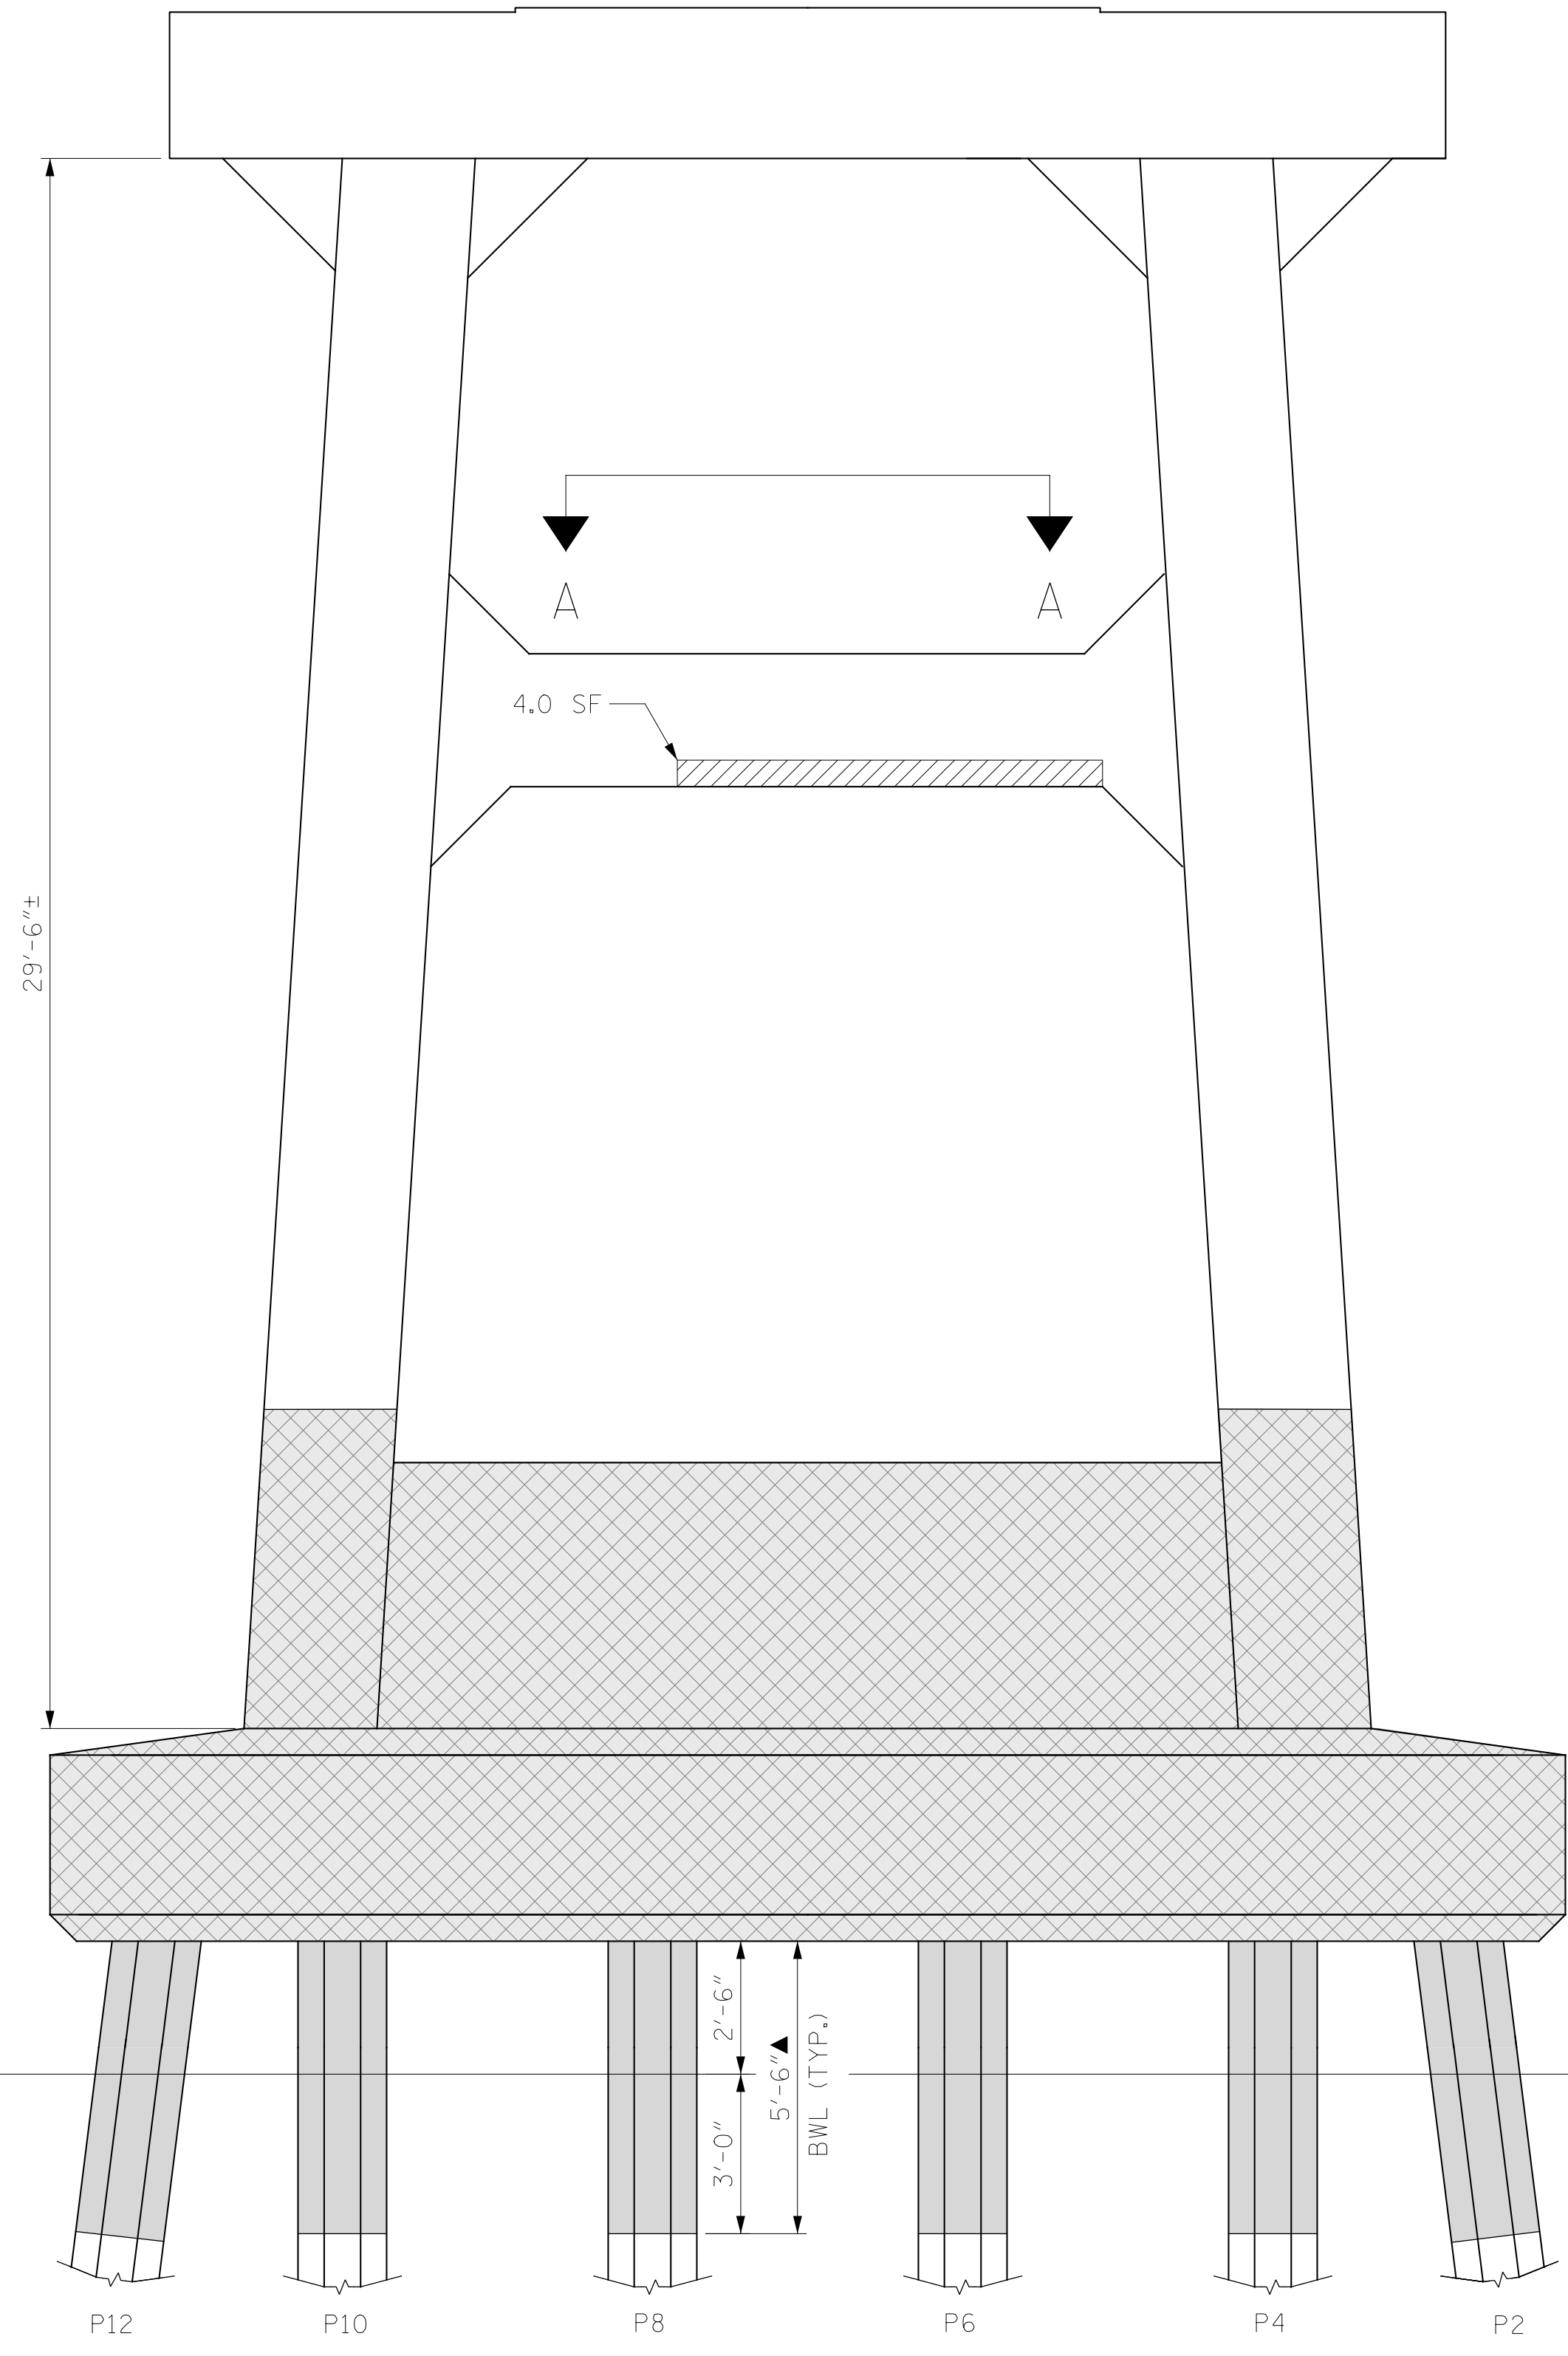
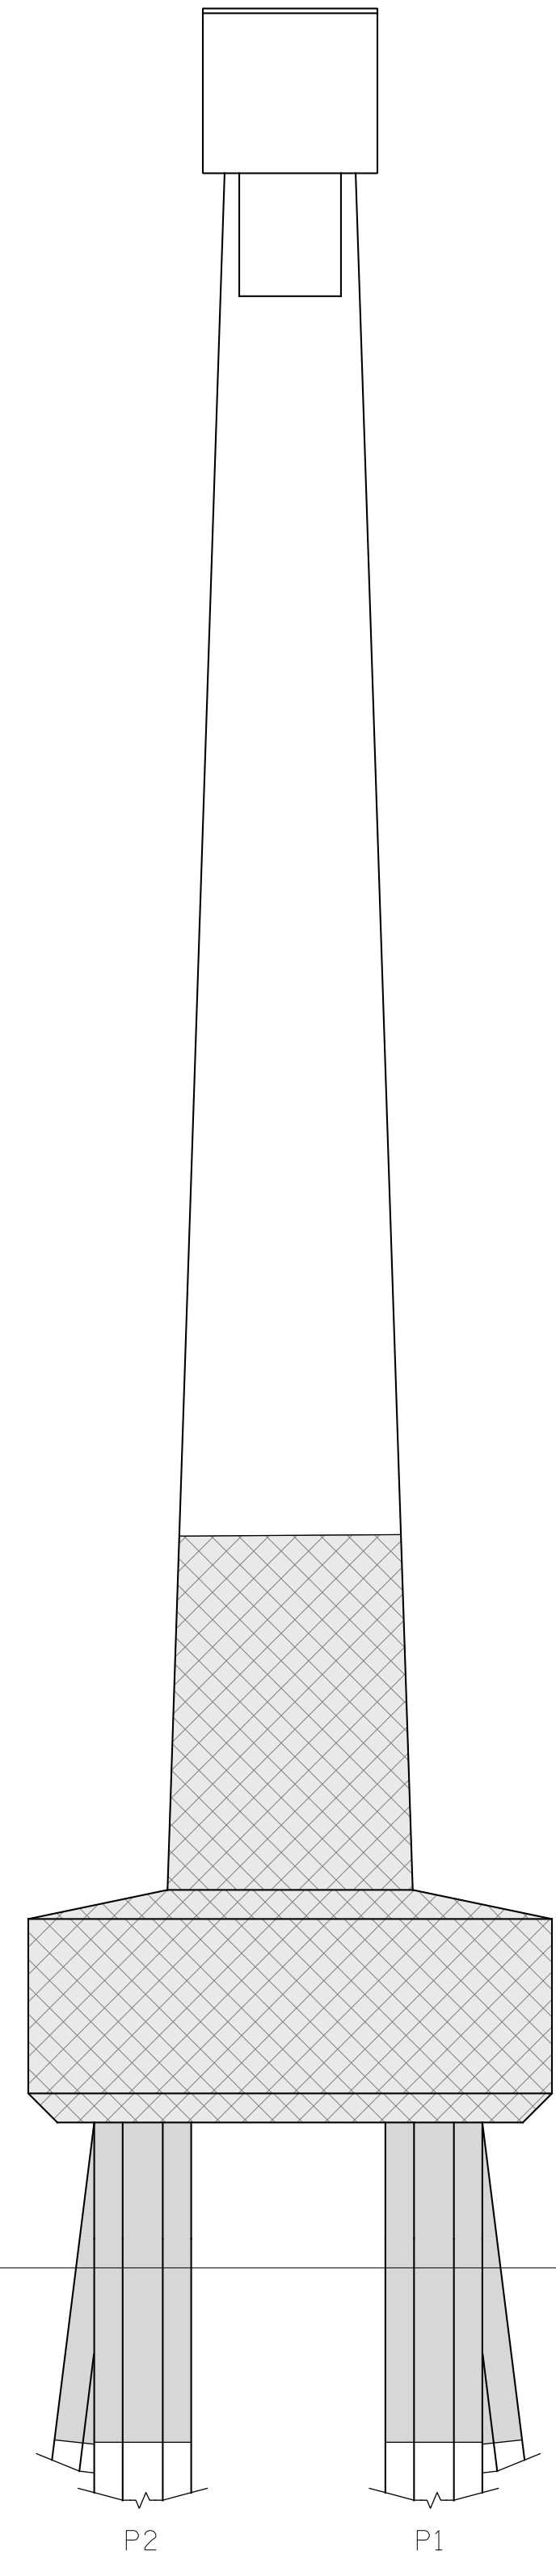
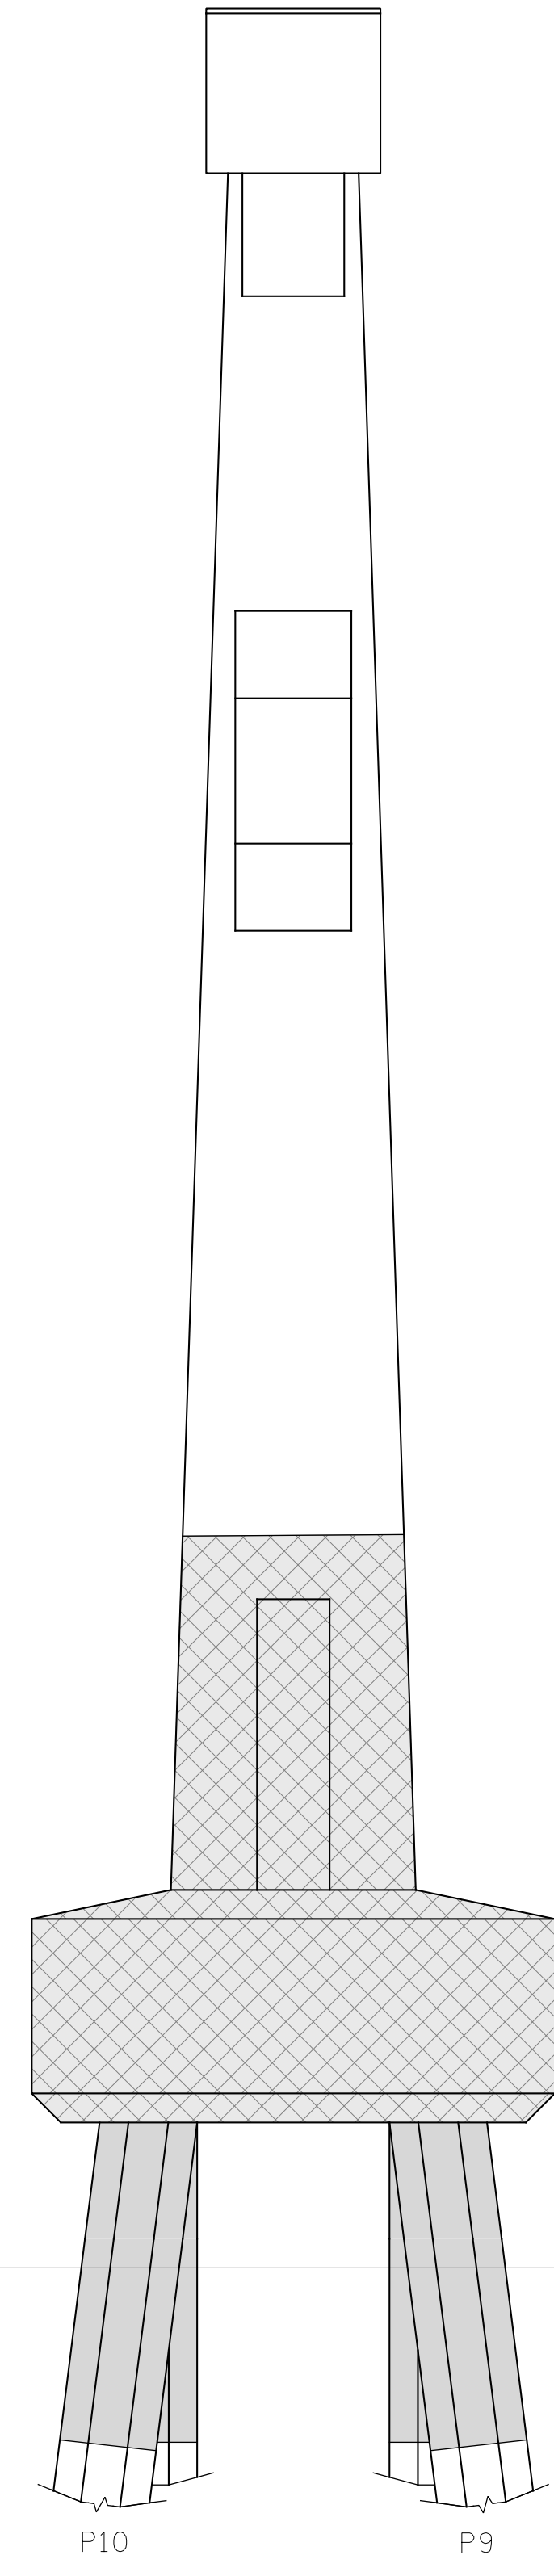
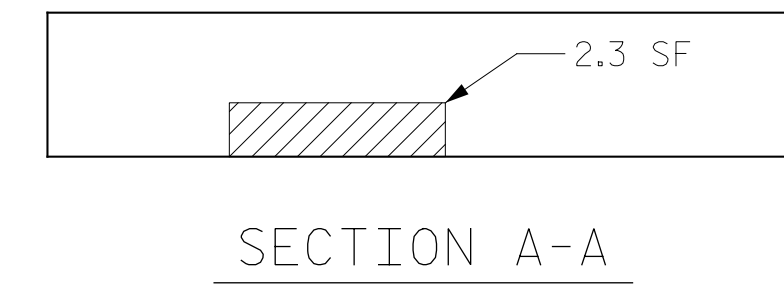
BENT 144
 EAST FACE

CAP REPAIRS		ESTIMATE		ACTUAL	
SHOTCRETE REPAIRS	- SF	- CF	SF	CF	
EPOXY RESIN INJECTION	3.0 LF				LF
COLUMN REPAIRS		ESTIMATE		ACTUAL	
SHOTCRETE REPAIRS	46.0 SF	23.0 CF	SF	CF	
EPOXY RESIN INJECTION	- LF				LF
PILE REPAIRS		ESTIMATE		ACTUAL	
FRP PROTECTIVE SYSTEM AWL	- SF				SF
FRP PROTECTIVE SYSTEM BWL	363.0 SF				SF
