AS-BUILT REPAIR QUANTITY TABLE

PROJECT NO. HB-0017
DARE COUNTY
BRIDGE NO. 270009

BENT 73 & BENT 74

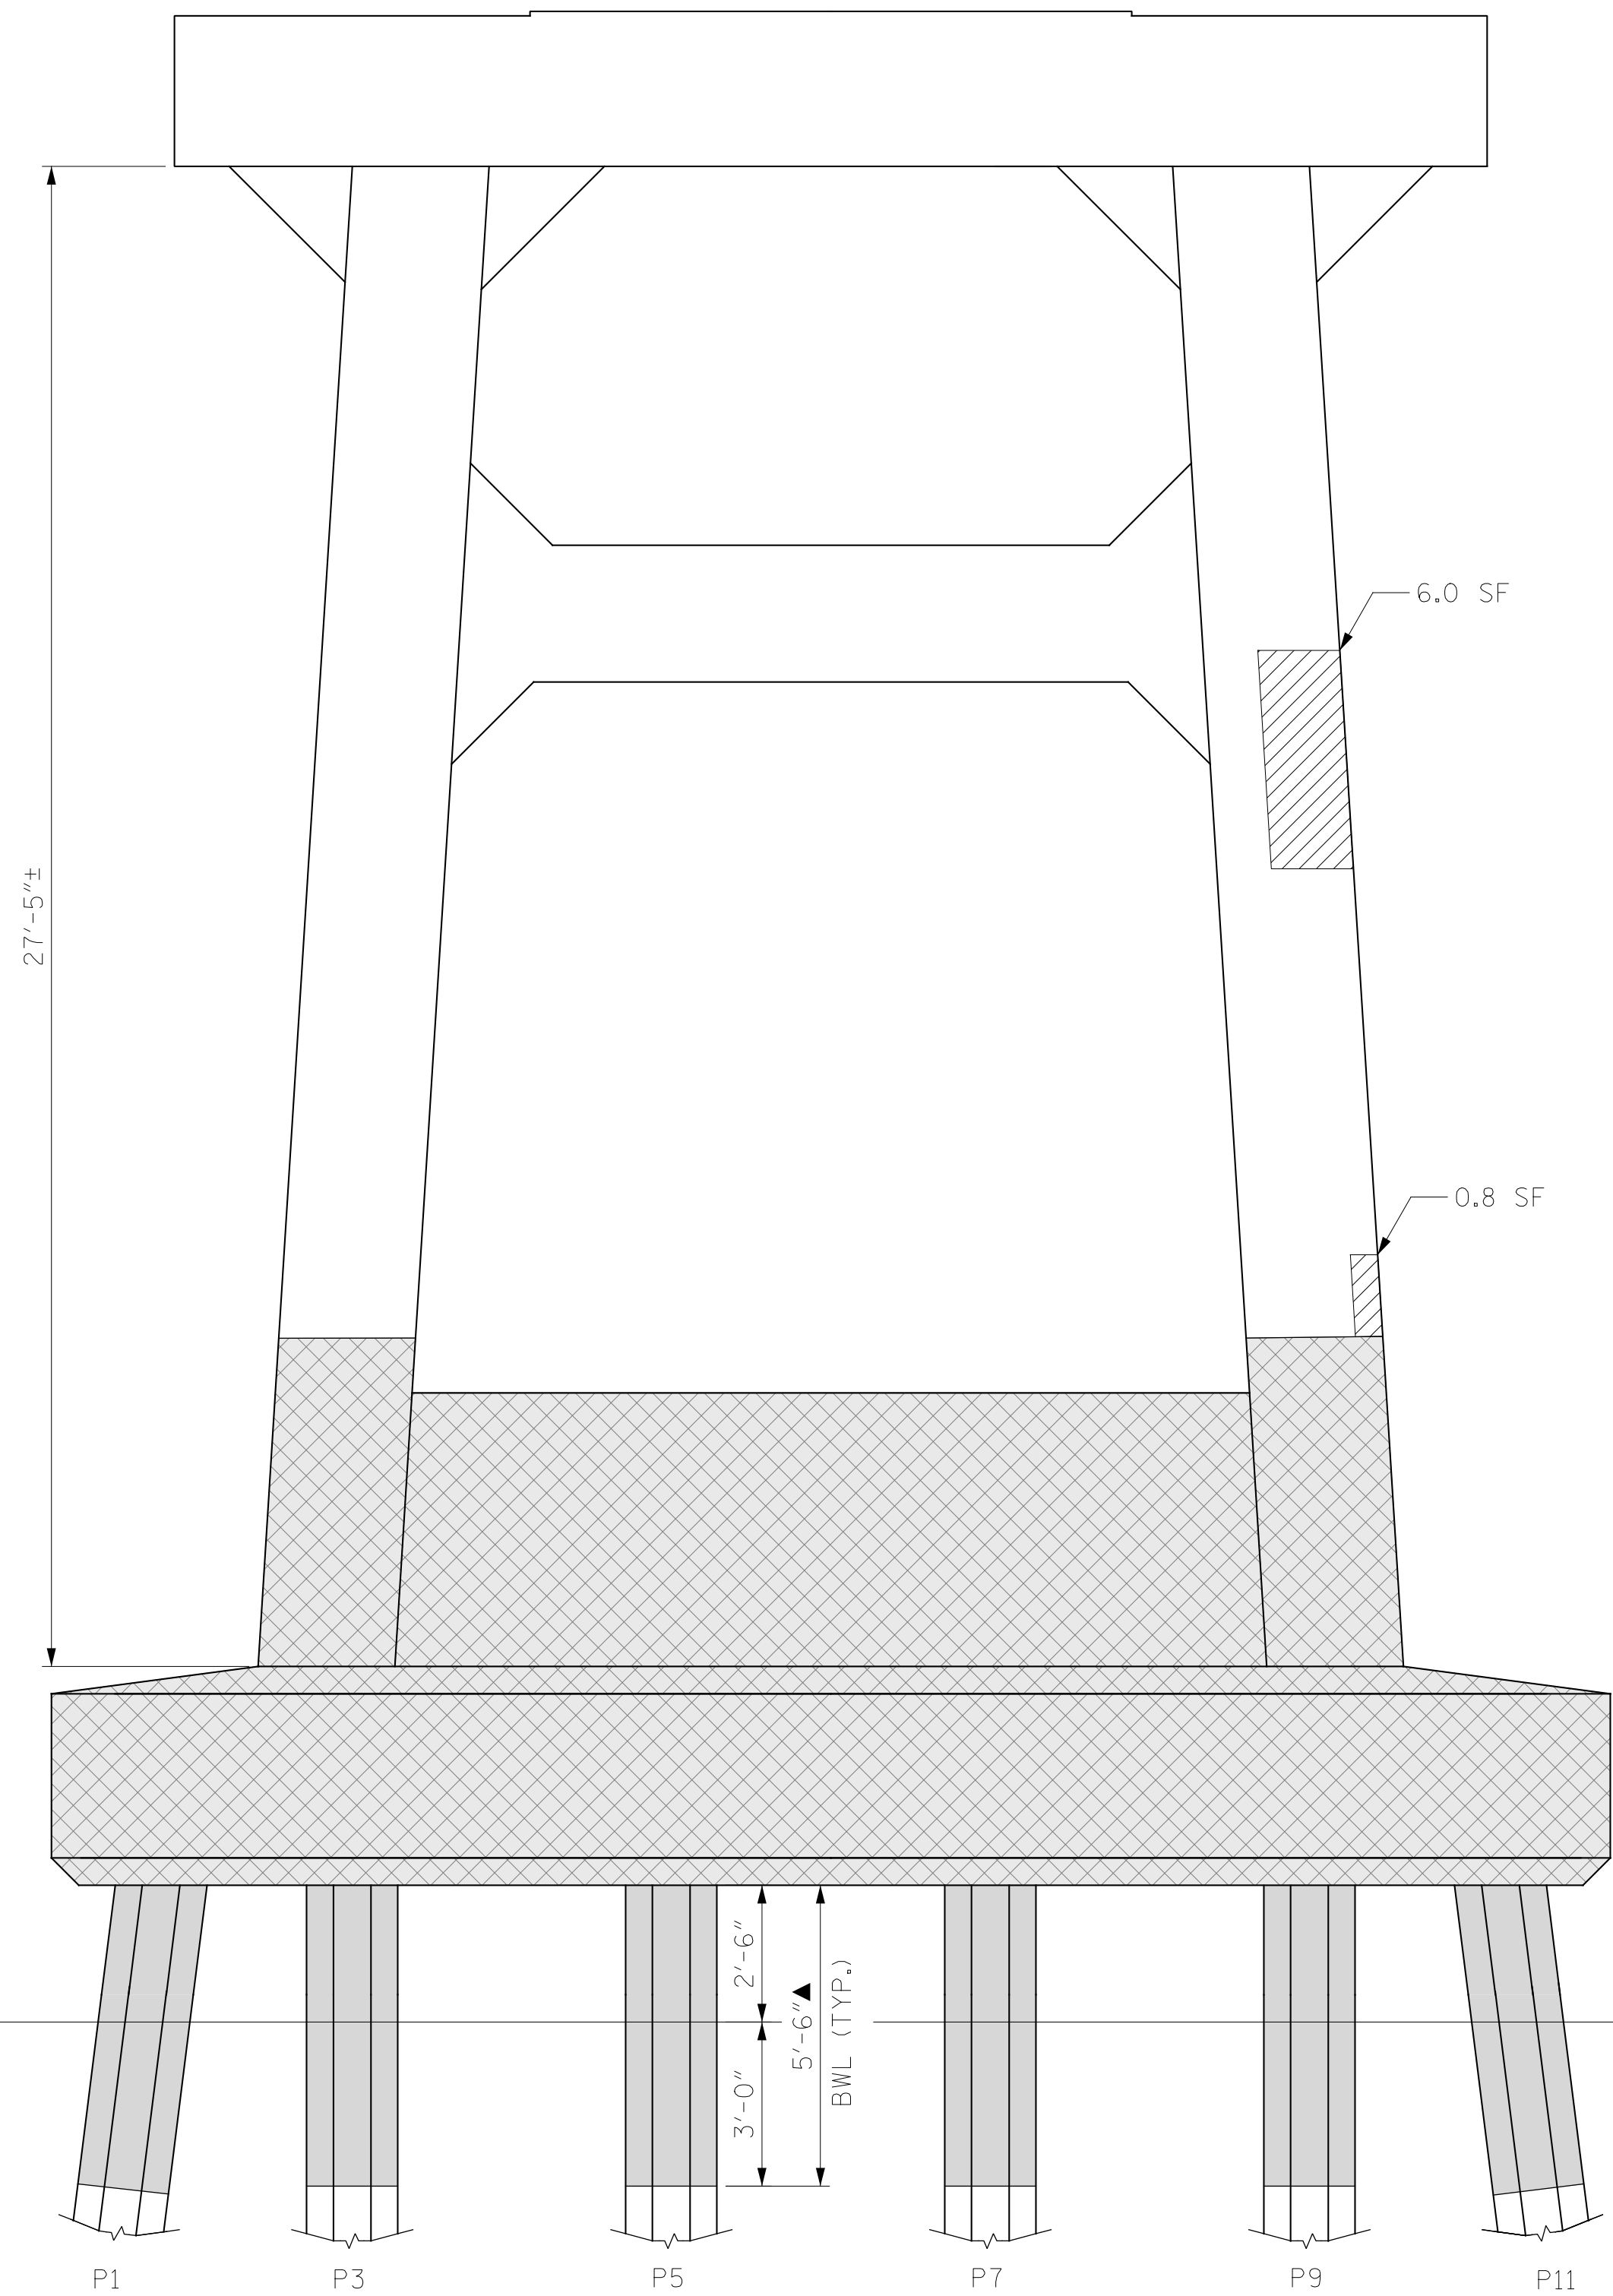
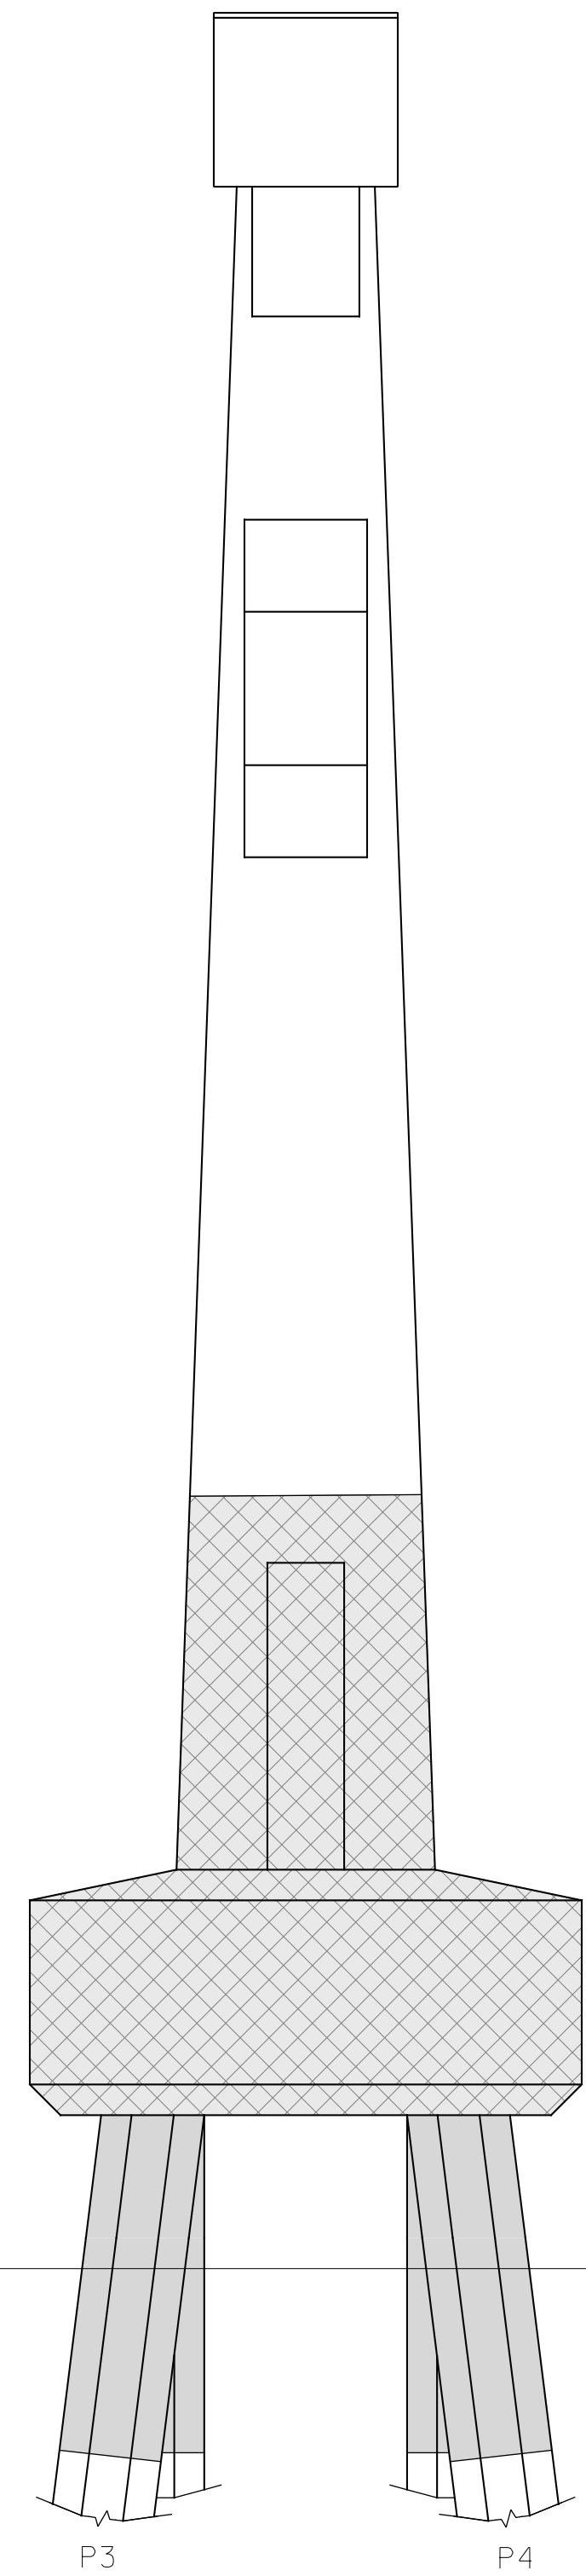
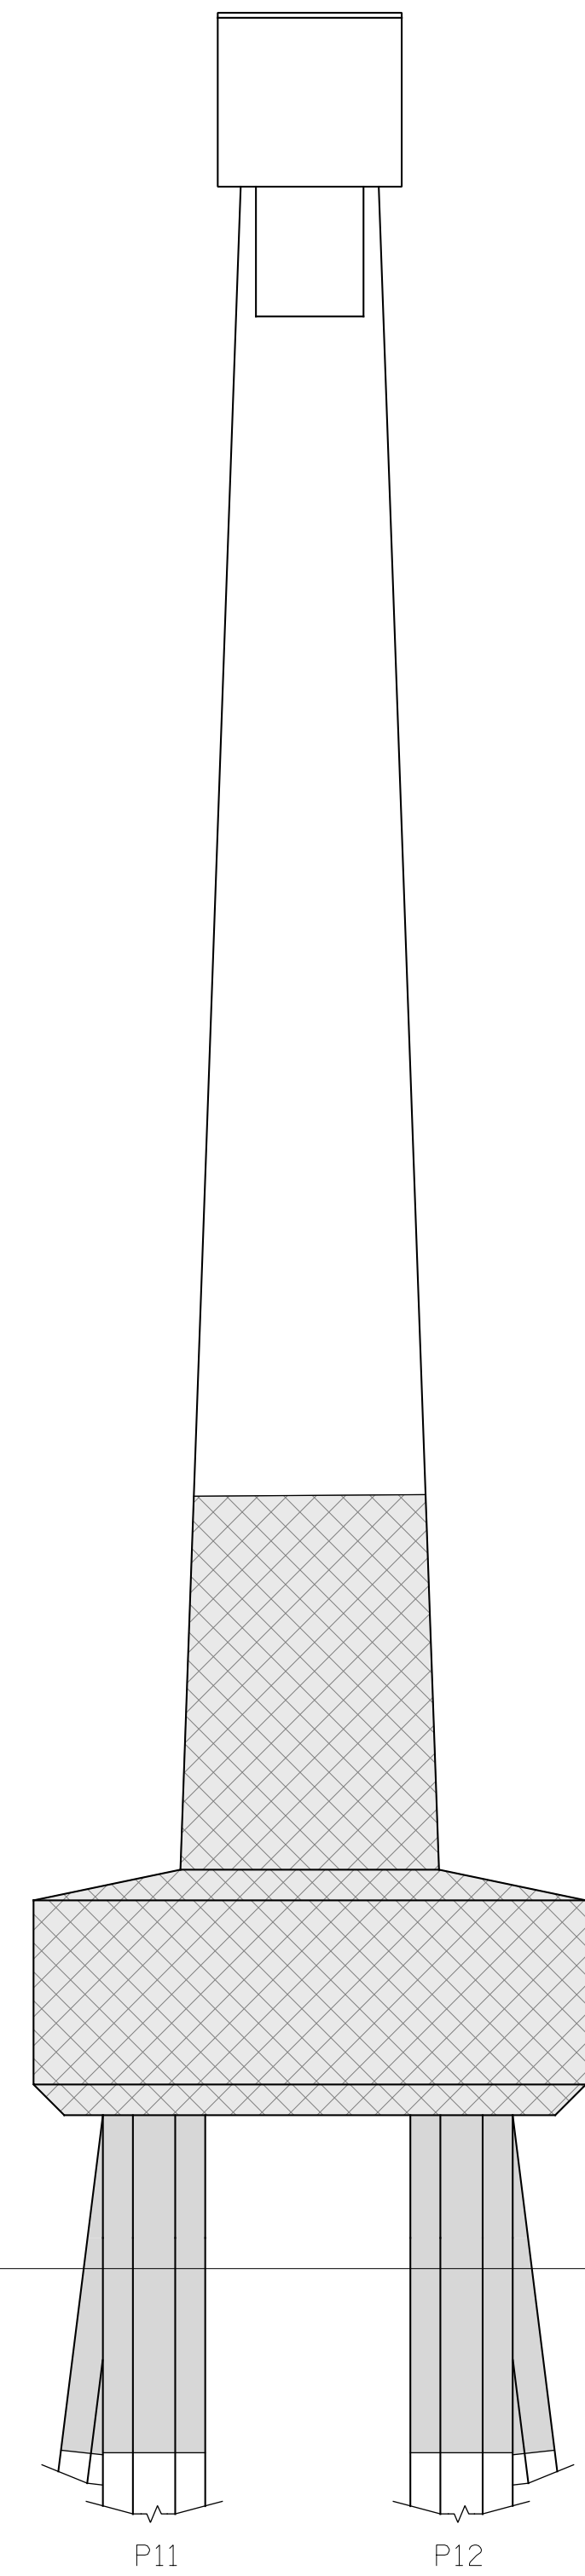
STATE OF NORTH CAROLINA DEPARTMENT OF TRANSPORTATION RALEIGH						SHEET NO.
BENT 145 WEST FACE						S-227
REVISIONS						TOTAL SHEETS
NO.	BY:	DATE:	NO.	BY:	DATE:	355
1			3			
2			4

CAP REPAIRS		ESTIMATE		ACTUAL	
SHOTCRETE REPAIRS	- SF	- CF	SF	CF	
EPOXY RESIN INJECTION		- LF		LF	
COLUMN REPAIRS		ESTIMATE		ACTUAL	
SHOTCRETE REPAIRS	11.0 SF	5.5 CF	SF	CF	
EPOXY RESIN INJECTION		- LF		LF	
PILE REPAIRS		ESTIMATE		ACTUAL	
FRP PROTECTIVE SYSTEM AWL	- SF		SF		
FRP PROTECTIVE SYSTEM BWL	363.0 SF		SF

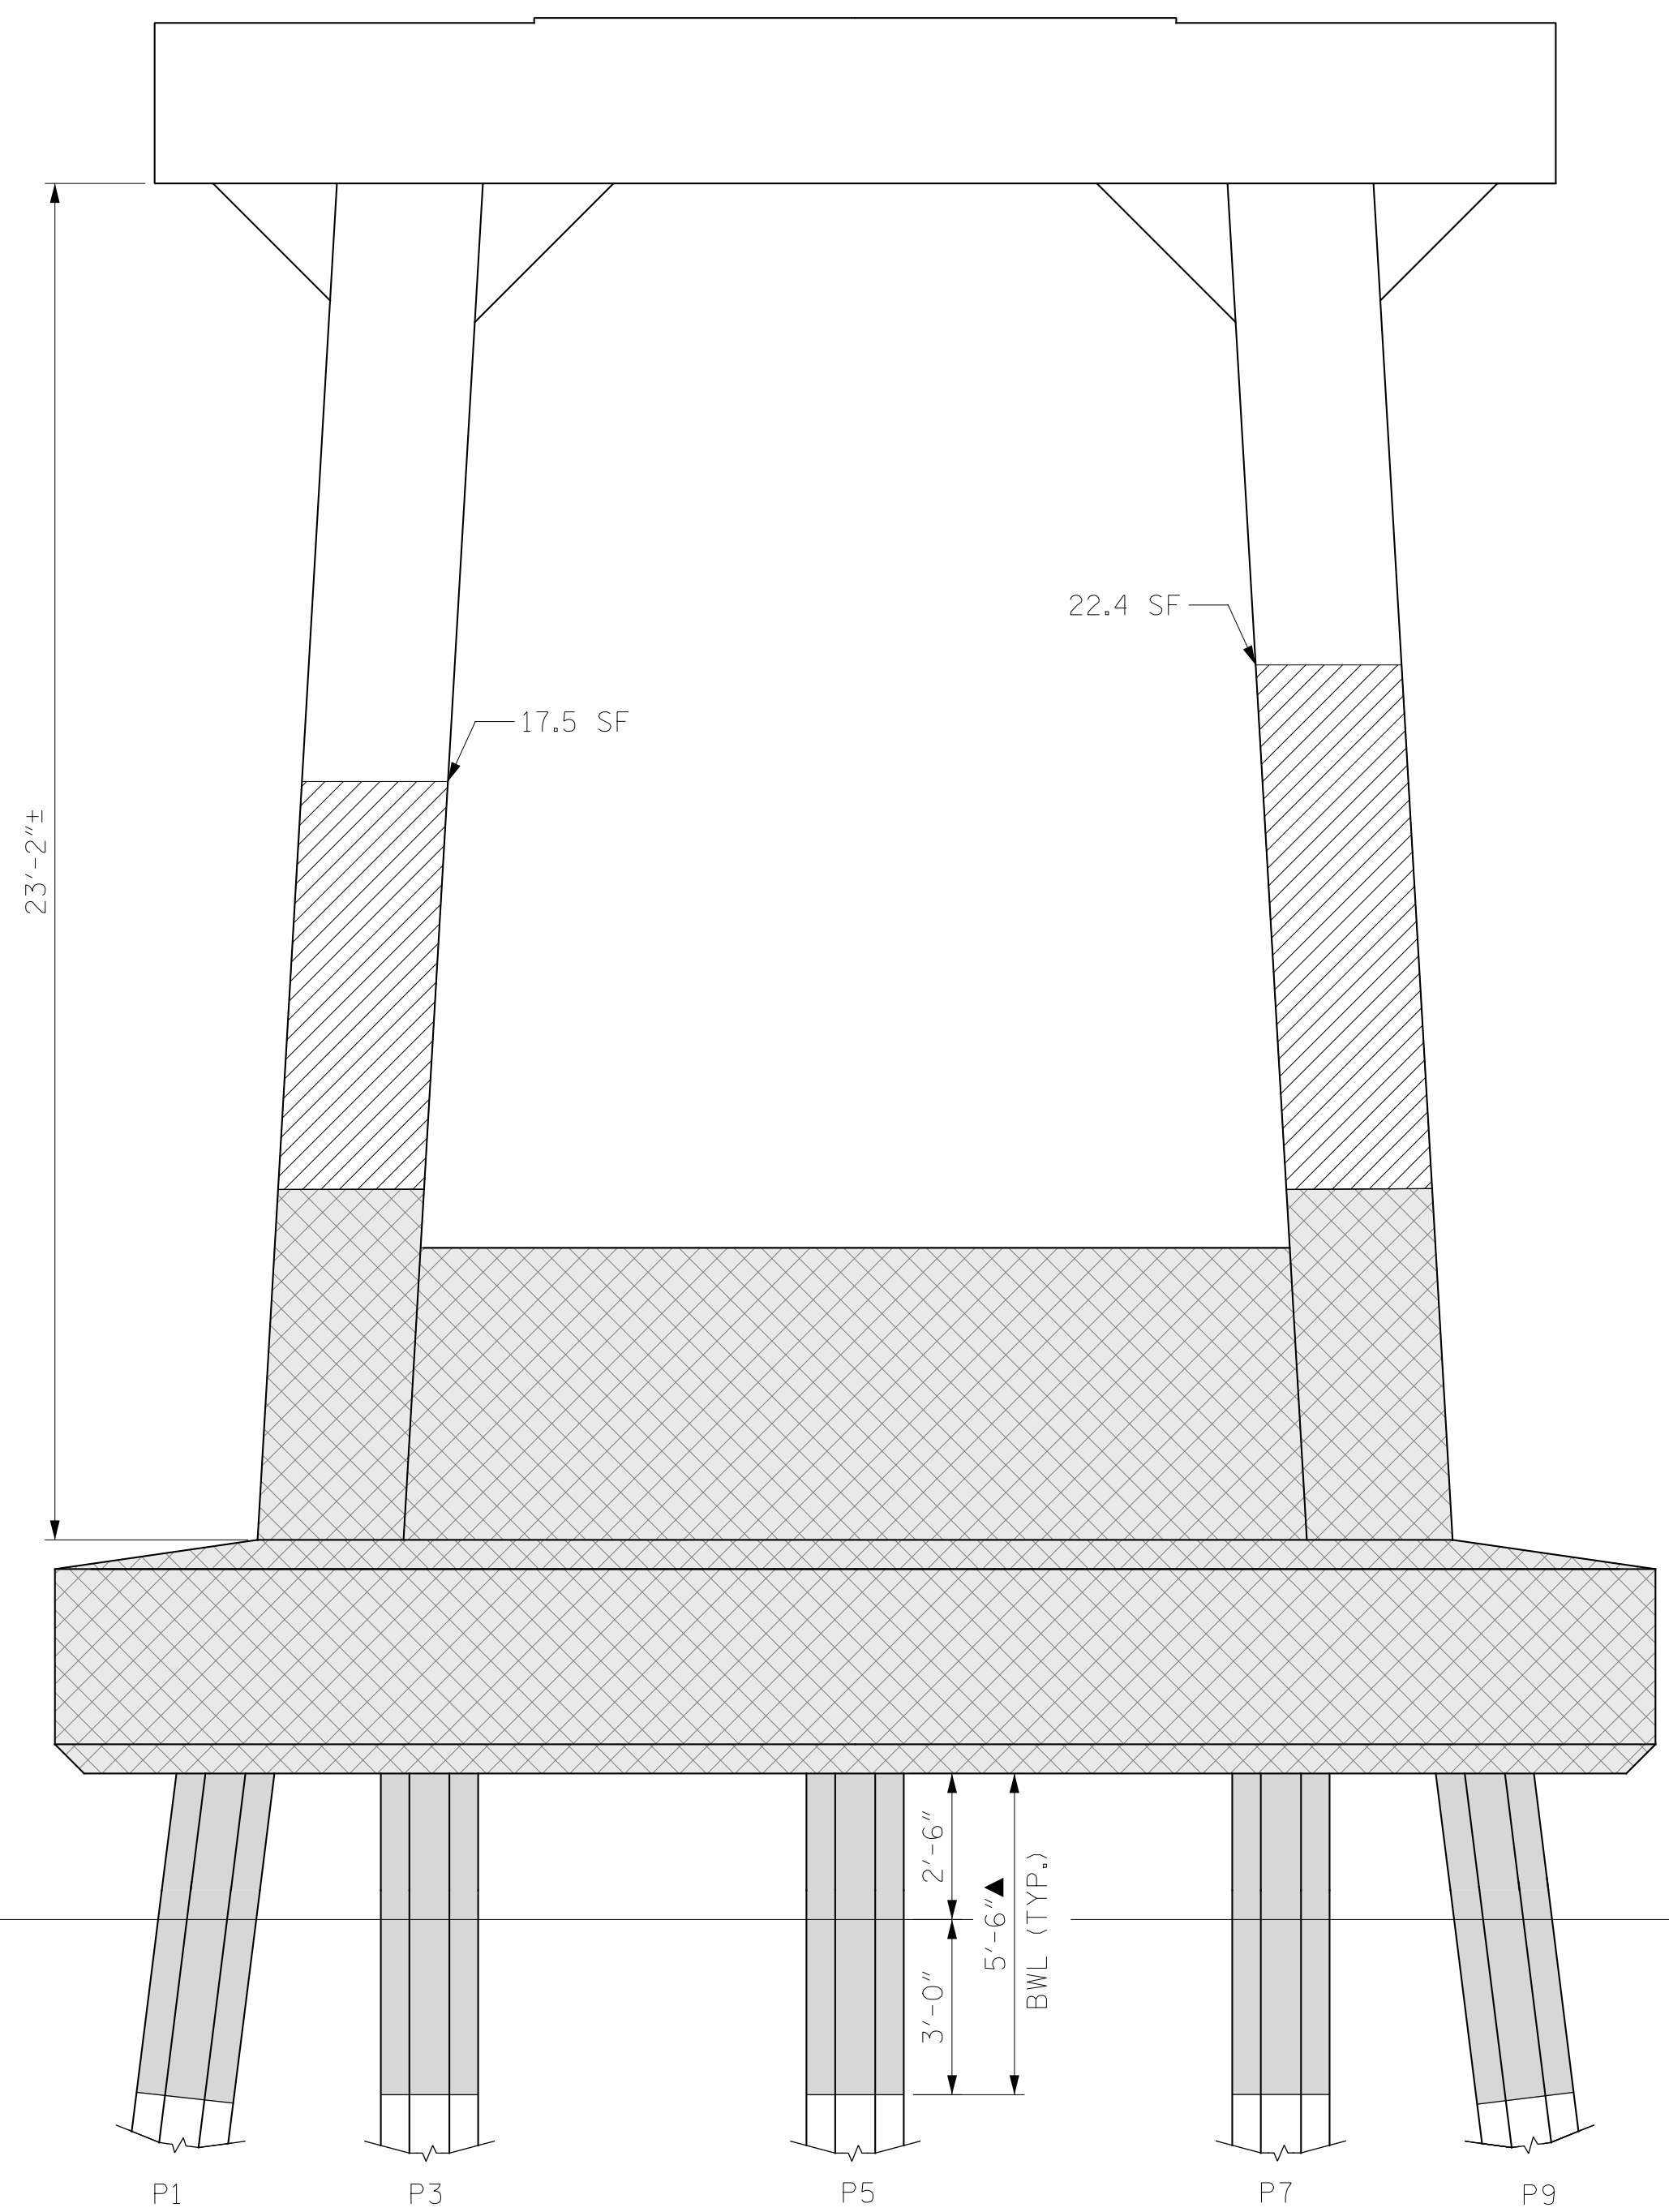
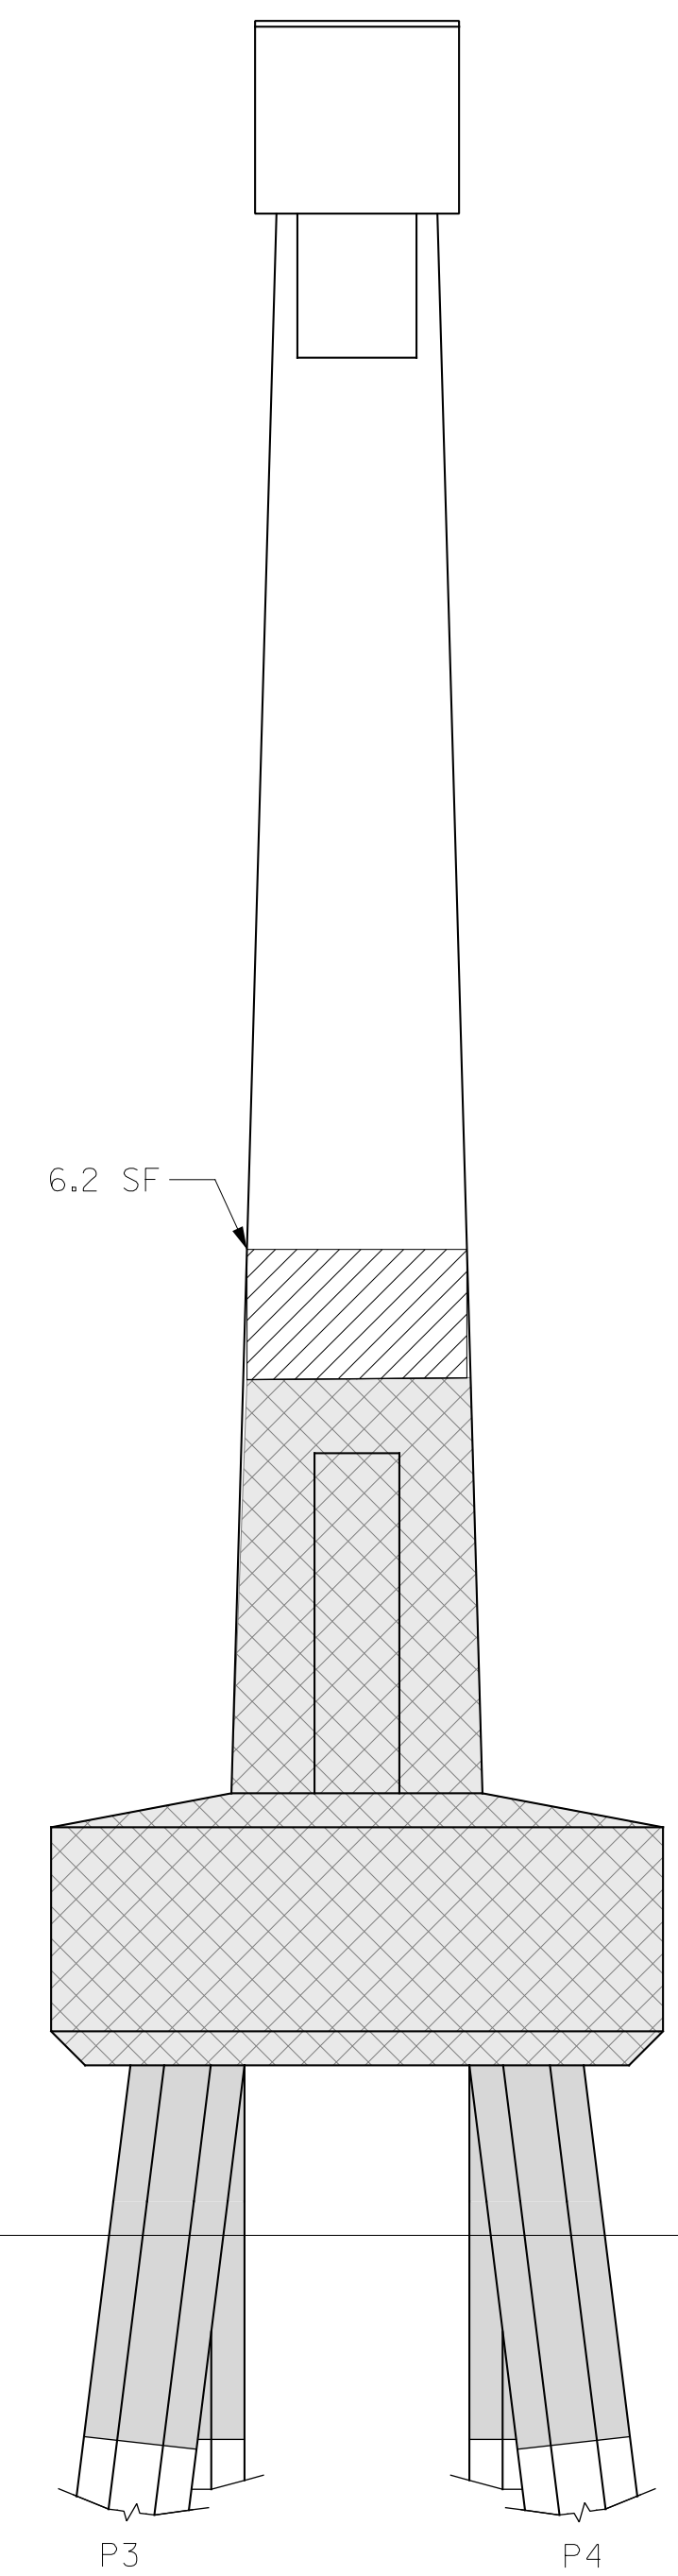
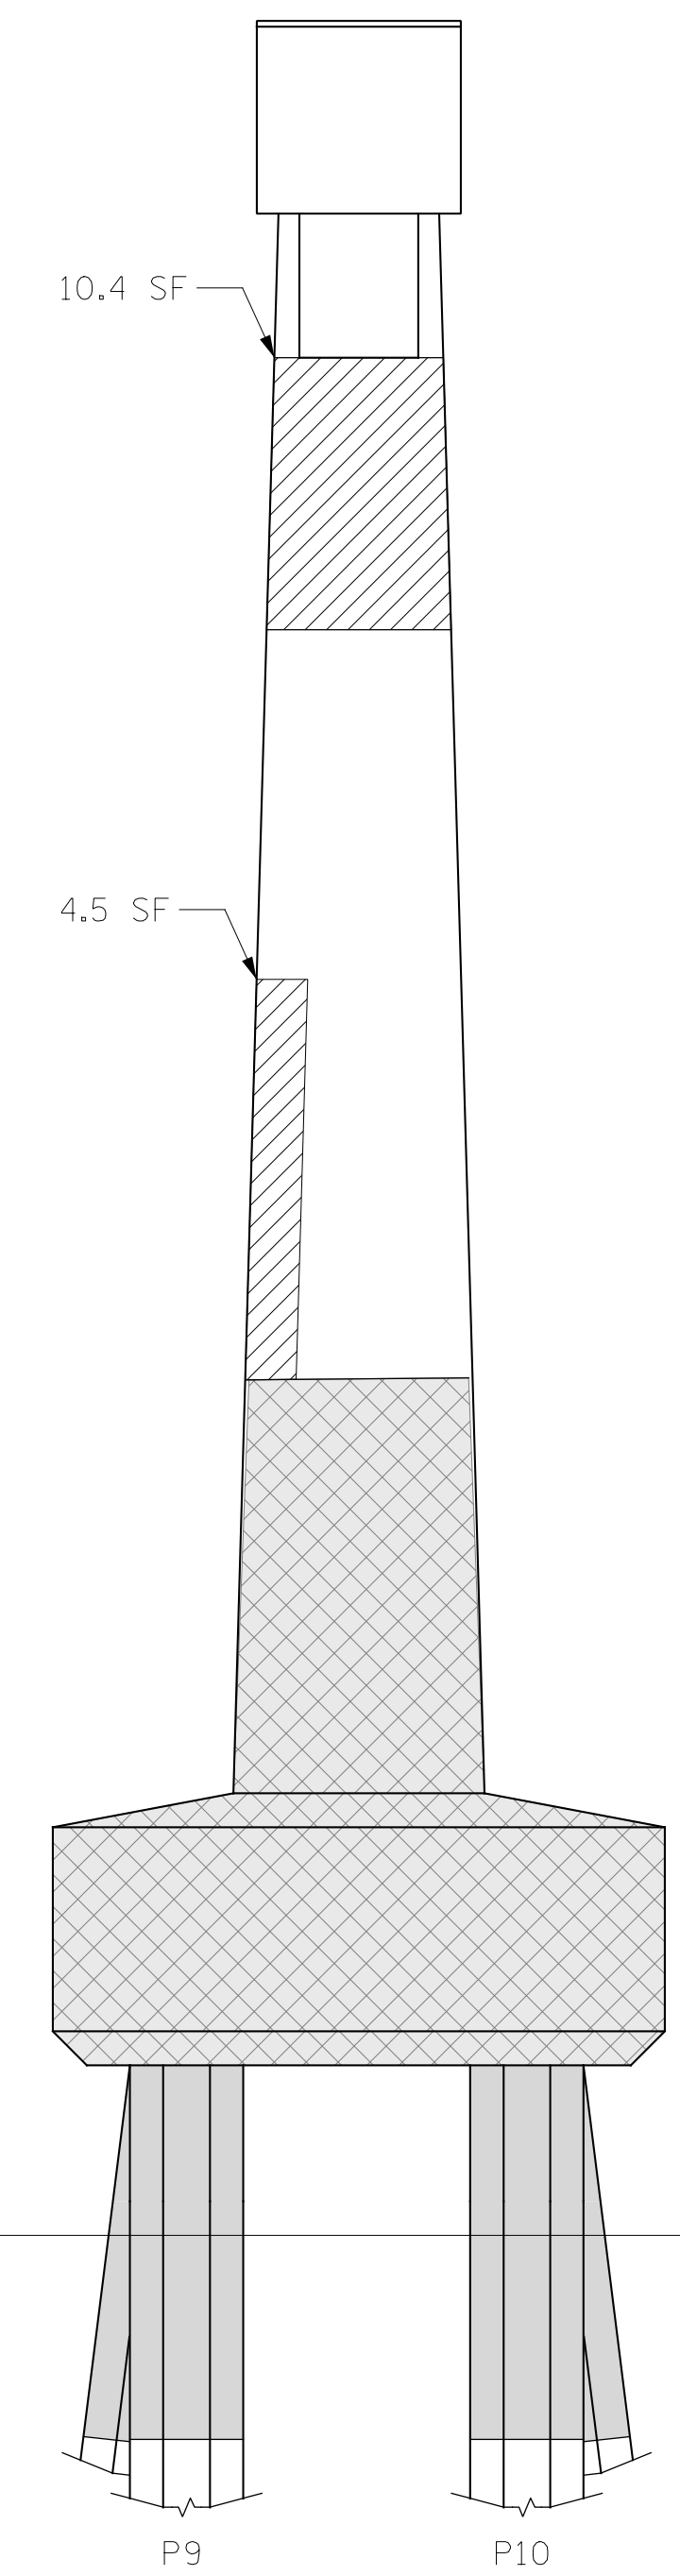
**BENT 147
 WEST FACE**

BENT 147				
CAP REPAIRS		ESTIMATE		ACTUAL
SHOTCRETE REPAIRS	- SF	- CF	SF	CF
EPOXY RESIN INJECTION	- LF			LF
COLUMN REPAIRS		ESTIMATE		ACTUAL
SHOTCRETE REPAIRS	61.0 SF	30.5 CF	SF	CF
EPOXY RESIN INJECTION	- LF			LF
PILE REPAIRS		ESTIMATE		ACTUAL
FRP PROTECTIVE SYSTEM AWL	- SF			SF
FRP PROTECTIVE SYSTEM BWL	302.5 SF			SF

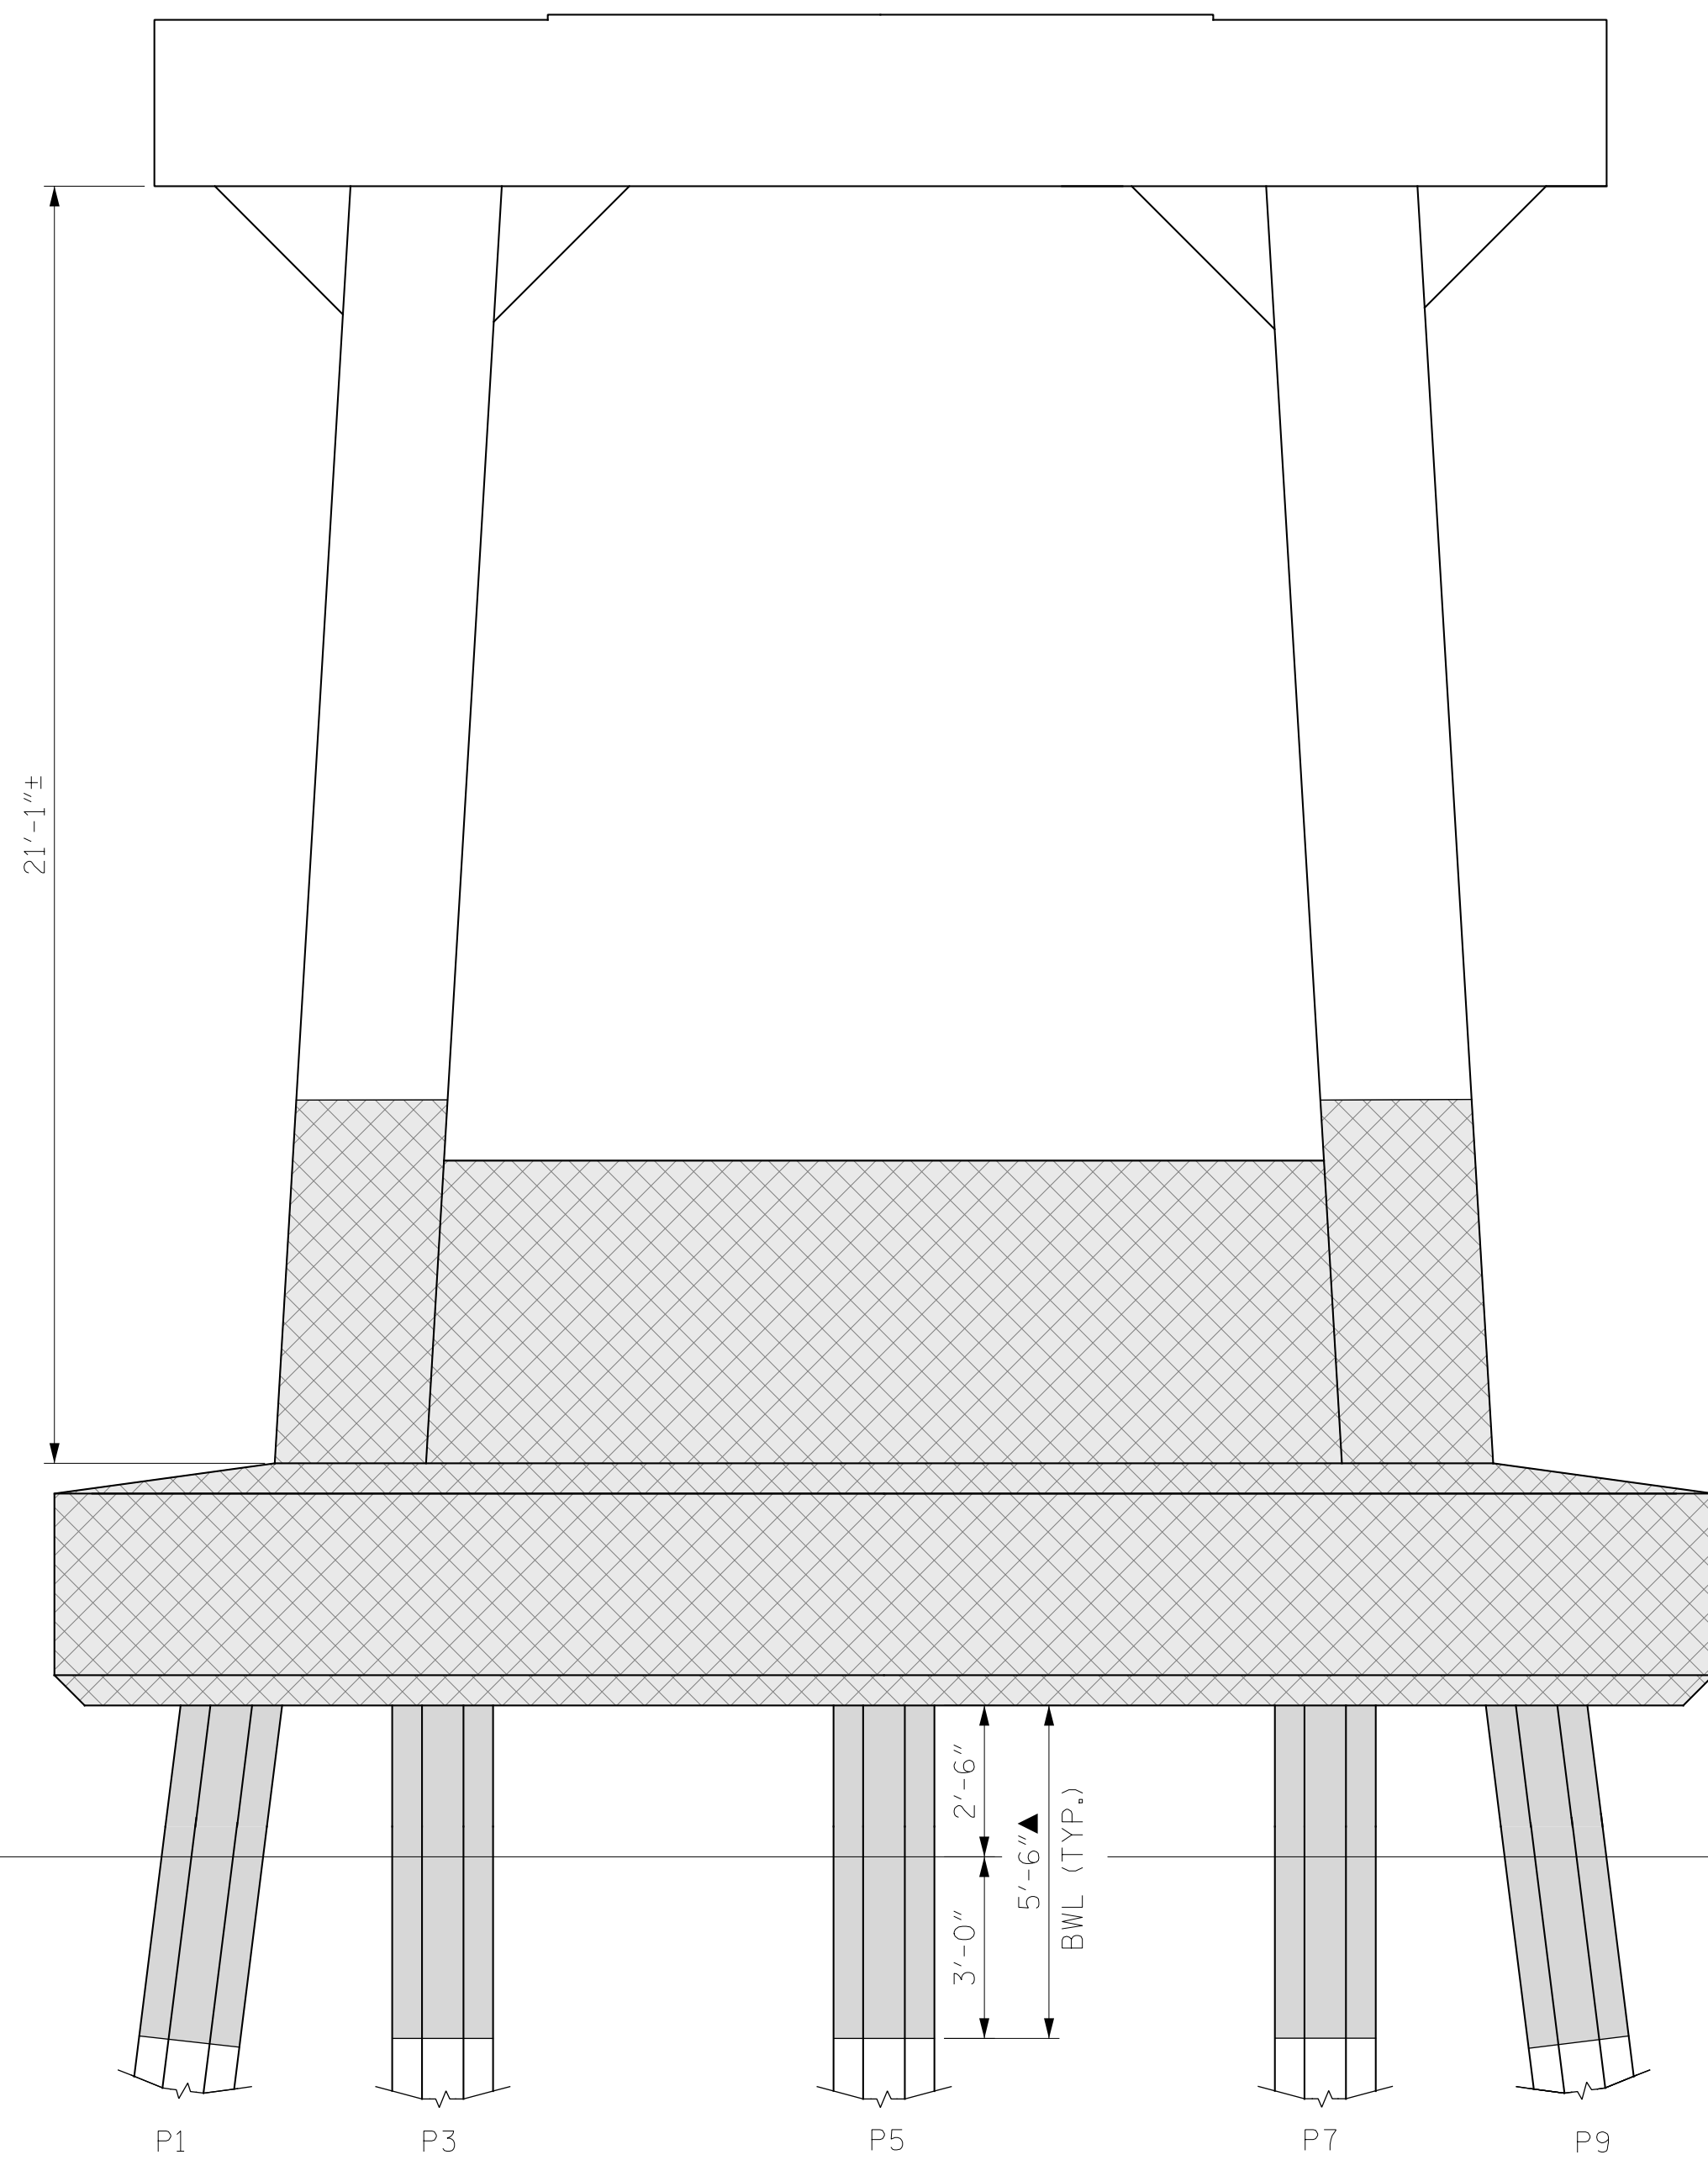
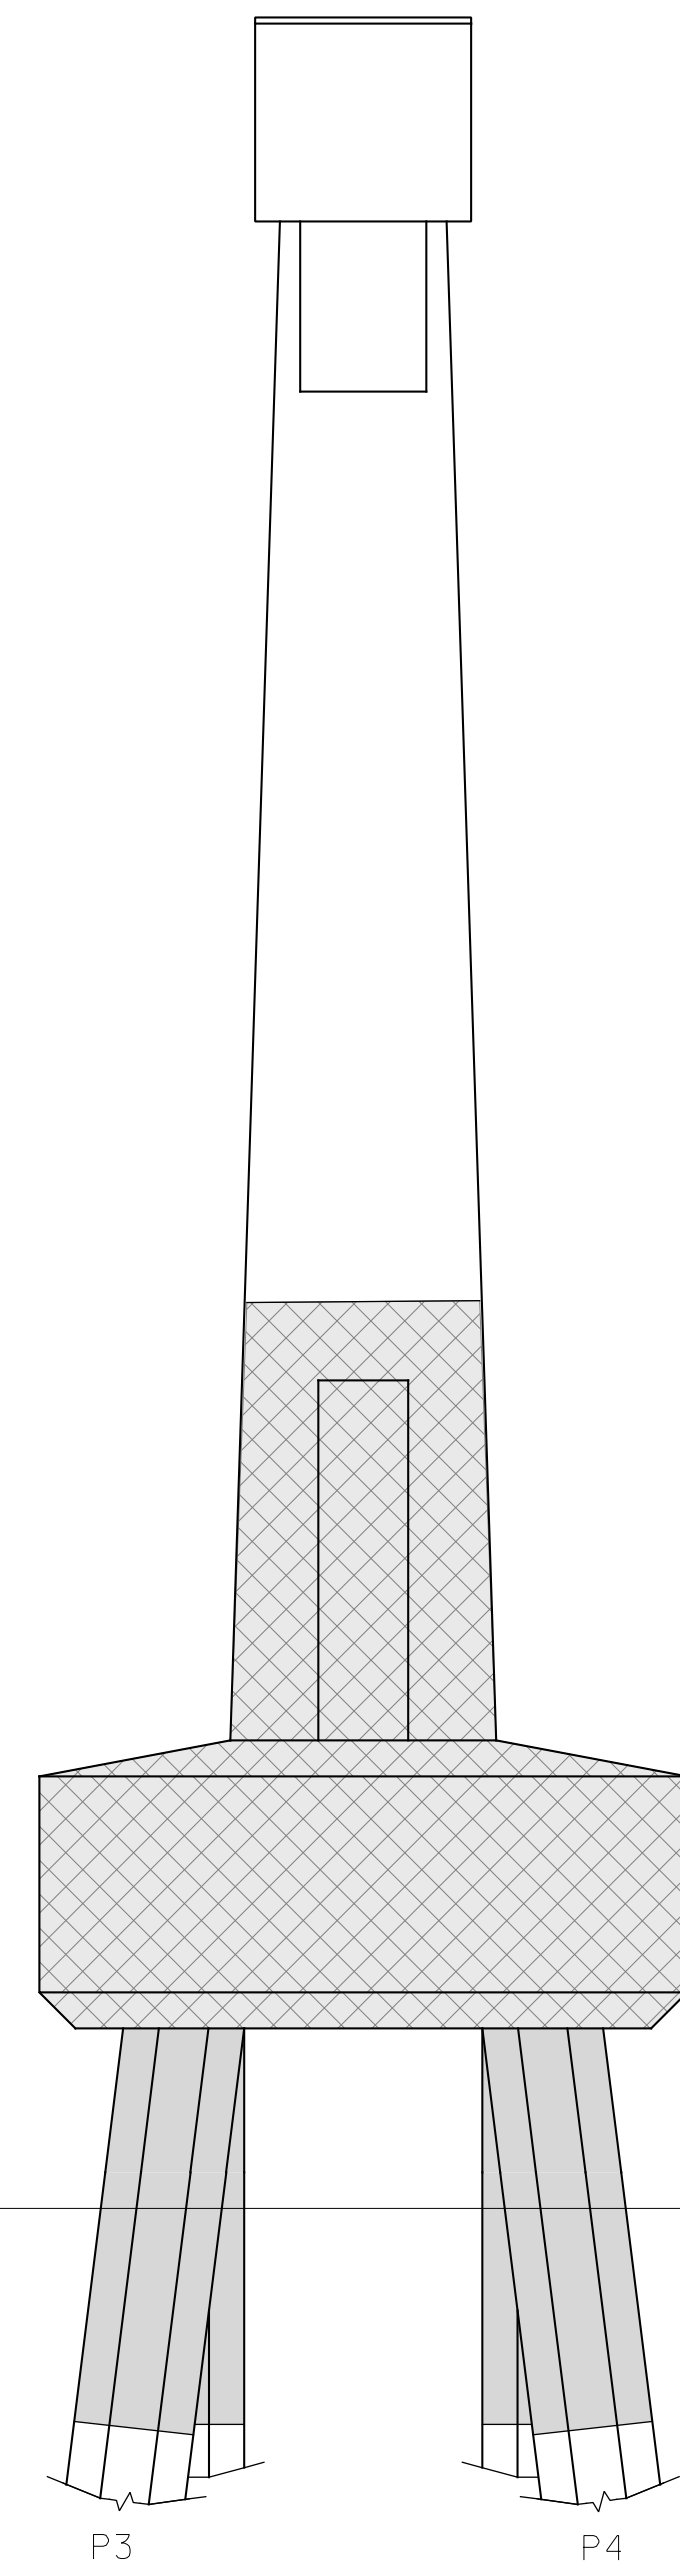
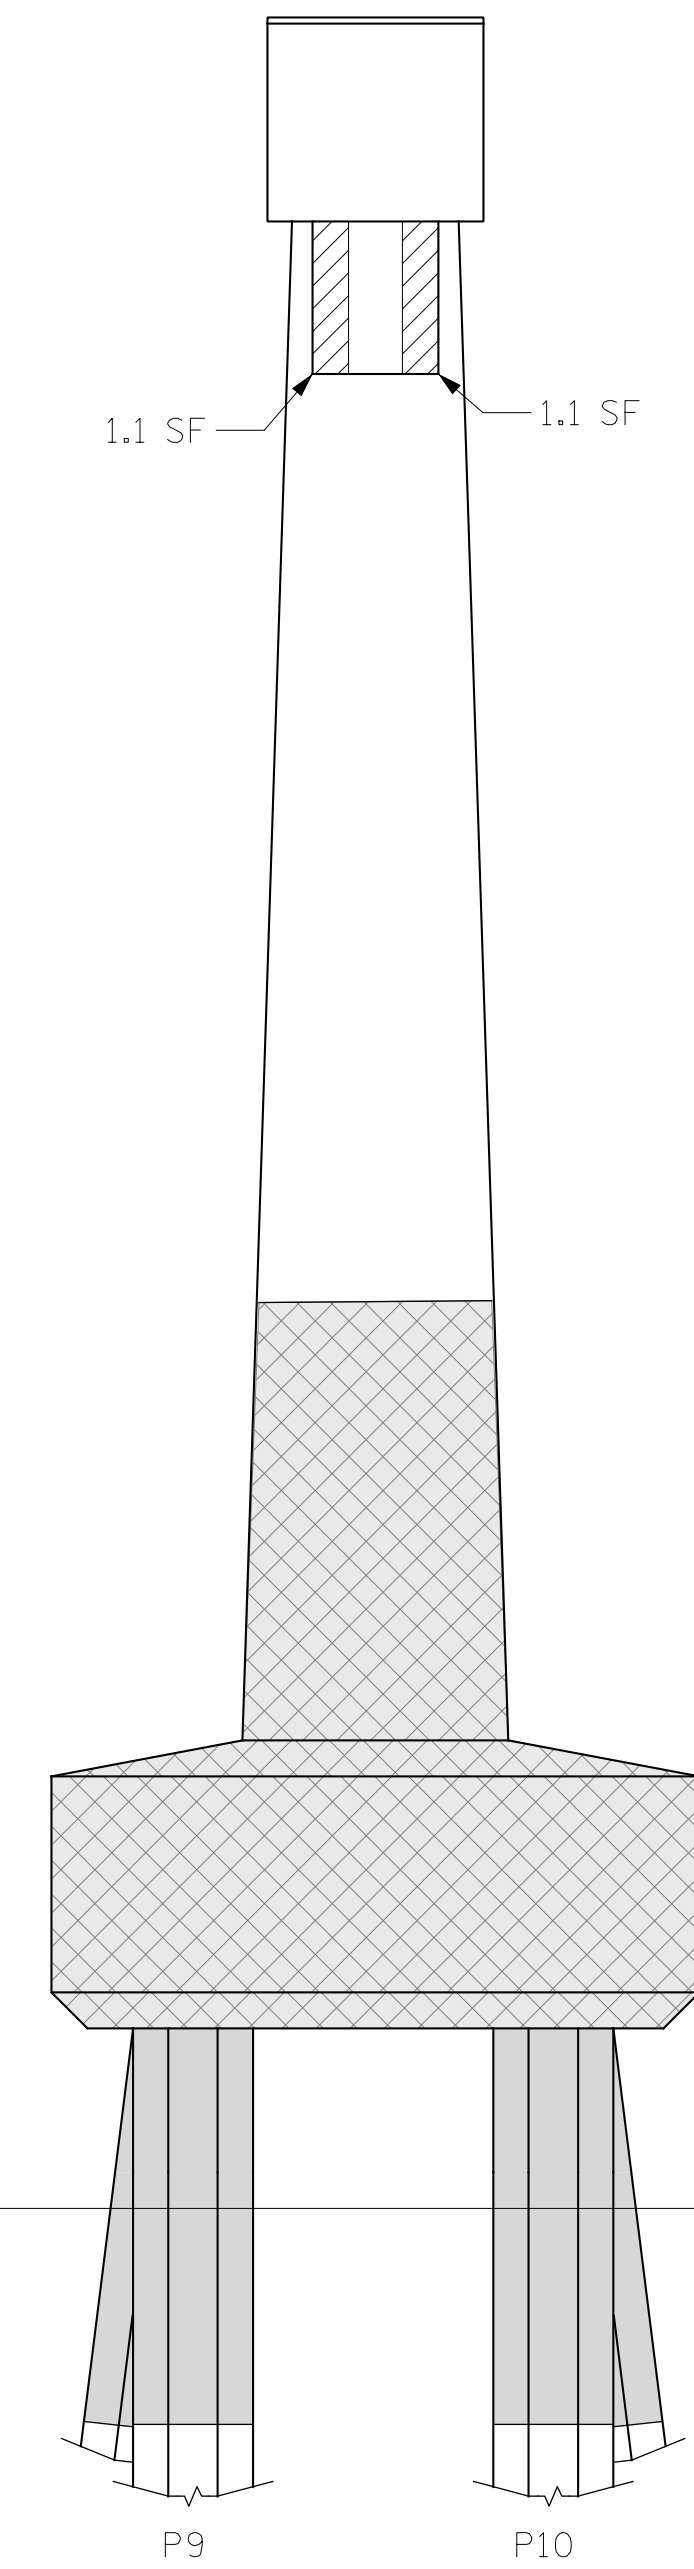
BENT 148
 WEST FACE

BENT 148				
CAP REPAIRS		ESTIMATE		ACTUAL
SHOTCRETE REPAIRS	- SF	- CF	SF	CF
EPOXY RESIN INJECTION	- LF			LF
COLUMN REPAIRS		ESTIMATE		ACTUAL
SHOTCRETE REPAIRS	3.3 SF	1.7 CF	SF	CF
EPOXY RESIN INJECTION	- LF			LF
PILE REPAIRS		ESTIMATE		ACTUAL
FRP PROTECTIVE SYSTEM AWL	- SF			SF
FRP PROTECTIVE SYSTEM BWL	302.5 SF			SF
