PROJECT NO. I-5955
GUILFORD COUNTY
 BRIDGE NO. 400367

STATE OF NORTH CAROLINA
 DEPARTMENT OF TRANSPORTATION
 RALEIGH

**BEARING
 REPOSITIONING
 DETAILS**

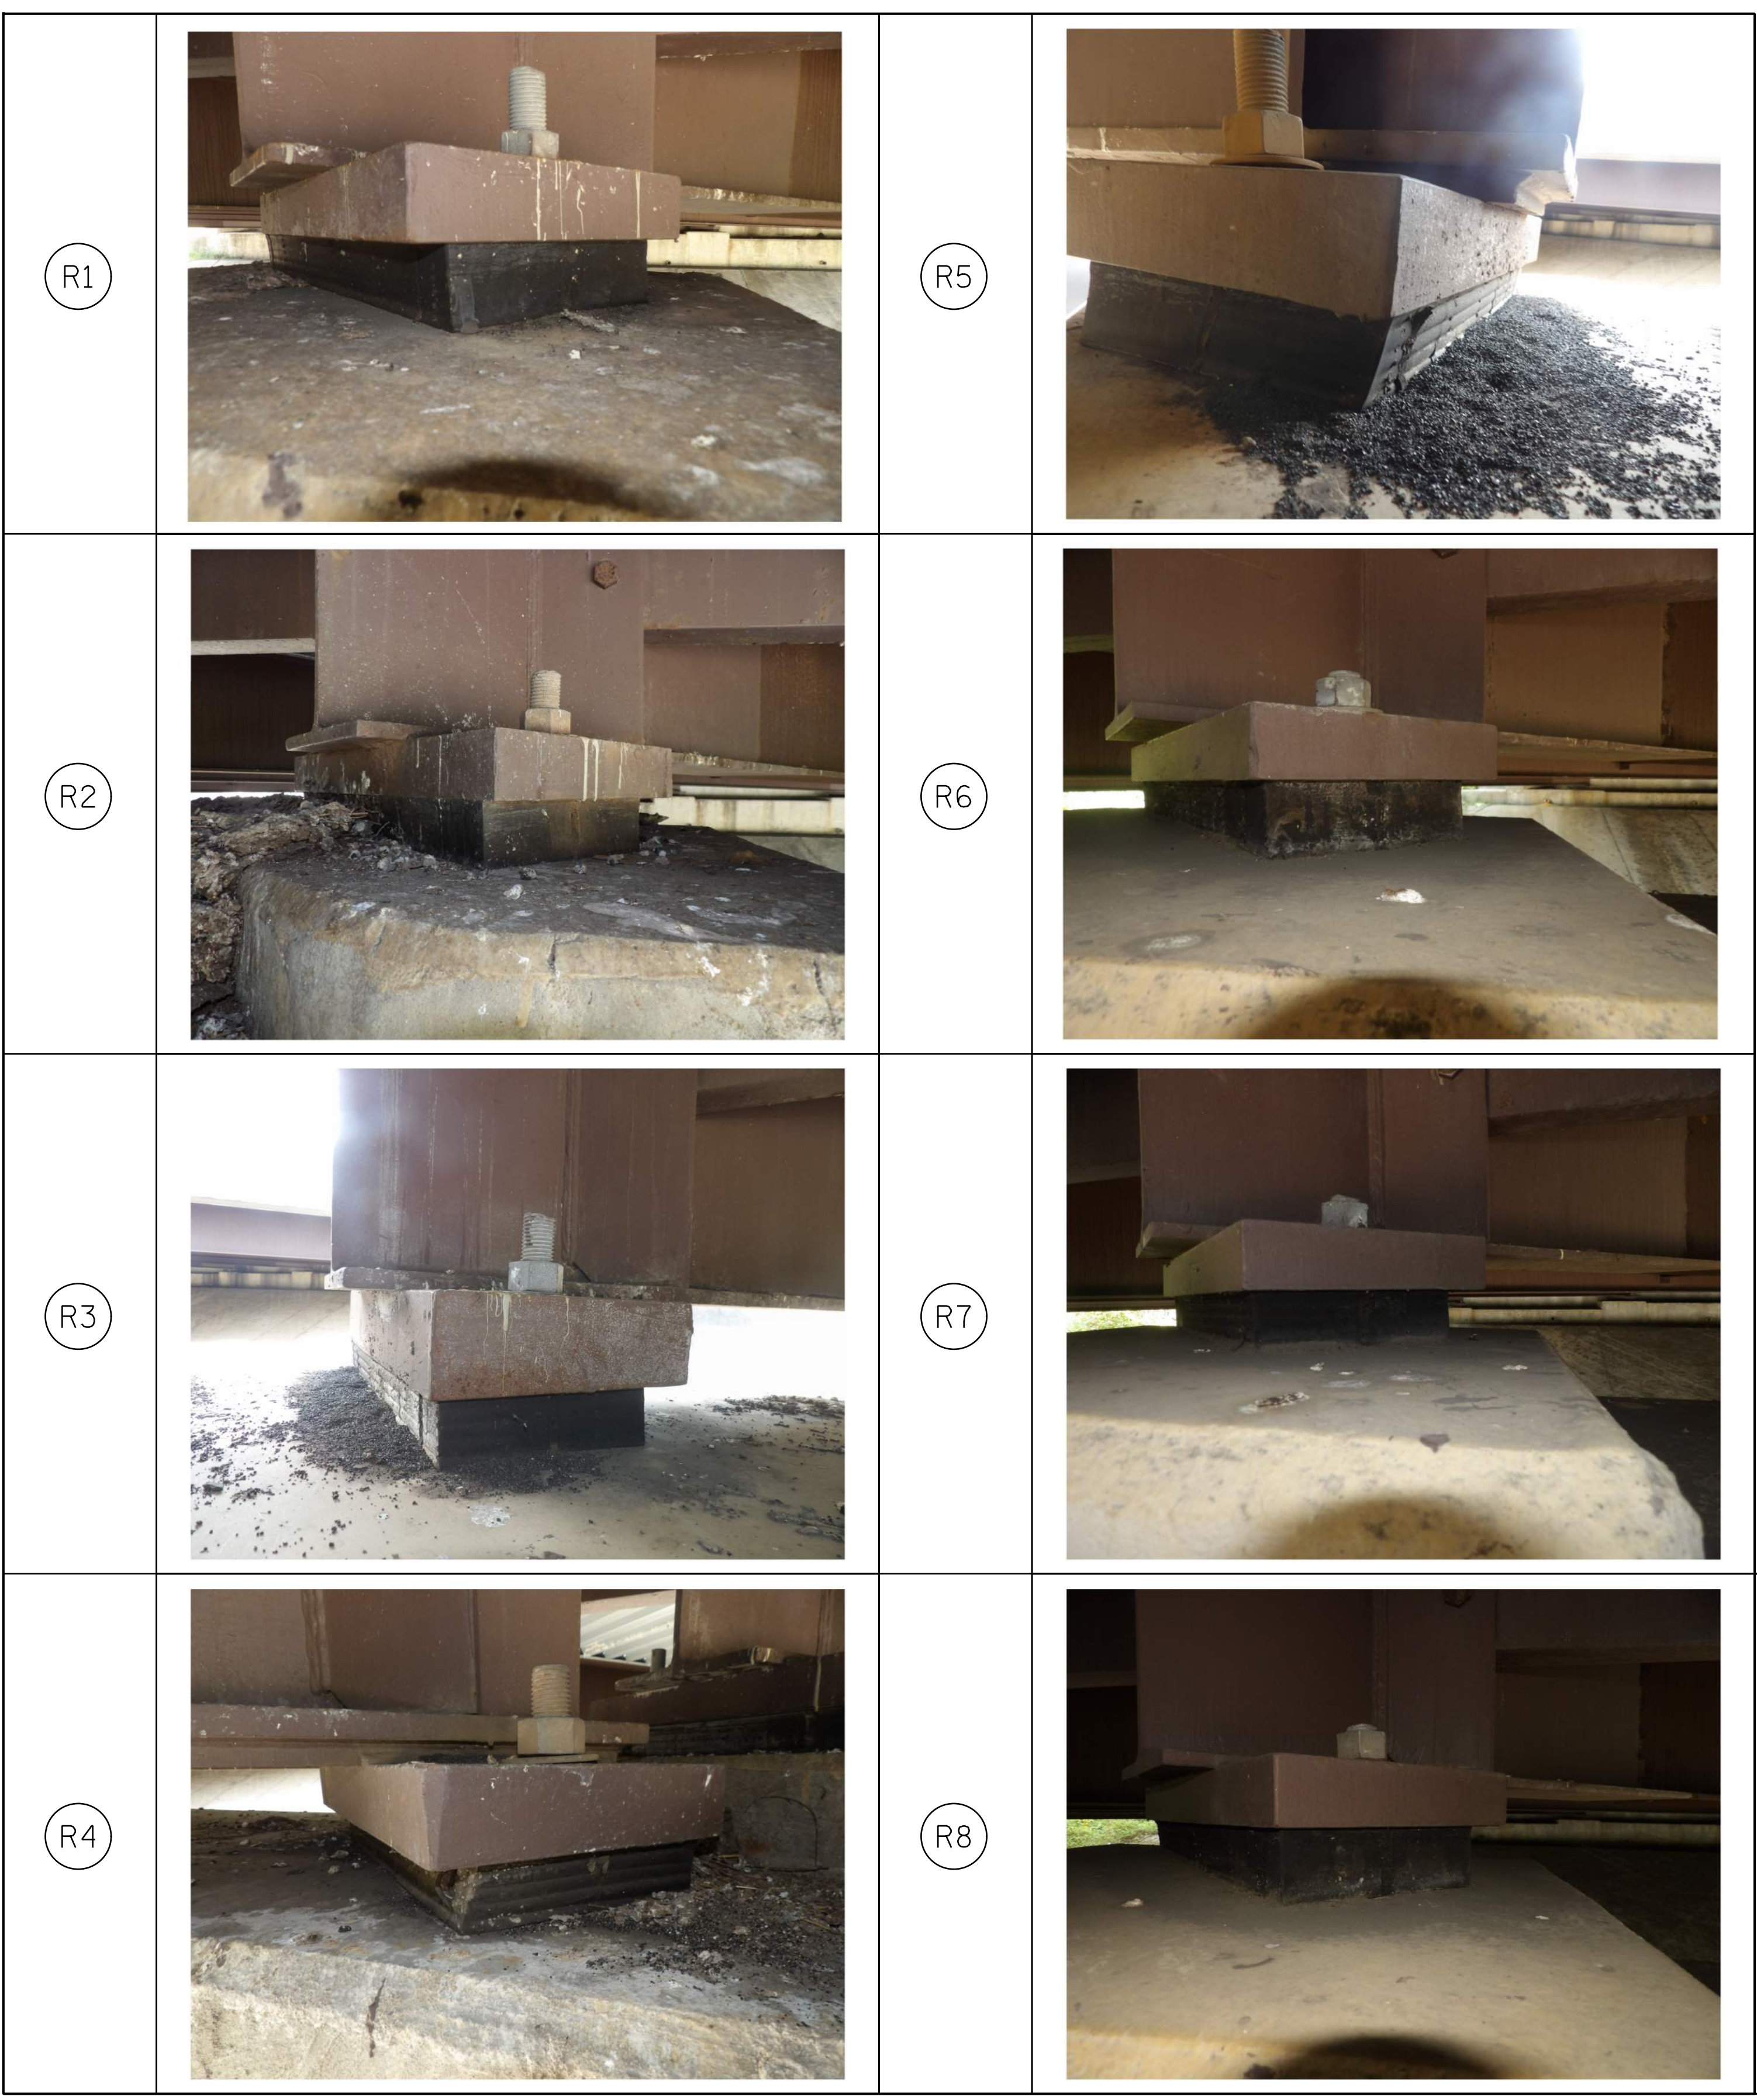
BEARING PHOTOGRAPHS

NOTES:
 THE GIRDERS SHALL BE JACKED AND THE BEARING PAD SHALL BE REPOSITIONED IN ORDER TO MEET THE MINIMUM CLEARANCES SHOWN IN THE BEARING ORIENTATION DETAIL. DUE TO THE DEFORMED ANCHOR BOLTS, ONE THE FOLLOWING MEANS MAY BE REQUIRED TO ACCOMPLISH THIS TASK:

1. DETACH THE EXISTING SOLE PLATE FROM THE GIRDER AND REPOSITION THE SOLE PLATE.
 2. REPOSITIONING THE BEARING PAD.
- THE CONTRACTOR MAY PROPOSE ALTERNATE METHODS, PROVIDED DETAILS ARE SUBMITTED TO THE ENGINEER FOR REVIEW AND APPROVAL.

WHEN FIELD WELDING THE SOLE PLATE TO THE GIRDER FLANGE, USE TEMPERATURE INDICATING WAX PENS, OR OTHER SUITABLE MEANS, TO ENSURE THAT THE TEMPERATURE OF THE SOLE PLATE DOES NOT EXCEED 300oF. TEMPERATURES ABOVE THIS MAY DAMAGE THE ELASTOMER.
