December 9, 2020

**Subject: Removal Site Evaluation Report
Davidson Community Asbestos
Davidson, Mecklenburg County, North Carolina
EPA Contract No.: 68HE0519D0006
Task Order / Task Order Line Item No.: 68HE0419F0097 / 97-005**

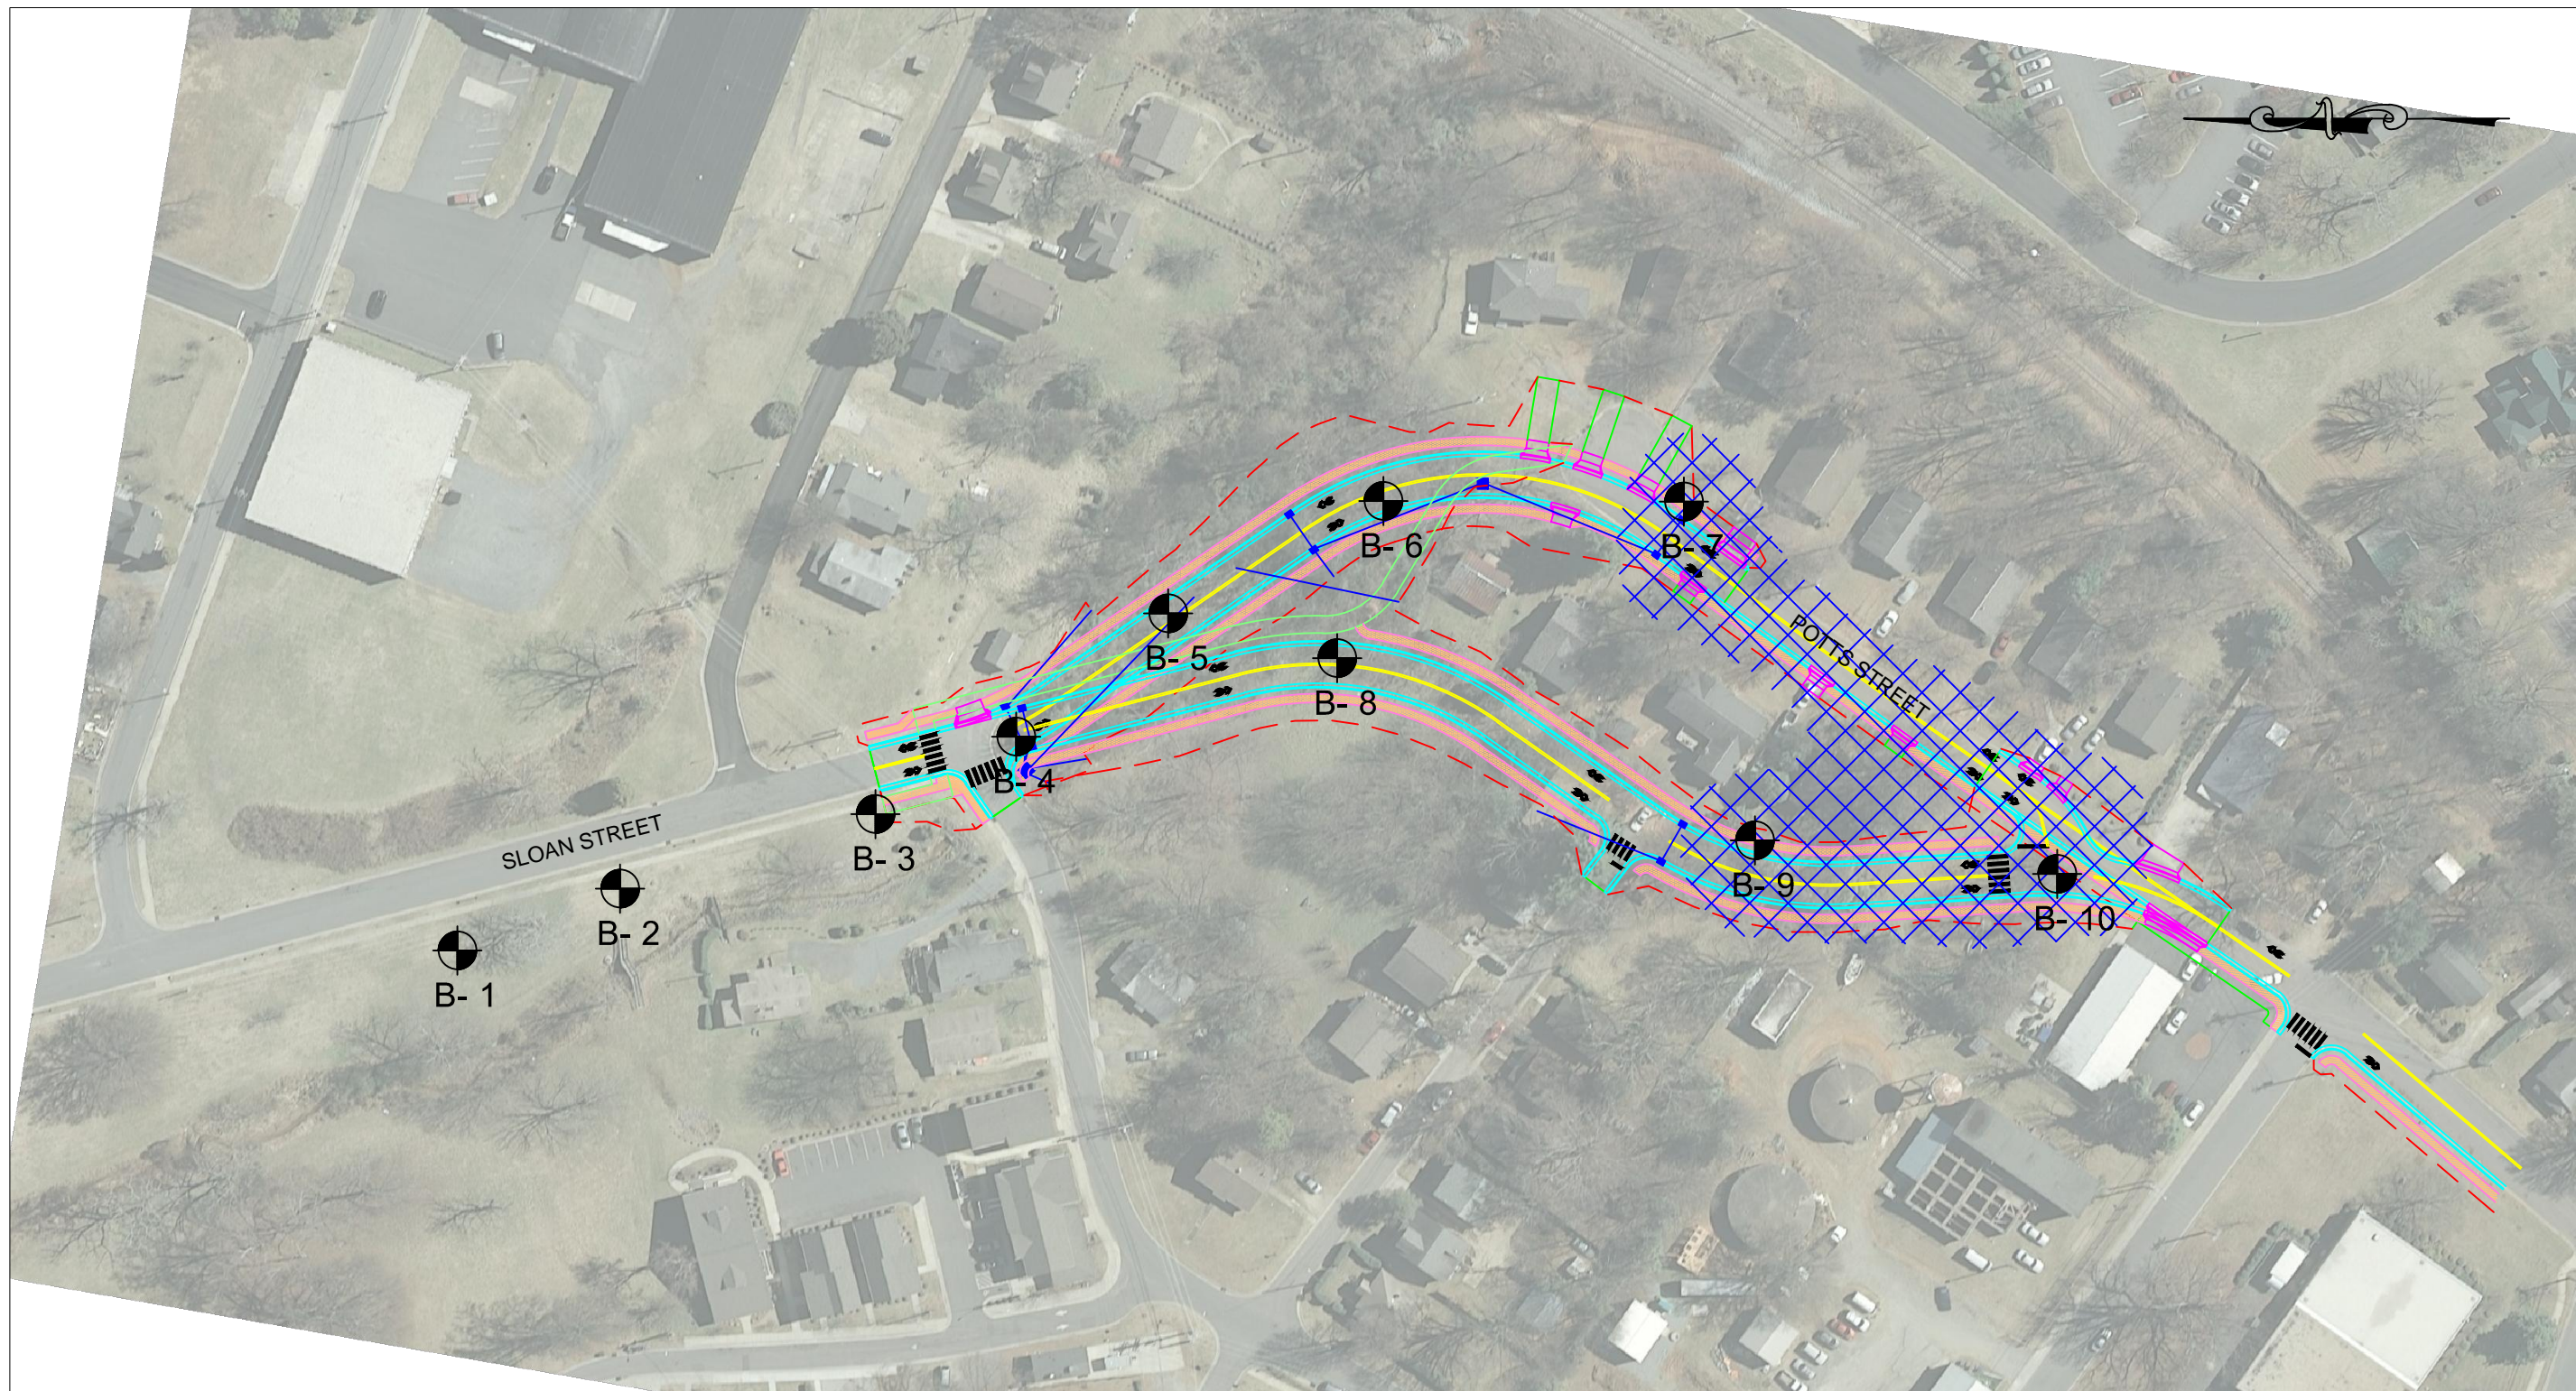
Results of the soil test borings and our visual observations of the split-spoon samples recovered indicate highly plastic clay (CH) soils and moderately plastic clayey silt (MH) soils exist at the site. The area where these soils were encountered is shown on Figure 5. Plastic soils can undergo change in volume (shrink/swell) with changes in their moisture content. The presence of the moderate to high plasticity material can adversely affect the performance of the pavement systems. Therefore, the presence of these materials should be considered for design and budgeting purposes.

In order to reduce the risk of damage of the pavement systems, high plasticity (CH) materials should be completely undercut from pavement areas or adequate separation be provided. High plasticity clay (CH) residual and existing fill soils may remain in place provided they are stable under proofrolling and are separated from design pavement subgrades by a minimum of 3 feet. Separation material should consist of newly placed structural fill soils. Moderately plastic clayey silt (MH) soils may remain in place provided they are stable under proofrolling and are separated from design pavement subgrades by a minimum of 1 foot. Unstable plastic soils should be undercut and replaced with structural fill.

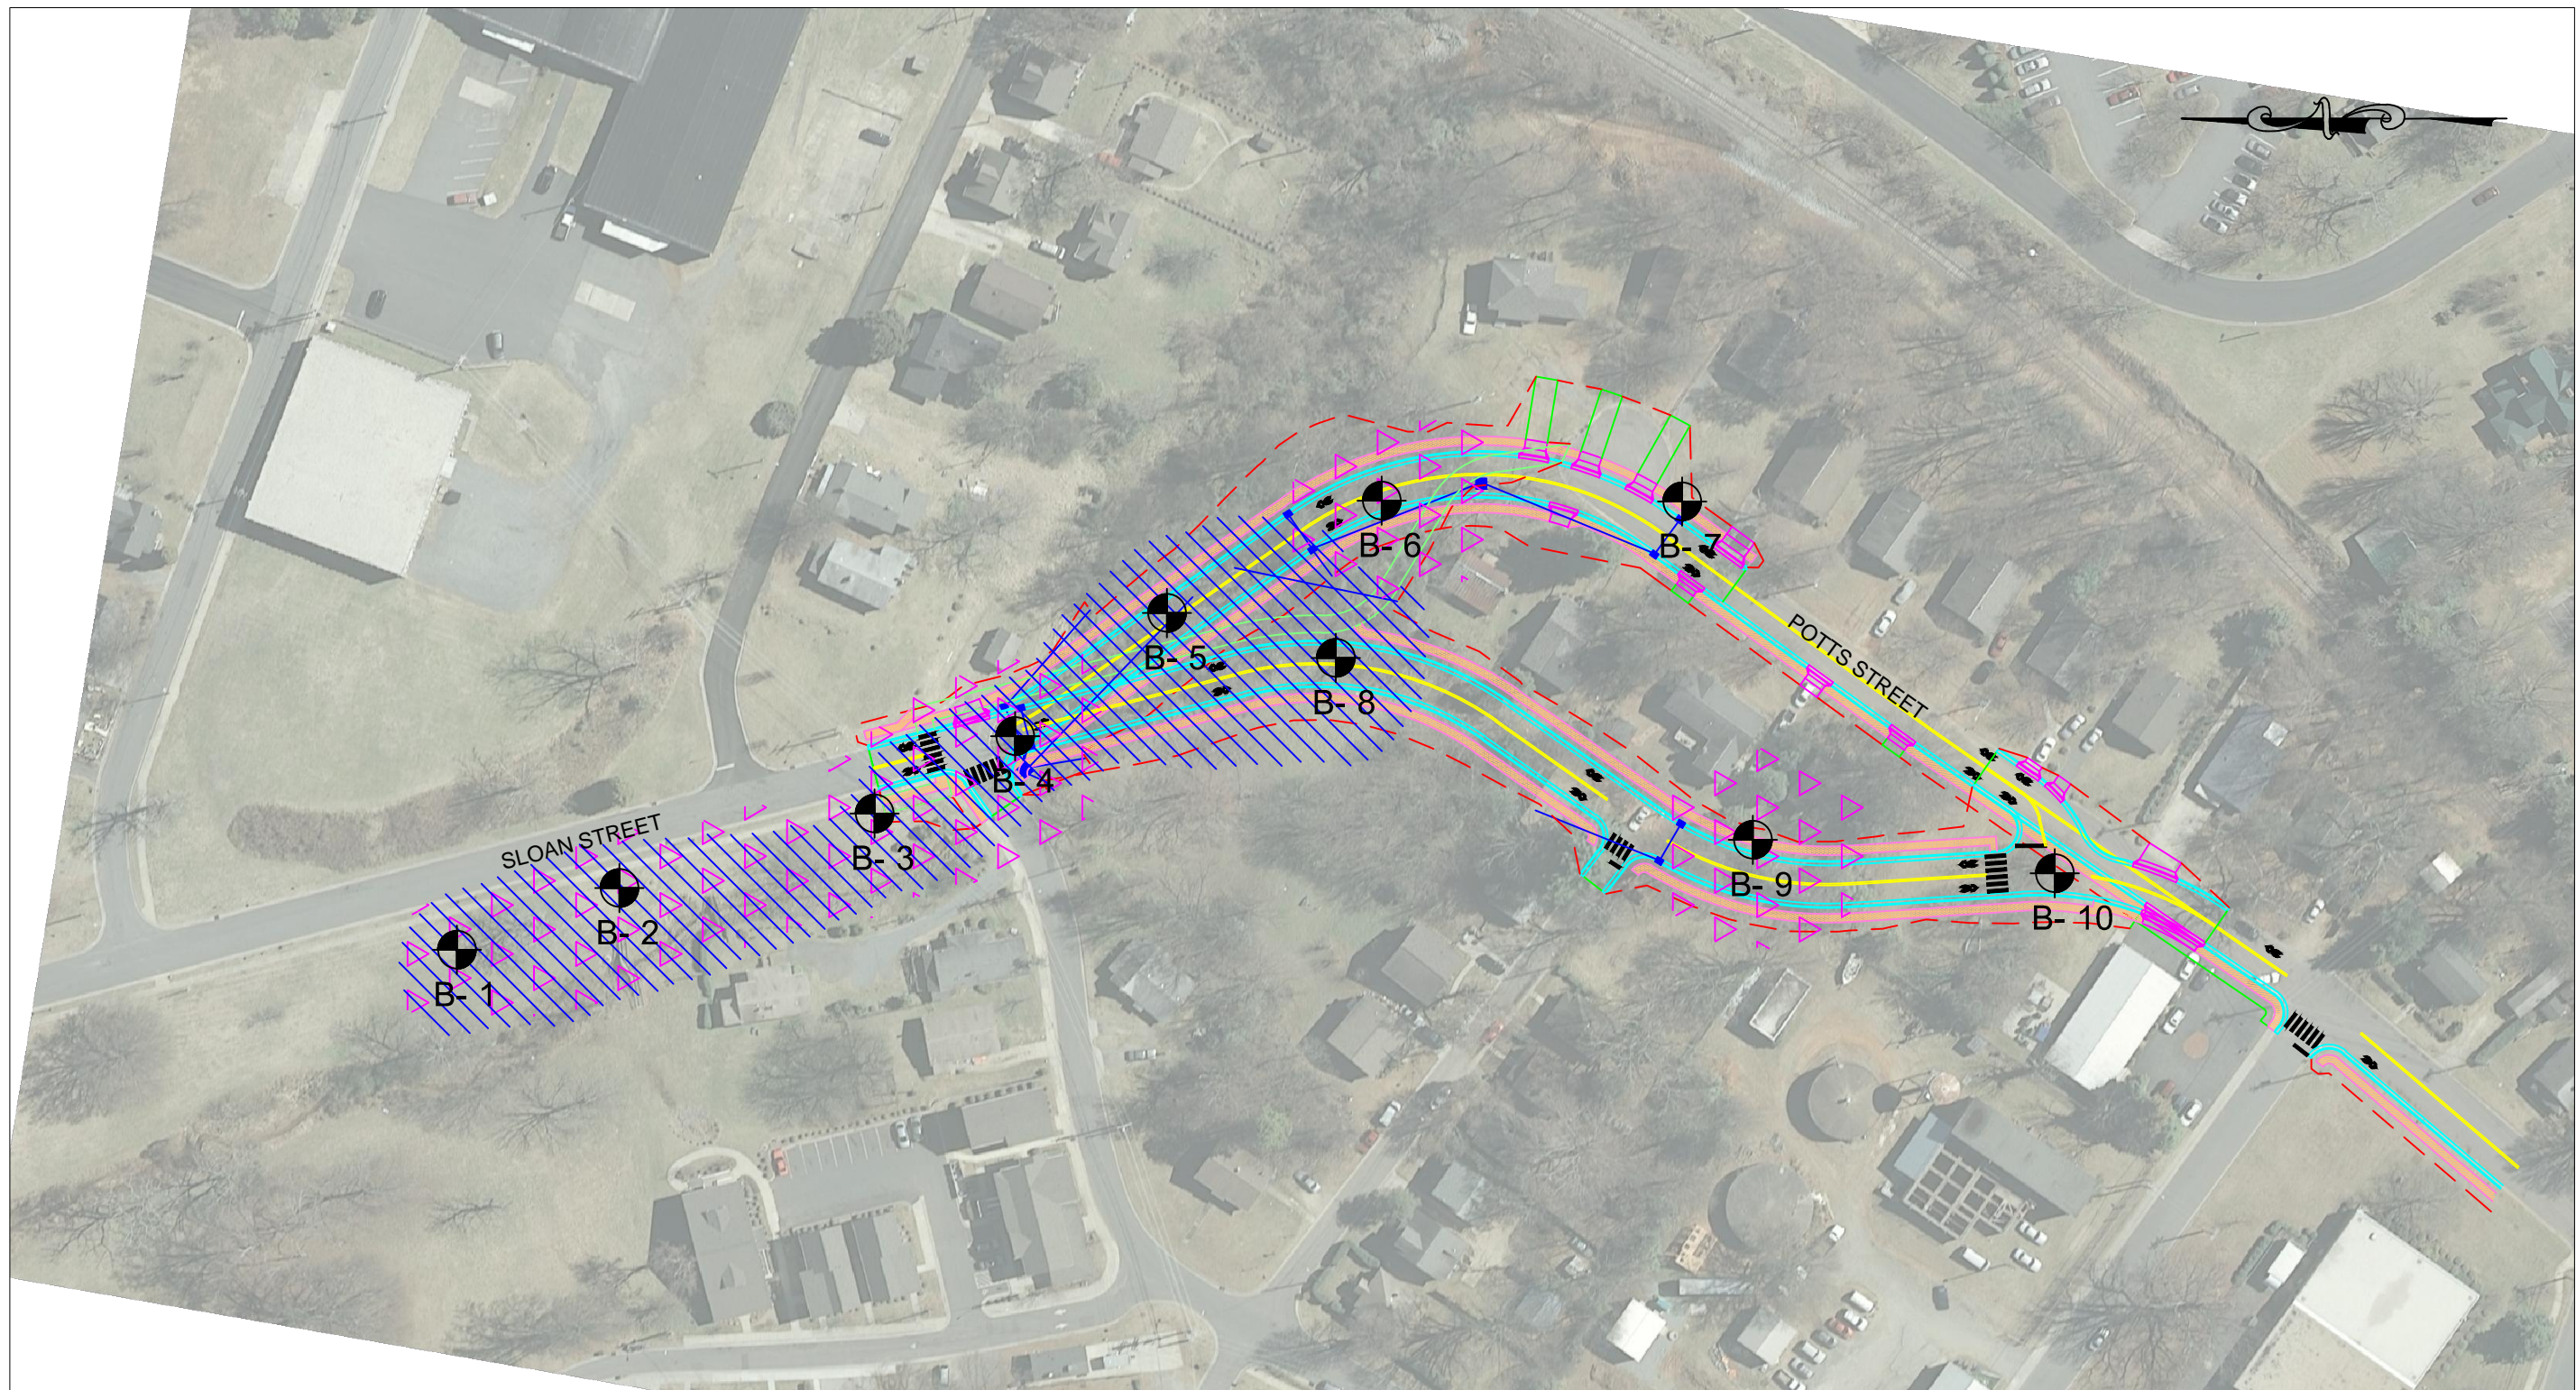
FIGURE NO.
6

Alluvial soils were encountered in Borings B-1, B-2, B-3, B-4, B-5, and B-8 to depths ranging from 6 to 12 feet. Based on our site reconnaissance, we anticipate that alluvial soils are present along and adjacent to the existing drainage feature which runs along the proposed roadway. The area where these soils were encountered is shown on Figure 6.

Typically, alluvial soils are low in consistency/relative density as they are water-deposited and have not been subjected to significant overburden pressures. They are also often high in moisture and organic content, and can be highly plastic. Because these materials are lower in consistency/relative density, additional site preparation (e.g., undercutting, stabilization, etc.) and/or reduced geotechnical strength parameters (e.g., bearing pressures, subgrade modulus values, etc.) would be required if foundations for culverts and pavement subgrades bear near these lower consistency materials.

Based on the borings, undercutting prior to fill placement should be anticipated in the vicinity of Borings B-1, B-2, B-3, B-4, B-5, B-6, B-8 and B-9 due to soft fill/ alluvial soils and in the vicinity of Borings B-7, B-9, and B-10 to create separation from plastic soils. The amount of undercut is dependent upon final grades and whether chemical stabilization will be used. These areas are shown on the attached Figures 5 and 6.
