PROJECT NO: 8.2752101 (B-3926)  
COUNTY: WATAUGA

BRIDGE 36  
EB1-A

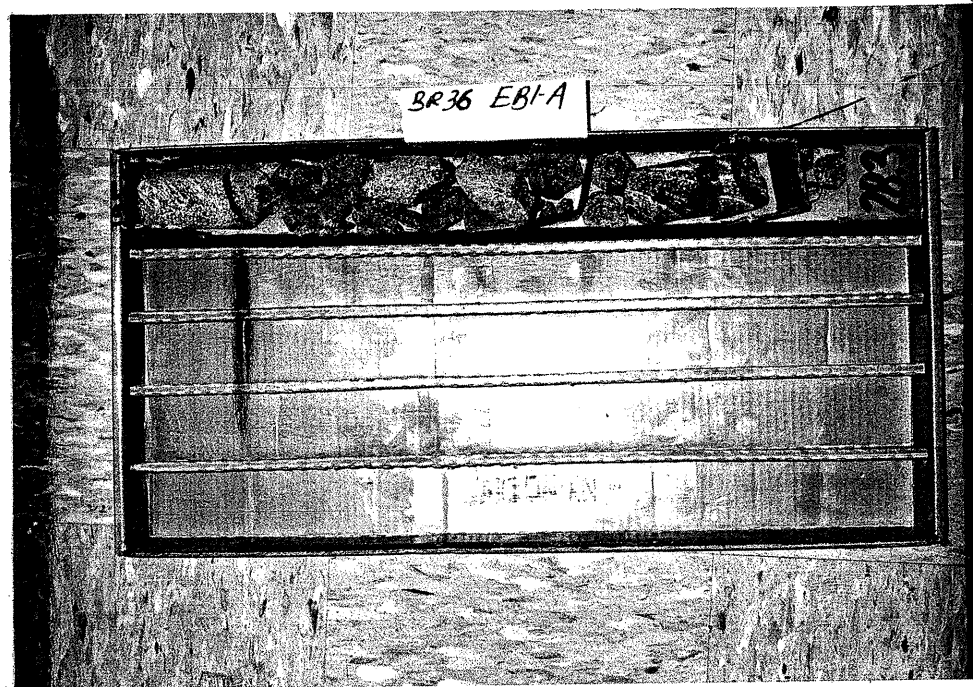
CORE 1: 14.6 – 18.3	REC=32% RQD=0%
CORE 2: 18.3 – 23.3	REC=8% RQD=0%
CORE 3: 23.3 – 28.3	REC=<1% RQD=0%

LAYER 1: 14.6 – 20.3 Weathered rock and saprolite (not recovered) with few seams of hard, slightly weathered amphibolite. REC=28% RQD=0%

LAYER 2: 20.3 – 28.3 Saprolite and weathered rock with thin seam of hard amphibolite. REC = <1% RQD=0%
