PRELIMINARY SITE ASSESSMENT

SR 1997 (FAYETTEVILLE ROAD) WIDENING
TIP NO. U-5797, WBS NO. 44367.1.1

PARCEL NO. 14
OWNER: RT & DT ENTERPRISES LLC
2500 FAYETTEVILLE ROAD
LUMBERTON, ROBESON COUNTY, NORTH CAROLINA

PROJECT NUMBER: G19011.00
JUNE 9, 2020

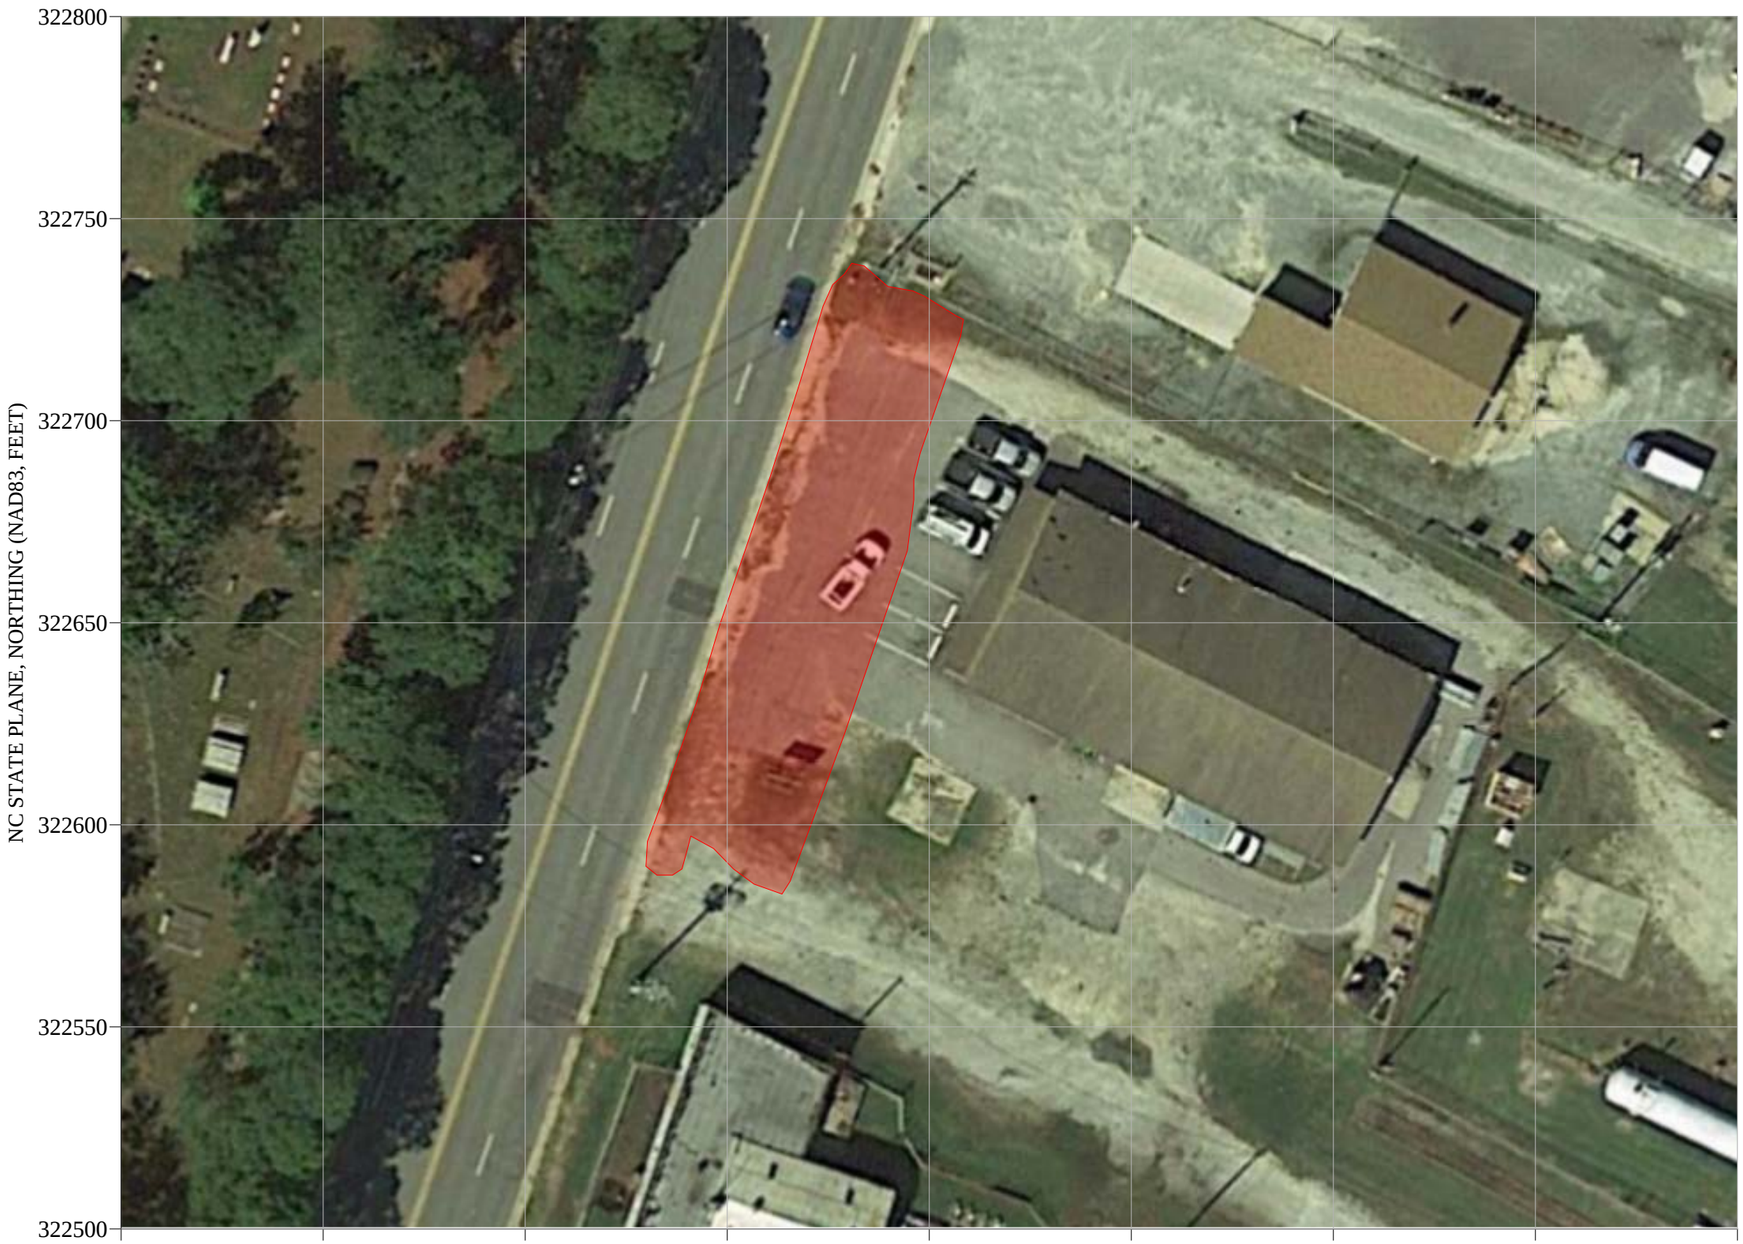
APPROXIMATE BOUNDARIES OF GEOPHYSICAL SURVEY AREA

View of Survey Area
(Facing Approximately North)

View of Survey Area
(Facing Approximately South)

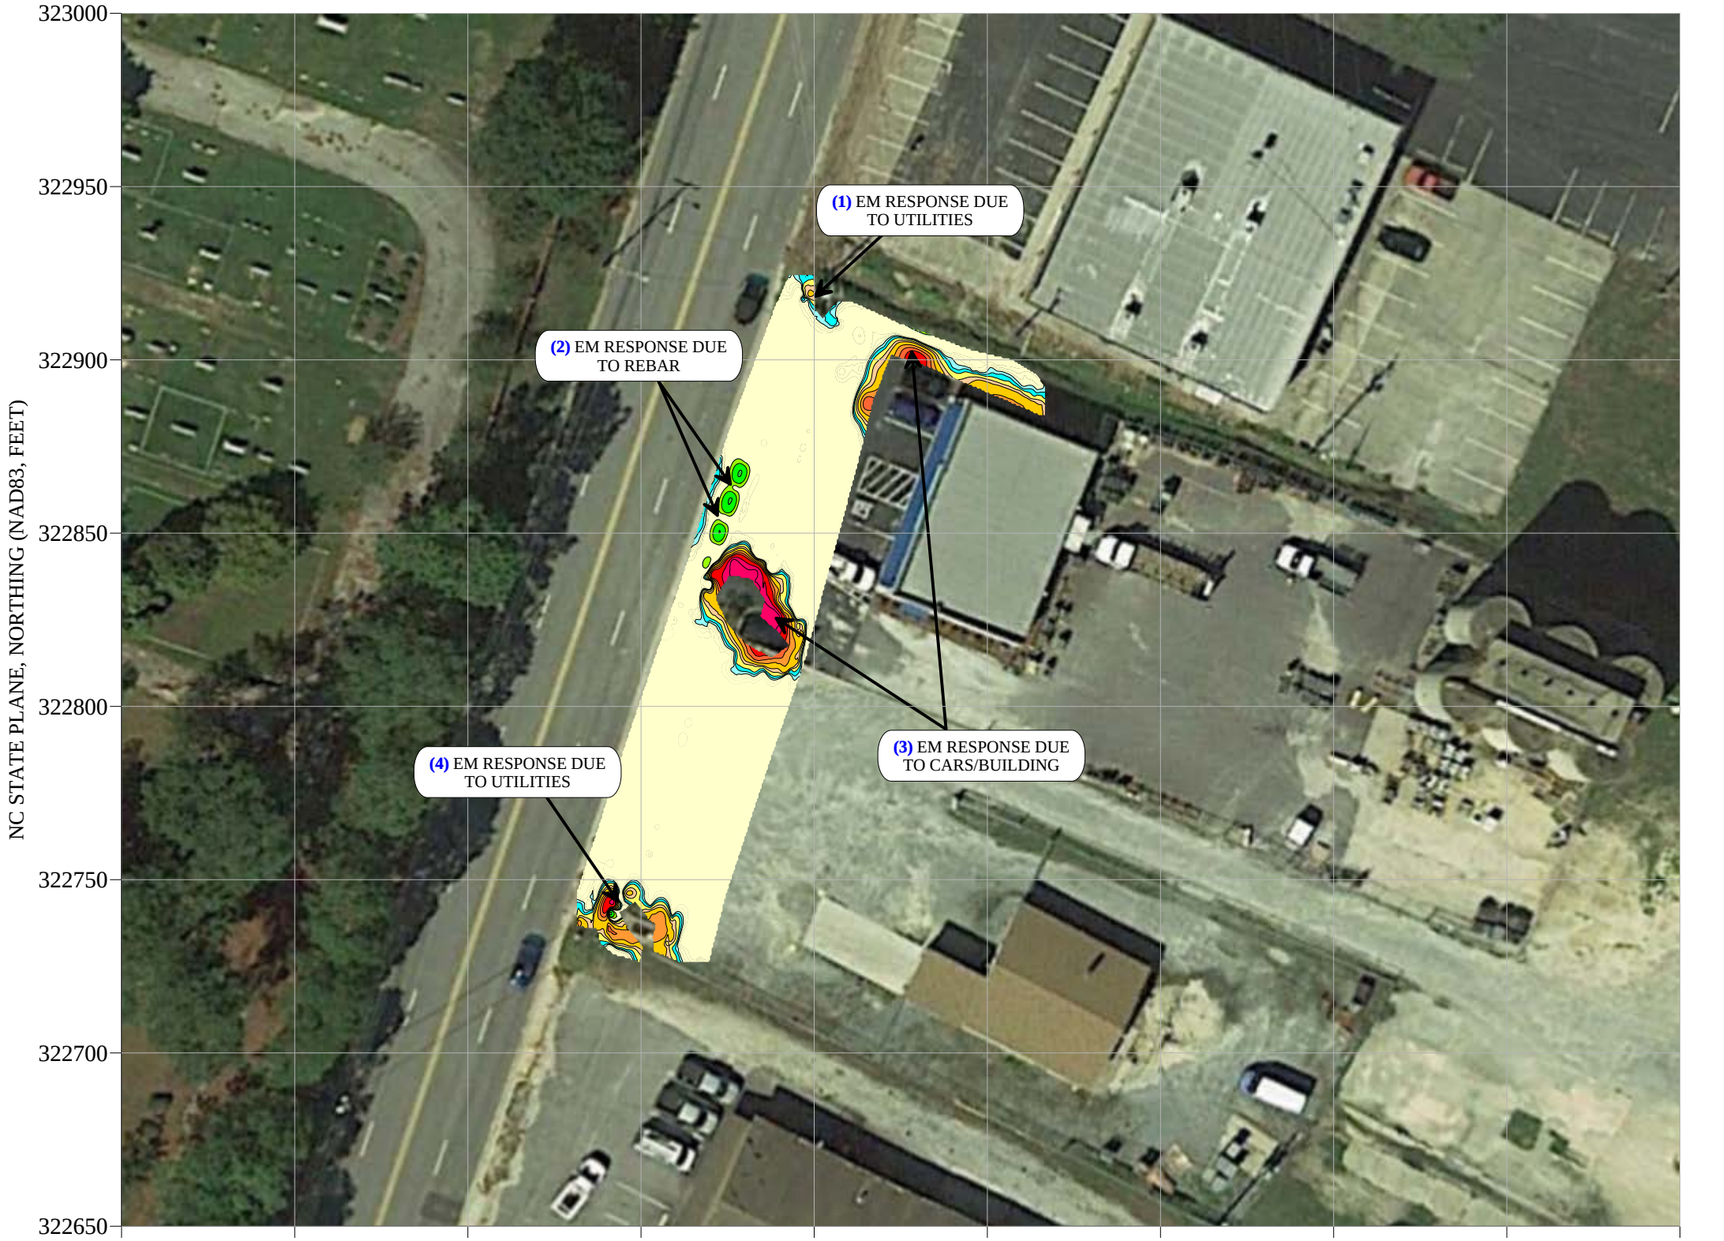
EM61 METAL DETECTION RESULTS

NO EVIDENCE OF METALLIC USTs OBSERVED.

The contour plot shows the differential results of the EM61 instrument in millivolts (mV). The differential results focus on larger metallic objects such as USTs and drums. The EM data were collected on March 18, 2019, using a Geonics EM61-MK2 instrument.Verification GPR data were collected using a GSSI UtilityScan DF instrument with a dual frequency 300/800 MHz antenna on March 26, 2019.

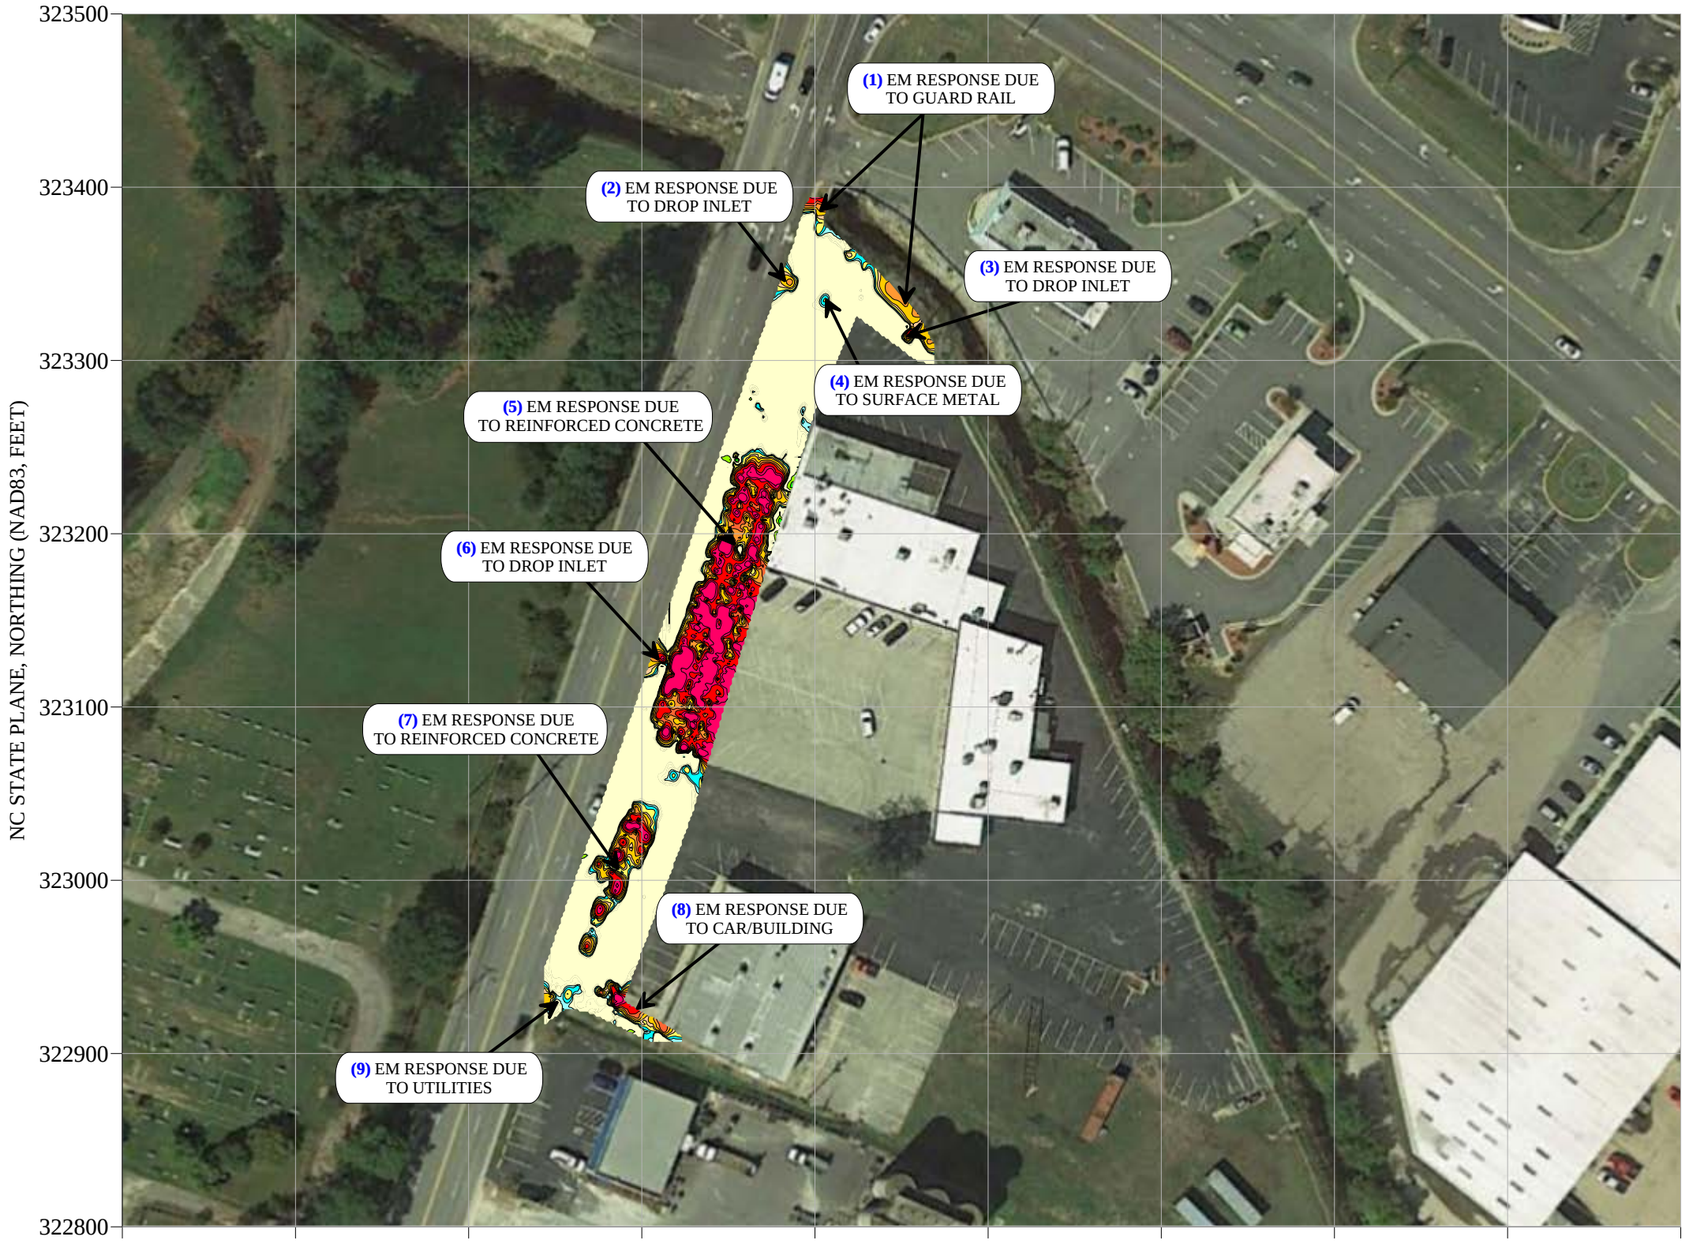
EM61 METAL DETECTION RESULTS

NO EVIDENCE OF METALLIC USTs OBSERVED.

The contour plot shows the differential results of the EM61 instrument in millivolts (mV). The differential results focus on larger metallic objects such as USTs and drums. The EM data were collected on March 18, 2019, using a Geonics EM61-MK2 instrument.Verification GPR data were collected using a GSSI UtilityScan DF instrument with a dual frequency 300/800 MHz antenna on March 26, 2019.

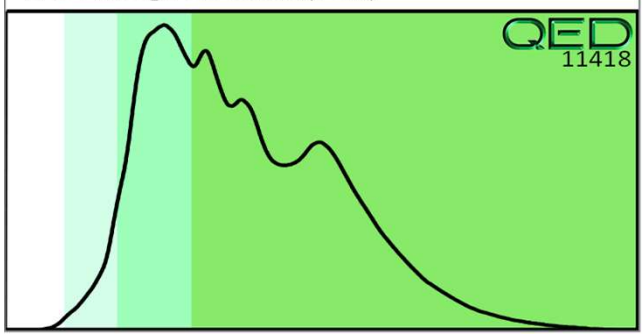
B20 : V.Deg.PHC 96.9%,(FCM)

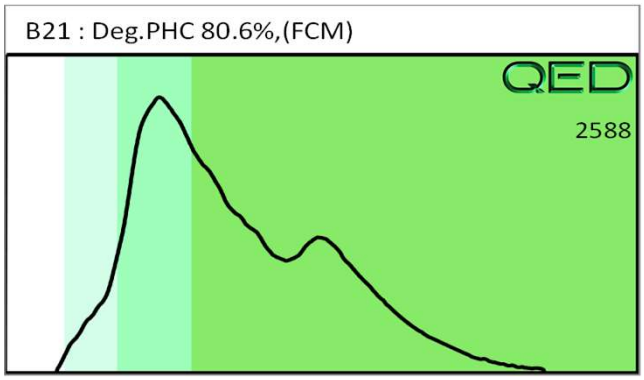
B21 : Deg.PHC 80.6%,(FCM)

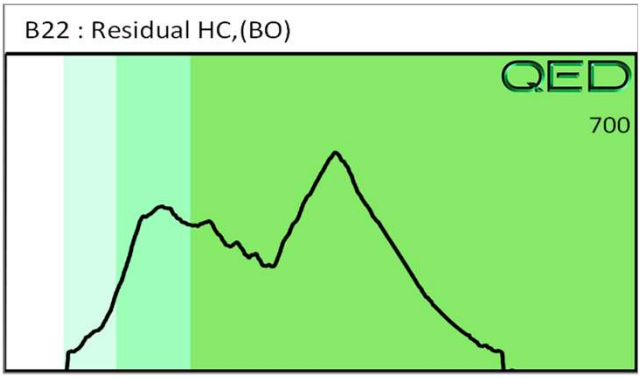
B22 : Residual HC,(BO)

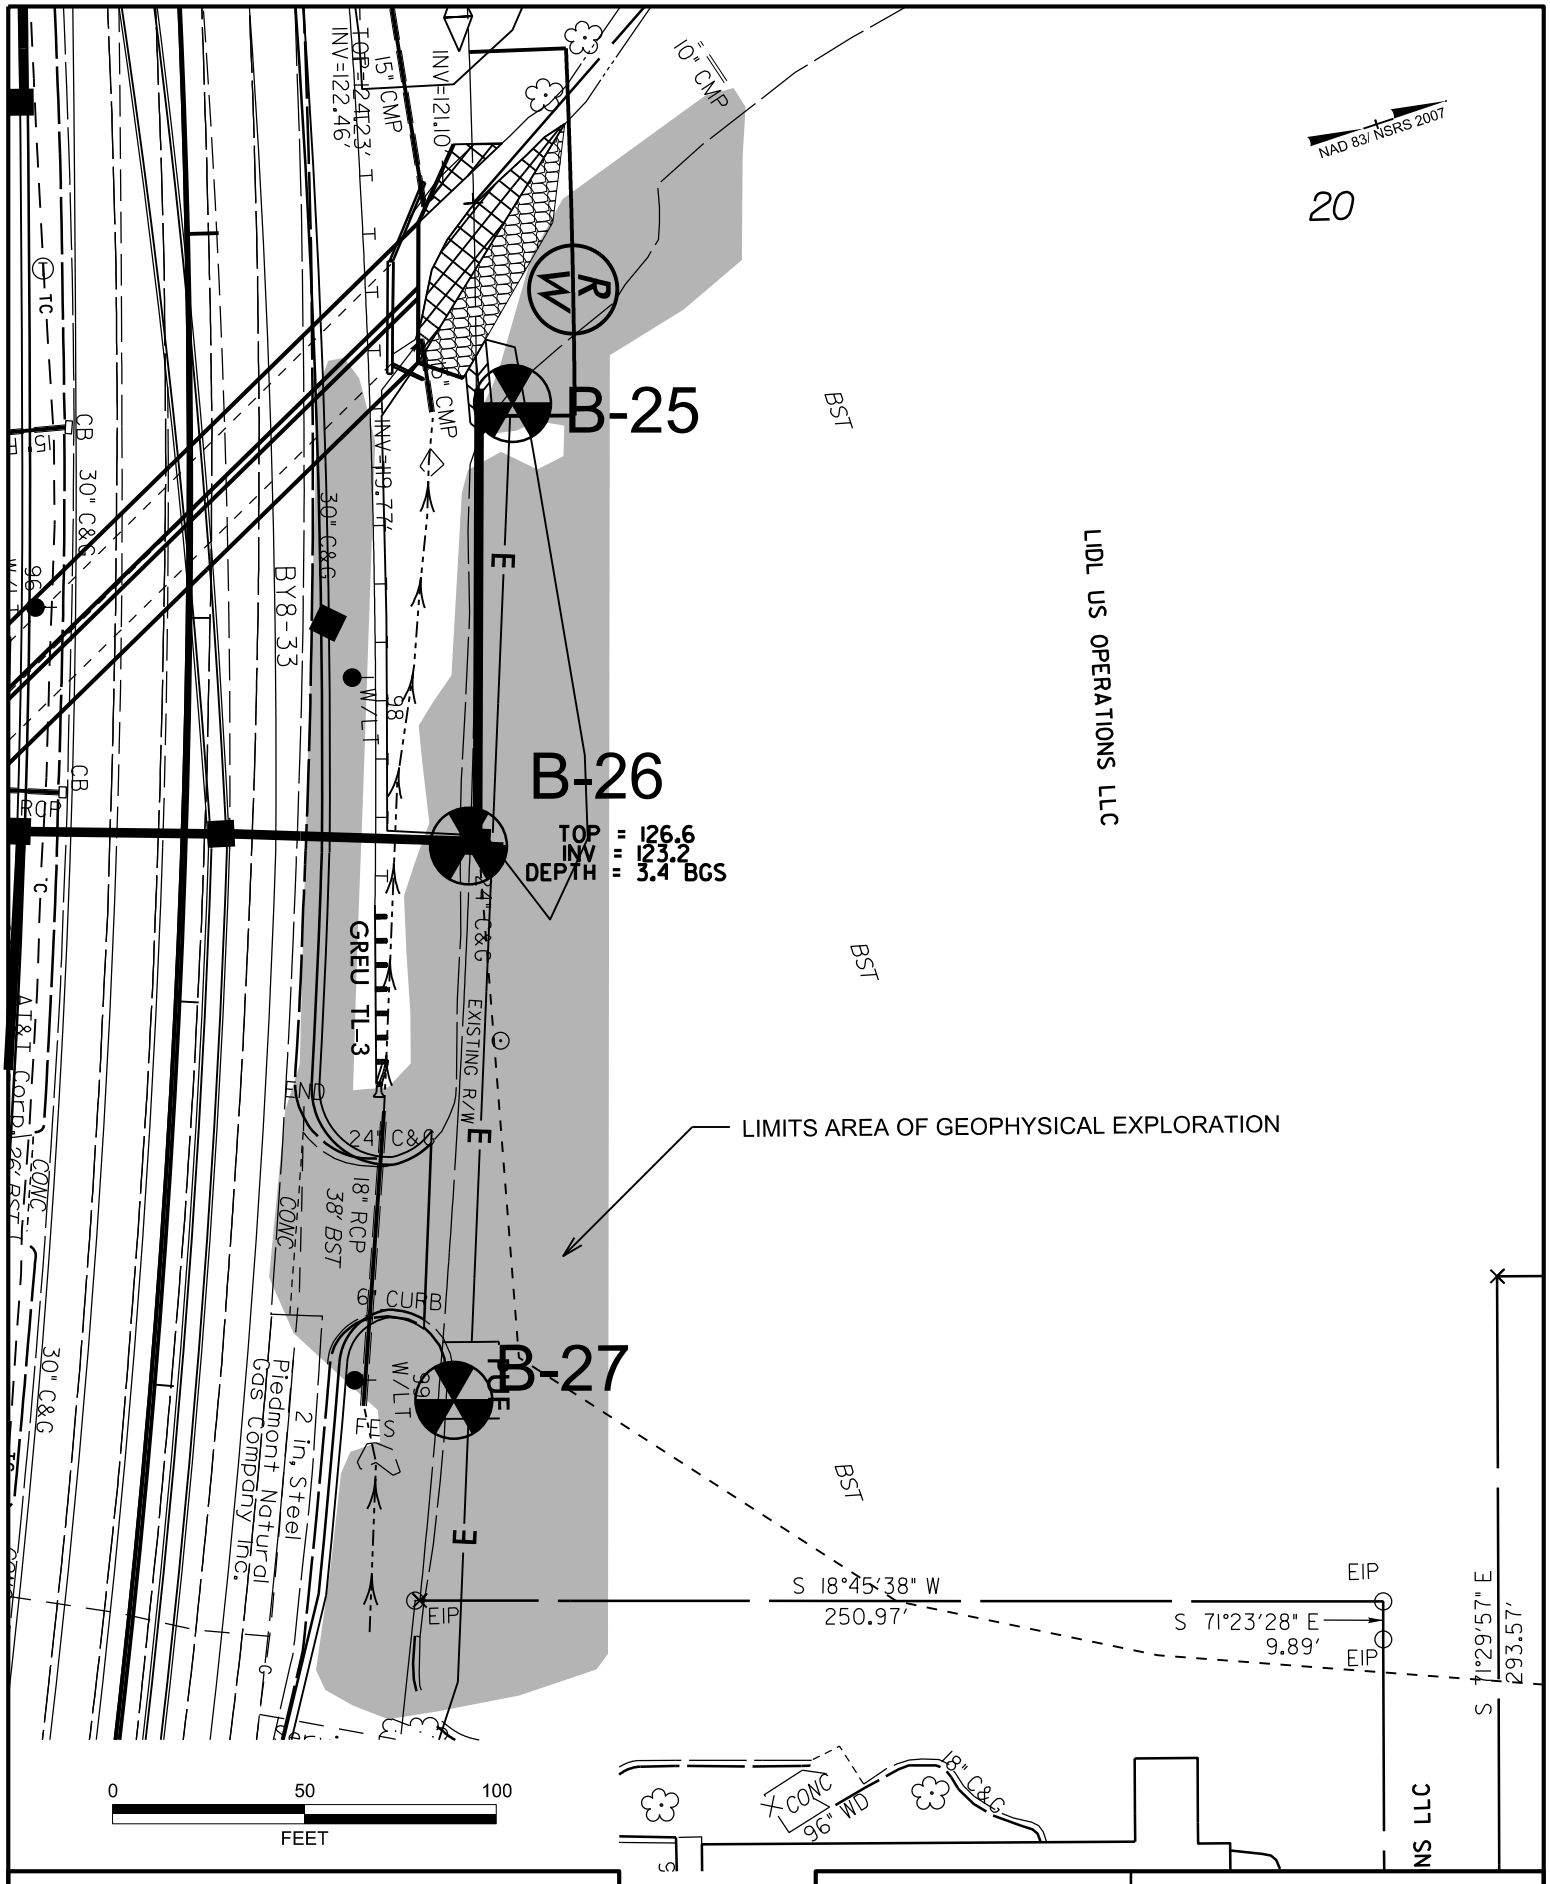
- BGS = BELOW GROUND SURFACE
- BORINGS B-25 & B-27 WERE DRILLED TO 4.0 BGS

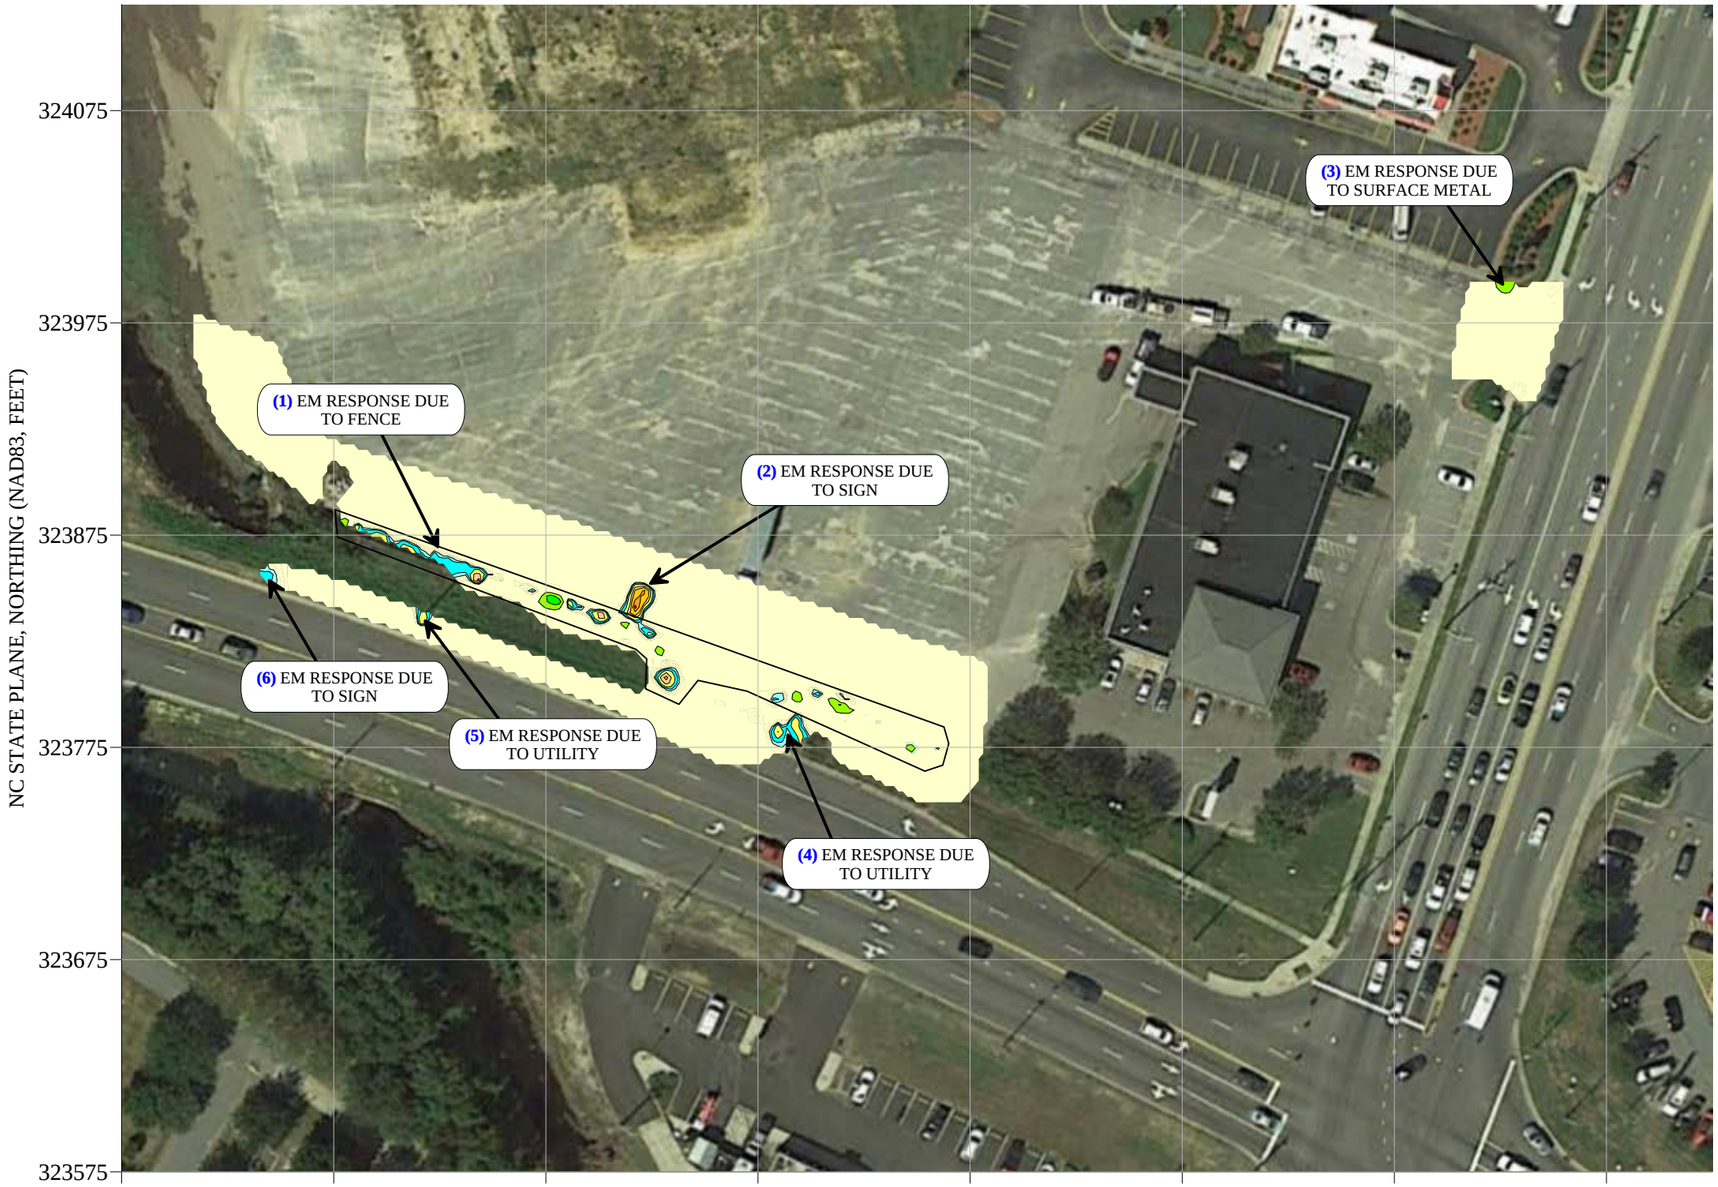
EM61 METAL DETECTION RESULTS

NO EVIDENCE OF METALLIC USTs OBSERVED.

The contour plot shows the differential results of the EM61 instrument in millivolts (mV). The differential results focus on larger metallic objects such as USTs and drums. The EM data were collected on March 18-19, 2019, using a Geonics EM61-MK2 instrument. All of the EM anomalies were associated with surface features and verification GPR was not necessary.
