PROJECT NO: 8.2752101 (B-3926)
 COUNTY: WATAUGA

BRIDGE 35
 EB1-C

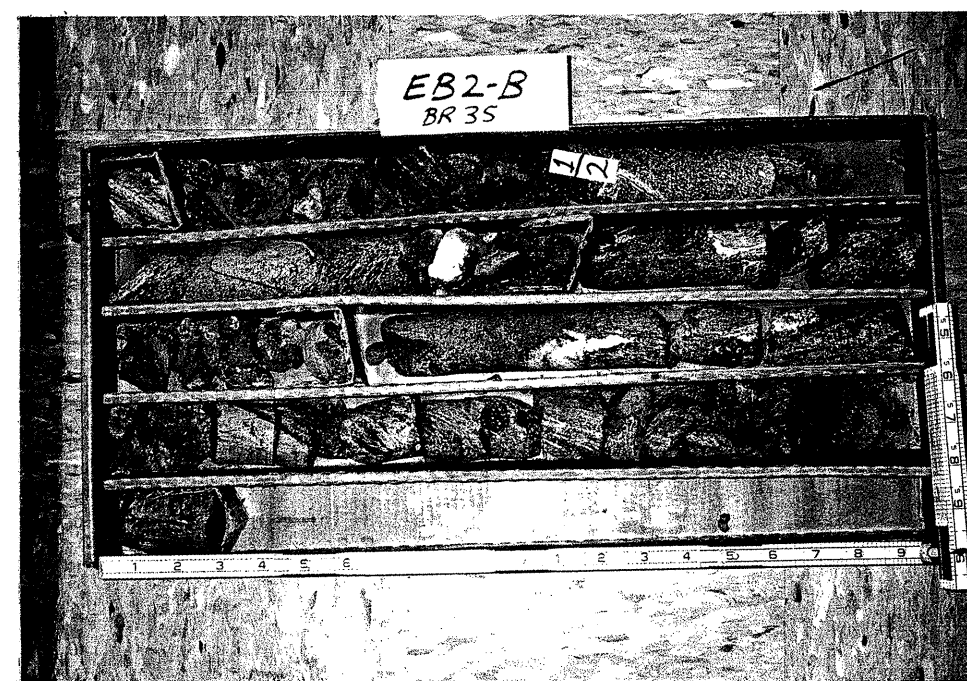
BRIDGE 35
 EB2-B

CORE 1: 6.9 - 8.2	REC=12% RQD=0%
CORE 2: 8.2 - 12.1	REC=69% RQD=31%
CORE 3: 12.1 - 16.1	REC=35% RQD=10%
CORE 4: 16.1 - 20.7	REC=72% RQD=14%

LAYER 1: 6.9 - 9.2 Boulders

LAYER 2: 9.2 - 20.7 Soft to hard, slightly to severely weathered amphibolite with seams of weathered rock and saprolite. Very close- to close-fractured, longest piece 0.7 feet. Joints numerous and indeterminate. REC=57% RQD=20%
