# **STREAM MITIGATION PLAN**

## **US HIGHWAY 19, R-2518B ON-SITE MITIGATION YANCEY COUNTY, NORTH CAROLINA**

WBS ELEMENT: 34445.3.1  
LSC NUMBER: 6300013251  
TIP NUMBER: R-2518WM

NORTH CAROLINA DEPARTMENT OF TRANSPORTATION  
PROJECT DEVELOPMENT AND ENVIRONMENTAL  
ANALYSIS BRANCH  
RALEIGH, NORTH CAROLINA

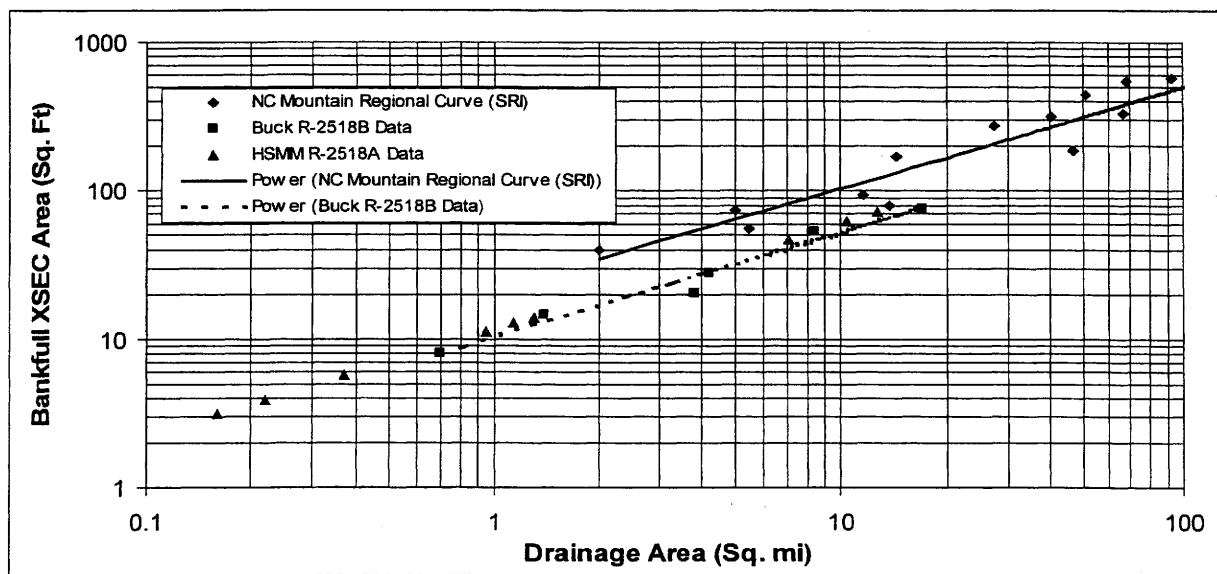
**FIGURE 3. COMPARISON OF REGIONAL CURVE INFORMATION FOR PROJECT REACHES.**

The project site is located in a low rainfall hydrologic sub-region within the mountain physiographic province of western North Carolina. In a previous NCDOT mitigation report for project R-2518A, a project located several miles from the sites described here, Hayes, Seay, Mattern & Mattern, Inc. (HSMM) reported that streams within the area exhibited smaller bankfull cross-sectional areas than would be predicted by the SRI mountain regional curve. Data collected from the R-2518B site also follows the same trend indicated by the R-2518A report, as illustrated in Figure 3. Therefore, the curve developed with data from both the R-2518A and R-2518B projects (Figure 3) was used to predict and verify bankfull cross sectional areas of the proposed mitigation reaches.
