PROJ. NO. I-5825
 MECKLENBURG COUNTY
 BRIDGE NO. 215

STATE OF NORTH CAROLINA
 DEPARTMENT OF TRANSPORTATION
 RALEIGH

TYPICAL CAP
 AND COLUMN
 REPAIR DETAILS

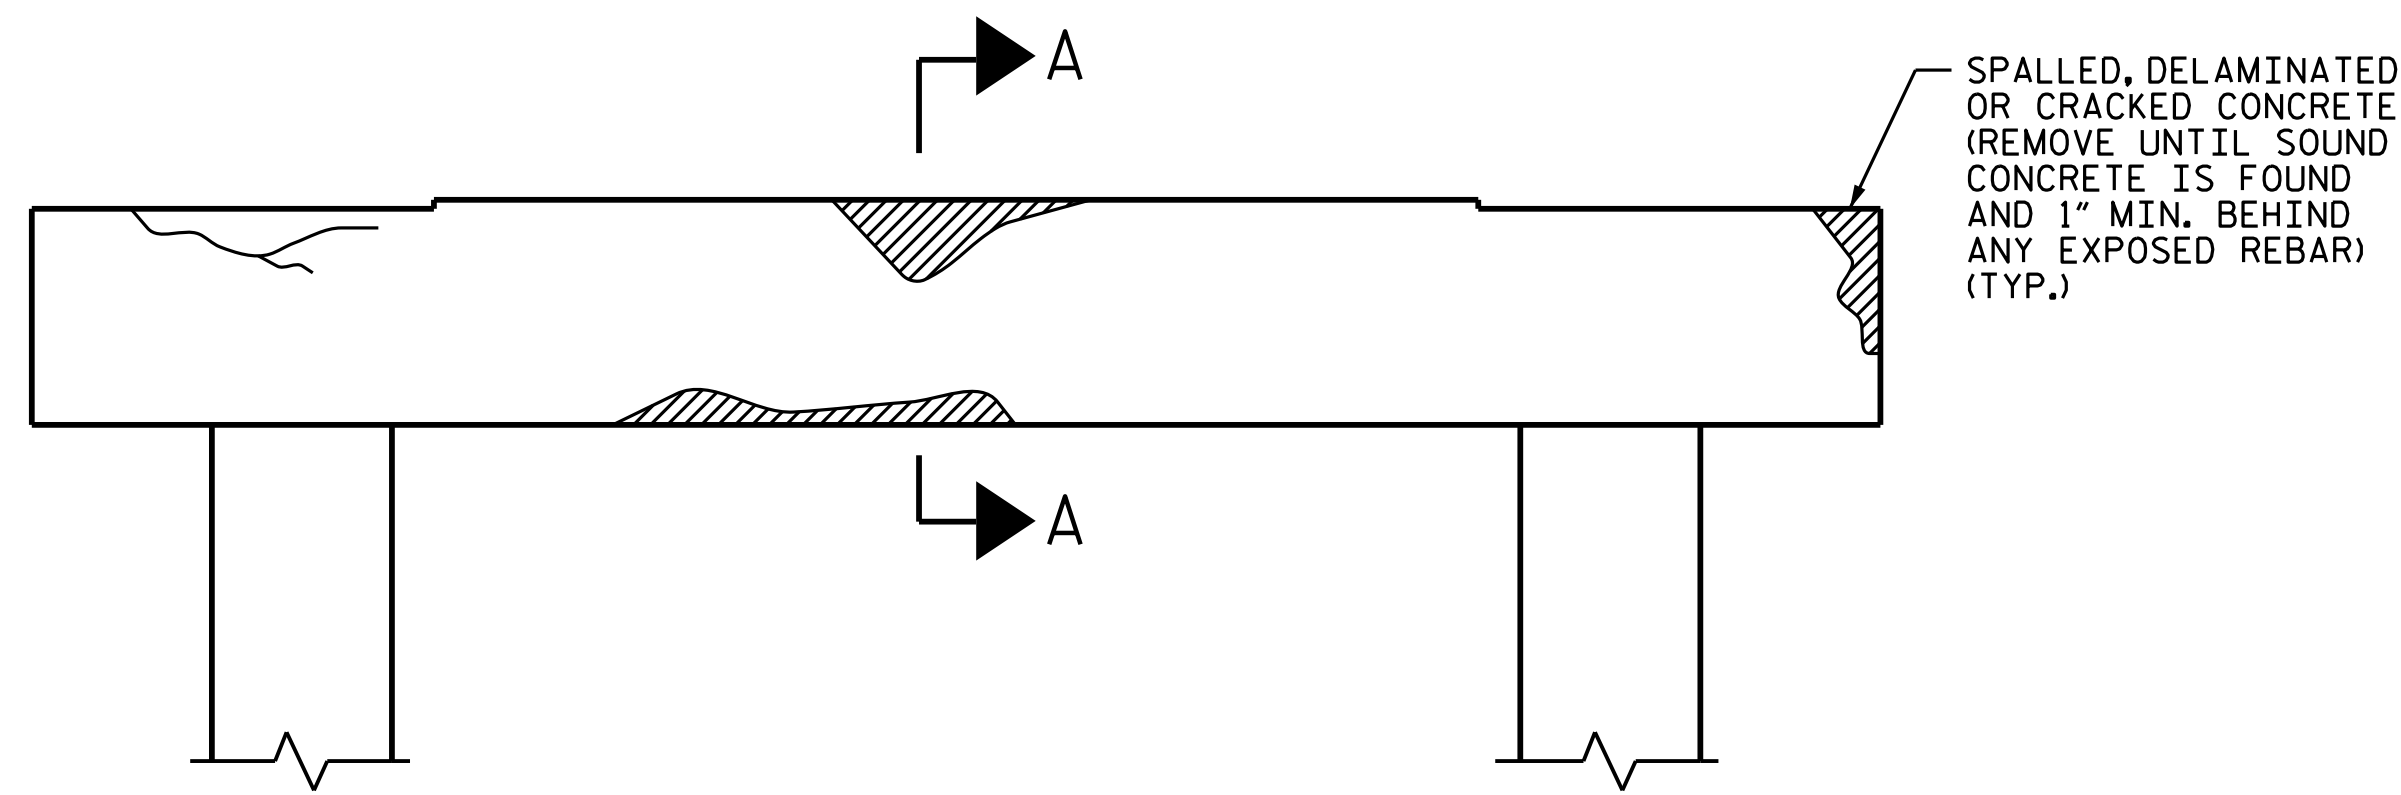
TYPICAL BENT CAP REPAIRS ARE SHOWN. REPAIR DETAILS SIMILAR FOR END BENT CAPS AND STRUTS.

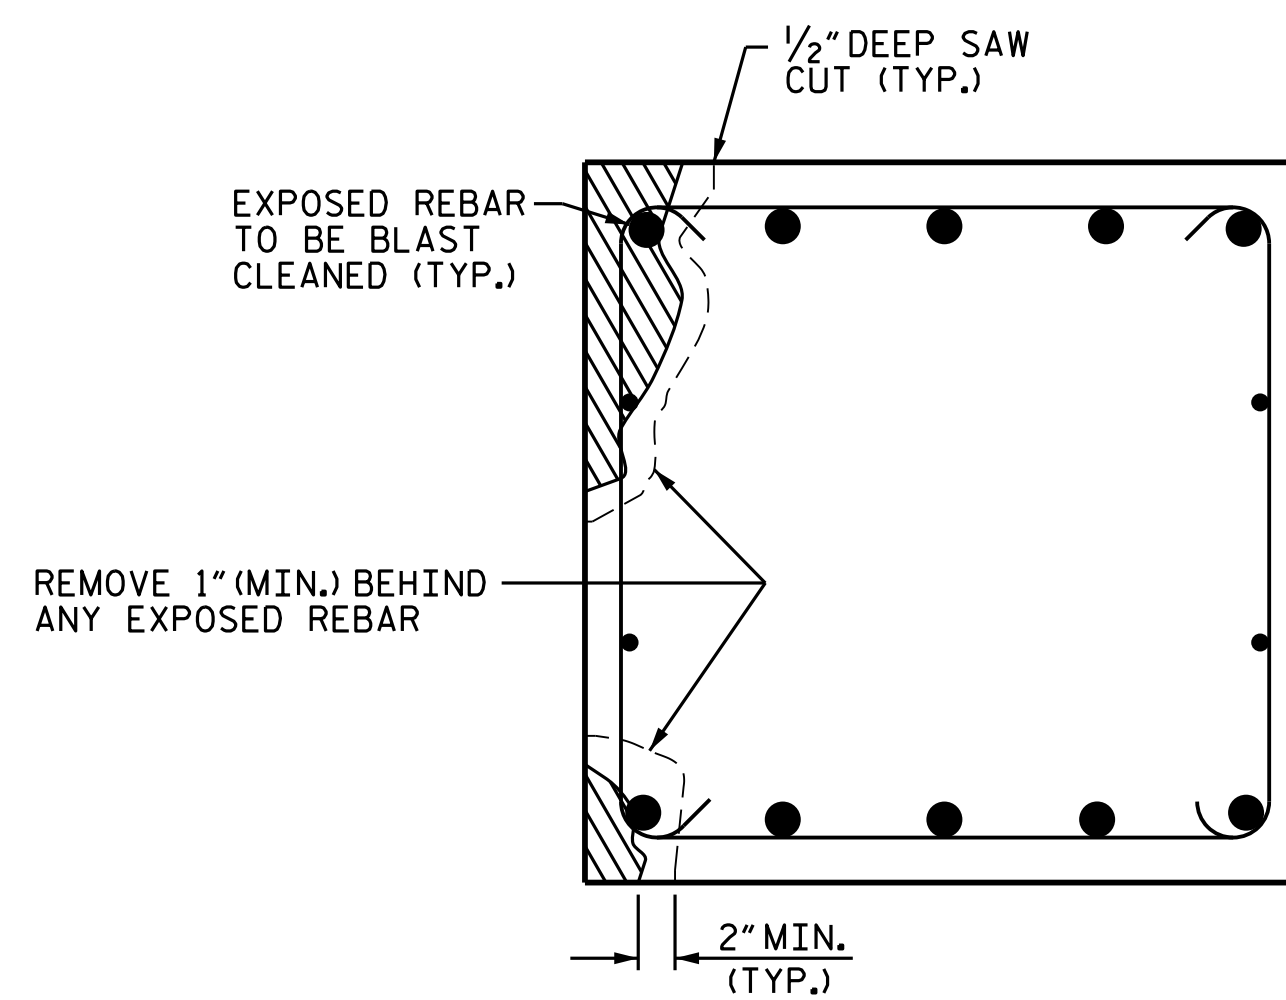
SECTION A-A

CAP REPAIR

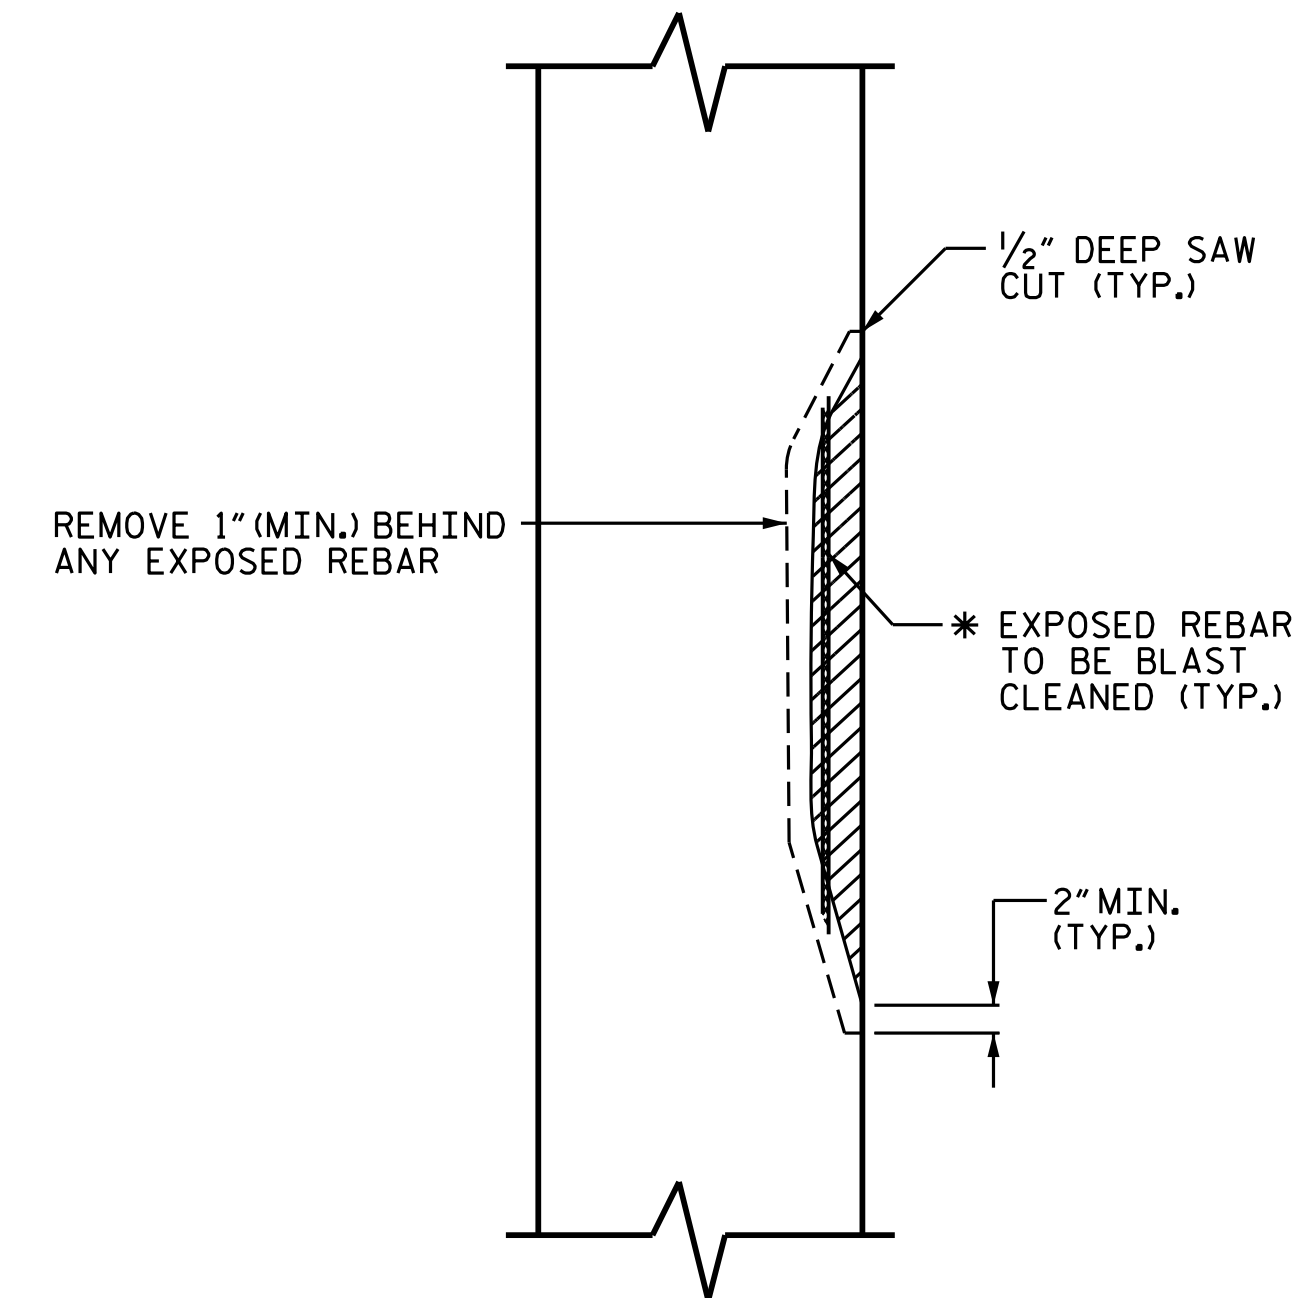
ELEVATION OF COLUMN

* REPAIR LENGTH SHALL NOT EXCEED 10 FEET.

COLUMN REPAIR
