CAP REPAIRS

BENT CAP REPAIRS

COLUMN REPAIRS

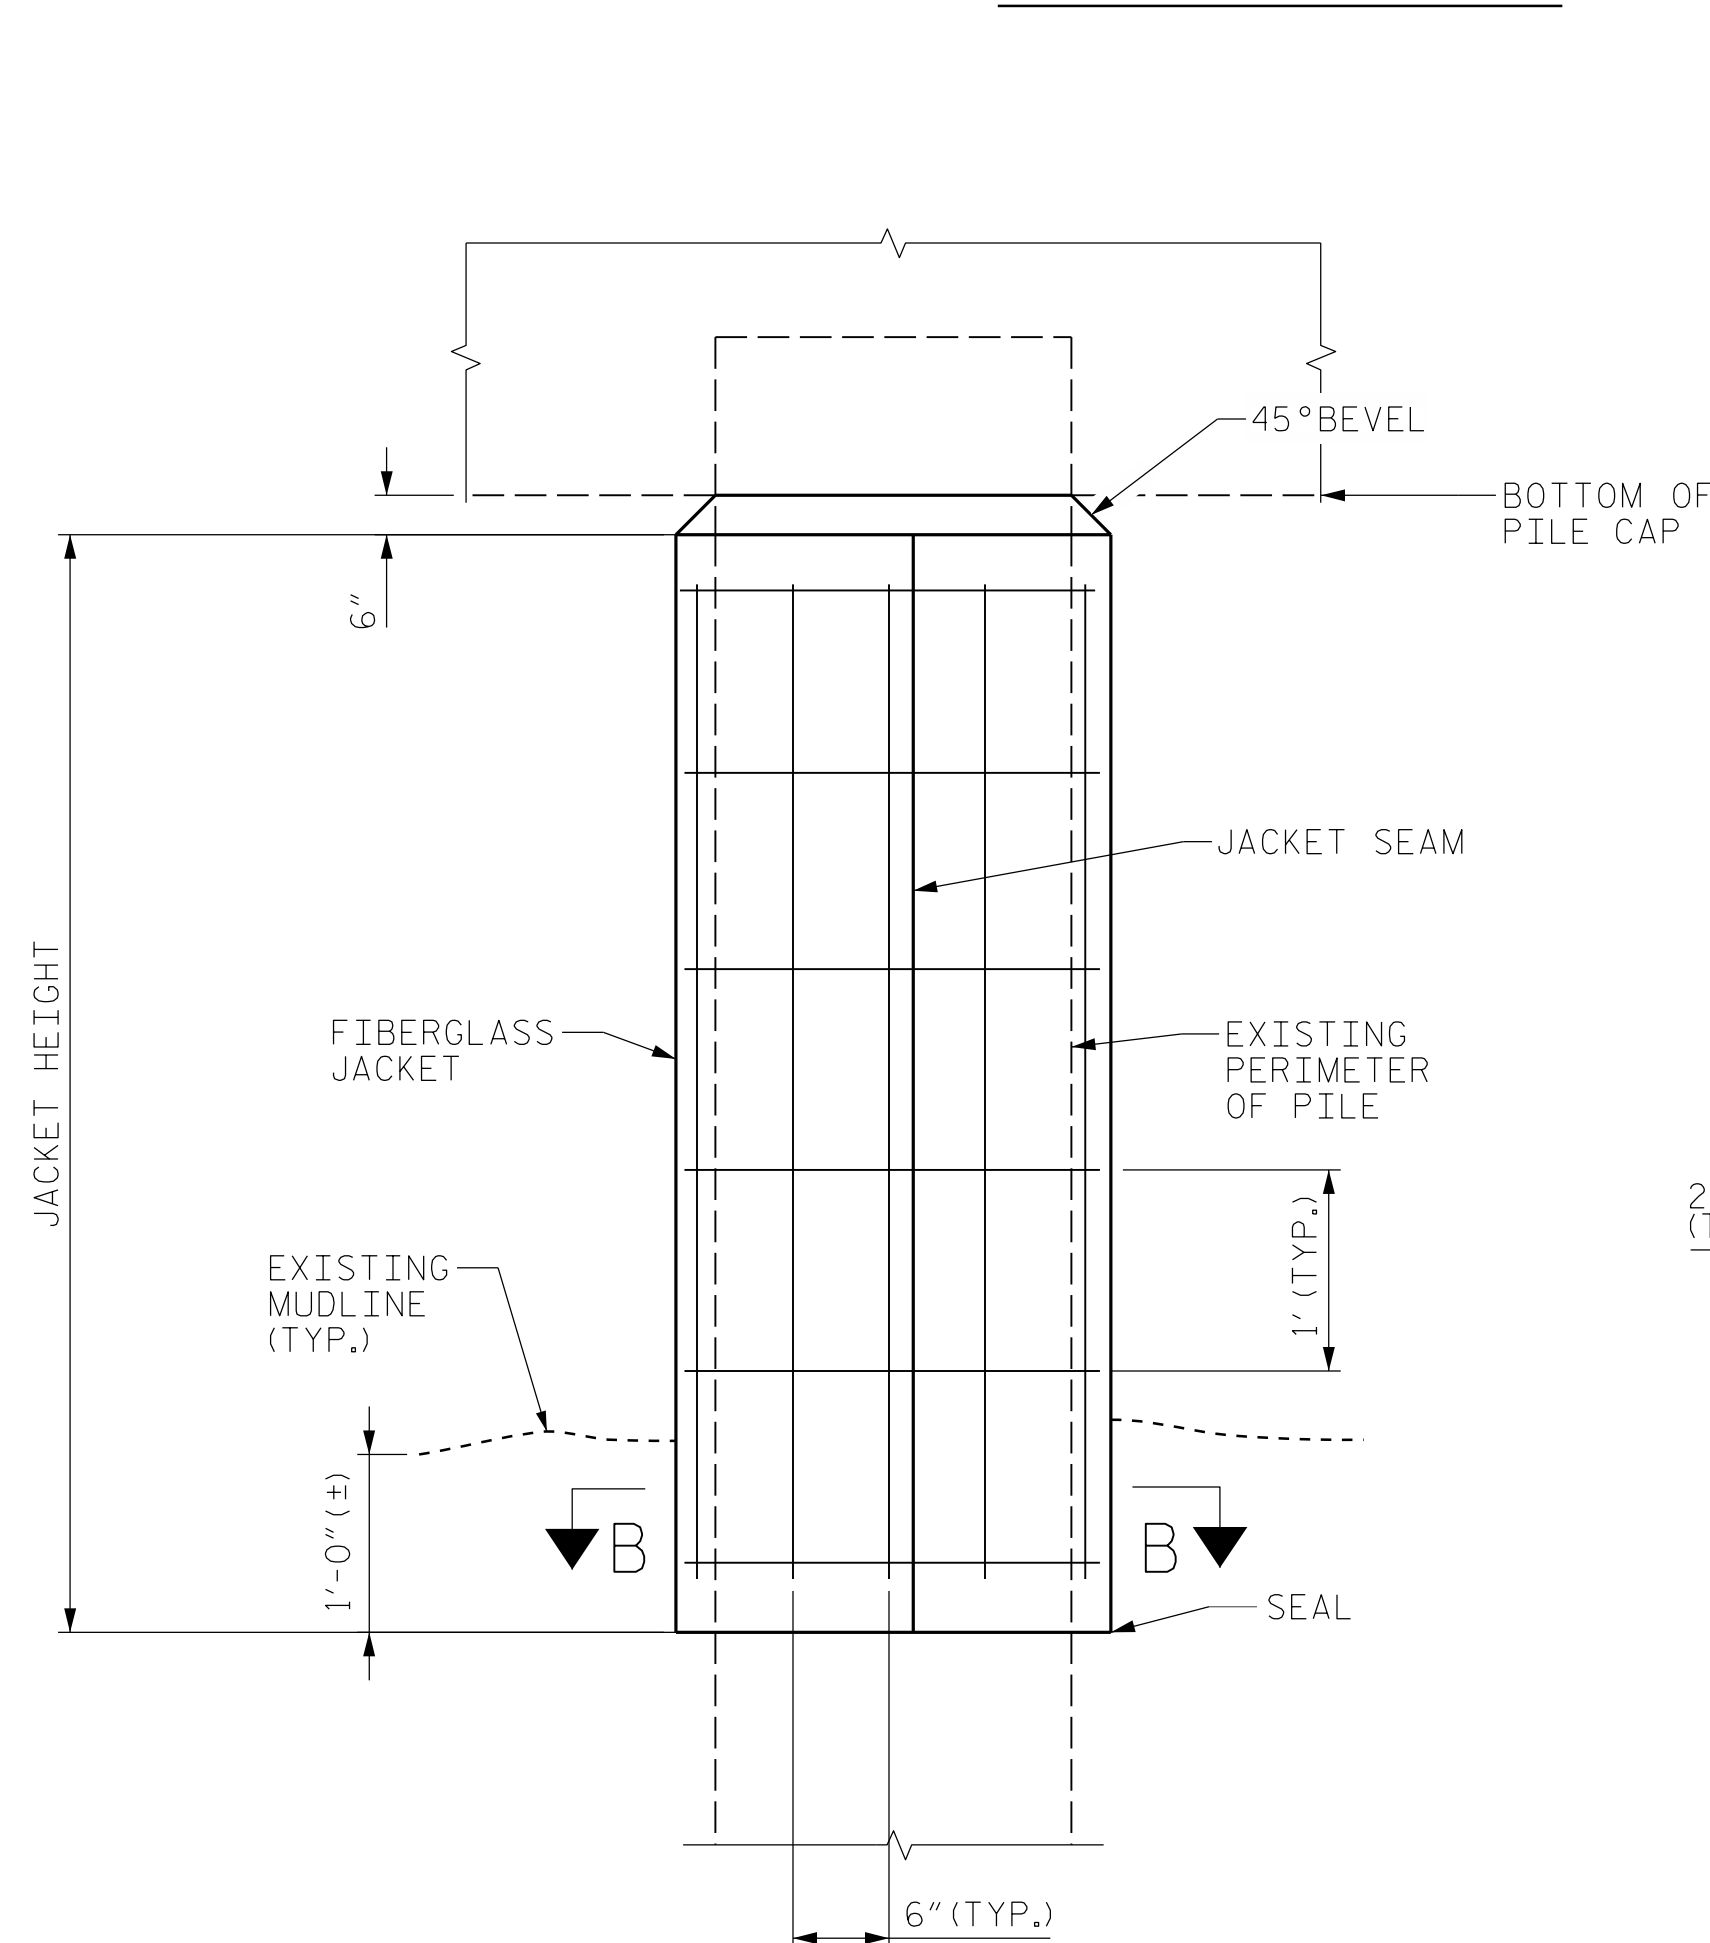
TYPICAL INTEGRAL PILE JACKETS AT BENT 15

CONSTRUCTION SEQUENCE FOR PILE JACKETS:

1. PREPARE SPALL AREAS WITHIN THE LIMITS OF THE PILE JACKETS IN ACCORDANCE WITH THIS SHEET PRIOR TO INSTALLING STRUCTURAL PILE JACKETS.
2. POSITION JACKET FORMS AND STEEL AROUND THE ENTIRE PILE PERIMETER FOR THE LENGTH OF THE JACKET IN PREPARATION FOR POUR.
3. POUR CONCRETE JACKET AS INDICATED ON THIS SHEET.
4. REMOVE FORMS. NO FORMS SHALL BE LEFT IN PLACE.
5. EXTEND JACKETS 1 FT. INTO THE MUDLINE AND FILL BACK AS APPROPRIATE.
6. REPAIR SPALLS ABOVE THE LIMITS OF THE APPROVED JACKETS LENGTHS IN ACCORDANCE WITH THIS SHEET.
7. PATCH AND FILL ANY REMAINING EXCAVATIONS WITH APPROVED MATERIAL.

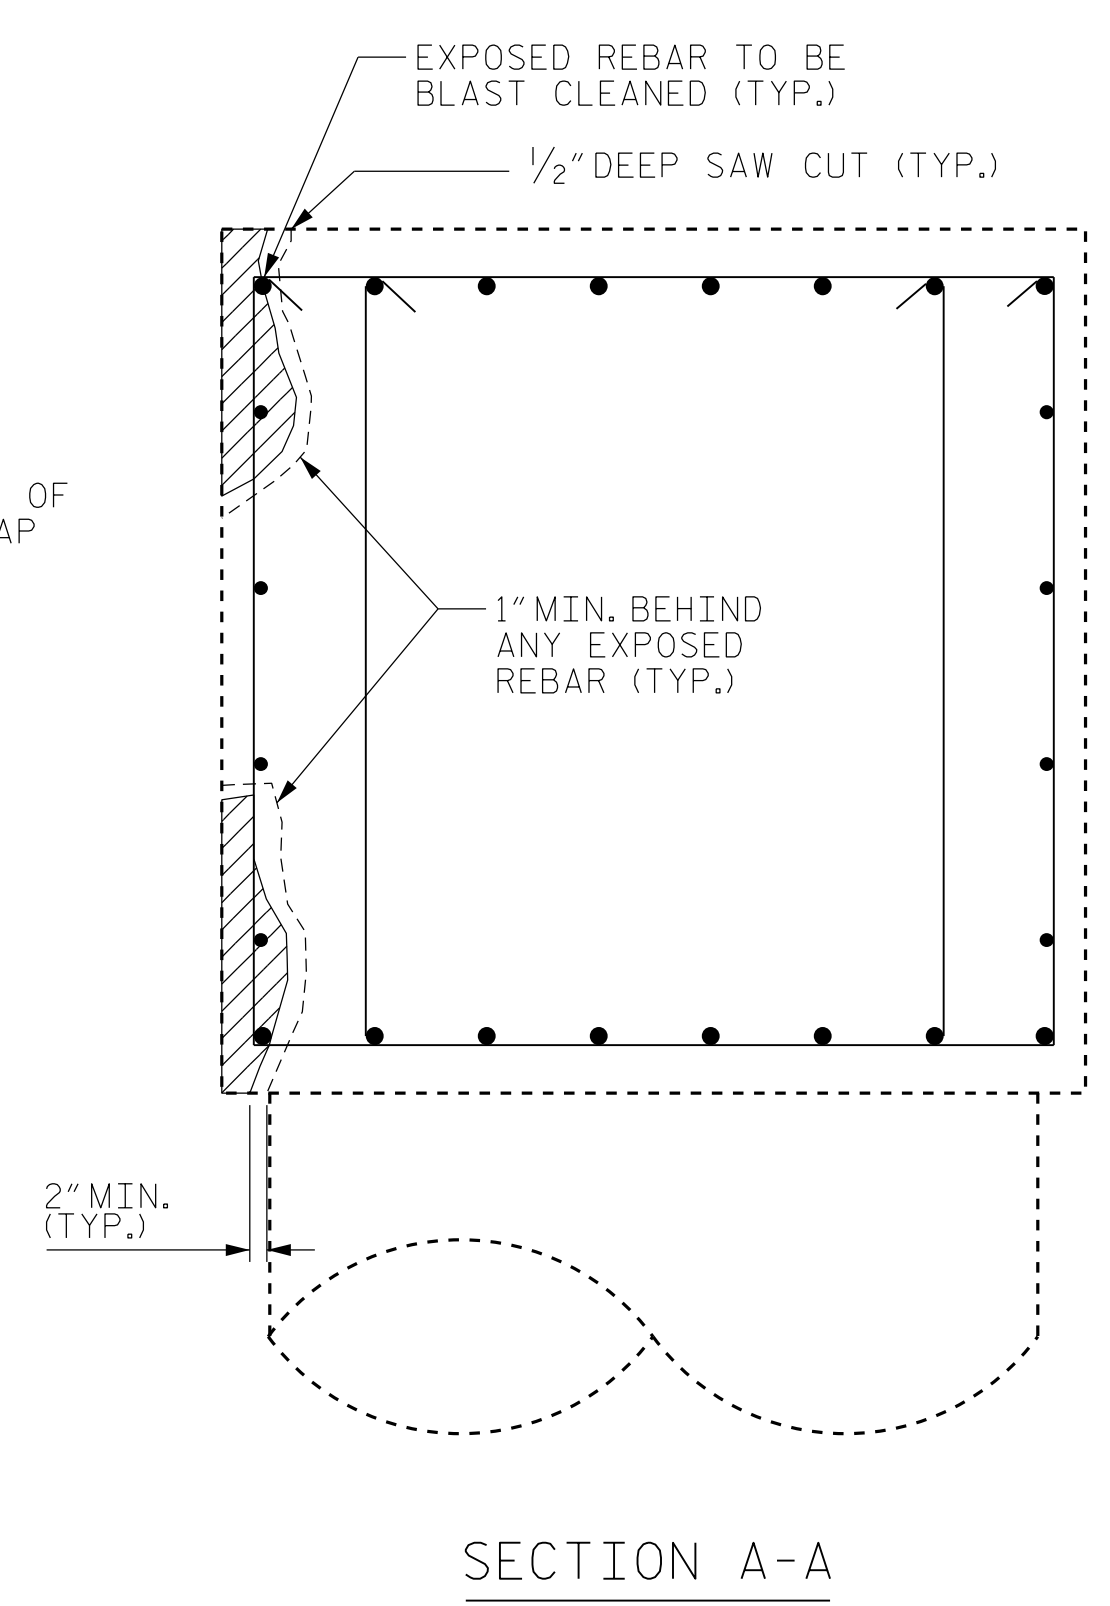
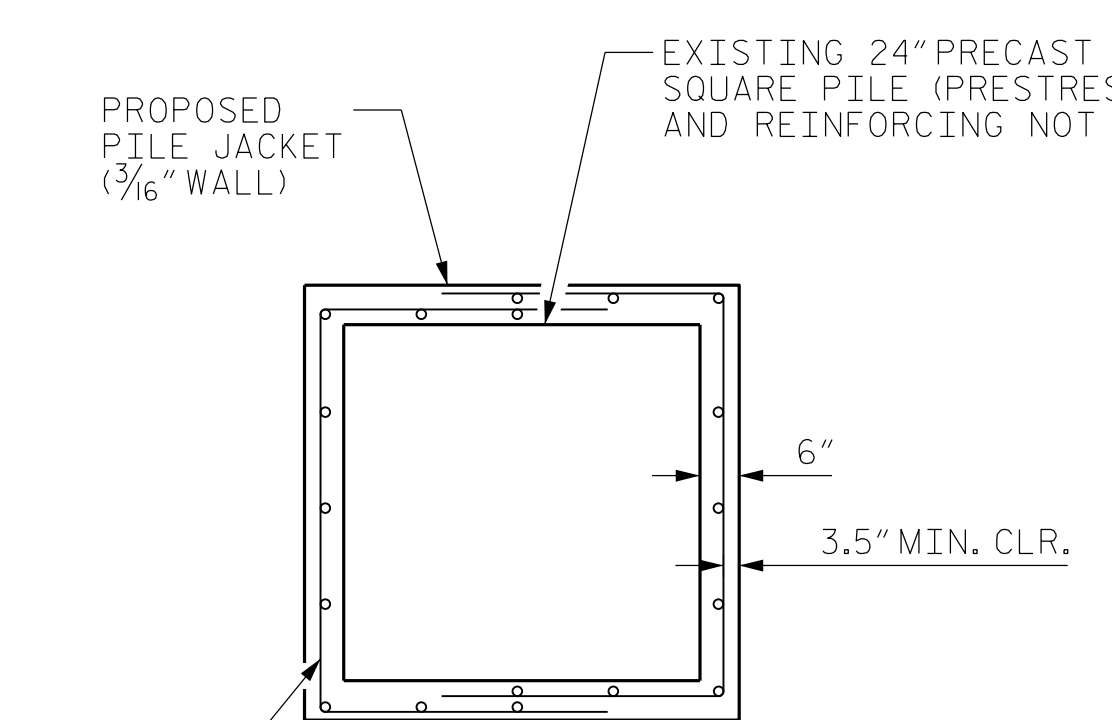
1. WORK THIS SHEET WITH REPAIR METHODS AND CONCRETE REPAIR NOTES IN "CONCRETE RESTORATION DETAILS" SHEET 1 OF 3.
2. TYPICAL BENT CAP REPAIRS ARE SHOWN IN THIS SHEET. REPAIR DETAILS SIMILAR FOR END BENT CAPS.

10. COAT ALL THE SURFACE AREA ON THE TOP OF CAPS, INCLUDING CHAMFERS, WITH EPOXY COATING. DO NOT COAT AREA UNDER BEARINGS.
11. FOR CONCRETE REPAIRS, SEE SPECIAL PROVISIONS.

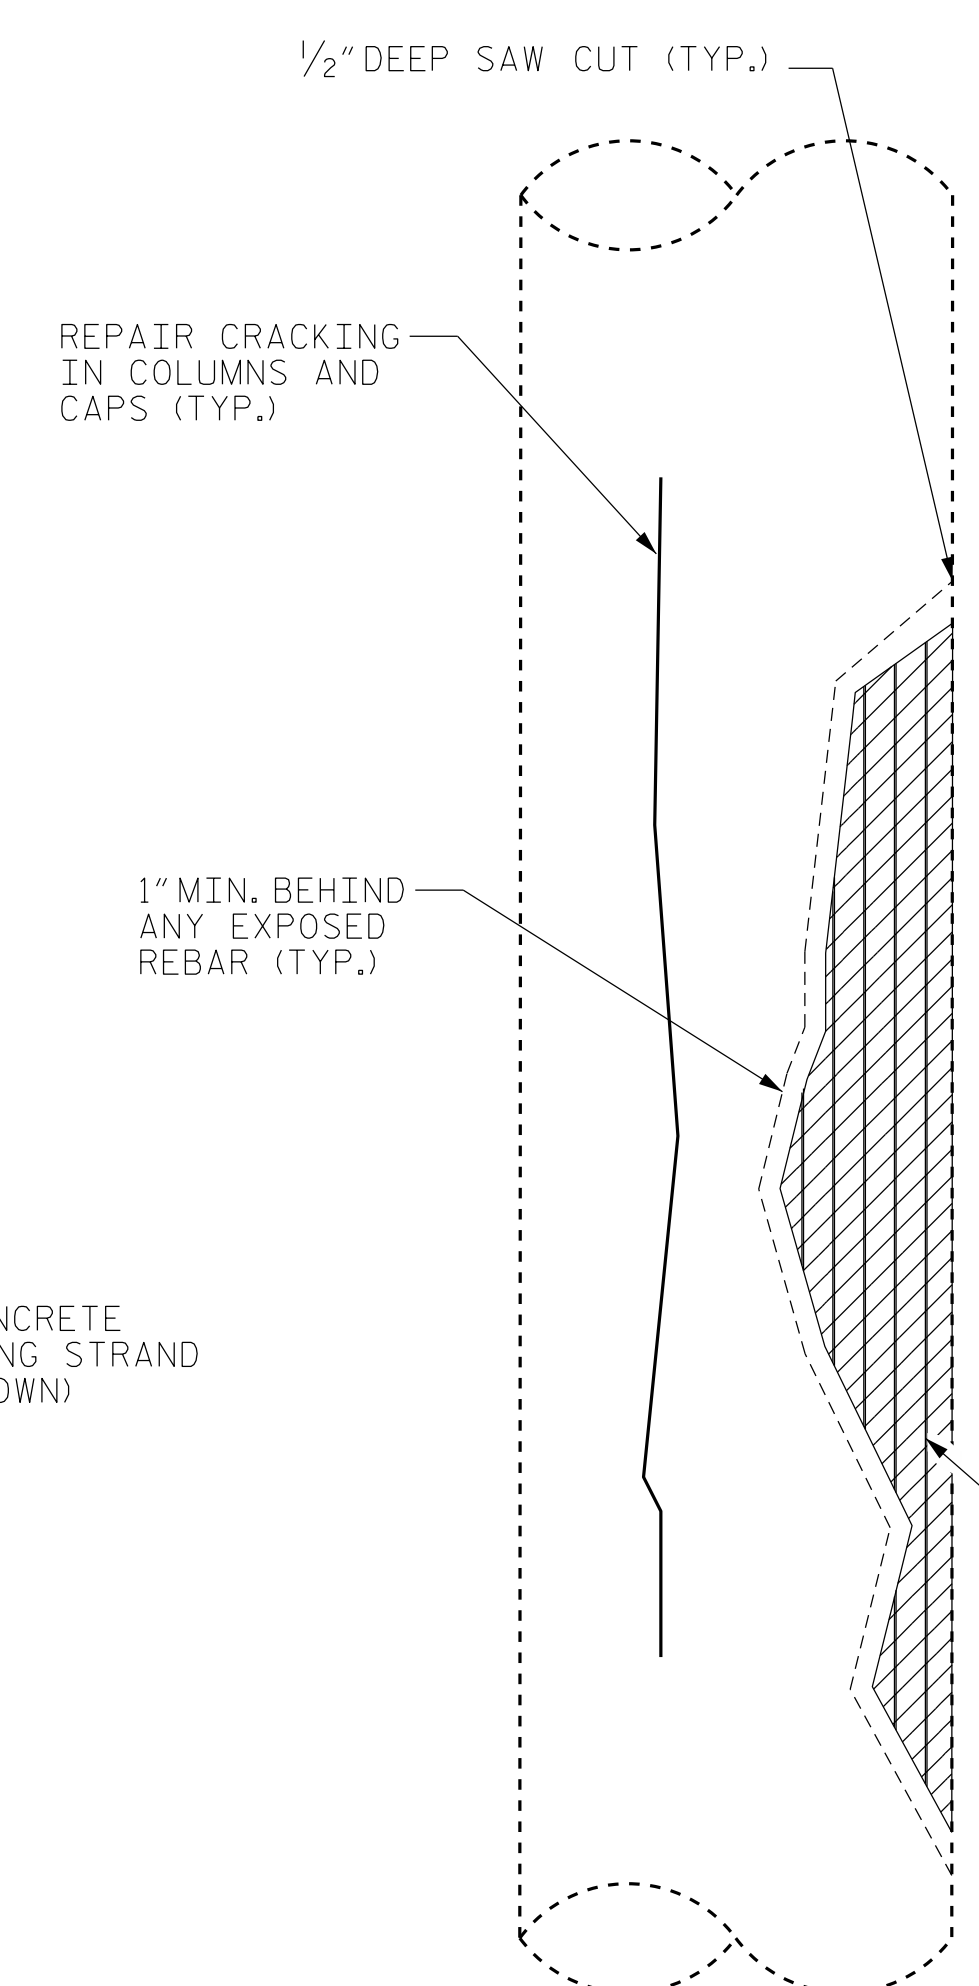
ELEVATION OF COLUMN

* REPAIR LENGTH SHALL NOT EXCEED 10 VERTICAL FEET AT ONCE OR 1/2 COLUMN DIAMETER.
