PROJECT NO. B-5981

BRIDGE NO. <u>300017</u>

STATE OF NORTH CAROLINA
DEPARTMENT OF TRANSPORTATION

DECK UNDERSIDE REPAIR SPAN B

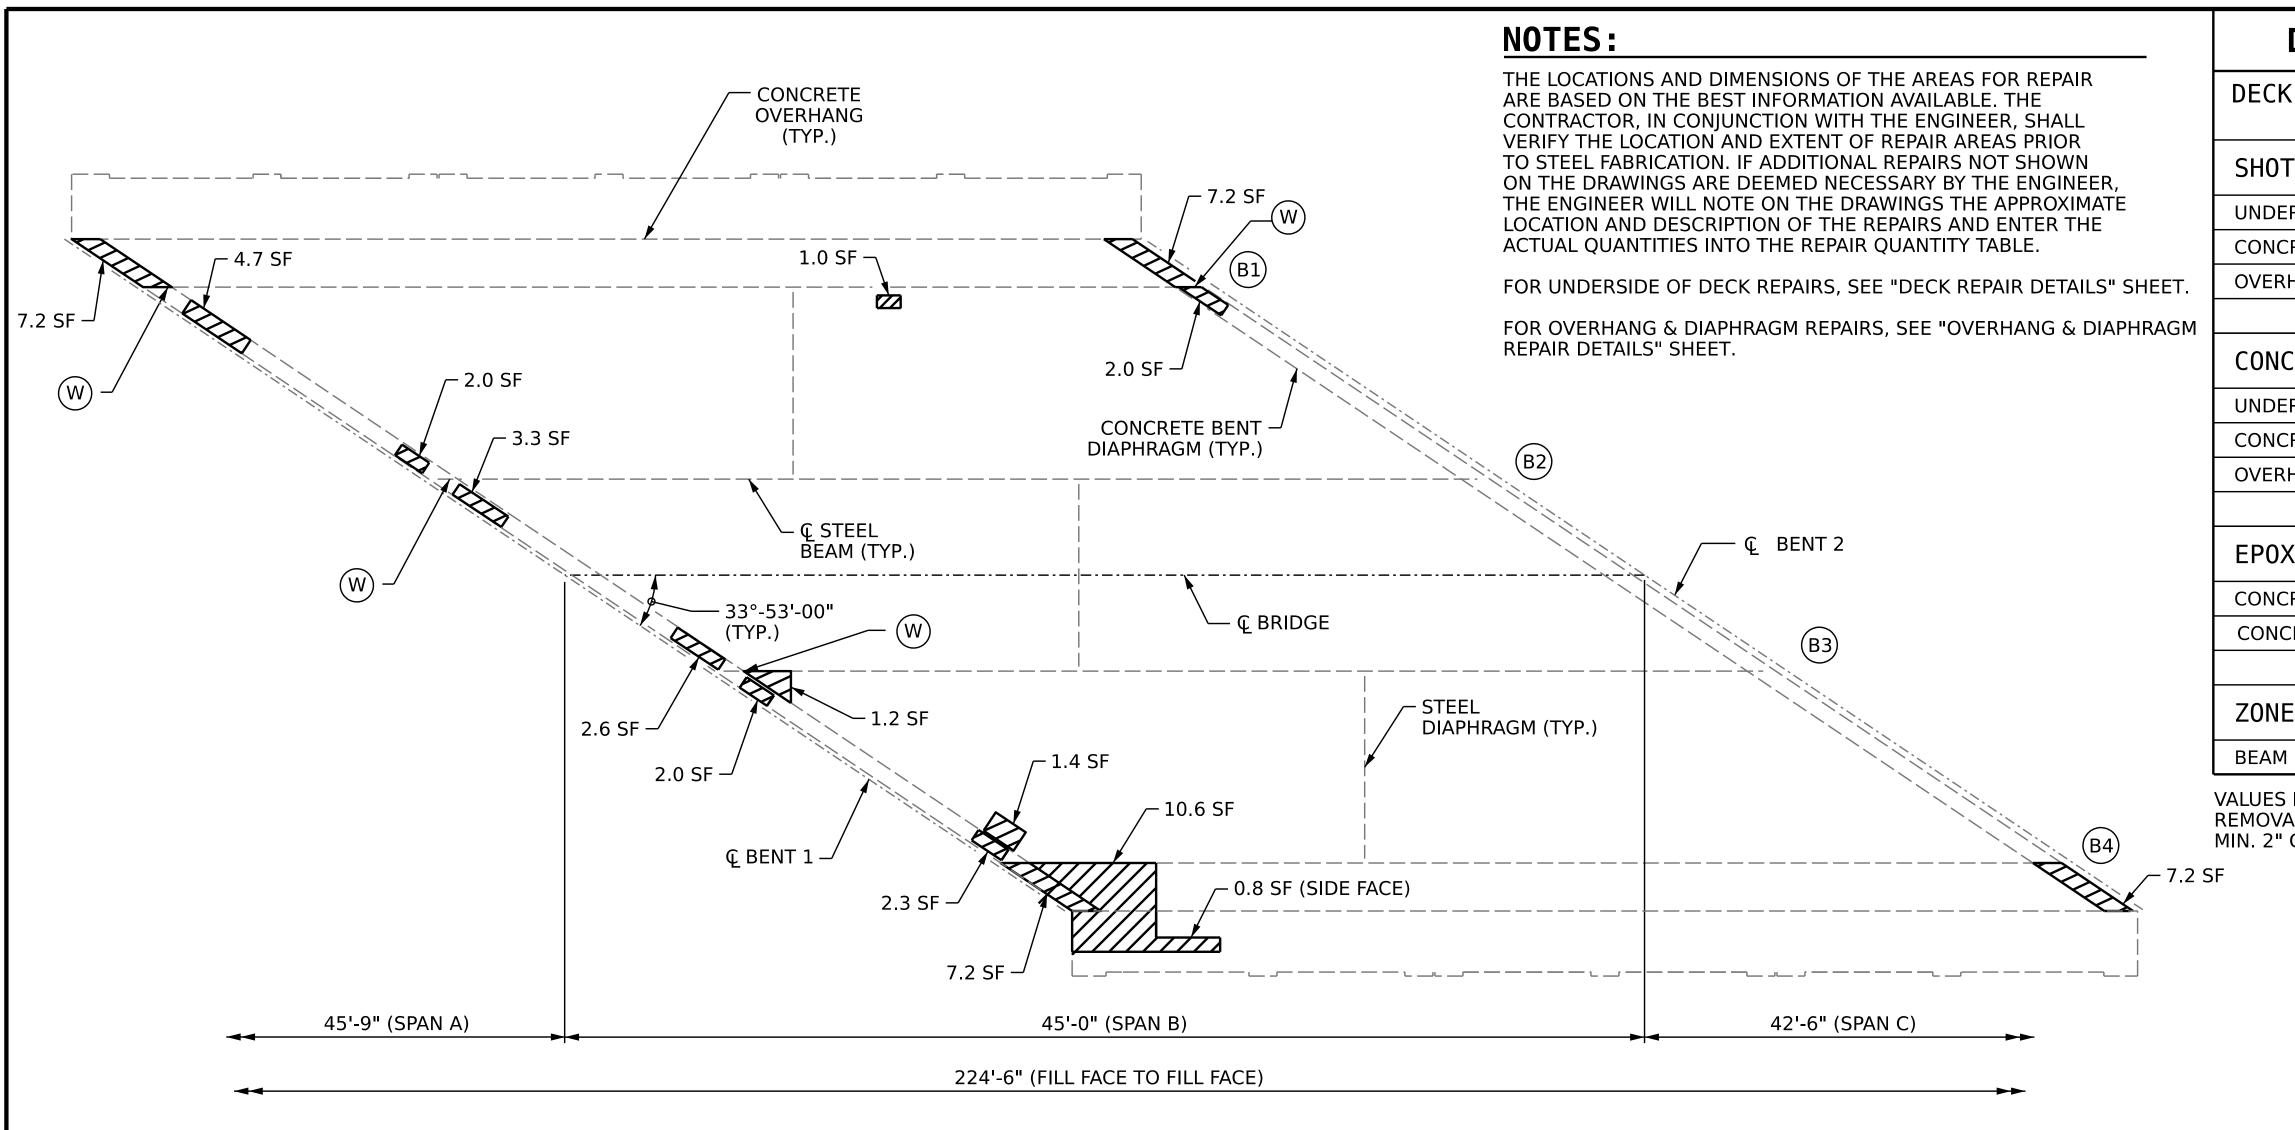
SPAN B

(SEE SHEETS S2-26, S2-27 AND S2-28 FOR BEAM REPAIR DETAILS AND DIMENSIONS.)
