NC DEPARTMENT OF TRANSPORTATION
 DIVISION OF HIGHWAYS
 STRUCTURE MANAGEMENT UNIT

Structure Safety Report

Routine Element Inspection

STRUCTURE NUMBER: 830102 SAP STRUCTURE NO: 0840102 FHWA STRUCTURE NO: 000000001670102

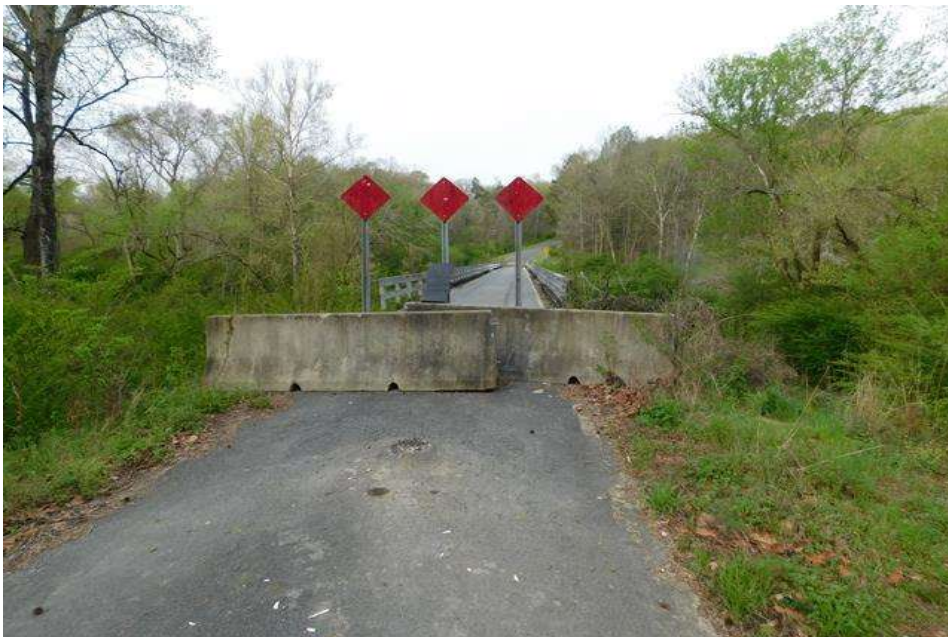
LOOKING WEST

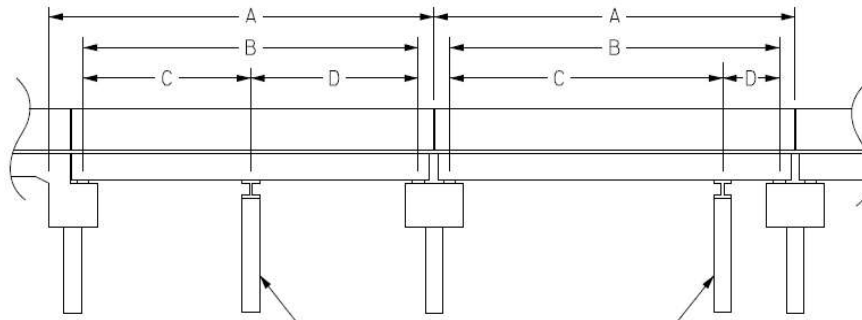
A: SPAN LENGTH
 B: BEARING TO BEARING
 C: DISTANCE FROM NEAR BEARING
 D: DISTANCE TO FAR BEARING

Span Number	Span Length	Bearing to Bearing	Crutch/ Helper Bent	Distance to Near Bearing	Distance to Far Bearing
1	27.250	26.417			
2	36.083	35.667			
3	36.083	35.667			
4	35.917	35.500			
5	36.167	35.750			
6	27.000	26.583			
7	27.583	27.123			
8	27.417	26.417

SPANS: 8 SPANS. SEE SPAN PROFILE SHEET FOR SPAN DETAILS
