PROJECT NO. **HI-0015**  
**COLUMBUS** COUNTY  
 BRIDGE NO. **230083**  
 SHEET 1 OF 3

STATE OF NORTH CAROLINA  
 DEPARTMENT OF TRANSPORTATION  
 RALEIGH  
**DECK UNDERSIDE REPAIR  
 SPAN A**

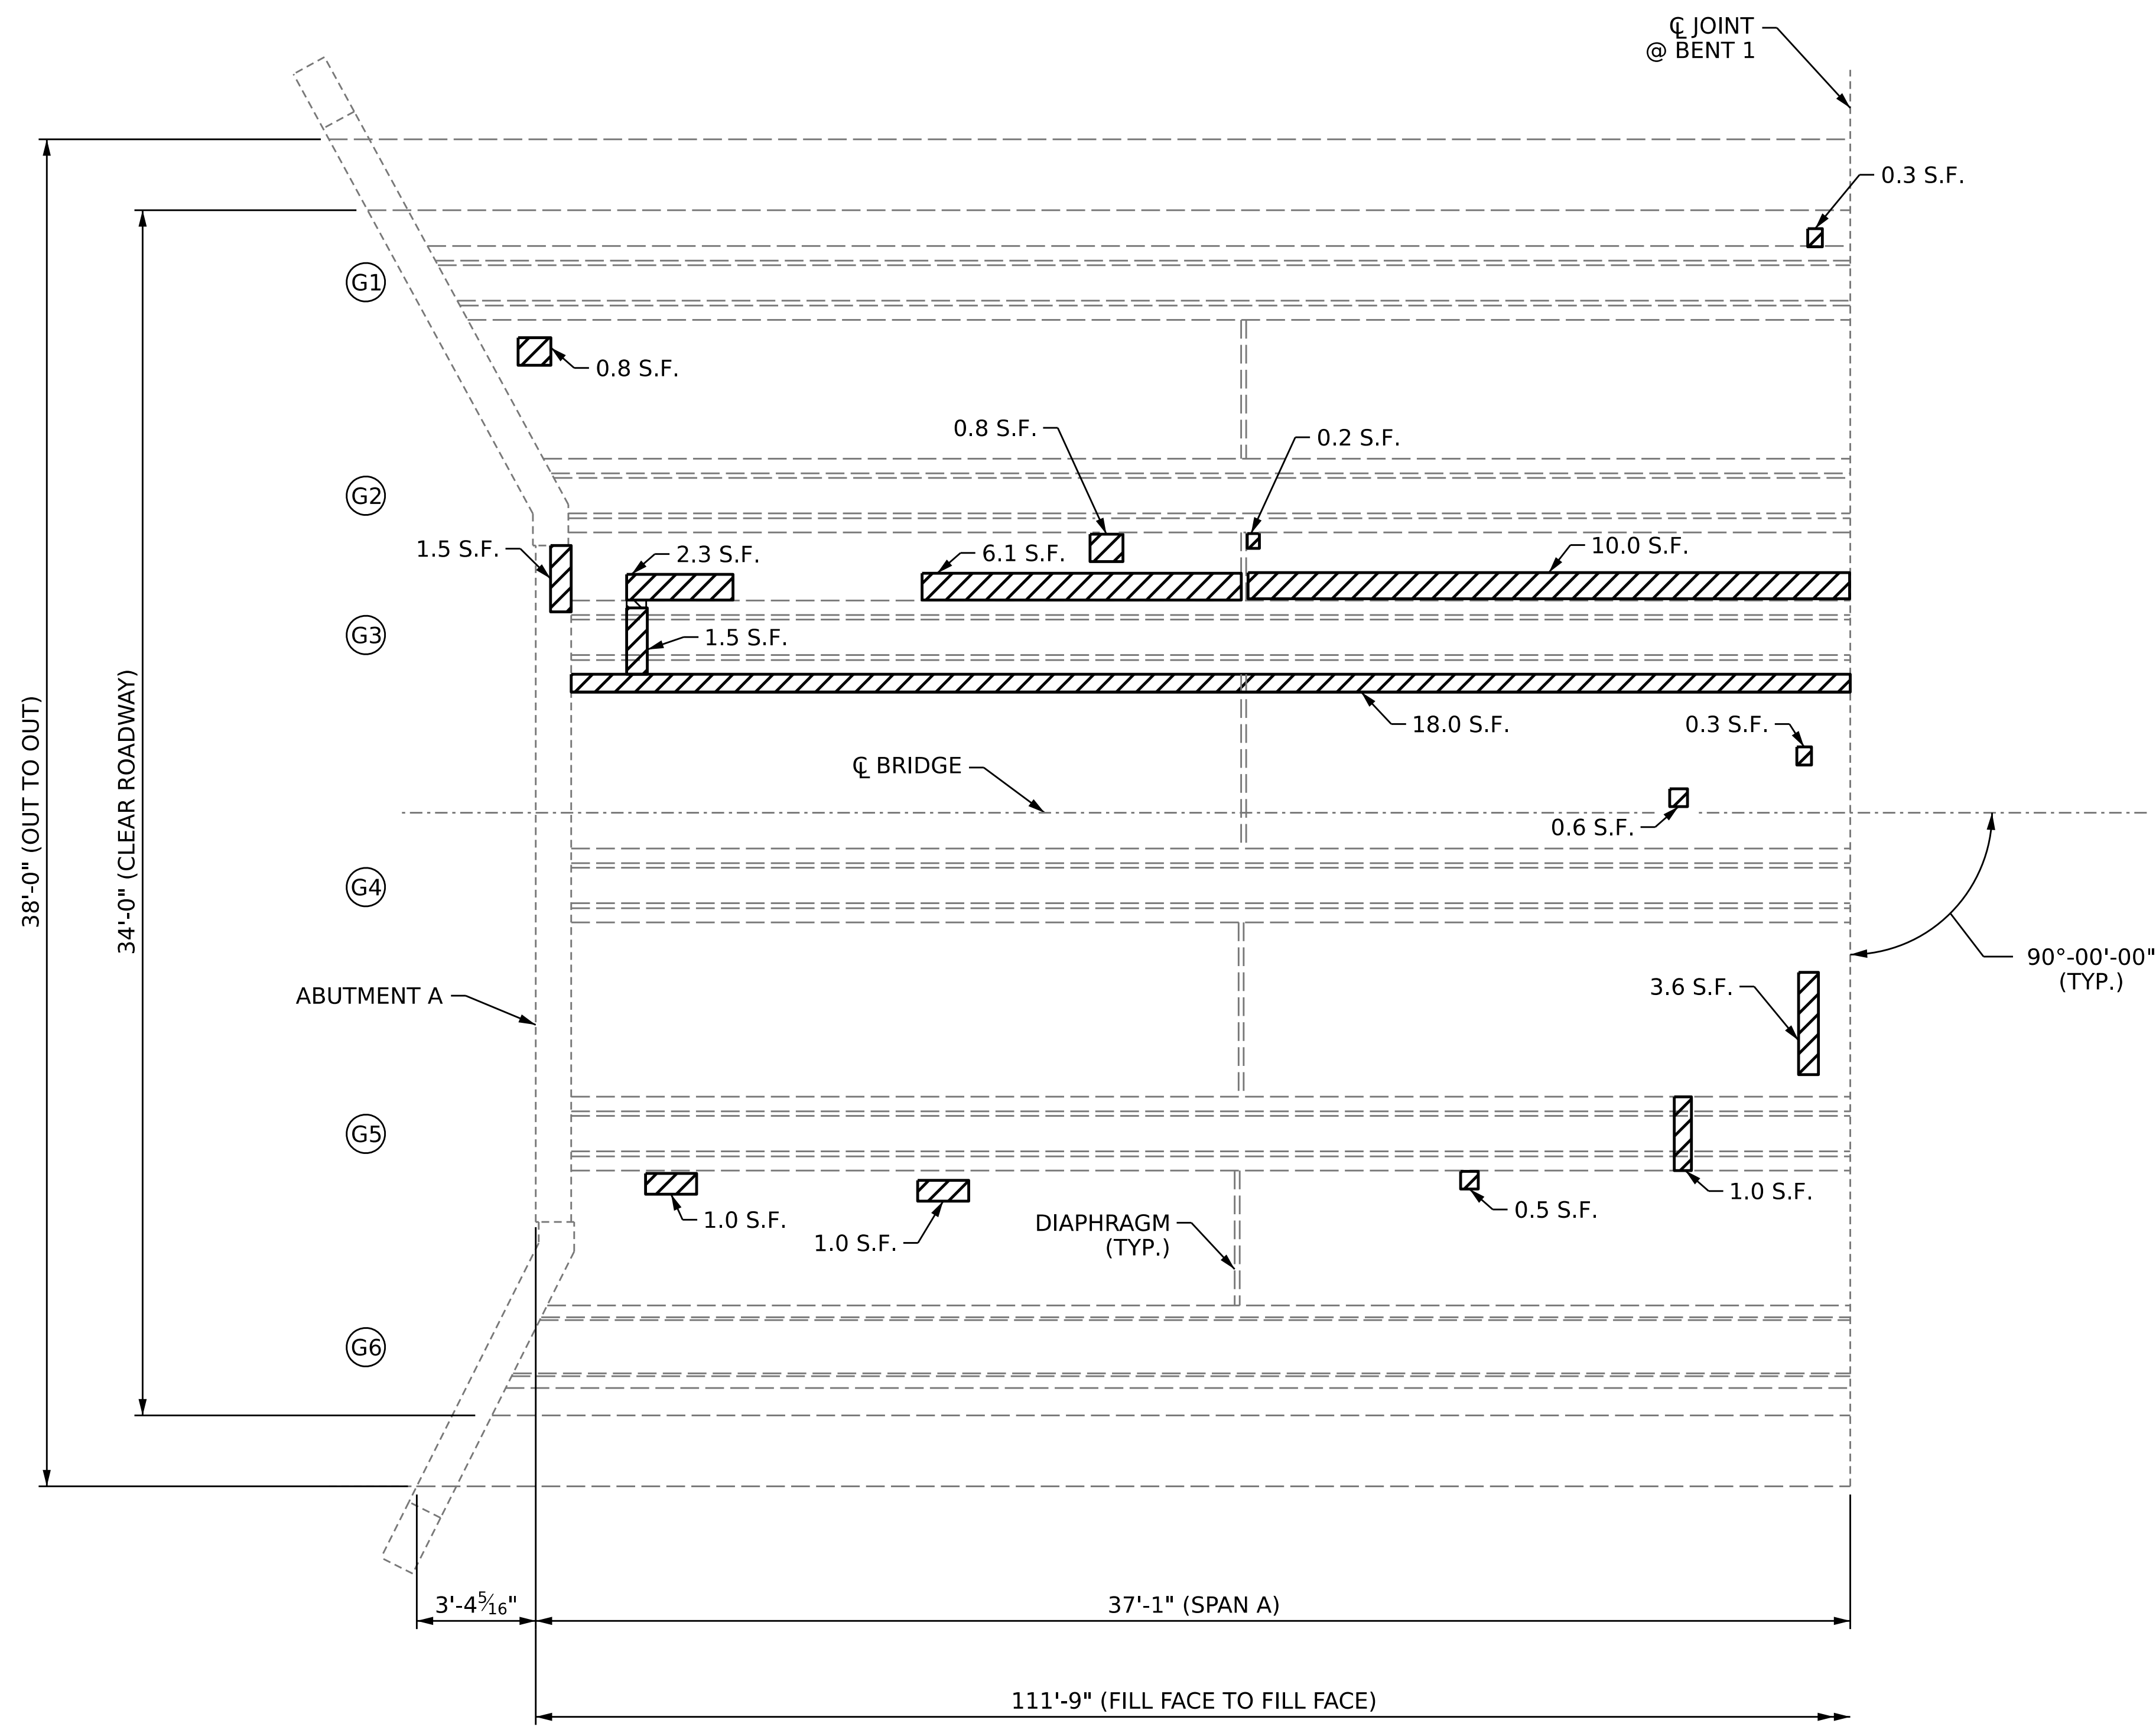
**PLAN OF SPAN A**

VALUES IN CHART REPRESENT ESTIMATED REPAIR TOTALS AFTER REMOVAL OF UNSOUND CONCRETE, MIN. OF 1" BEHIND REBAR AND MIN. 1" CLEAR TO SAWCUT. SEE REPAIR DETAILS.
