PROJECT NO. I-5941 DURHAM COUNTY BRIDGE NO. 108, 112, 135,

STATE OF NORTH CAROLINA DEPARTMENT OF TRANSPORTATION

SUBSTRUCTURE

TYPICAL CAP AND COLUMN REPAIR DETAILS

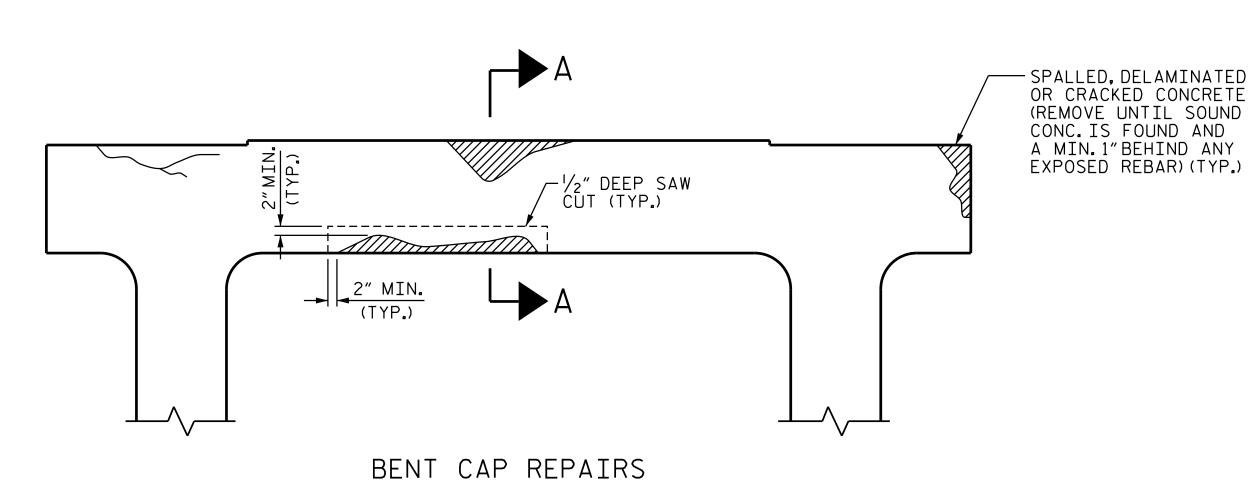
ELEVATION OF CAP

* IF CONFINEMENT STEEL IS NOT PRESENT, THEN REPAIR LENGTH SHALL NOT EXCEED 10 FEET.

CZ″ MIN. (TYP.)

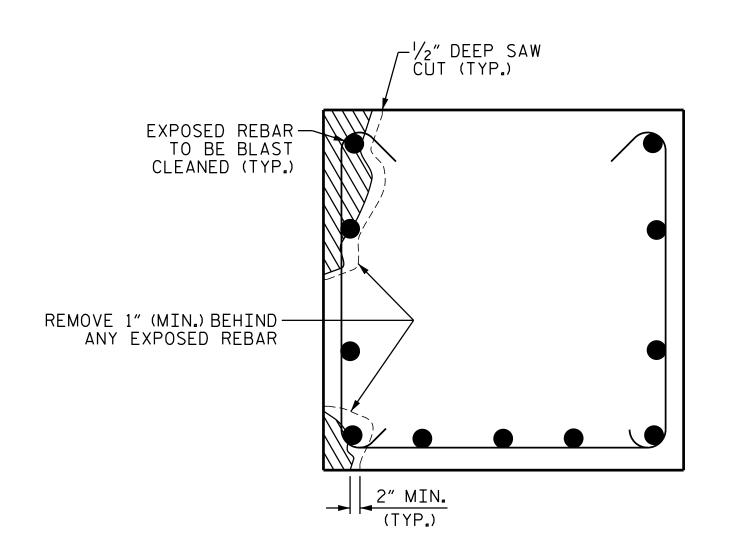
SECTION THRU CAP (EXAMPLE ONLY. ACTUAL REBAR SIZES & LOCATIONS MAY VARY)

CAP REPAIR

-★ EXPOSED REBAR TO BE BLAST

CLEANED (TYP.)

REMOVE 1" (MIN.) BEHIND —

ANY EXPOSED REBAR

1/2" DEEP SAW-CUT (TYP.)

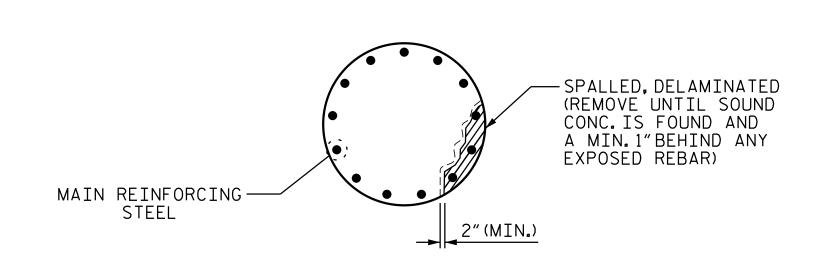
PLAN OF COLUMN

COLUMN REPAIR
