STATE OF NORTH CAROLINA  
 DEPARTMENT OF TRANSPORTATION  
 RALEIGH

STANDARD  
 TYPICAL CAP  
 AND COLUMN  
 REPAIR DETAILS

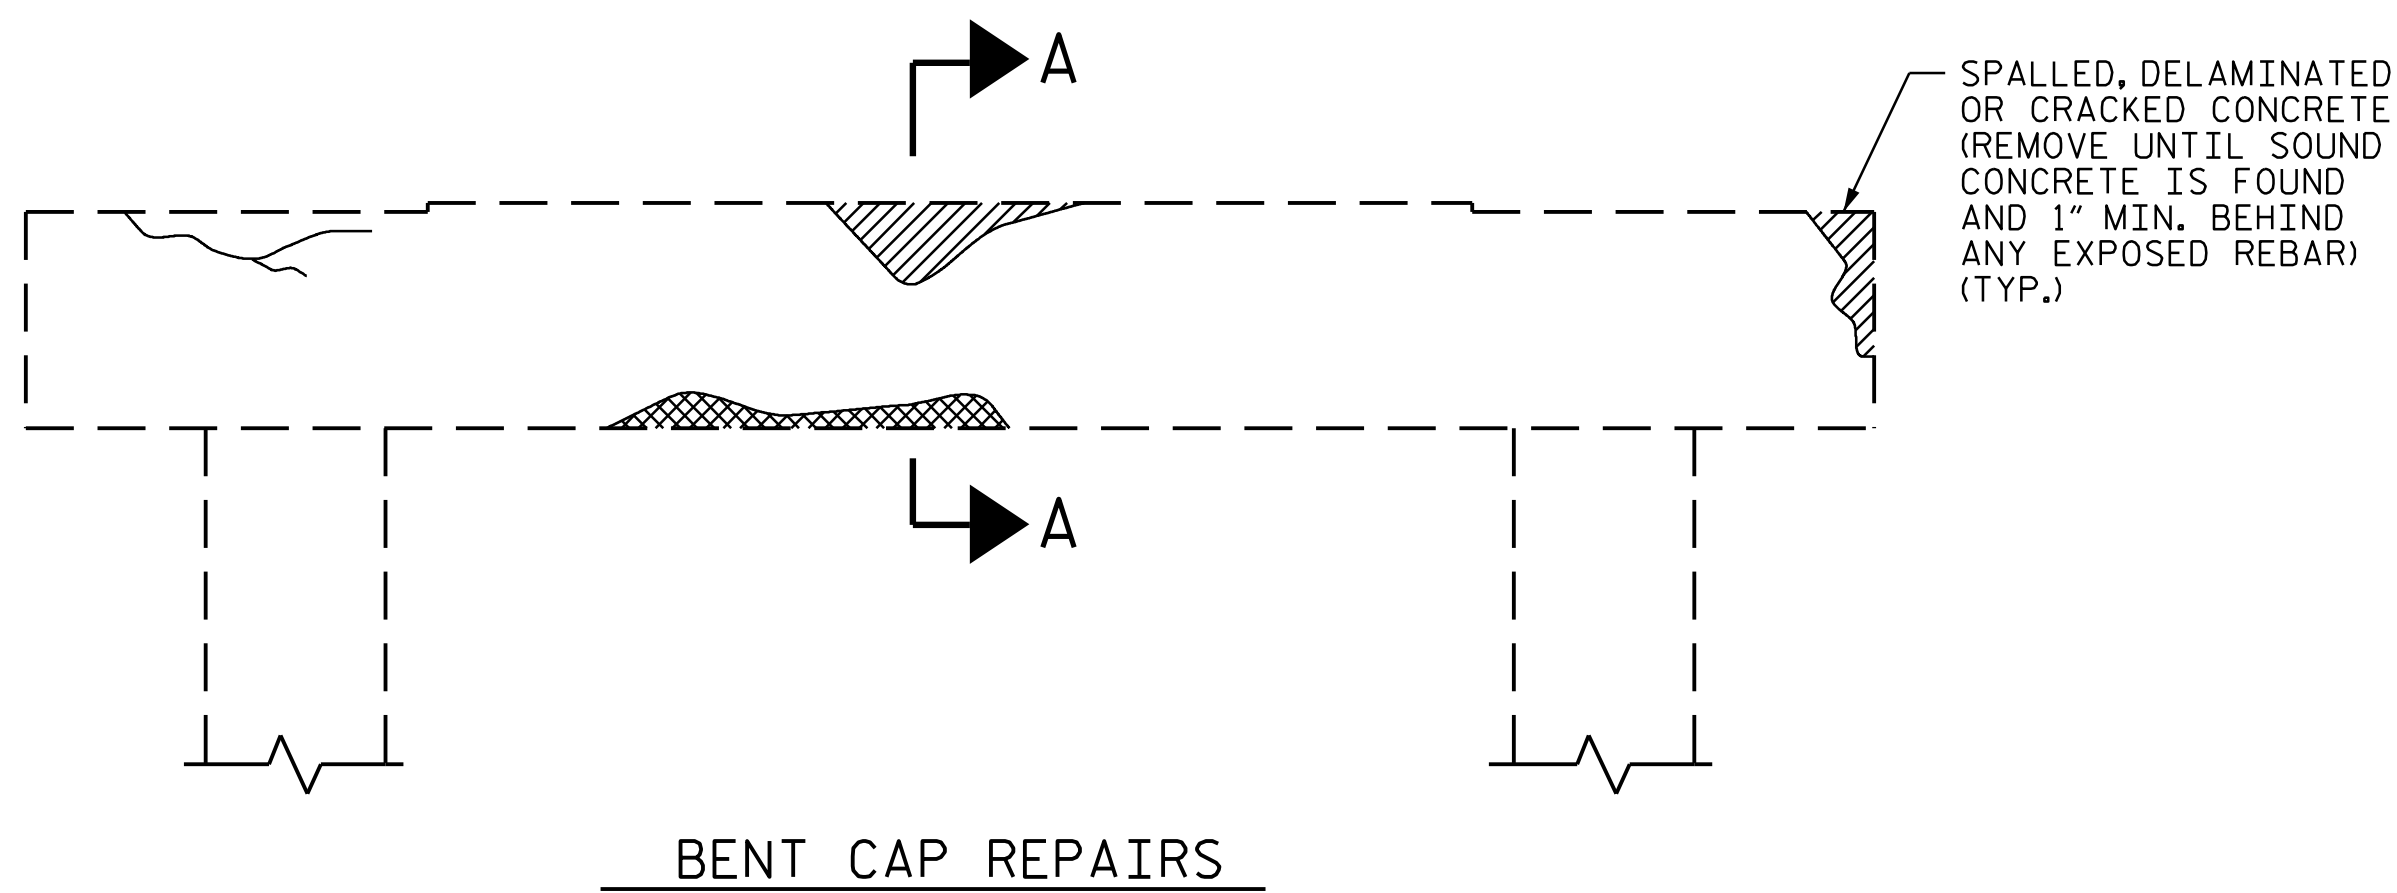
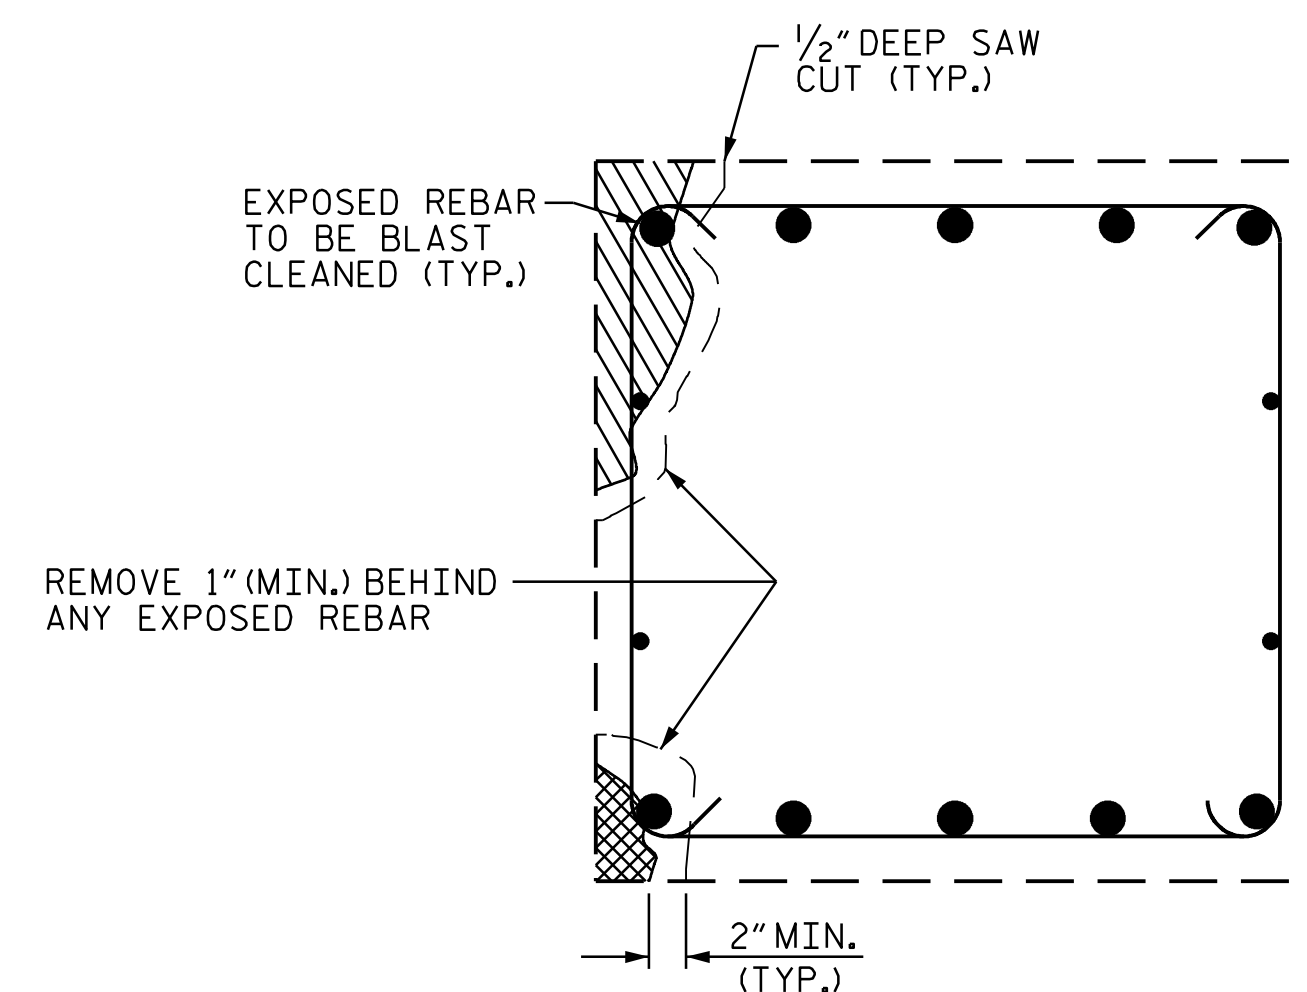
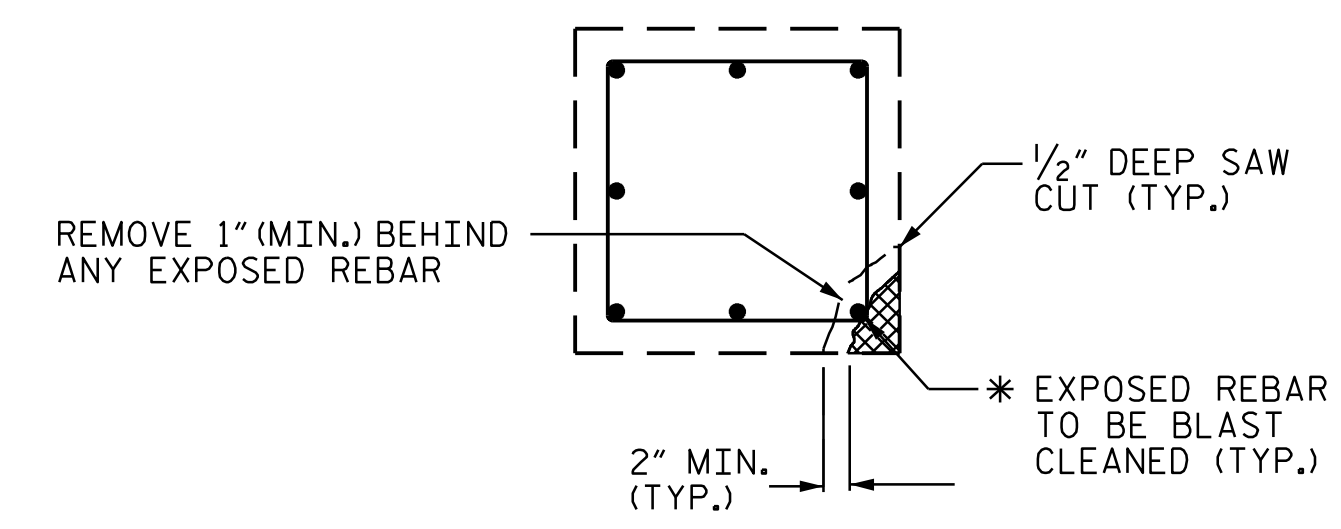
**SECTION A-A**  
**CAP REPAIR**

TYPICAL BENT CAP REPAIRS ARE SHOWN. REPAIR DETAILS SIMILAR FOR END BENT CAPS AND STRUTS.

REMOVE UNSOUND CONCRETE TO THE EXTENT NECESSARY, MINIMUM OF 1" BEHIND REBAR AND MINIMUM OF 2" CLEARANCE TO SAWCUT.

COAT ALL REPAIR SURFACE AREAS ON THE TOP OF CAPS, INCLUDING CHAMFERS, WITH EPOXY COATING, OVERLAPPING THE REPAIR AREA BY A MINIMUM OF 3" ON ALL POSSIBLE SIDES.

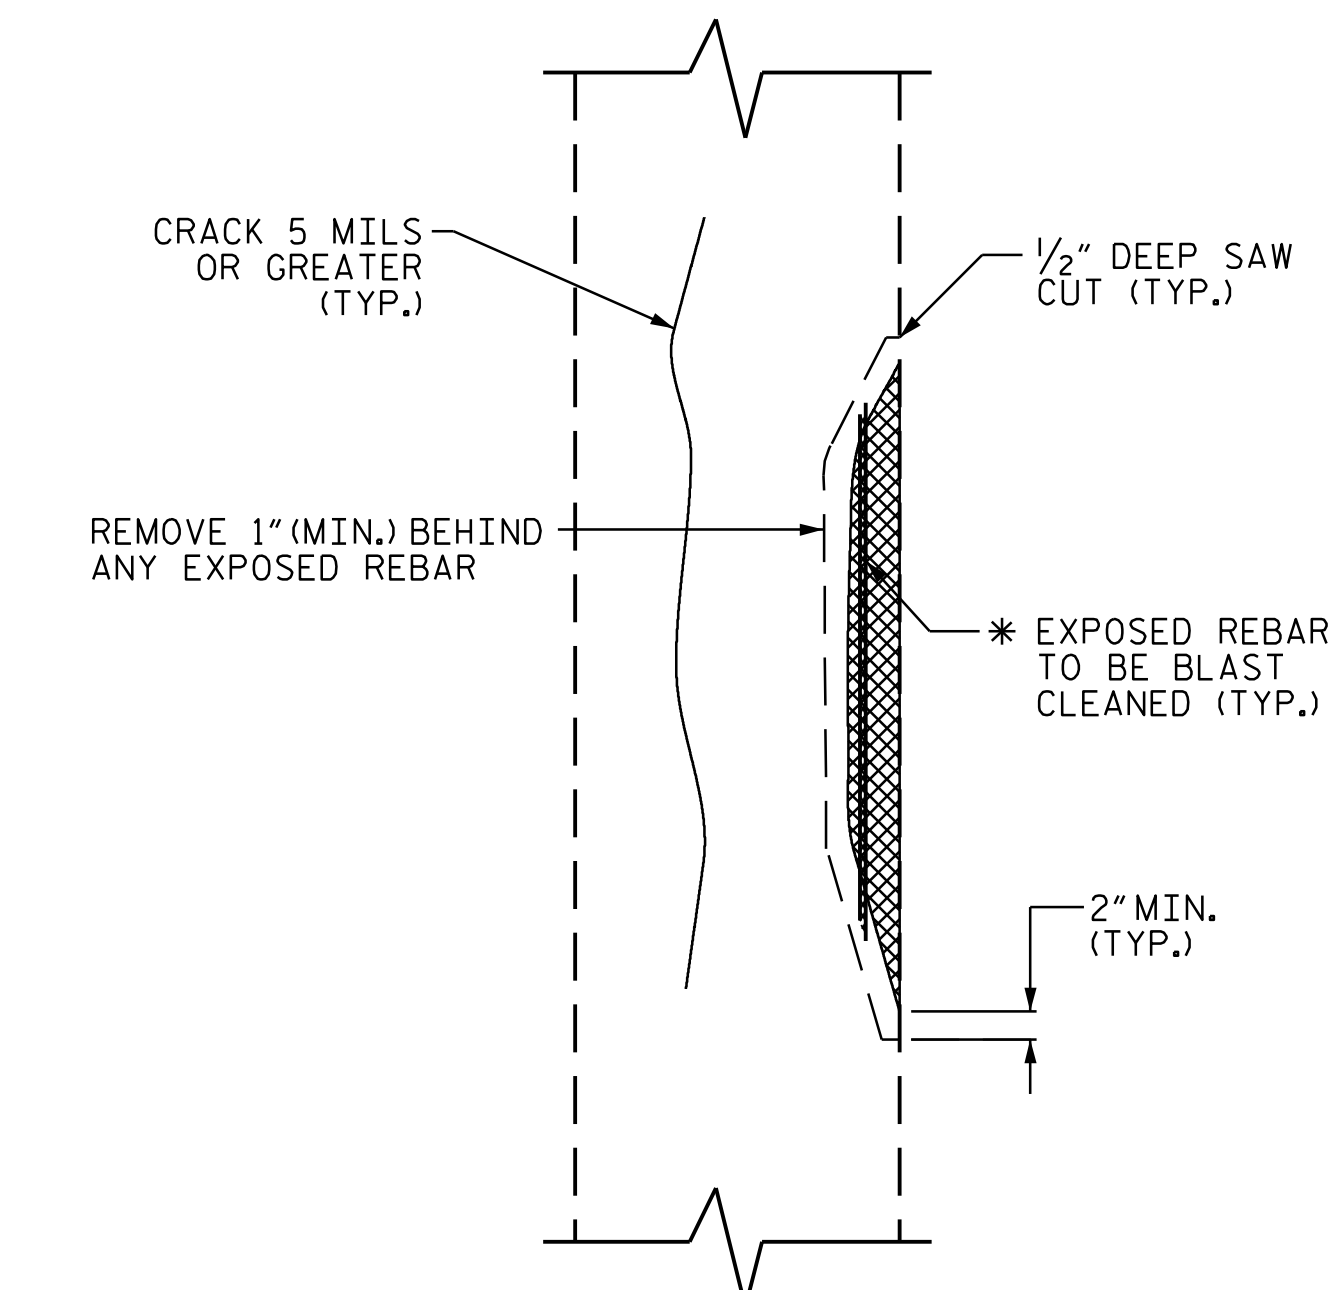
**ELEVATION OF COLUMN**  
**COLUMN REPAIR**

NO MORE THAN ONE-THIRD OF THE CAP OR COLUMN CROSS SECTIONAL AREA SHALL BE REMOVED AT ONE TIME. SHOULD IT BECOME NECESSARY TO REMOVE MORE THAN 30% OF A CAP OR COLUMN CROSS SECTIONAL AREA, NOTIFY THE ENGINEER PRIOR TO PROCEEDING.

SIMULTANEOUS REMOVAL OF UNSOUND CONCRETE MAY BE PERMITTED ON MORE THAN ONE FACE OF A CAP AND/OR COLUMN, IF THE AREAS OF REMOVAL ARE NOT ADJACENT TO OR DIRECTLY OPPOSITE ONE ANOTHER. IF REMOVAL EXTENDS MORE THAN 1 1/2" BEHIND THE MAIN REINFORCING BARS, NOTIFY THE ENGINEER PRIOR TO PROCEEDING.
