## STATE OF NORTH CAROLINA DIVISION OF HIGHWAYS

## CURRITUCK & DARE COUNTIES

LOCATION: BRIDGE 16 ON US 158 EBL OVER CURRITUCK SOUND
TYPE OF WORK: BRIDGE DECK PRESERVATION WITH POLYESTER
POLYMER CONCRETE DECK OVERLAY,
BRIDGE REHABILITATION

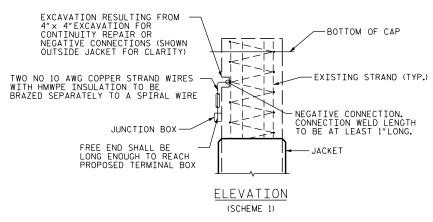
### SCHEME 1

- 1. EXCAVATE A 4" x 4" AREA AT EACH STRAND OF DISCONTINUITY SUCH THAT IT EXTENDS TO THE FIRST ADJACENT STRAND THAT IS CONTINUOUS. EXCAVATION AREA TO BE WITHIN THE TOP 2 FEET OF THE JACKET. EXCAVATION SHOWN OUTSIDE JACKET FOR CLARITY.

2. FOR ABOVE WATER INSTALLATION RESISTANCE WELD TWO MILD STEEL WIRES FROM ONE DISCONTINUOUS STRAND TO THE ADJACENT STRAND UNTIL A CONTINUOUS STRAND IS REACHED. COAT CONNECTION WITH NON-CONDUCTIVE EPOXY.

3. A MINIMUM OF TWO CONTINUITY CONNECTIONS SHALL BE MADE TO FACH DISCONTINUINS STRAND.
- EACH DISCONTINUOUS STRAND.

LOCATIONS OF EXCAVATIONS FOR CONTINUITY CORRECTIONS SHALL BE SELECTED BASED ON THE ALTERNATIVE RESULTING IN THE LEAST REMOVAL OF CONCRETE. IF POSSIBLE, ALL EXCAVATIONS TO EXPOSED REINFORCING STEEL SHALL BE MADE INSIDE THE JACKET LIMITS. CONTINUITY TEST AND CONTINUITY CORRECTION EXCAVATIONS SHALL BE SEALED PRIOR TO PLACEMENT OF THE JACKET.

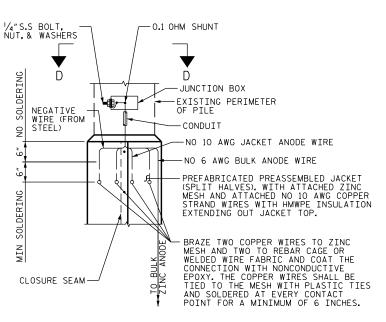
### JACKET DETAIL

(NON-STRUCTURAL SHOWN, STRUCTURAL SIMILAR)

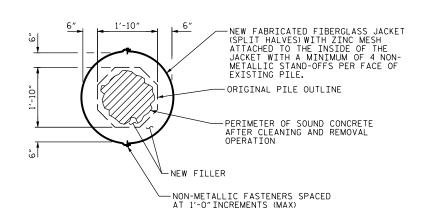
### VIEW D-D

PRESTRESSING STRANDS AND REINFORCING STEEL NOT SHOWN FOR CLARITY

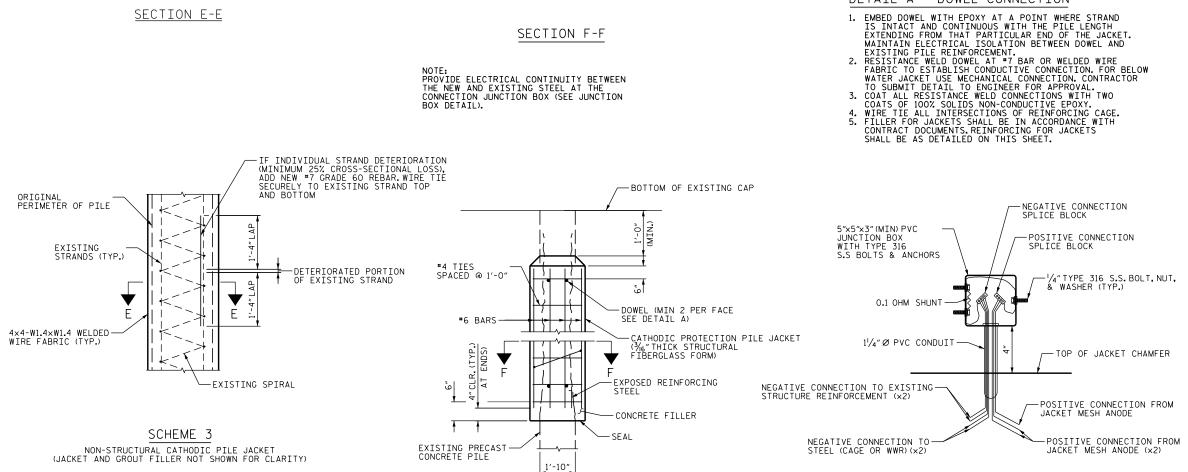
# SCHEME 4 STRUCTURAL CATHODIC PILE JACKET (CATHODIC COMPONENTS NOT SHOWN FOR CLARITY)

NOTE:
PROVIDE ELECTRICAL CONTINUITY BETWEEN
THE NEW AND EXISTING STEEL AT THE
CONNECTION JUNCTION BOX (SEE JUNCTION

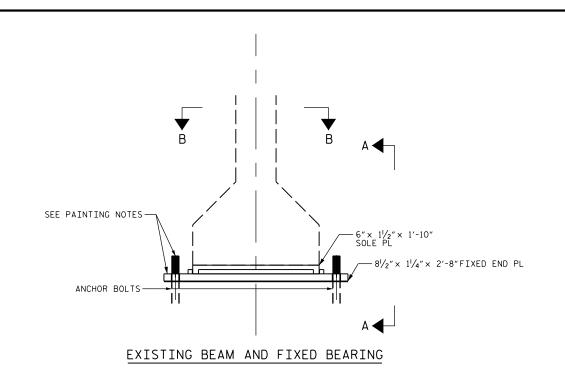
SECTION A-A

- 1. CLEAN AND PAINT ALL EXPOSED AREAS OF PLATES, NUTS, BOLTS, AND WASHERS AT EACH BEARING IN ACCORDANCE WITH PROJECT SPECIAL PROVISIONS FOR COATING OF EXISTING BEARINGS.
  2. DURING ALL CLEANING AND PAINTING OPERATIONS, THE CONTRACTOR SHALL ISOLATE THE WORK AREA WITH APPROPRIATE CONTAINMENT DEVICES (CANVASSES, TARPAULINS, SCREENS, ETC.) IN ORDER TO PREVENT ANY GENERATED DEBRIS FROM CAUSING VIOLATIONS OF CURRENT FEDERAL, STATE AND LOCAL AIR AND WATER POLLUTION REGULATIONS.
  3. THE CONTRACTOR SHALL BE RESPONSIBLE FOR LEGAL DISPOSAL OF ALL DEBRIS COLLECTED BY THE CONTAINMENT DEVICES.

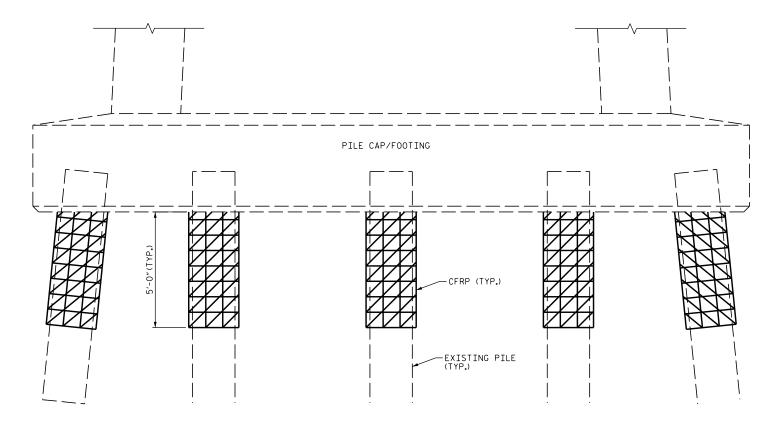
TYPICAL FOOTING SHOWN - ELEVATION

BENTS 172-176,181-185 BENTS 177-180 SIMILAR

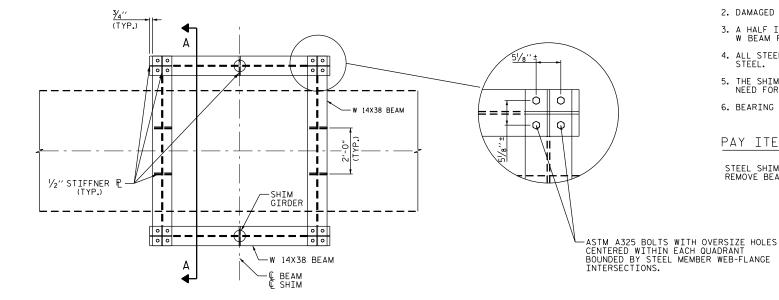
### REPAIR NOTES:

- WITH THE BEAMS SHIMMED AND SECURED, THE CONTRACTOR SHALL REMOVE AND REPAIR ALL UNSOUND CONCRETE IN ACCORDANCE WITH CONTRACT DOCUMENTS.
- 2. CRACKS IN OTHERWISE SOUND CONCRETE (AS APPROVED BY THE ENGINEER) SHALL BE INJECTED WITH EPOXY IN ACCORDANCE WITHTHE CONCRETE RESTORATION DETAILS SHEET.
- 3. UPON CURING REPAIR CONCRETE TO A MINIMUM OF 3.4 KSI. REMOVE SHIMS, AND RETURN BEAMS TO ORIGINAL BEARING
- 4. USE SUPPLEMENTAL BEAM BRACE DETAIL WHEN CAP CONCRETE REPAIR IS ANTICIPATED TO EXPOSE 10% OR MORE OF THE MASONRY PLATE, OR WHEN INSTABILITY OF THE BEARING IS ANTICIPATED. THE ENGINEER SHALL APPROVE USAGE OF THE FRAME IN COORDINATION WITH

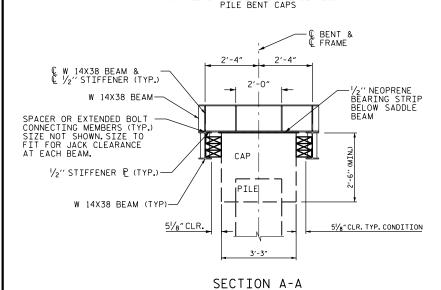
### PARTIAL PLAN

SUPPLEMENTAL BEAM BRACE DETAILS -PILE BENT CAPS
