PROJECT NO. I-5711
ALAMANCE COUNTY
STATION: STA. 27+02.26 -L-

STATE OF NORTH CAROLINA
DEPARTMENT OF TRANSPORTATION
RALEIGH
PRESERVATION

SUBSTRUCTURE REPAIR DETAILS

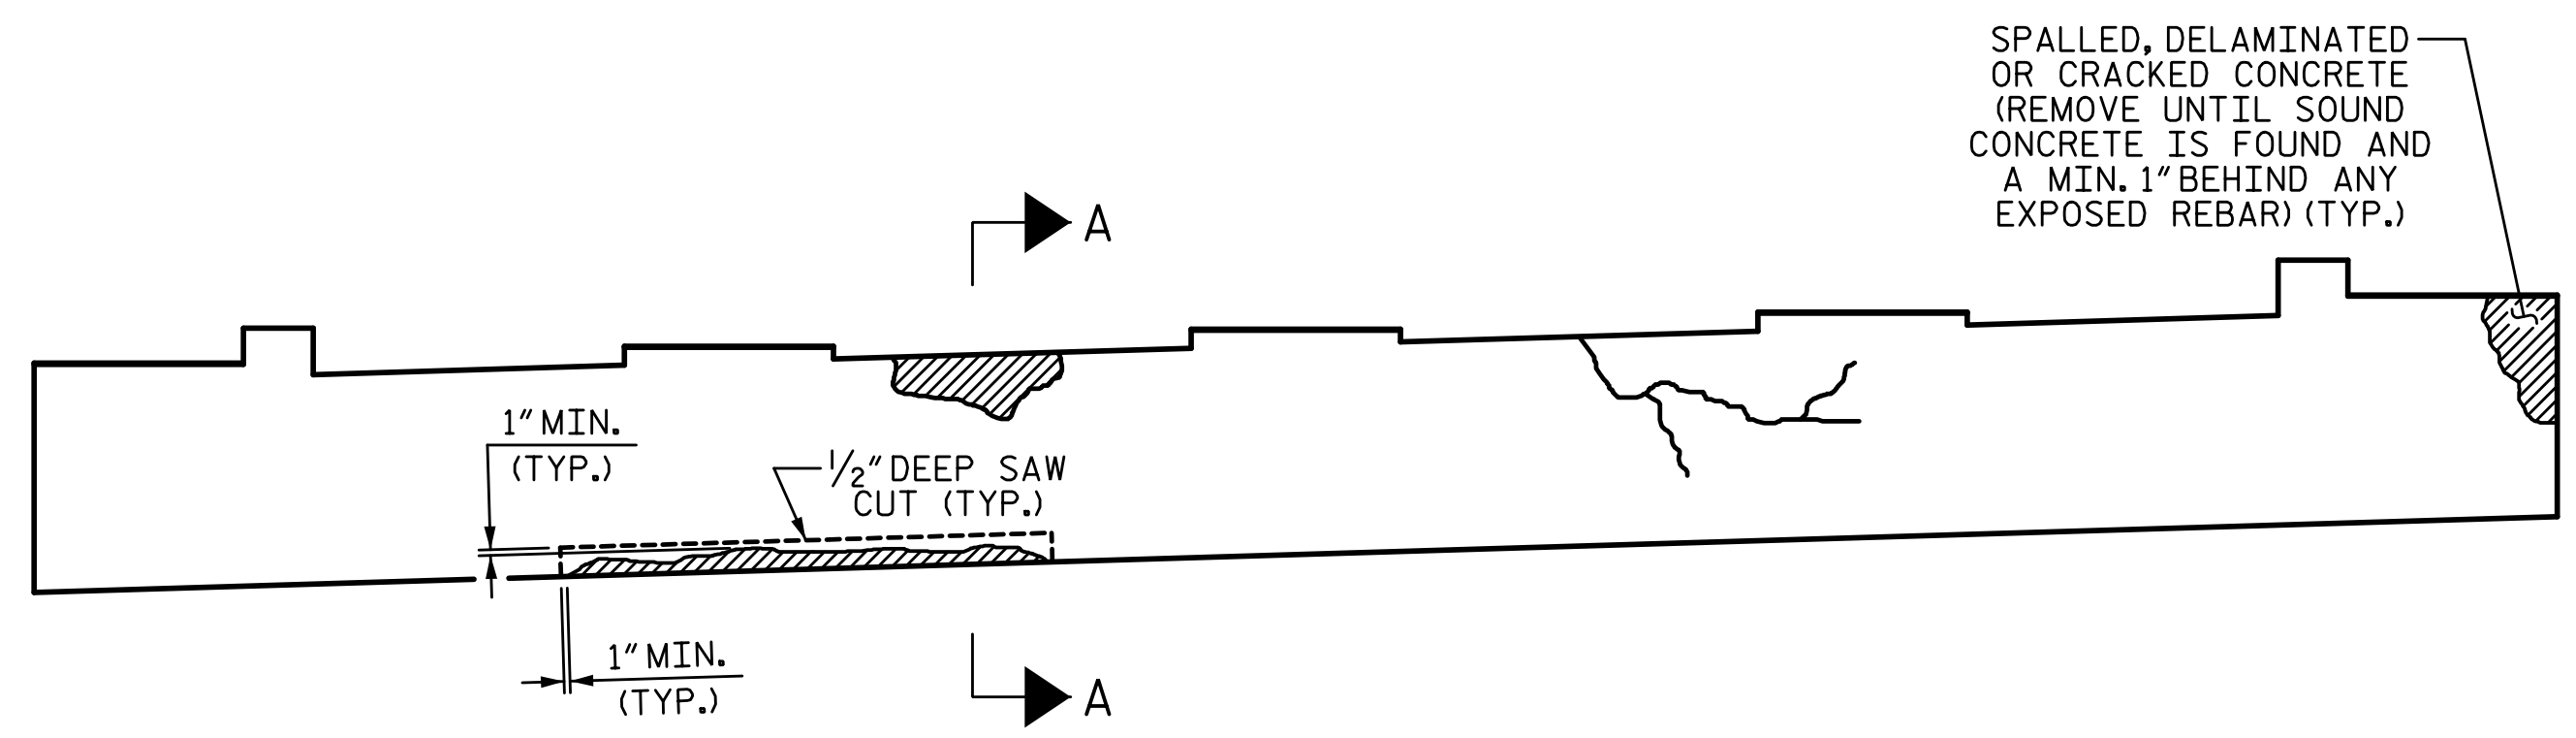
CAP REPAIRS
BENT SHOWN, END BENT CAP SIMILAR

CAP REPAIR

- TYPICAL BENT CAP REPAIRS ARE SHOWN, REPAIR DETAILS SIMILAR FOR END BENT CAPS AND STRUTS.
- THE METHOD USED TO DELINEATE THE AREAS OF UNSOUND CONCRETE TO BE REPAIRED SHALL NOT PERMANENTLY MARK THE CONCRETE, LEAVE ANY RESIDUE AFTER REMOVAL OF REQUIRE HARSH CHEMICALS TO REMOVE.

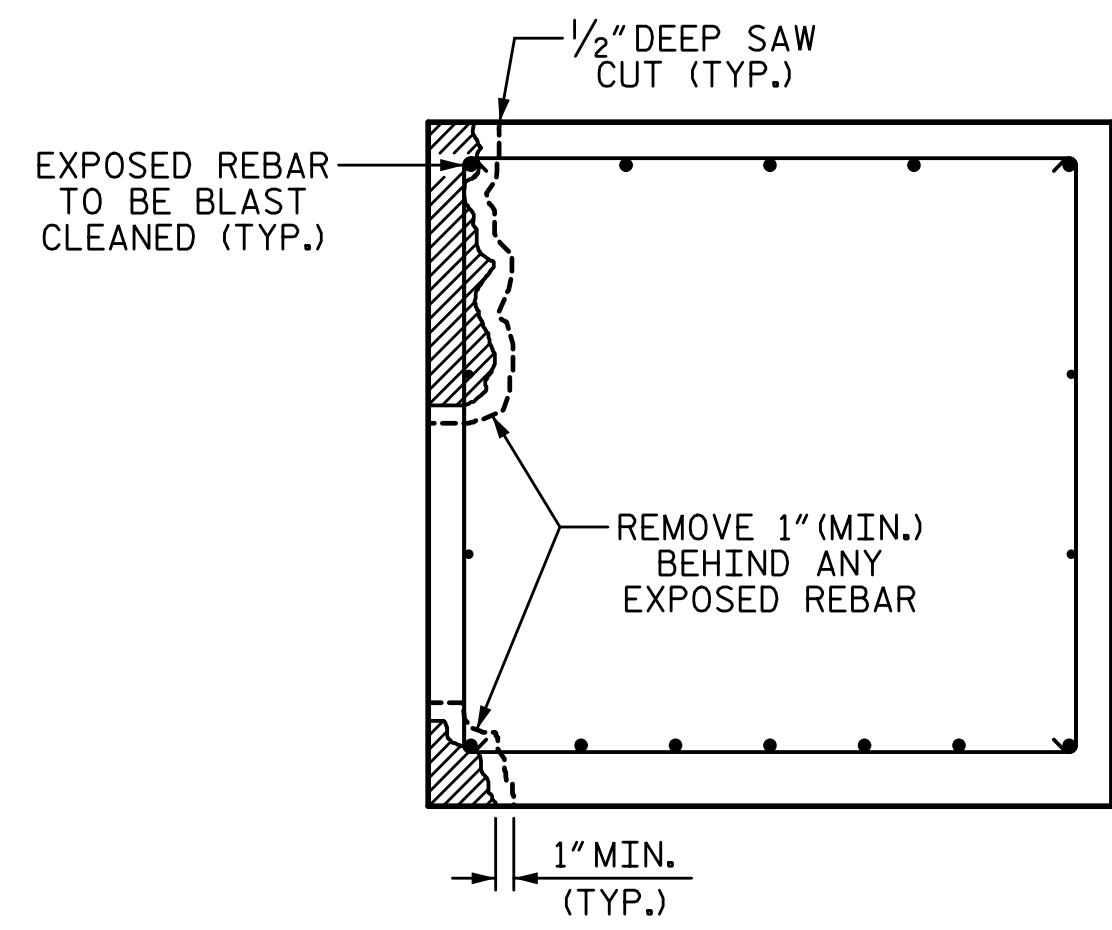
SECTION A-A
BENT SHOWN, END BENT CAP SIMILAR

SPALLED, DELAMINATED OR CRACKED CONCRETE (REMOVE UNTIL SOUND CONCRETE IS FOUND AND A MIN. 1" BEHIND ANY EXPOSED REBAR) (TYP.)

- REMOVE UNSOUND CONCRETE TO THE EXTENT NECESSARY, MINIMUM OF 1" BEHIND REBAR AND MINIMUM OF 2" CLEARANCE TO SAWCUT.
- NO MORE THAN ONE-THIRD OF THE CAP OR COLUMN CROSS SECTIONAL AREA SHALL BE REMOVED AT ONE TIME. SHOULD IT BECOME NECESSARY TO REMOVE MORE THAN 30% OF A CAP OR COLUMN CROSS SECTIONAL AREA, NOTIFY THE ENGINEER PRIOR TO PROCEEDING.

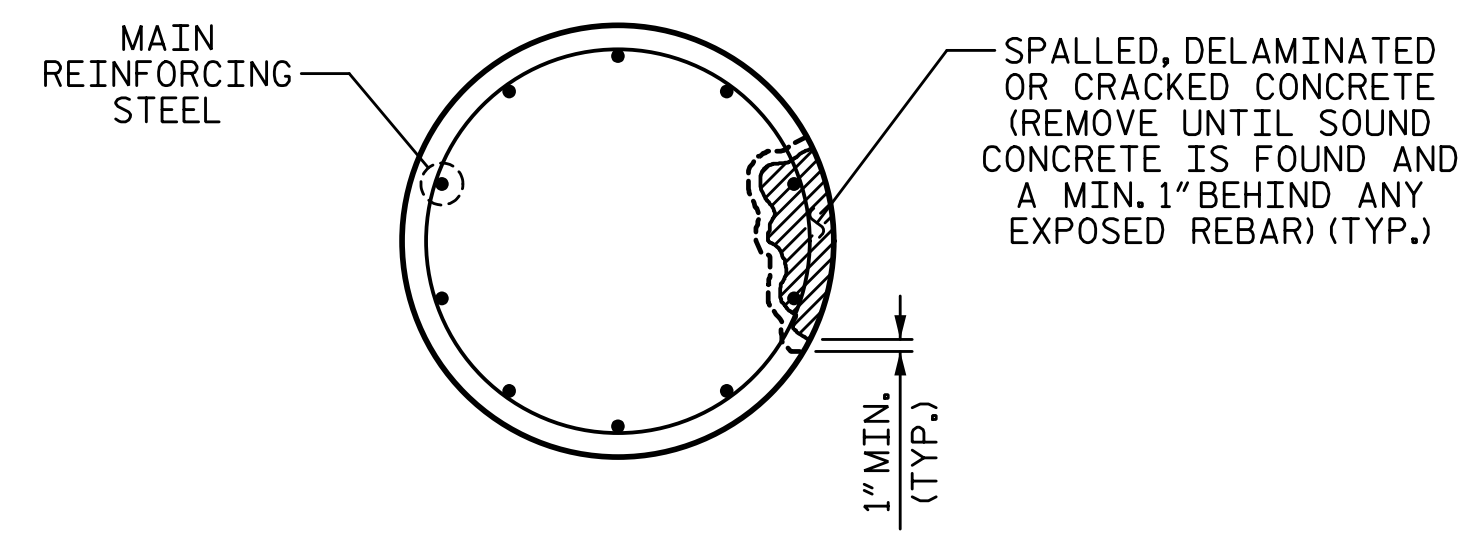
PLAN OF COLUMN

COLUMN REPAIR

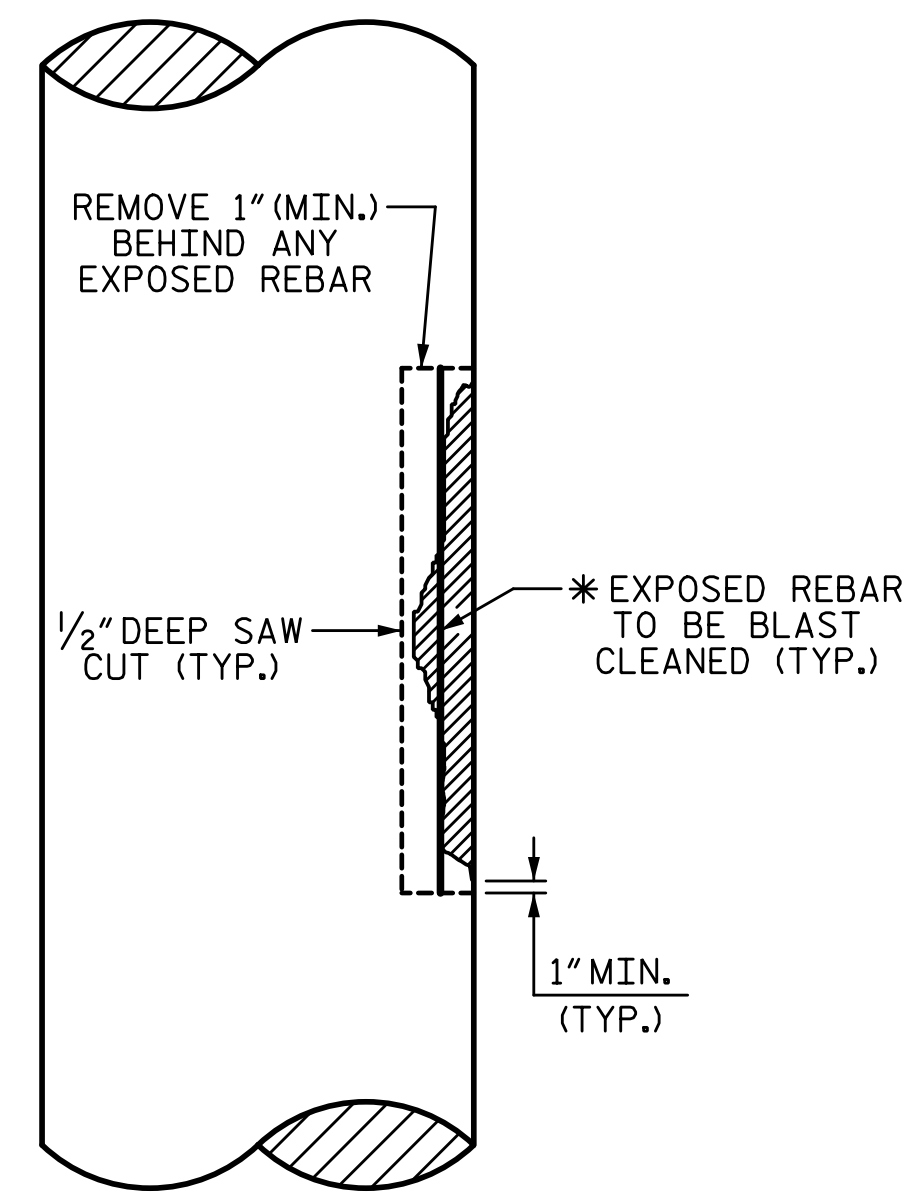
ELEVATION OF COLUMN
* IF CONFINEMENT STEEL IS NOT PRESENT, THEN REPAIR LENGTH SHALL NOT EXCEED 10 FEET

- REINFORCING STEEL WHICH IS DETERMINED BY THE ENGINEER TO BE REPLACED, SHALL BE REMOVED TO A POINT WHERE IT IS SOUND. THE PATCH SHALL EXTEND A SUFFICIENT DISTANCE BEYOND THIS POINT TO DEVELOP A SPLICE LENGTH SPECIFIED IN THE TABLE ON THIS SHEET.
