PROJECT NO. B-4626

STATION: 45+22.65 -EBL-

STATE OF NORTH CAROLINA

SUBSTRUCTURE REPAIR
BENT 2
SPAN "B" FACE

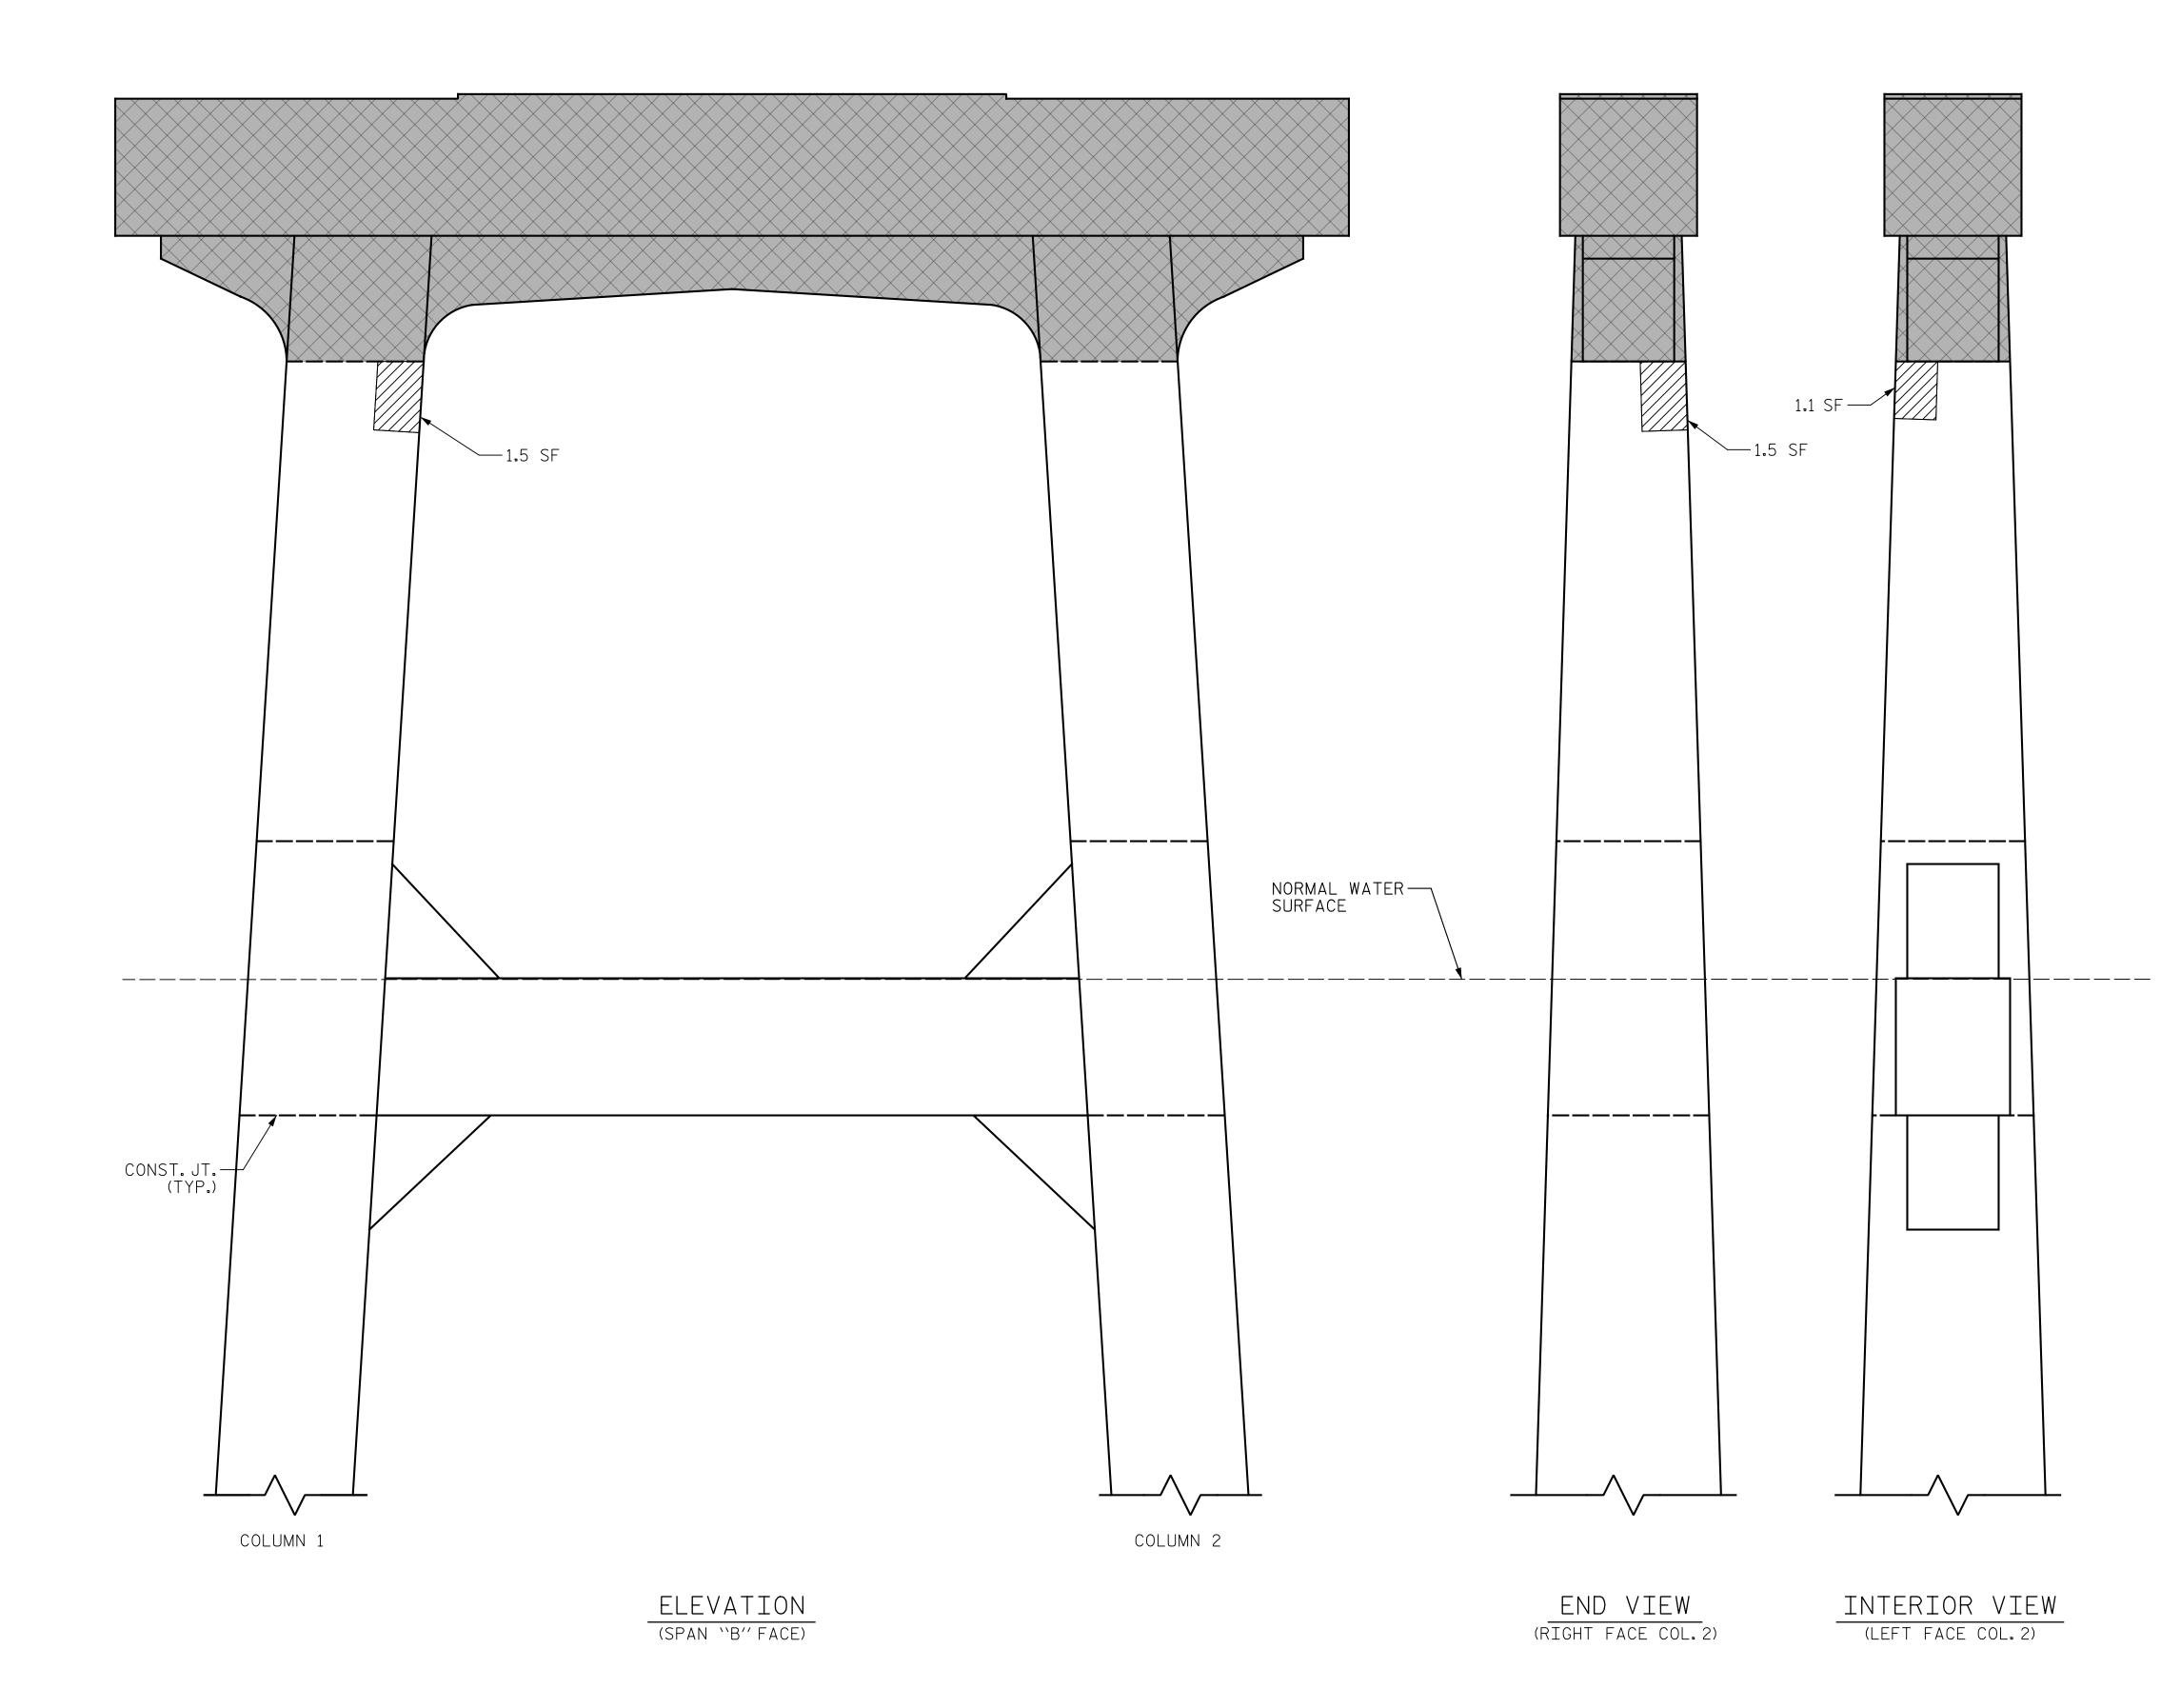
WHEN COLUMN REPAIRS ARE INDICATED TO GROUND LINE, EXTEND REPAIR MININUM OF 1'BELOW GROUND LINE.

FOR PROPOSED BENT CAP REPLACEMENT DETAILS, SEE SUBSTRUCTURE BENT SHEETS.

- SHOTCRETE REPAIR

ERI - EPOXY RESIN INJECTION

- DEMOLITION (SEE "CAP DEMOLITION DETAILS" SHEET)
