PROJECT NO. I-5746C

BRIDGE NO. 590320

UNDERSIDE DECK REPAIR

SPAN B

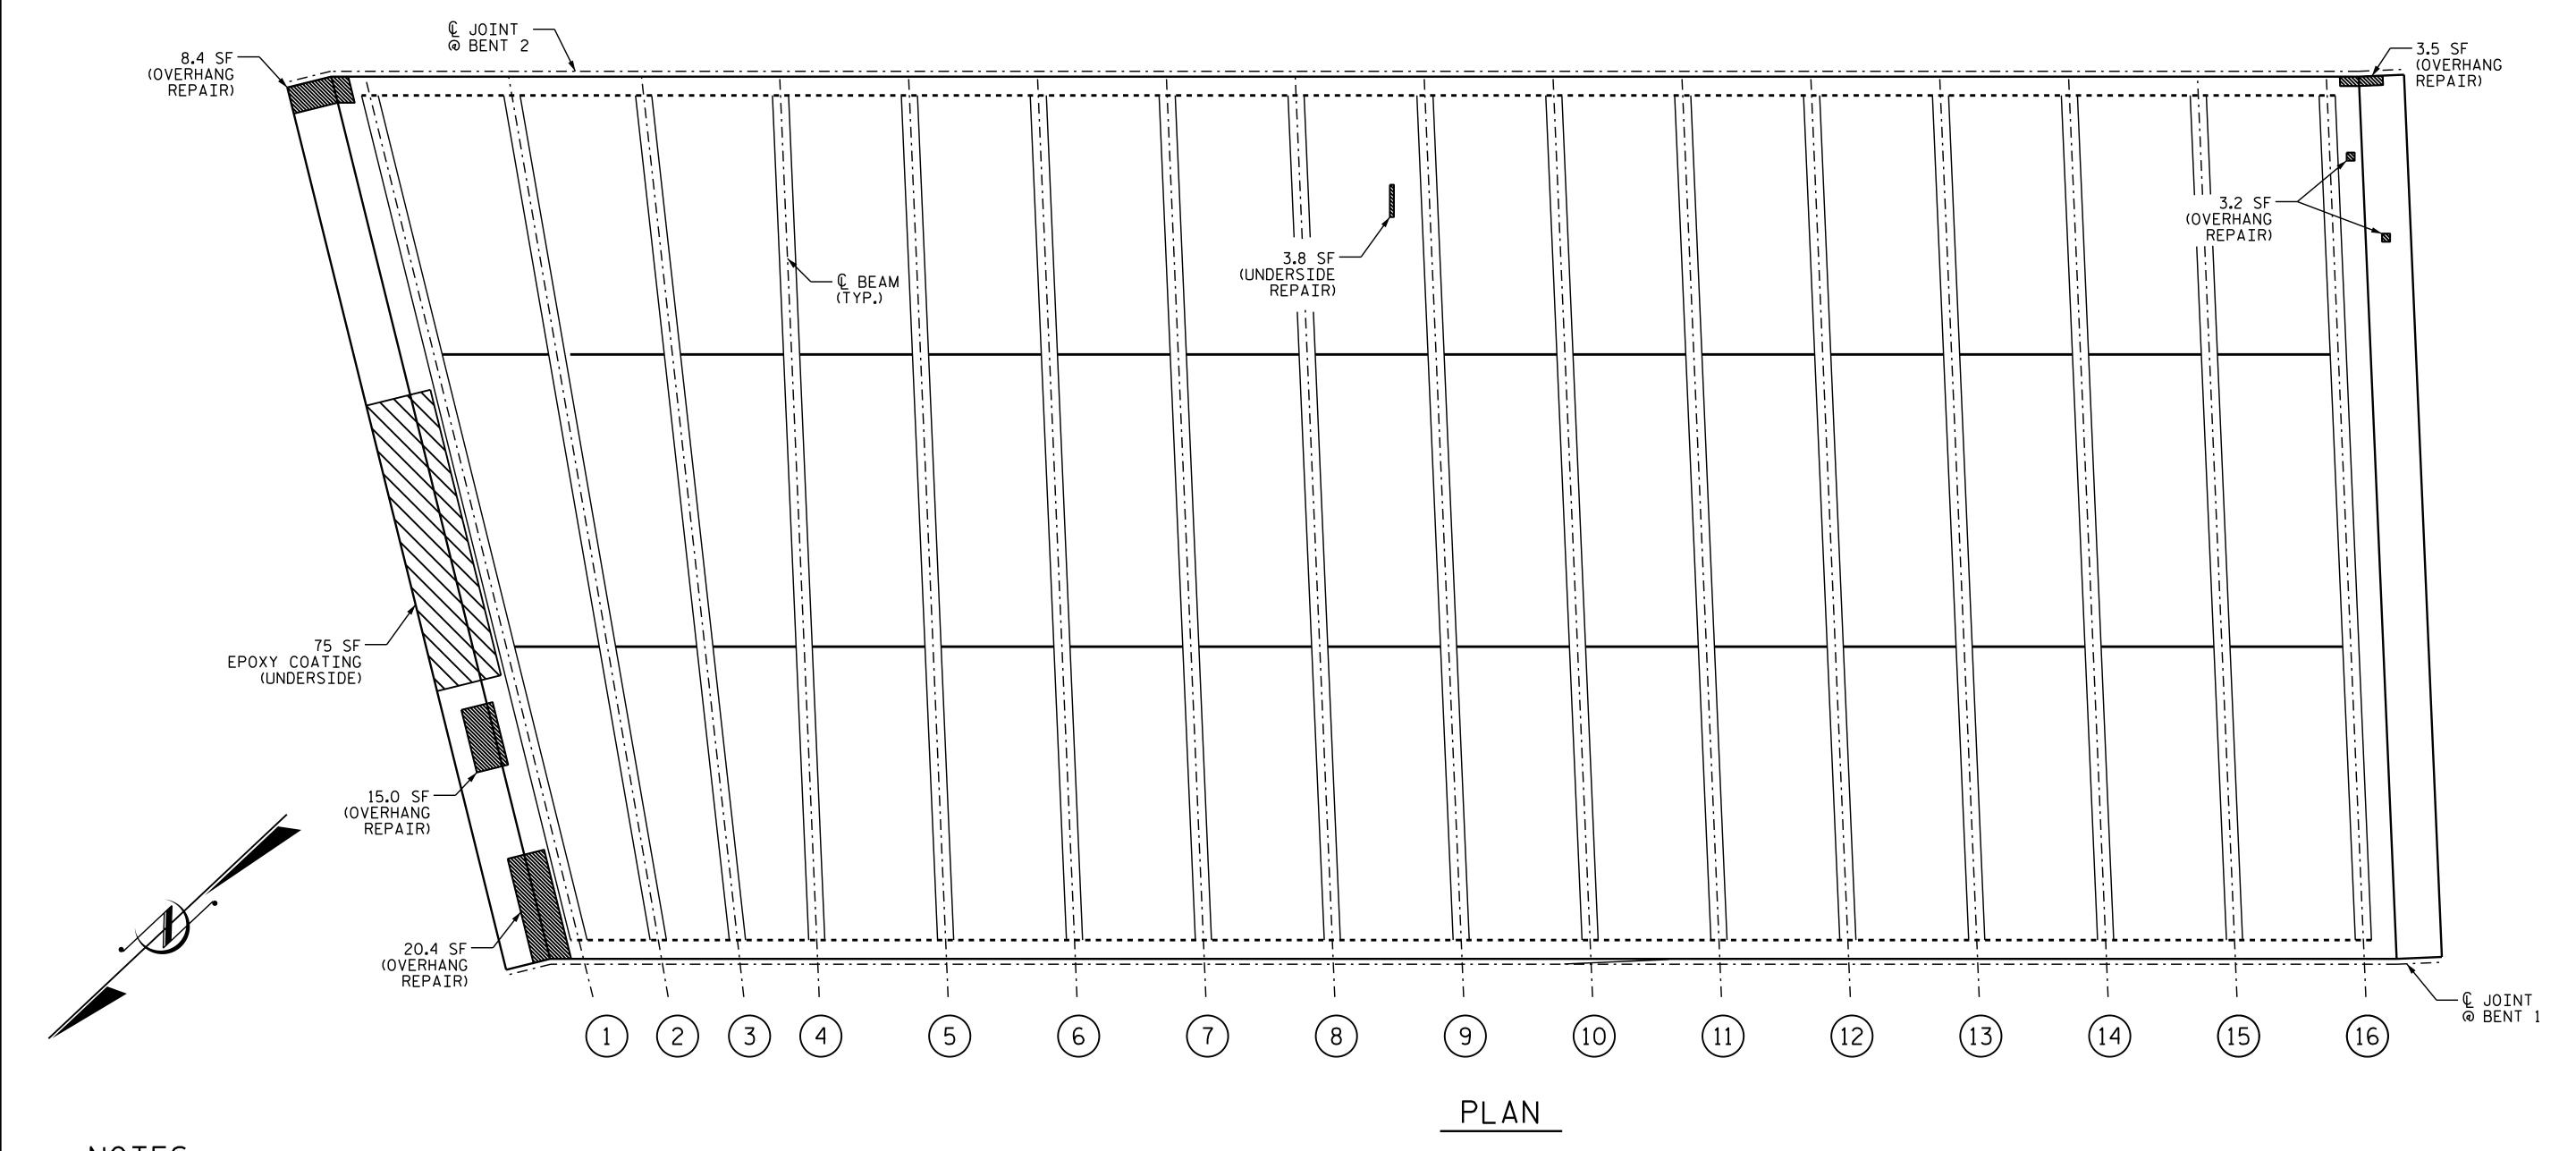
UNDERSIDE EPOXY COATING
UNDERSIDE REPAIR

DIAPHRAGM REPAIR

- 1) BEAM NUMBER
- B BEAM END REPAIR
- P PLATING REPAIR
- S) STIFFENER REPAIR
- (D) STEEL DIAPHRAGM REPAIR
